The Murals of the beiwusheng huiguan in Ziyang

Final report

Part 2: Condition, Conservation and Restoration

Research Project 01UG1001
„German-Chinese co-operation in the preservation of Cultural Heritage: Researches for the
conservation of selected monuments in the PR China“

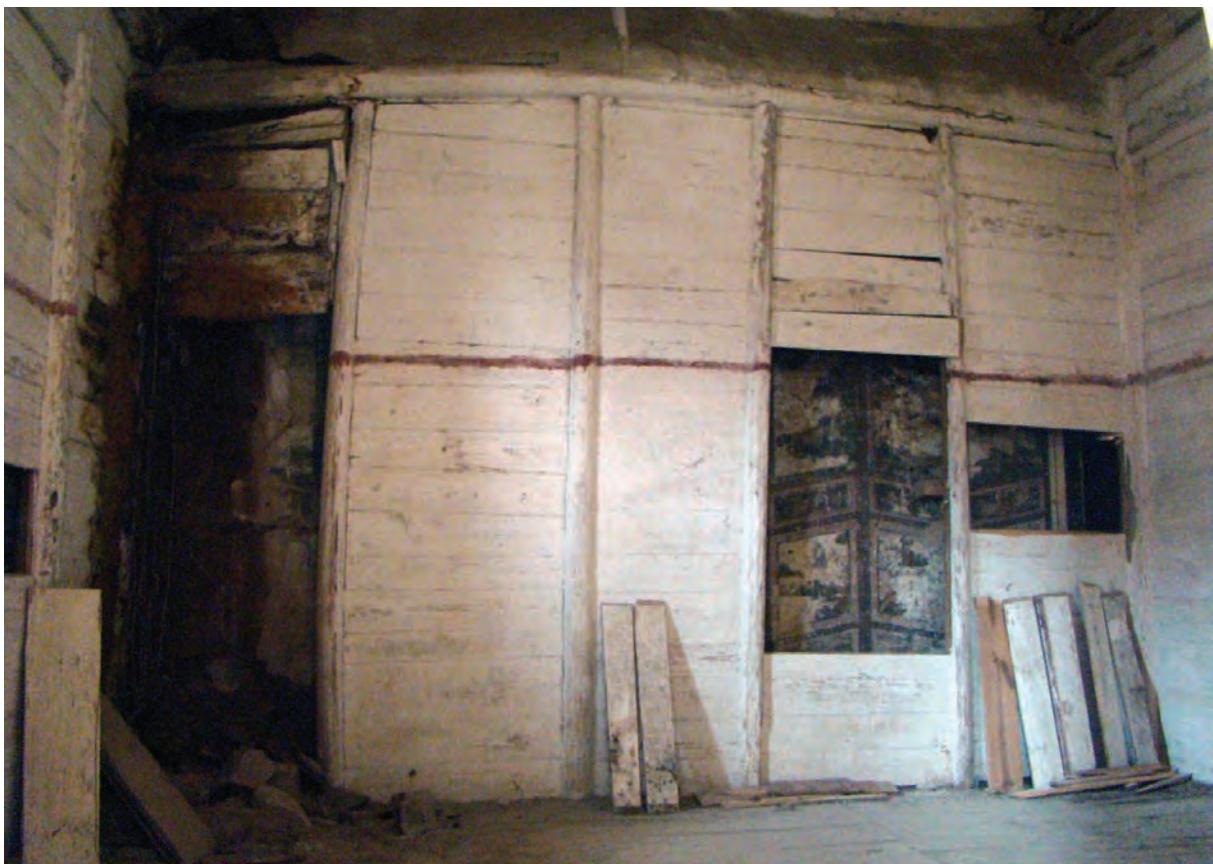
Fig. 2

Photo taken in 2008 before the wooden panelling and additional walls (left and right) were removed, *pingfeng xi* is located behind the panelling. In the corner on the left the roof was leaking. [Photo provided by Mr. Jiangbo]

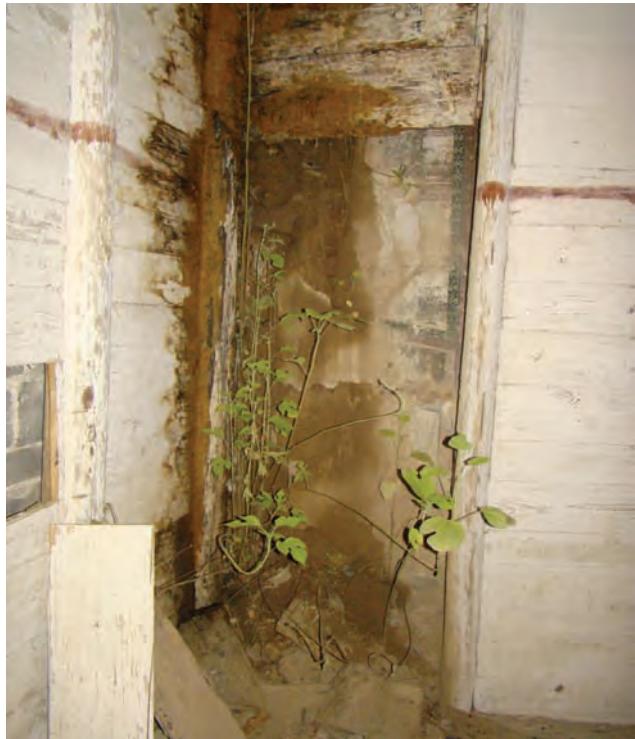
Fig. 4

After repairing the roof in 2008 the loss of plasters on the left was filled up to 2nd undercoat level. In adjoining areas, the priming layer has been washed off from the fine coat.

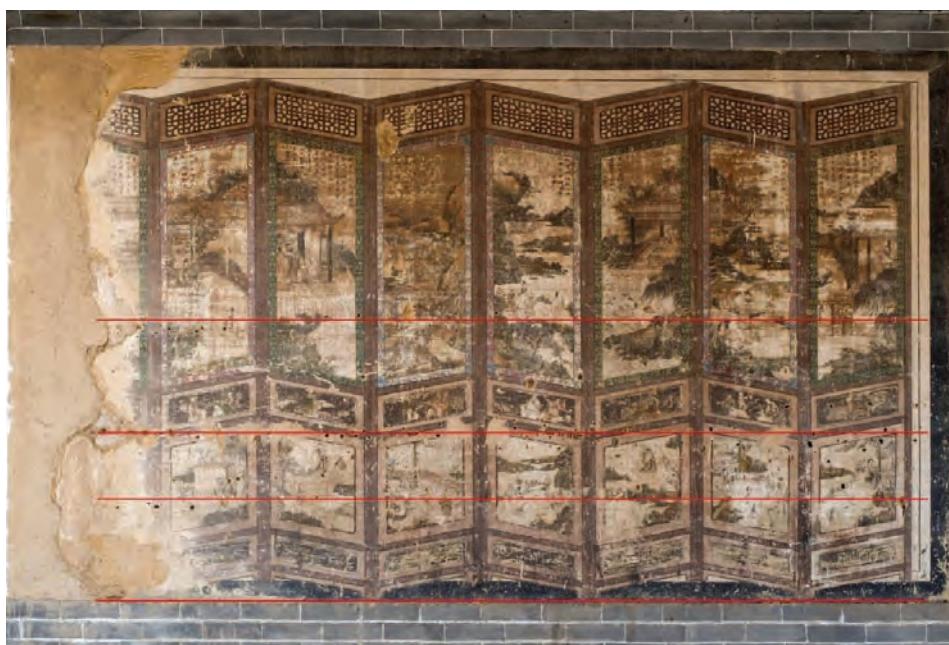
Fig. 5

Pingfeng xi, the red lines sketch zones where holes are concentrated. They are not all exactly on the same level; still the holes seem to be in relation with some construction that has been there at a time.

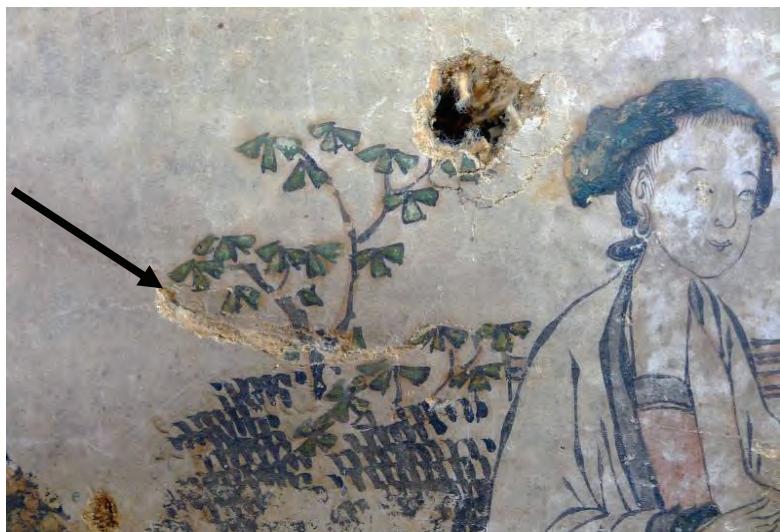
Fig. 6
Pingfeng xi detail 8d: In the green bush is a dented area, where the fine coat and paint layer is pushed in. On the bottom the dent is so bad, that the painted surface is ripped apart and displaced behind the surface level. Along the edge of this the painting and priming layer is bashed. Fibres of the fine coat are sticking out of the edges of the hole. The hole is caused by a pin or dowel. The lower edges of the hole are bulged and partly bashed.

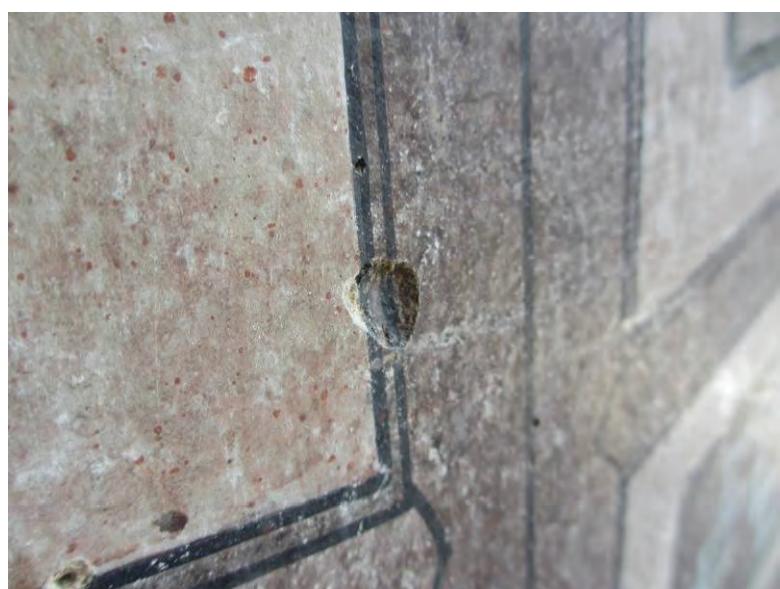
Fig. 7
Pingfeng xi, detail of the framework: The fine coat and overlying paint layer is pushed in, along the edges the paint layer has broken apart.

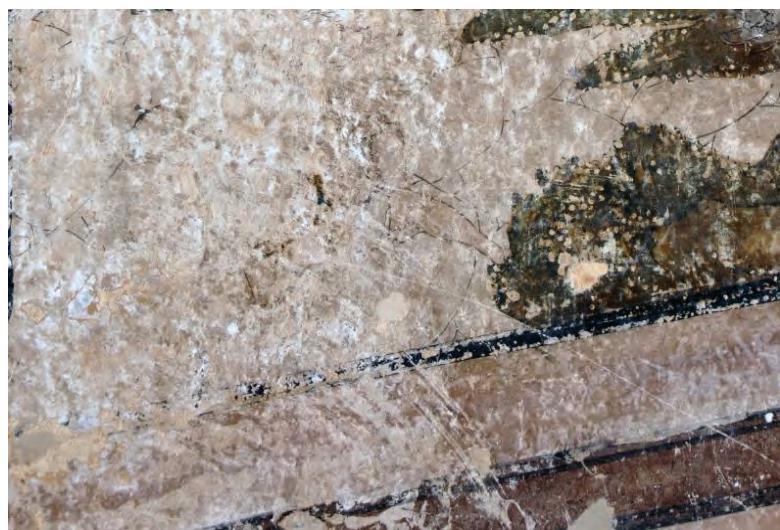
▲ Fig. 9
Pingfeng xi, panel 6 d, detail of the man in the bottom left corner trying to melt the ice with his body, almost unreadable because of the damage by scratching.

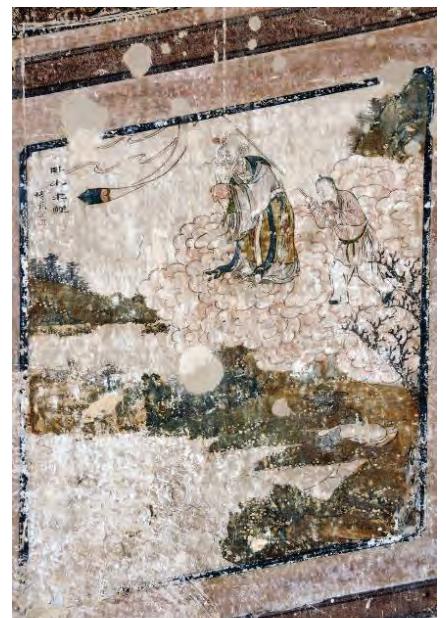
▼ Fig. 8
Pingfeng xi, panel 6 d, the man in the bottom left corner trying to melt the ice with his body is hardly visible because the area was severely scratched up. (Holes are already filled at this photo.)

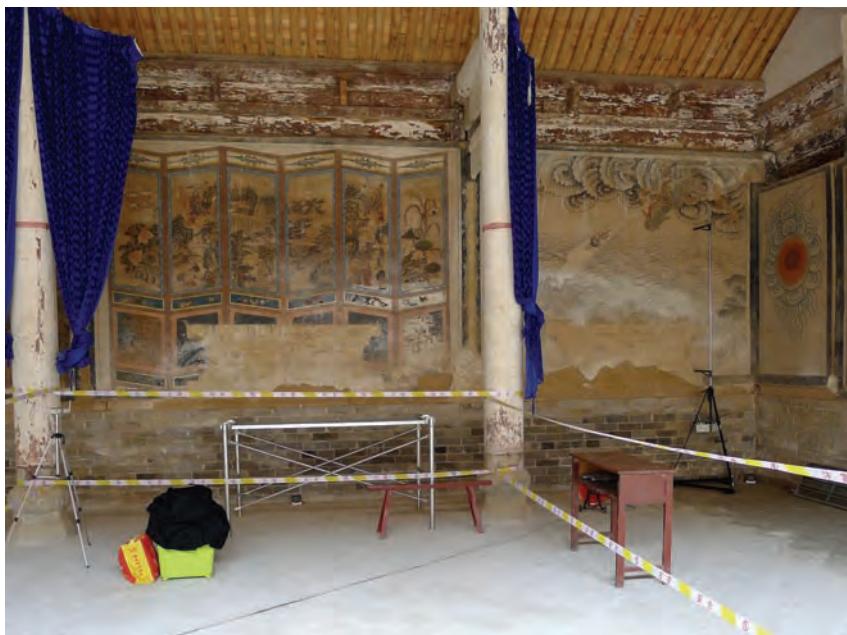
Fig. 14

The reason for this white efflorescence is a heap of coal which had still been stored on the outside of this wall when the roof was repaired in 2008 (fig. 16). The coal stock gathered the rain falling from the roof and directed the water towards the buildings' wall. The wall became wet and was also kept moist for some time by the coal. With the desiccation of the wall, water-soluble salts were transported towards the evaporation level on the painting's surface and the outer brickwork façade, where crystallization led to white efflorescence. The source of the salts could not be determined. One possibility is that they were already contained in the building materials; another is that they were dissolved in contaminated soil and were transported upwards through the brickwork wall. In raking light the surface of the mural *long* has a kind of rippled surface, altered by the former moist wall that caused swelling and shrinking resulting in this deformation (fig. 23). During the work stays the floor in the north-eastern area of *zheng dian* and also the eastern area of *guo dian* were often wet after heavy rain falls, but the pedestal zone did not seem to get moist anymore.

Crescent-shaped white salt efflorescence on the north wall of *zhengdian*, in the area of *pingfeng bei* on the left and *long* on the right. In a large part of this area the plasters have separated on their interfaces due to moisture and salts. This led to losses in the lower part of these two murals.

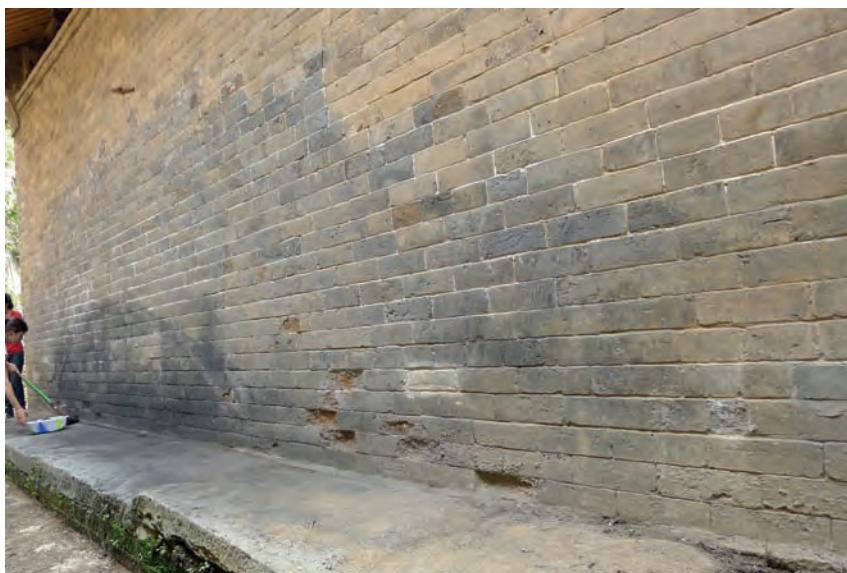
Fig. 15

On the façade of the north wall a crescent-shaped blackish area is present on which salts effloresced on joints and damaged bricks.

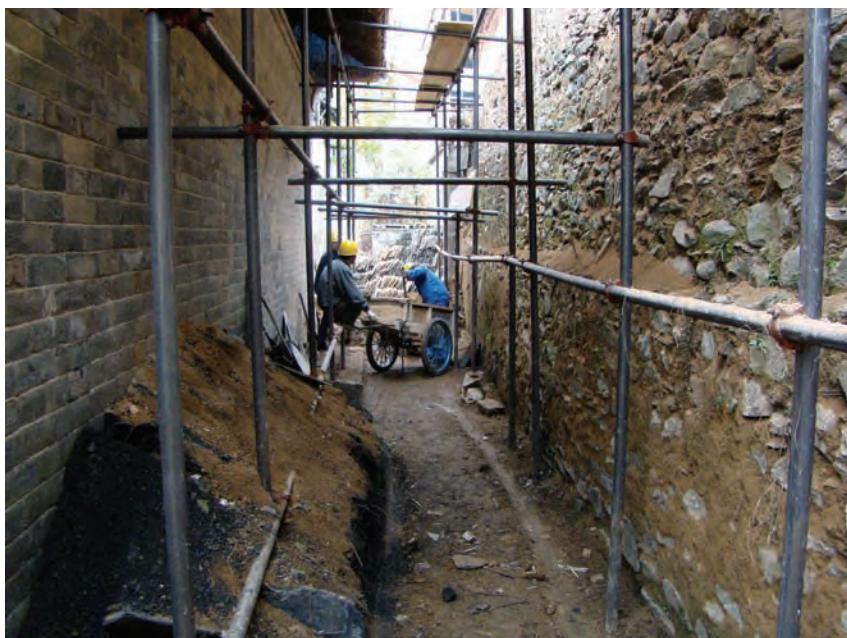
Fig. 16

Photo taken during the roof renewal in 2008, showing a coal stock outside *zhengdian*'s north wall [Photo provided by Mr. Jiangbo].

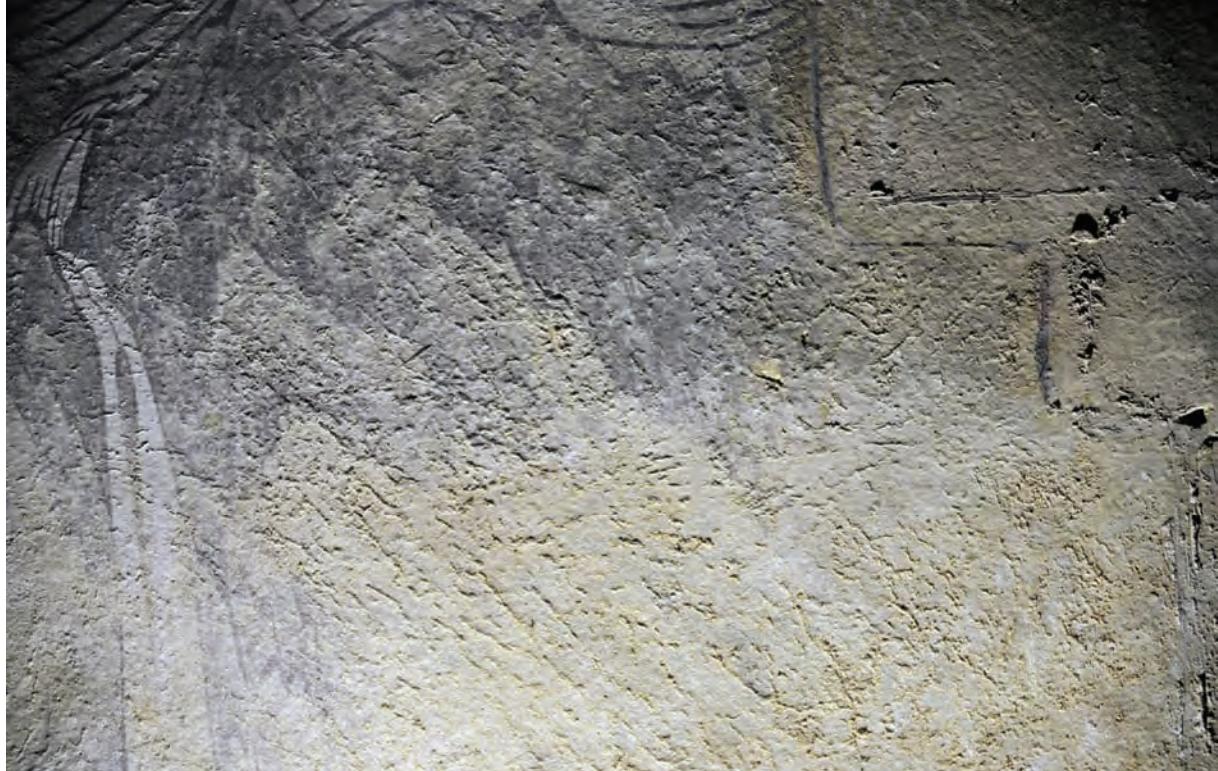
▲ Fig. 21

Detail of a repair plaster, with white salt effloresced on the surface and accumulations which led to crater-shaped losses. It seems as if salts have crystallized and by the uptake of volume have burst away the surface

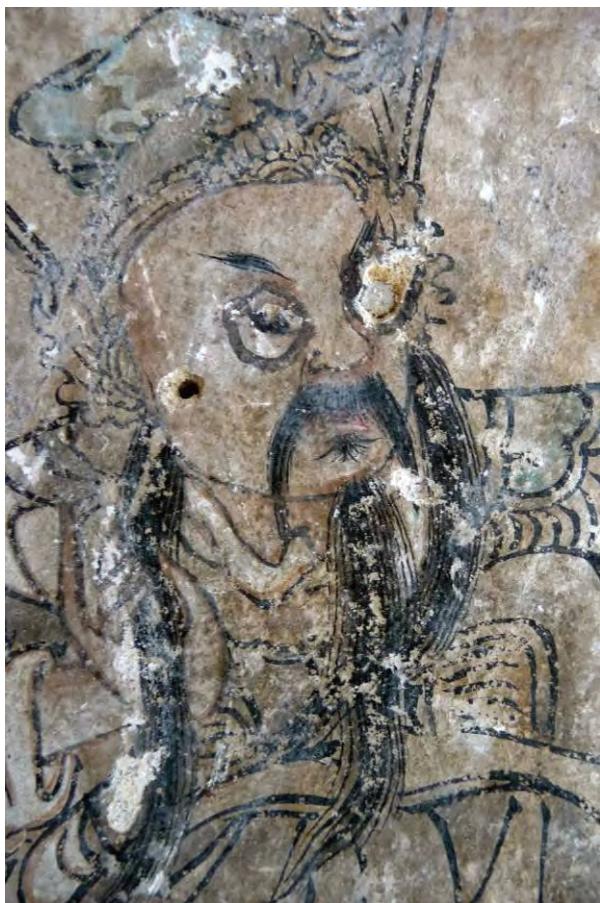
Fig. 24

Detail of a man in *pingfeng dong* panel 4 d. Holes are pricked into the face and eyes are circled with ink or paint.

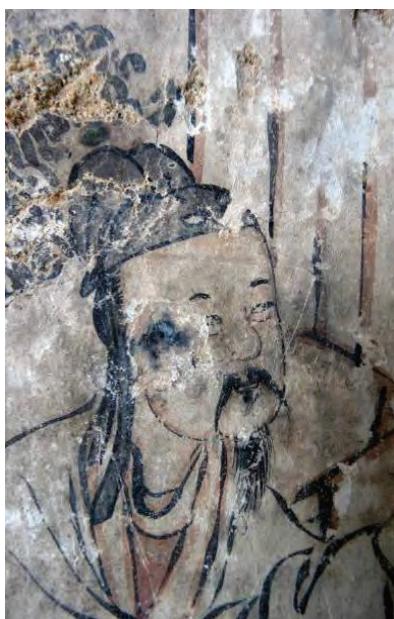
Fig. 26

Man with a burnt part in his face, *pingfeng xi* panel 2d.

In the lower part of *pingfeng xi*, in the area of the e-panels and nearby above and below, several stains were directly or indirectly caused by heat or fire. Several grey to black stains in the shape of flames are likely deposits from something like candle flames or smouldering incense sticks (fig. 51, 53). In one of these flame-shaped stains, the heat seems to have had impact on the colour of the paint.³ The normally black paint seems to have changed to red due to the heat, or it was prevented from turning black in this area. In the d-panels of *pingfeng xi* dark stains were caused by something that burned the surface directly and therefore scorched it. This damage can be observed mainly in the figures' faces of the d-panels. This was categorised as an act of vandalism and described above (fig. 26–28).

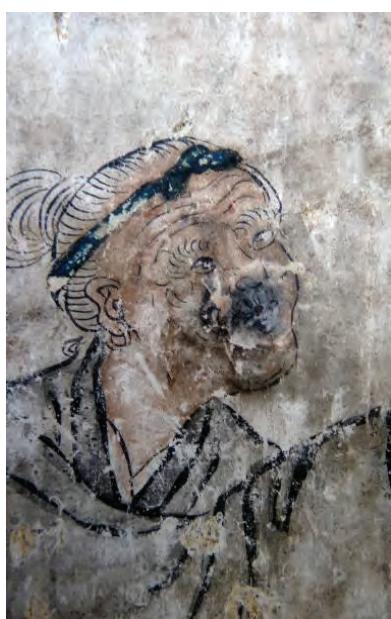
Fig. 27

Lady with a burnt part in her face, *pingfeng xi* panel 5d.

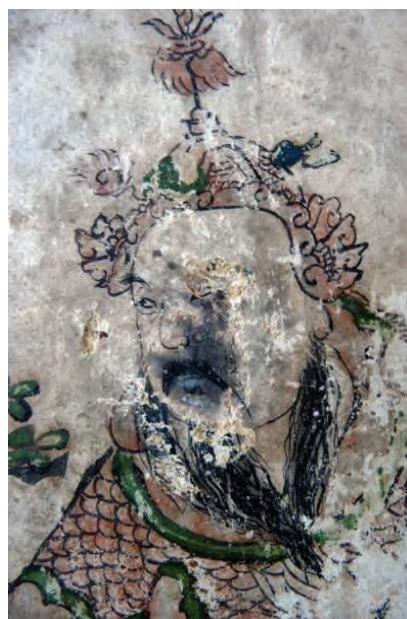
Fig. 28

Man with a burnt part in his face, *pingfeng xi* panel 5d.

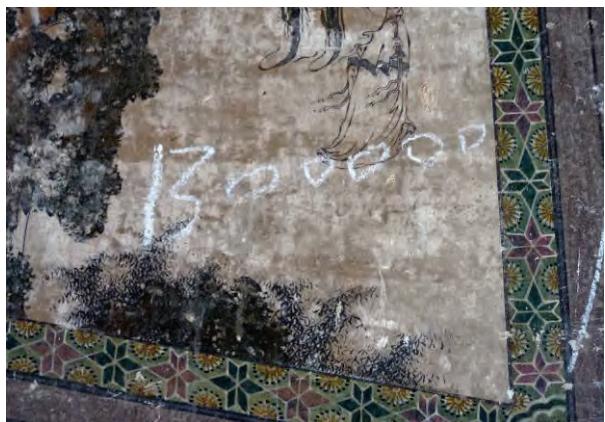
Fig. 29

Detail of *pingfeng dong* panel 3b, graffiti with chalk.

The Chinese colleagues wanted the numerous Graffiti to be removed or become illegible. Graffiti made from chalk was easily removed with the dry cleaning sponges. Graffiti made of other material could not be removed, although different approaches were tried. Cleaning with erasers led to damage of paint and priming layer. An eraser pen (Faber-Castell/Perfektion 7057) was tested and considered unsuitable. It was possible to reduce some of the graffiti paint with it, but at the same time the soft priming layer underneath was compressed and its surface gloss changed. The graffiti made with ink seem to have been carried out with different paints. Some were not affected by water at all, but some could be reduced a little with moist cotton swabs (fig. 58, 59). The paint also permeated layers of the painting and of priming layer, however, so the graffiti could not be taken off without damaging those. Since there was no possibility to clean or take off the Graffiti without damaging the mural, retouching was chosen as a way to conceal them and match these areas with the surrounding. Paint stains and soot, which has permeated into the painting layers, could also not be removed, but stains from waxy material could be removed with hexane. Paper sticking on the surface was lightly wetted and could then be taken off with the help of a wooden tool and the horn spatula.

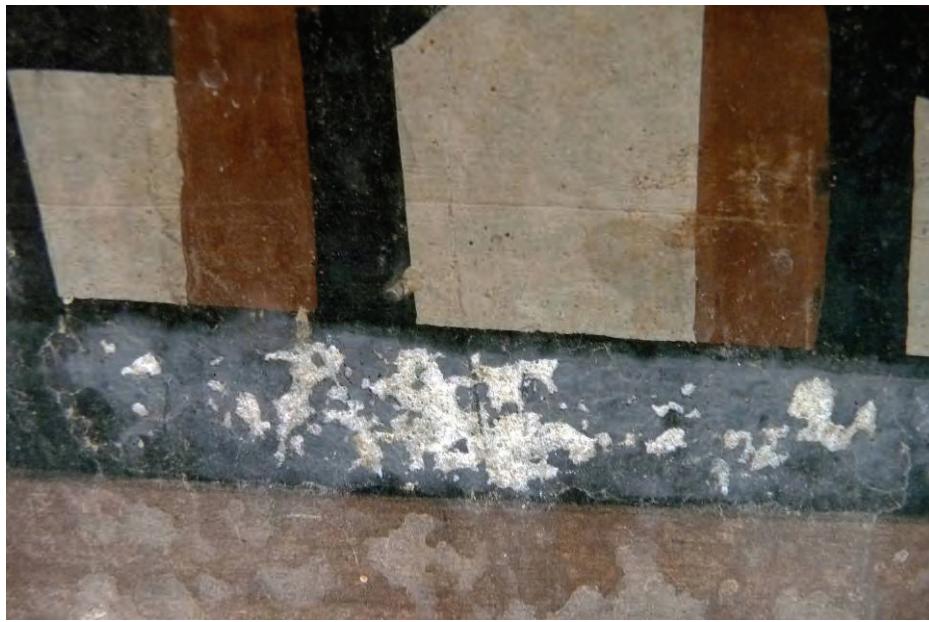
Fig. 34
Pingfeng xi, panel a, the black filling frame paint has a whitish blurred surface and some losses.

One of the black paints on *pingfeng xi* which has been used for the black filling frames of the panels a and d shows a distinctive deterioration, compared to the black fill that has been applied on top of the contour lining. The black fill paint does not have good adhesion to the carrier, so that fragments got lost. The surface of this paint has altered and turned whitish in some other parts. Compared to the other black paint used on *pingfeng xi* it seems more sensitive to water and gets blurred by it (fig. 34)

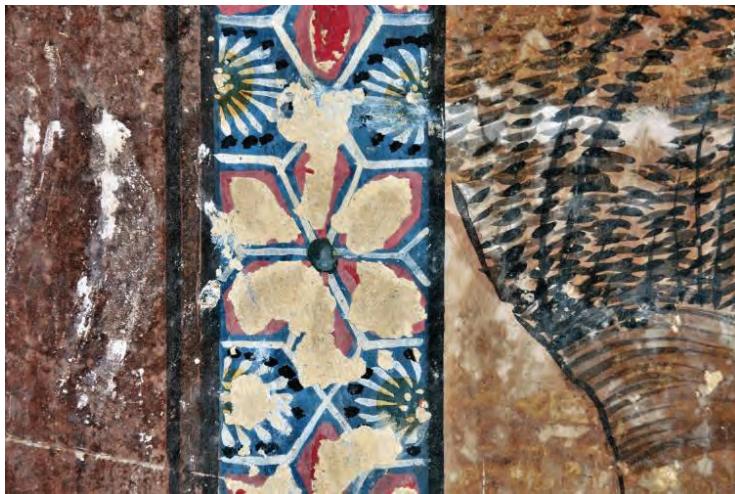
Fig. 37 , 38 ►

The flower-and-star-border of *pingfeng xi* has a distinctive pattern of damage. Losses derive from the dark red paint, which is present in the centre of the points of the stars and in the red centres of the small flowers (fig. 37, 38). Due to tensions within the red paint layer and on the interface between the priming layer and fine coat the red paint has flaked off. The detachment happened between priming layer and fine coat, although it was caused by the application of the red paint. In the loss one can see that the binder of the dark red paint has soaked and penetrated the priming layer. The permeated binder of the red paint is visible as a shadow in a distinctive shape on the exposed fine coat surface. The light red or pinkish paint around the red centres has partly the same problem. The blue paint has a better adhesion to the support, though in places it got peeled off by the flaking red layer together with the priming layer. The cohesion within the paint layer composite and the adhesion to the priming layer is stronger than the adhesion to the fine coat.

Pingfeng xi panel 4 b: Damages of paint layer in the flower-and-star-border began from the red paint of the points of the stars and from the red centre of the flowers. In the exposed fine coat the shape of the former dark red area of the star is visible. The binder of the red paint has permeated the priming layer and left dark marks on the fine coat.

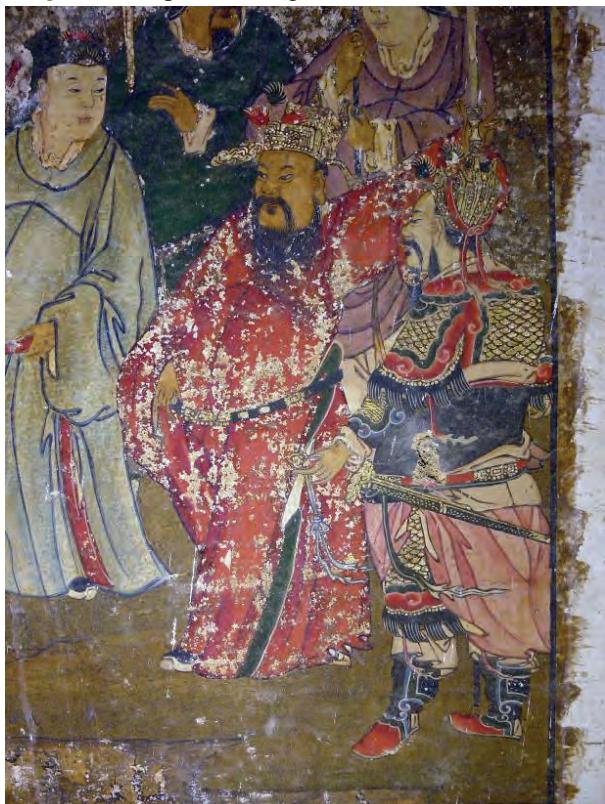
Fig. 40

Sanguo xi close-up, the red paint has cracked to small fragments; edges of fragments started coiling up.

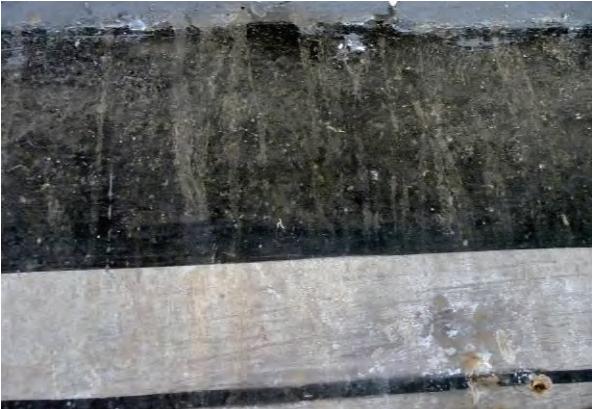
◀ Fig. 47
 Marks from washed up dust or clay where water was running down, can be found all along the top edge of *pingfeng xi*.

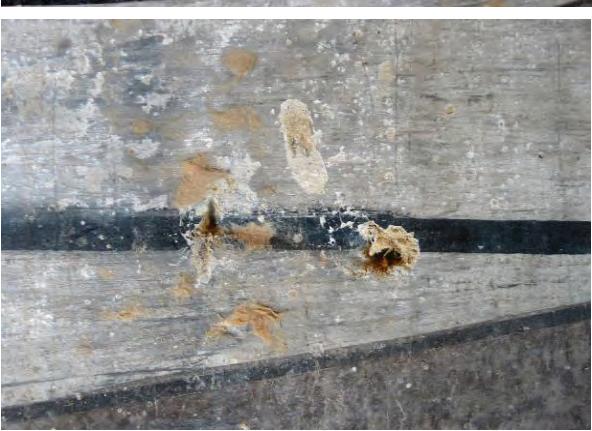
Fig. 48
Pingfeng xi, above the 6th wing of the painted folding screen, remains of light brown paper on the surface.

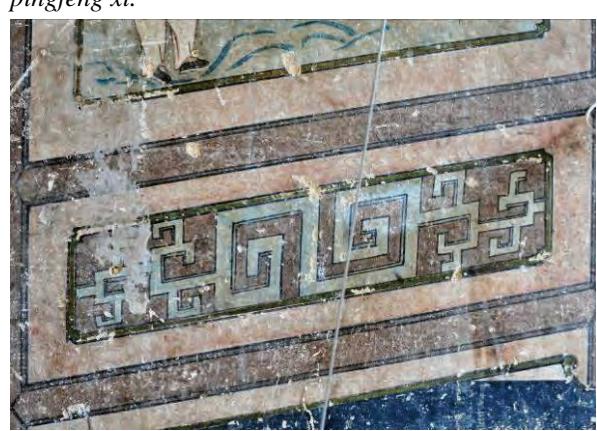
Fig. 49
Pingfeng dong, panel 6 e, greyish paper stuck onto the painting.

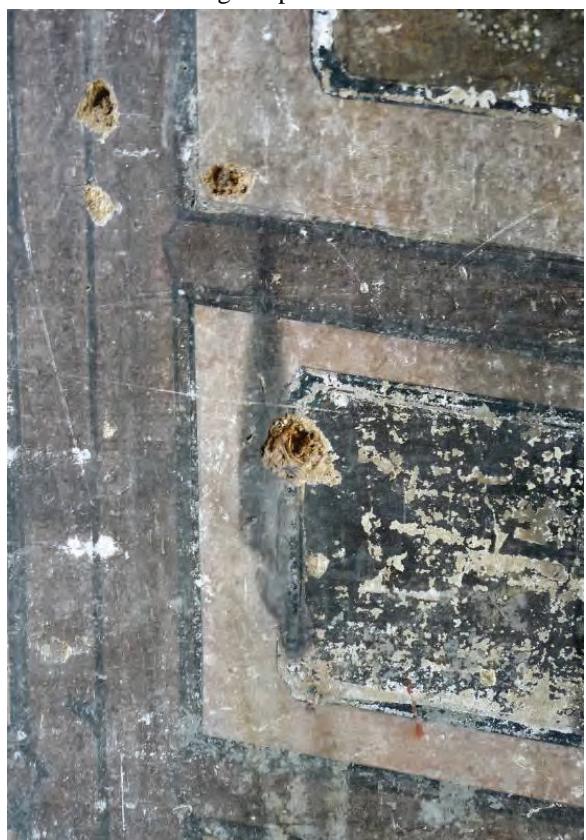
Fig. 53
Soot stain on the edge of panel 3e.

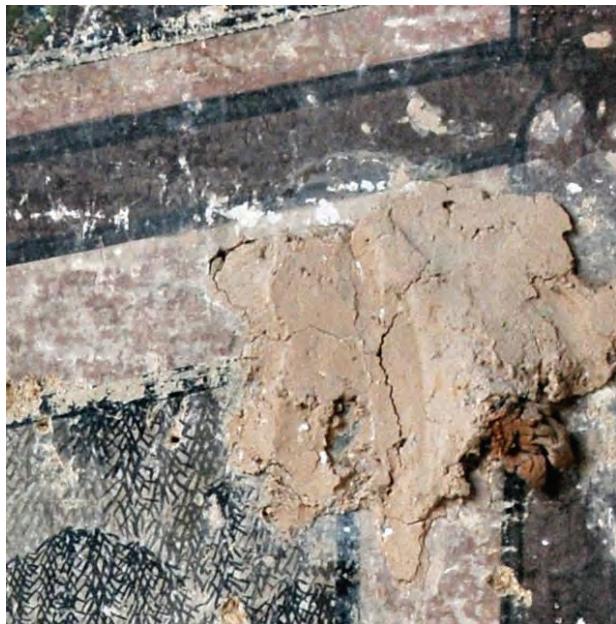
Clay soiling was another issue which originated from inappropriate repair fillings with clay smeared across the edge of losses onto the painting (fig. 60). The soiling adhered strongly to the painted surface, therefore taking it off mechanically was not possible because removing the clay resulted in splitting off the adhering painted surface with the priming layer. Consequently, thick lumps of clay were bit by bit thinned from the top. The clay was carefully wetted with a mixture of water and alcohol (mixed in parts 1:1), so that the underlying painting and priming layer did not get affected. This helped to soften the clay and reduced its cohesion. The clay was then thinned with scalpels and could be removed in a controlled way, using a horn spatula near the painting’s surface. This spatula was originally a cosmetic tool to clean and remove cuticle on finger nails. It was modified, so that it had a sharp and flexible end like a knife. It was used because metal spatulas and scalpels damaged the painting too easily. The last remaining thin layer of clay was then cleaned with „Akapad soft“ sponges (fig. 61).

Fig. 60
pingfeng xi panel 2d, detail of an old repair filling, clay smeared across the edge of the loss onto the painting.

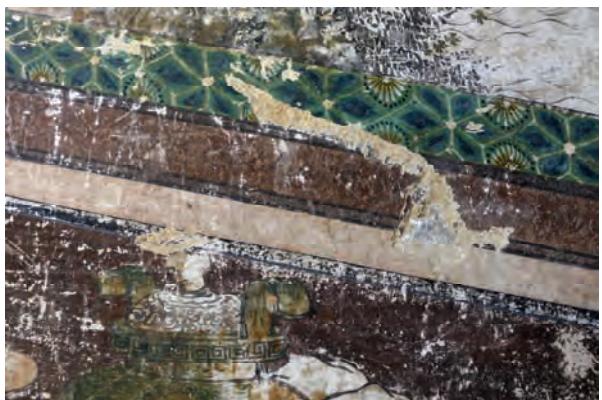
Fig. 77
Pingfeng xi, detail of panel 3 b, paint layer loss and damaged fine coat.

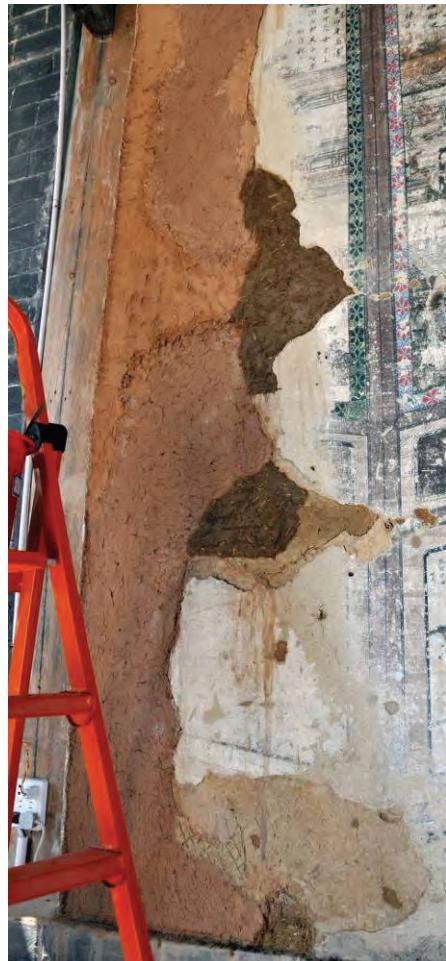
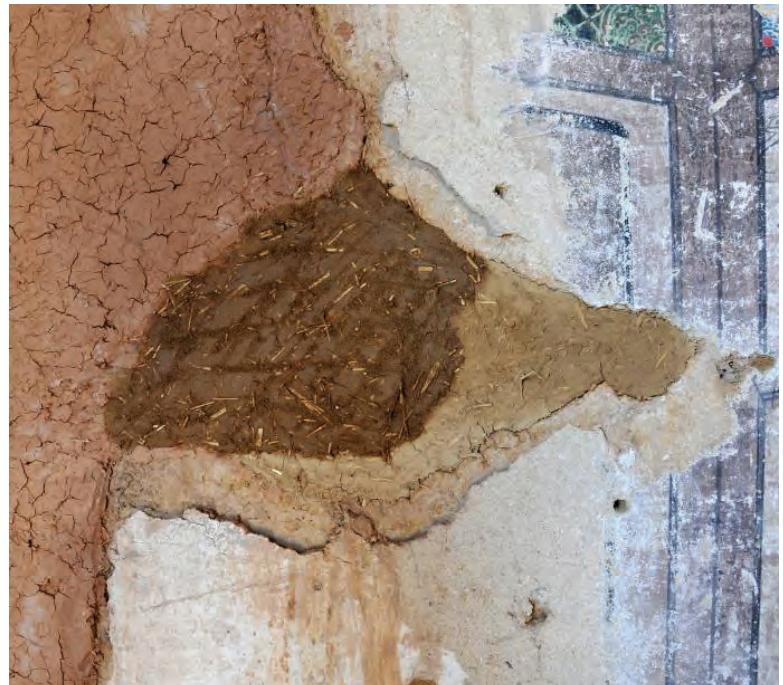
Fig. 79, 80 ▲
In the area of the big loss there are two different reddish repair mortars present. In little places there is the original surface of the 2nd coarse coat remained. For example in an oval shaped form on the bottom. The fillings up to the 2nd coarse coat level were made with the filler designed for losses in the coarse coat- The surface was roughened up with a criss-cross pattern, so that the fine coat would interlock with it.

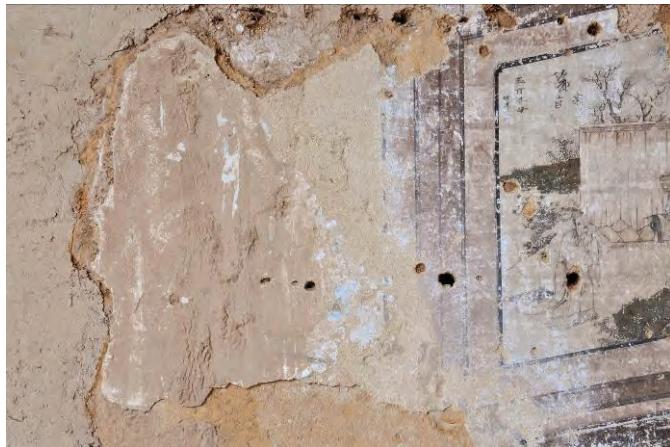
Fig. 132
Pingfeng xi, panel 1d, before restoration.
