Shuilu'an

Jahresbericht / Annual Report 2007-2009

**BMBF Forschungsprojekt / Research project
01GWS079**

Forschungsprojekt 01GWS079
„Deutsch-chinesische Zusammenarbeit im Kulturgüterschutz: Forschungen zum Erhalt
ausgewählter Denkmäler in der VR China“

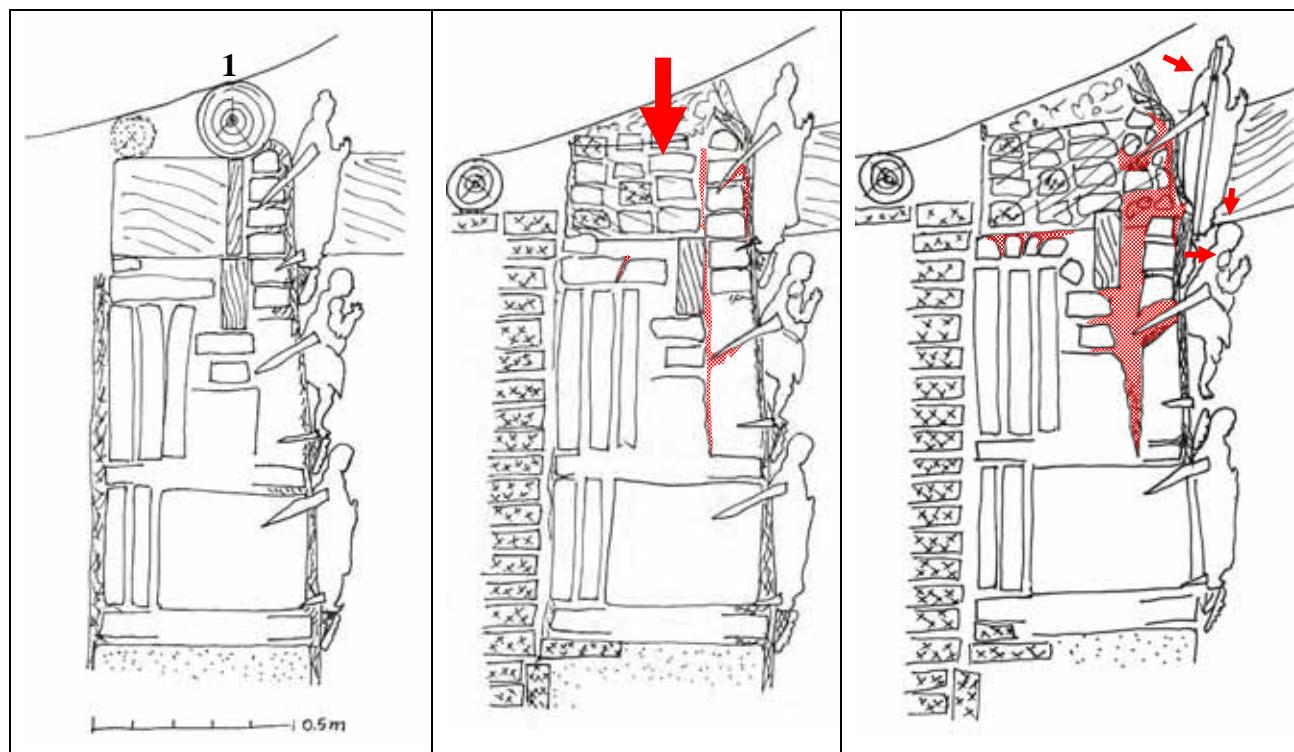
6a
West wall. section at building time

6b
West wall, eaves purlin removed,
roof resting on wall

The leakage of the roof especially on the western eaves side, where the slope is longer seems to have been a constant problem throughout the twentieth century, resulting in repeated interventions of repair. In one of the interventions the eaves purlin (fig. 6a, (1)) on top of the west wall and parts of the lintel below have been removed without replacement. The rafters were lying directly on top of the clay wall. The purlin is still missing today.

The weight of the heavy roof resting on the clay wall (fig. 6b) resulted in a compression of the wall of about 10 cm. The decayed wooden pillars were also pressed down. This can be seen

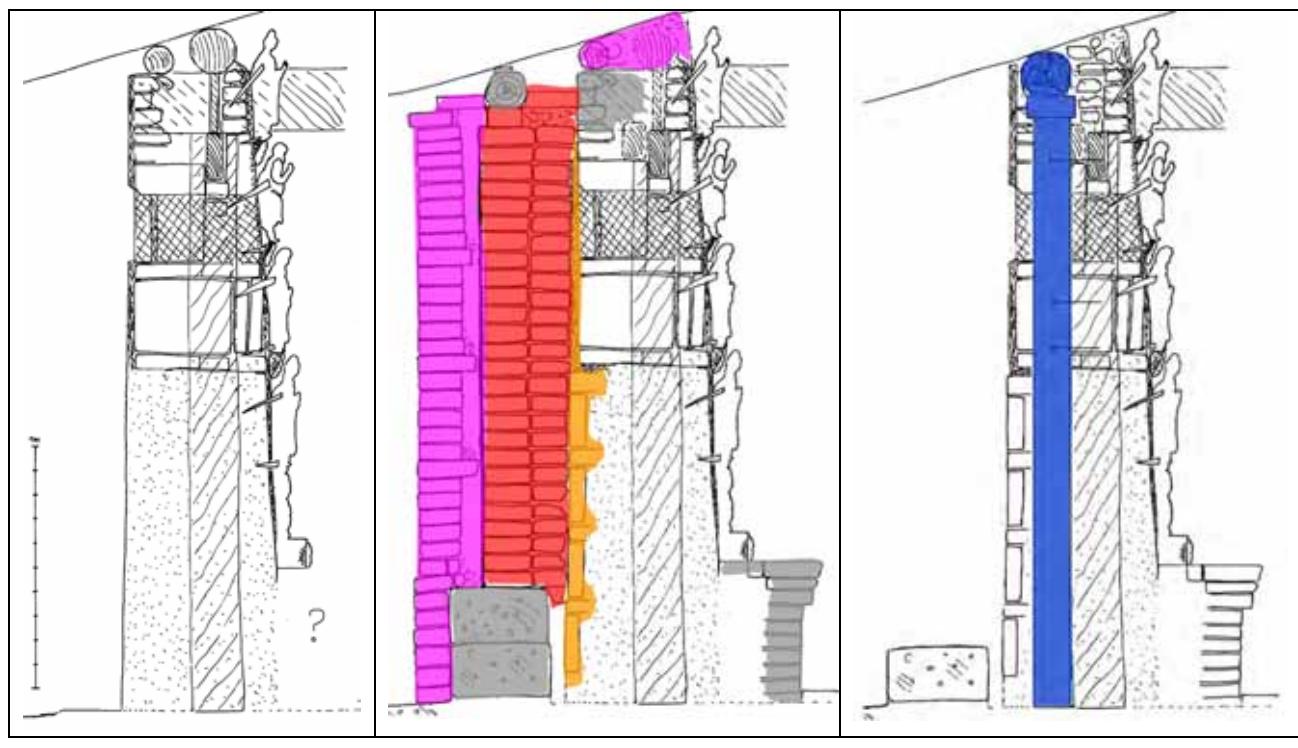
7a
West wall. section at building time

7b
West wall, situation until 2007
orange: repair before 1911
red: repair between 1912 and 1959
pink: repair of 1980-85
grey: repairs of unknown date

In 2008 the revetment walls were removed and the pillars were repaired by supporting them with steel bars. Between the steel bars, beams have been placed serving as eaves purlin (fig. 7c: blue). The two original windows in the middle of the wall have been reduced to half of their original wideness. In 2008 a new protection wall was built in front of the original wall.

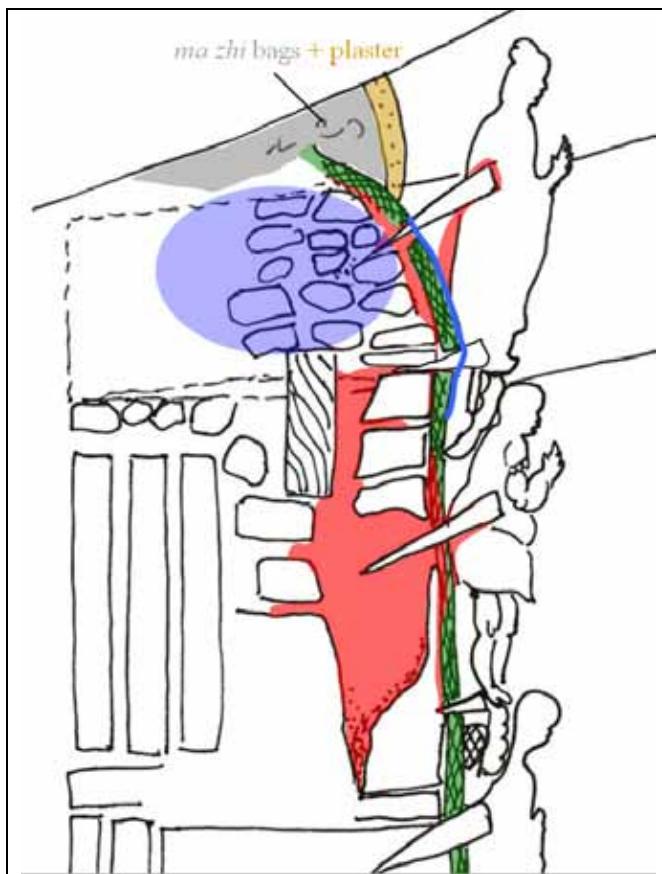
2

Sketch of damage situation:
 green: original plaster
 grey/ochre: *ma zhi* bags with plaster covering (1980-85)
 blue circle: compressed part of wall
 blue line: bulging part of wall
 red: void / loose

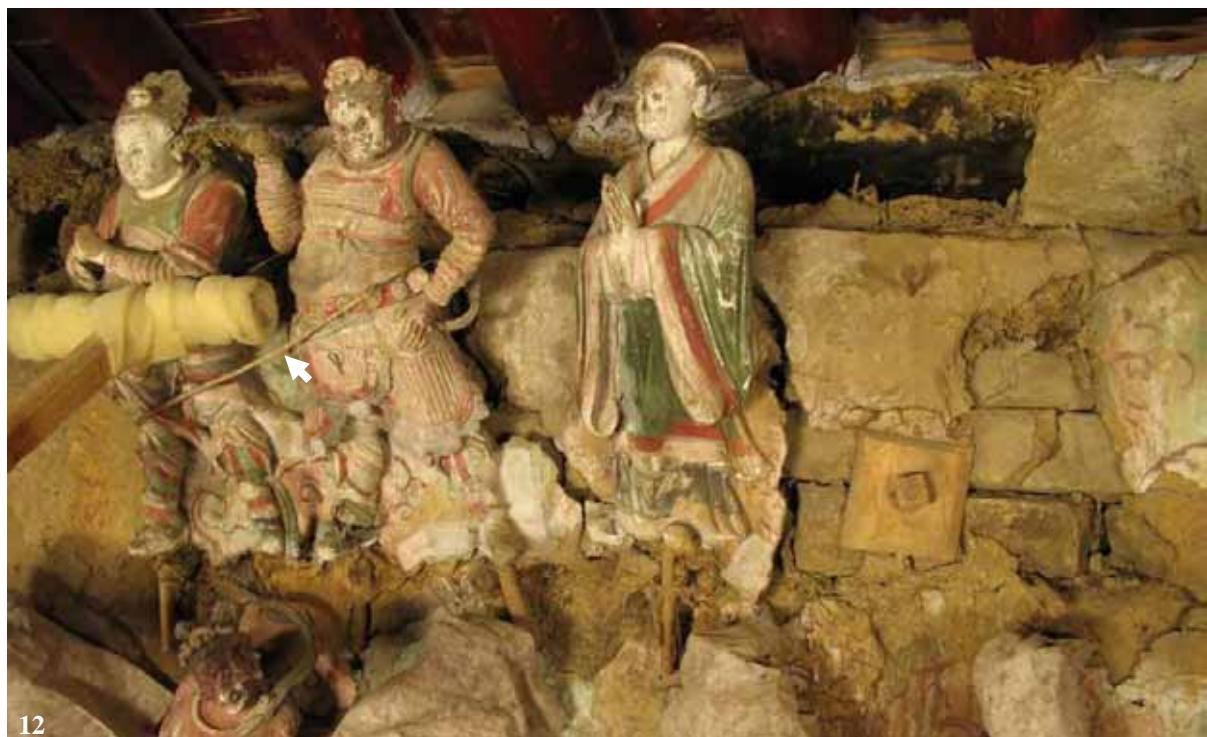
12-15 Situation before treatment, August 2009

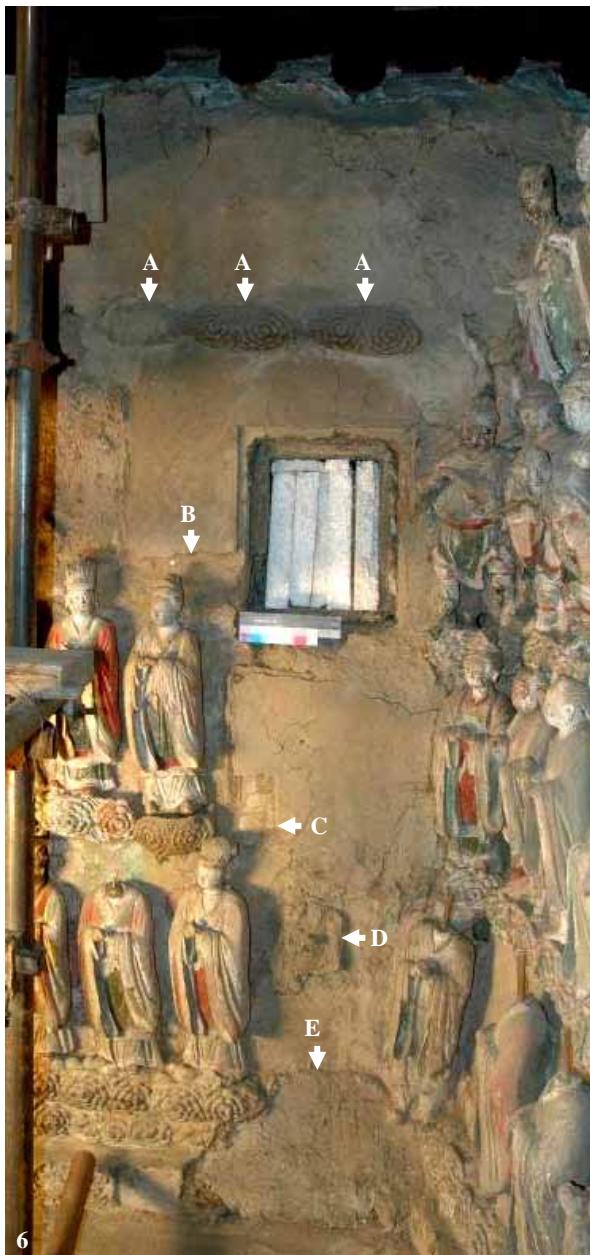
In the lowest tier (tier no. 4) on top of the repair plaster there is the imprint of a sculpture which was reattached here in 1980 to 1985, but is lost today (fig. 6, D). This situation was preserved, also in the hope that the sculpture might be found somewhere in the temple.

Section 1, window 1 before treatment in April 2007
 A: Reconstructed clouds from 1980-85
 B: Repair plaster overlapping painted cloud background

- C: Test area of 2001, revealing part of a decorative frame
 D: Substructure and peg from 1980-85 for attaching a sculpture (sculpture lost nowadays)
 E: repair of pedestal area with lime containing plaster (1980-85 ?)

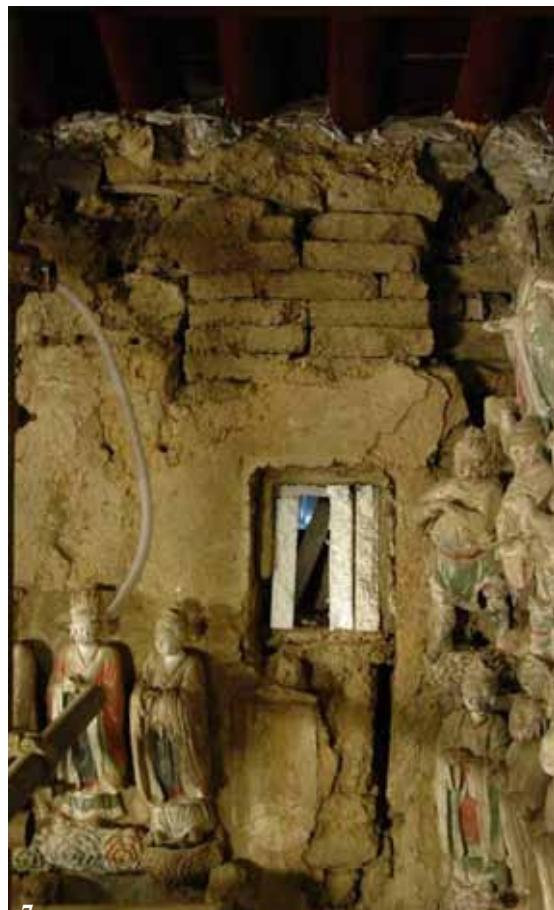
Removal of loose plaster reveals adobe brick repair

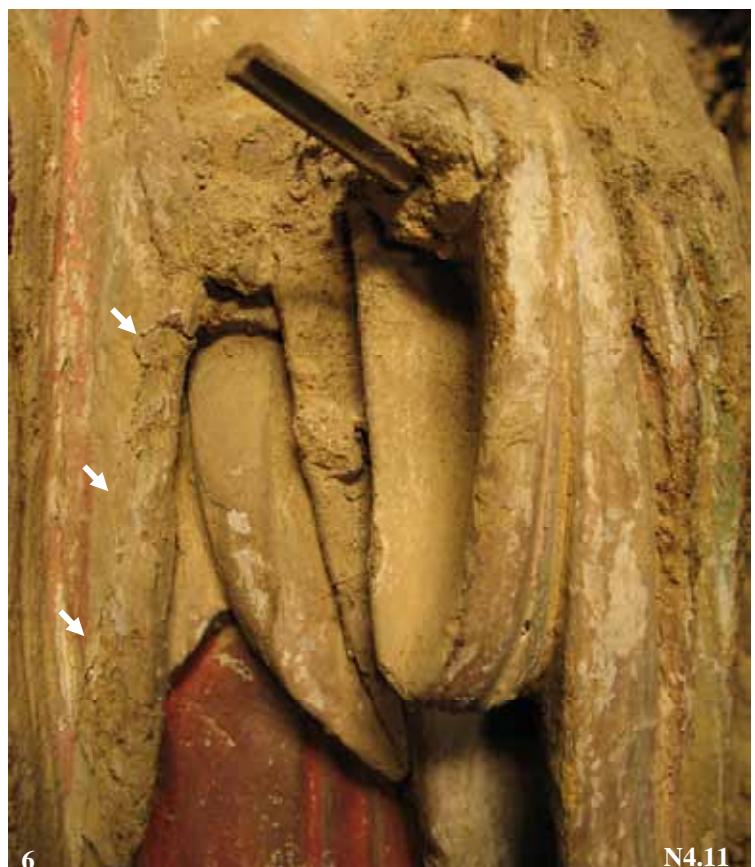
6
N4.11
Edges of sleeves damaged from the combination of water and
mechanical stress. Edges showing cracks parallel to the contour
and crumbling fine clay (arrows)

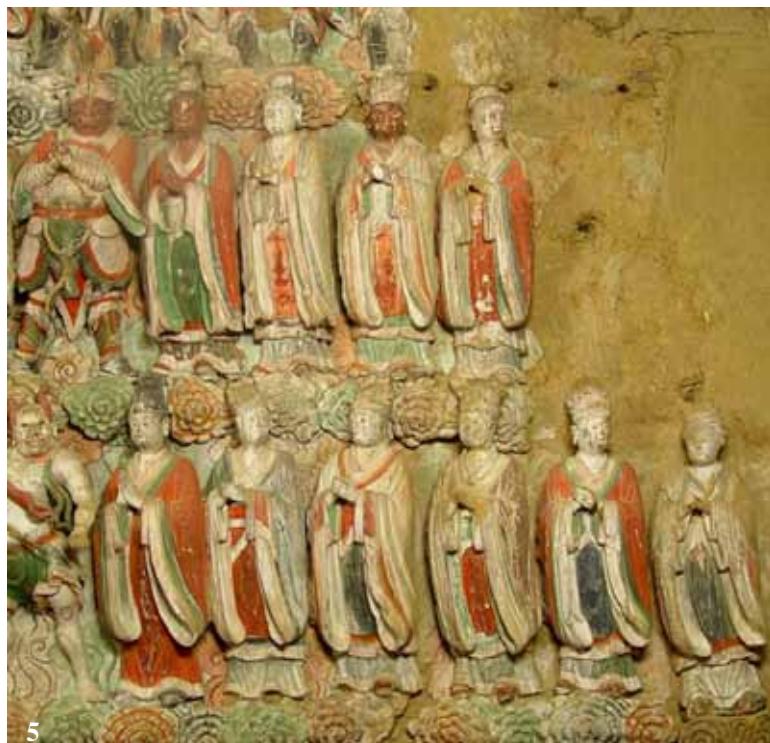
The same part of the west wall, section 1, in September 2007 after treatment. W2.50 and W2.59 are re-attached.

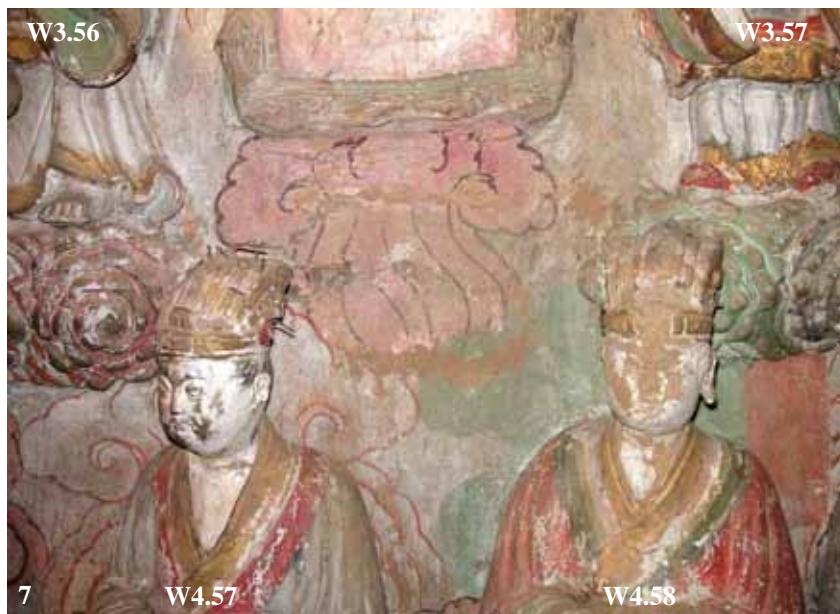
The decision for the treatment of the cloud was to bring it back to its position, but without re-attaching it to the wall. A break in the middle made the cloud unstable and flexible. The tips of the swirl “tails” were broken and could not hold the weight of the cloud anymore. The cloud was consolidated. To regain its stability again, a wooden stick was attached to the back of the cloud with a mixture of clay with hemp fibres (fig. 8). The stick is also serving to suspend the cloud on its tips. In the end, it was arranged in the same position as before the treatment, but it now is stabilised. It can be removed easily with endangering the cloud or the surrounding.

Decorative frame in section 2, hanging cloud removed. A big pink painted cloud is visible behind the cloud.

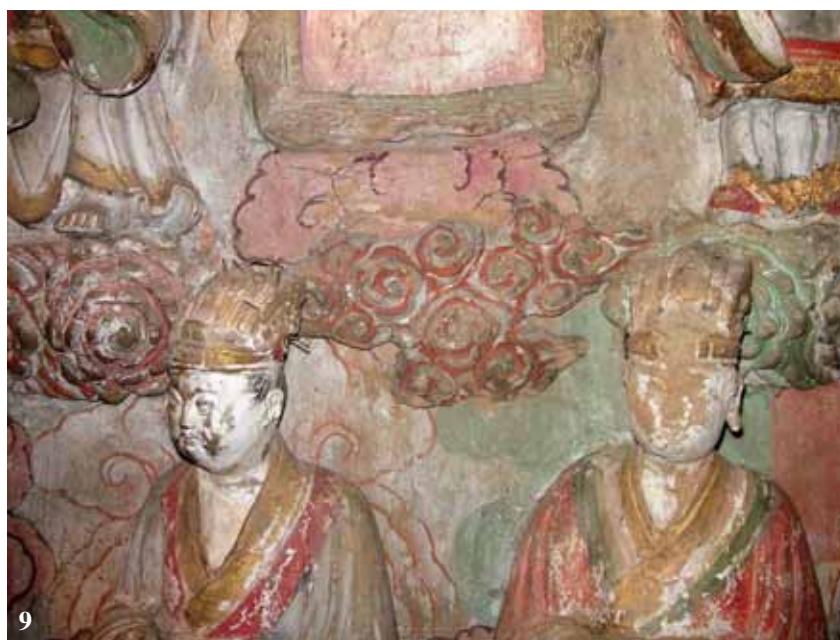
Hanging cloud after treatment

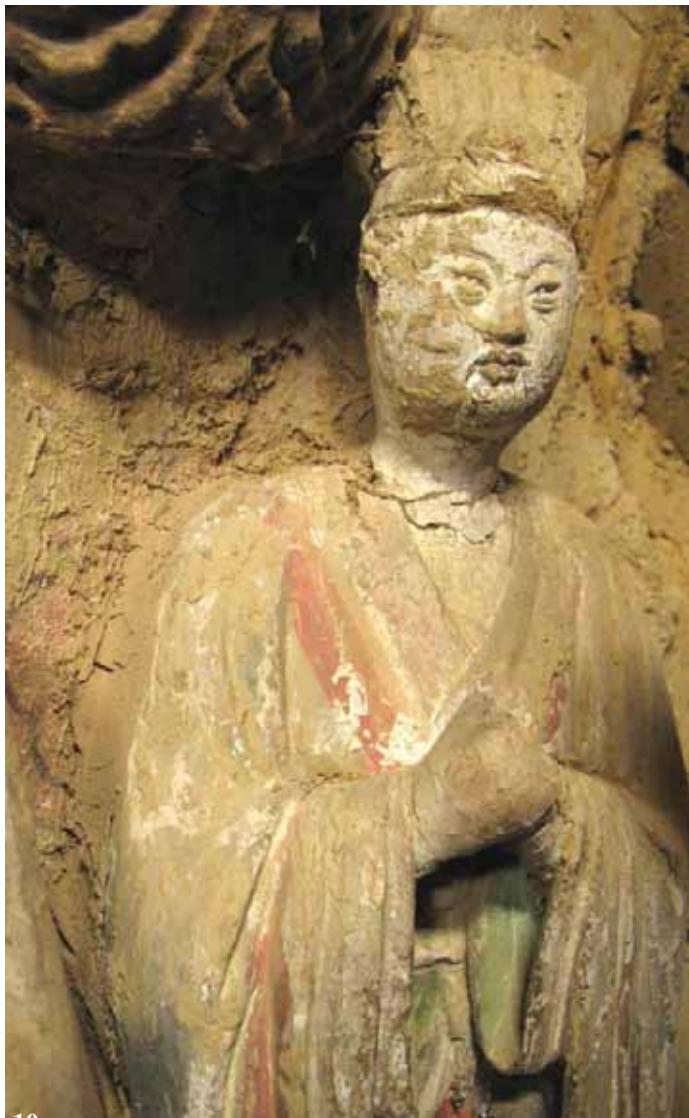
10

These traces of clay materials on the original polychromy are caused by an insufficient protection of the surfaces during work. The marks of fingers often occur on the body of the re-attached sculptures and seem to come from holding them in the hands or bringing them into the right position on the wall. Repair plasters overlapping the background show that the painted cloud decoration was not regarded as very important at that time.

Sculpture and background covered by splashes of clay material and overlapping repair plasters from 1980-85

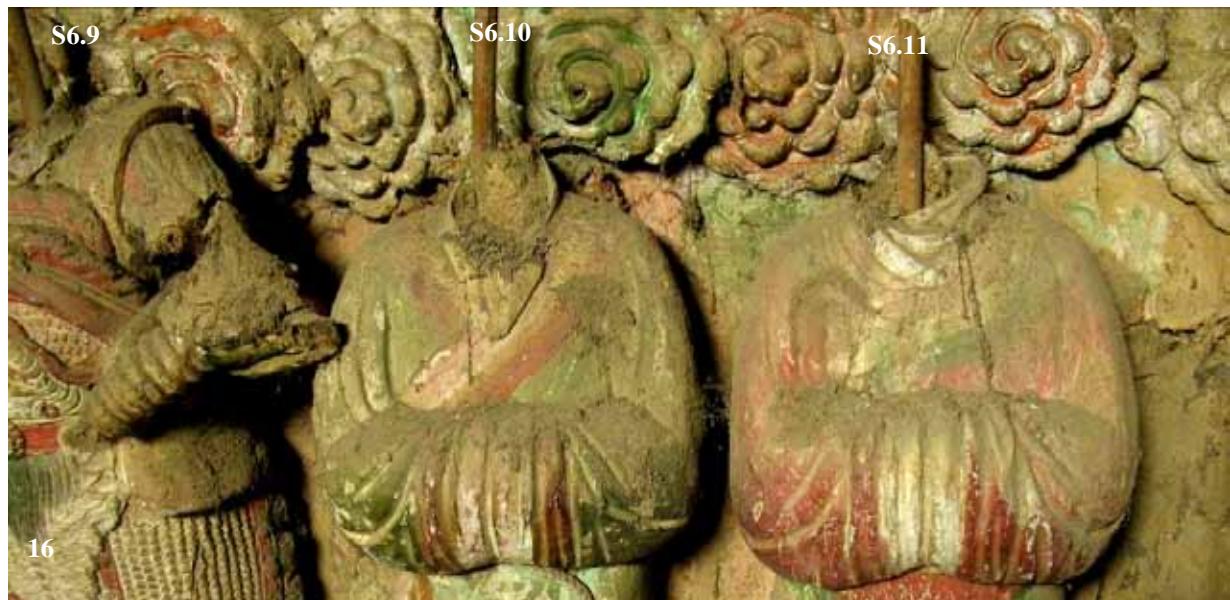
The serious earthquake, starting from May 12, 2008 resulted in such vehement movements of the building that dust and small clay particles were spread everywhere.

Massive dust accretion below the ventilator on the south wall
