# Shuilu'an

## Final report

Research Institute for Conservation of  
Cultural Heritage of Shaanxi Province  
陕西省文物保护研究院

Research Project 01UG1001  
„German-Chinese co-operation in the preservation of Cultural Heritage: Researches for the  
conservation of selected monuments in the PR China”

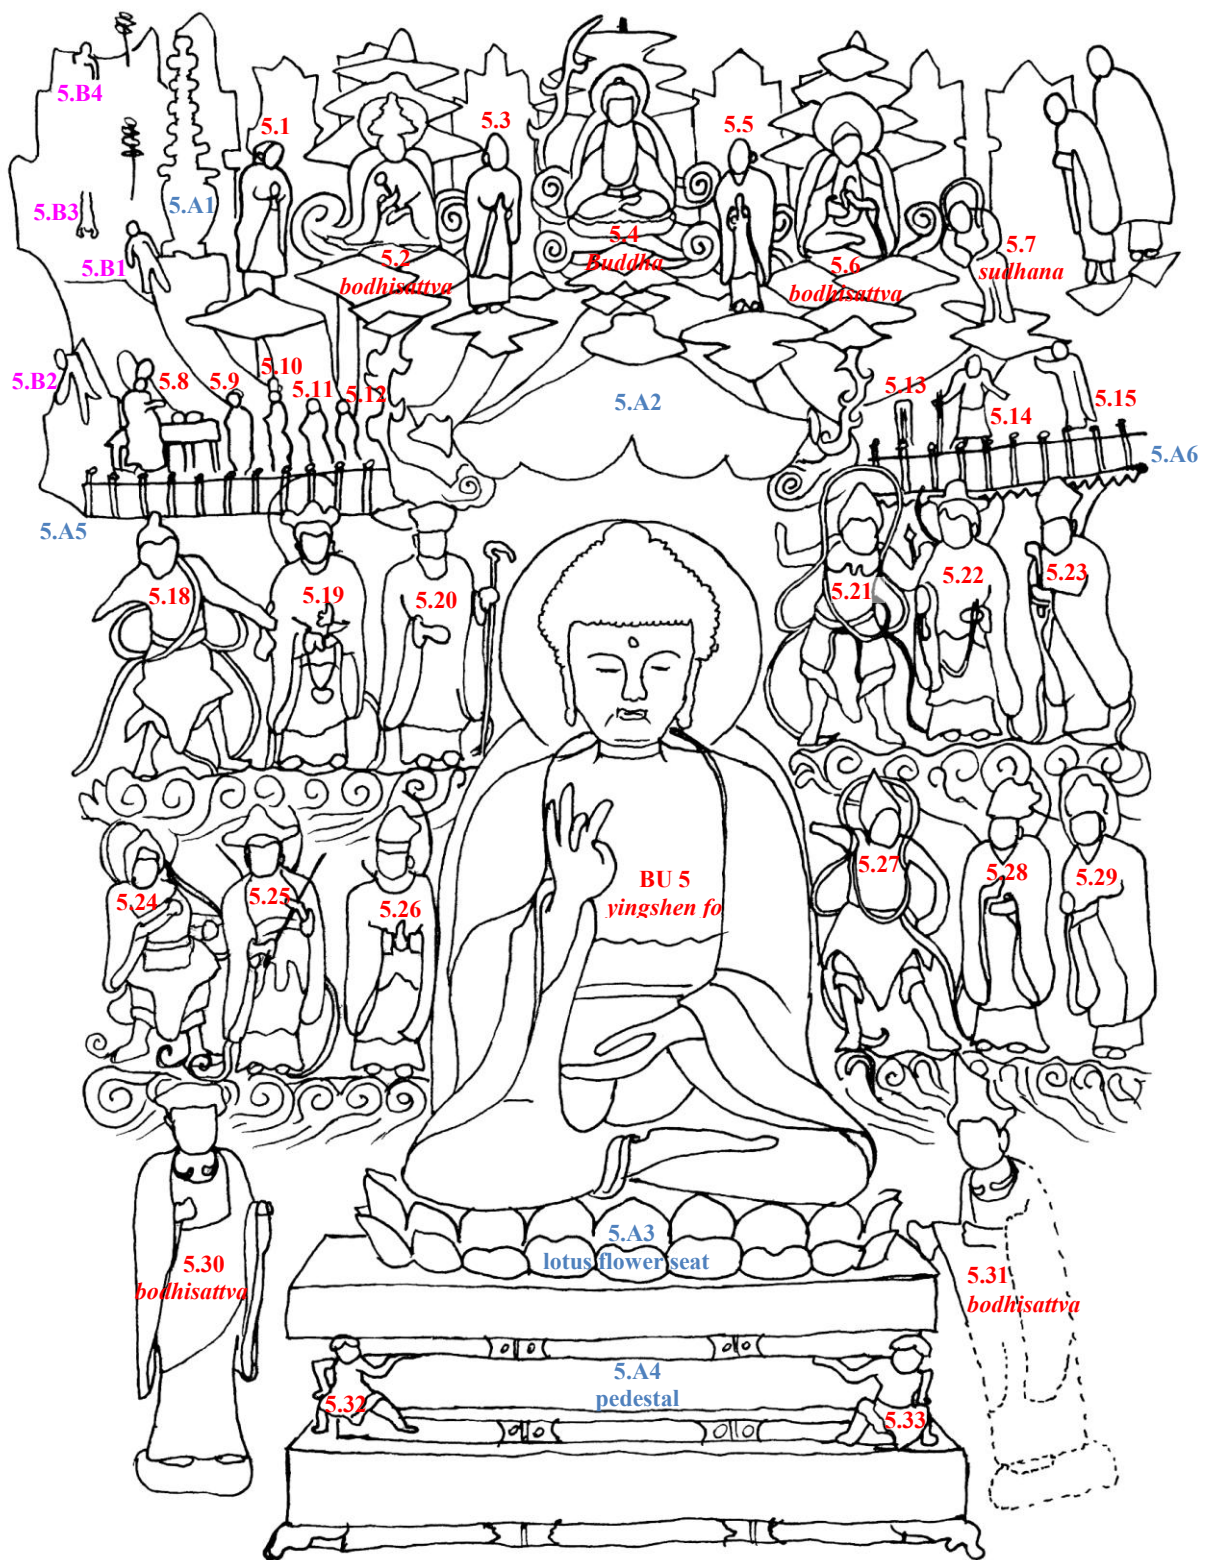
Fig. 4

East wall, southern part: Numbering of figures and parts of reliefs

Red: figures, pink: animals, blue: architecture (5.A5 and 5.A6 were added in Germany)

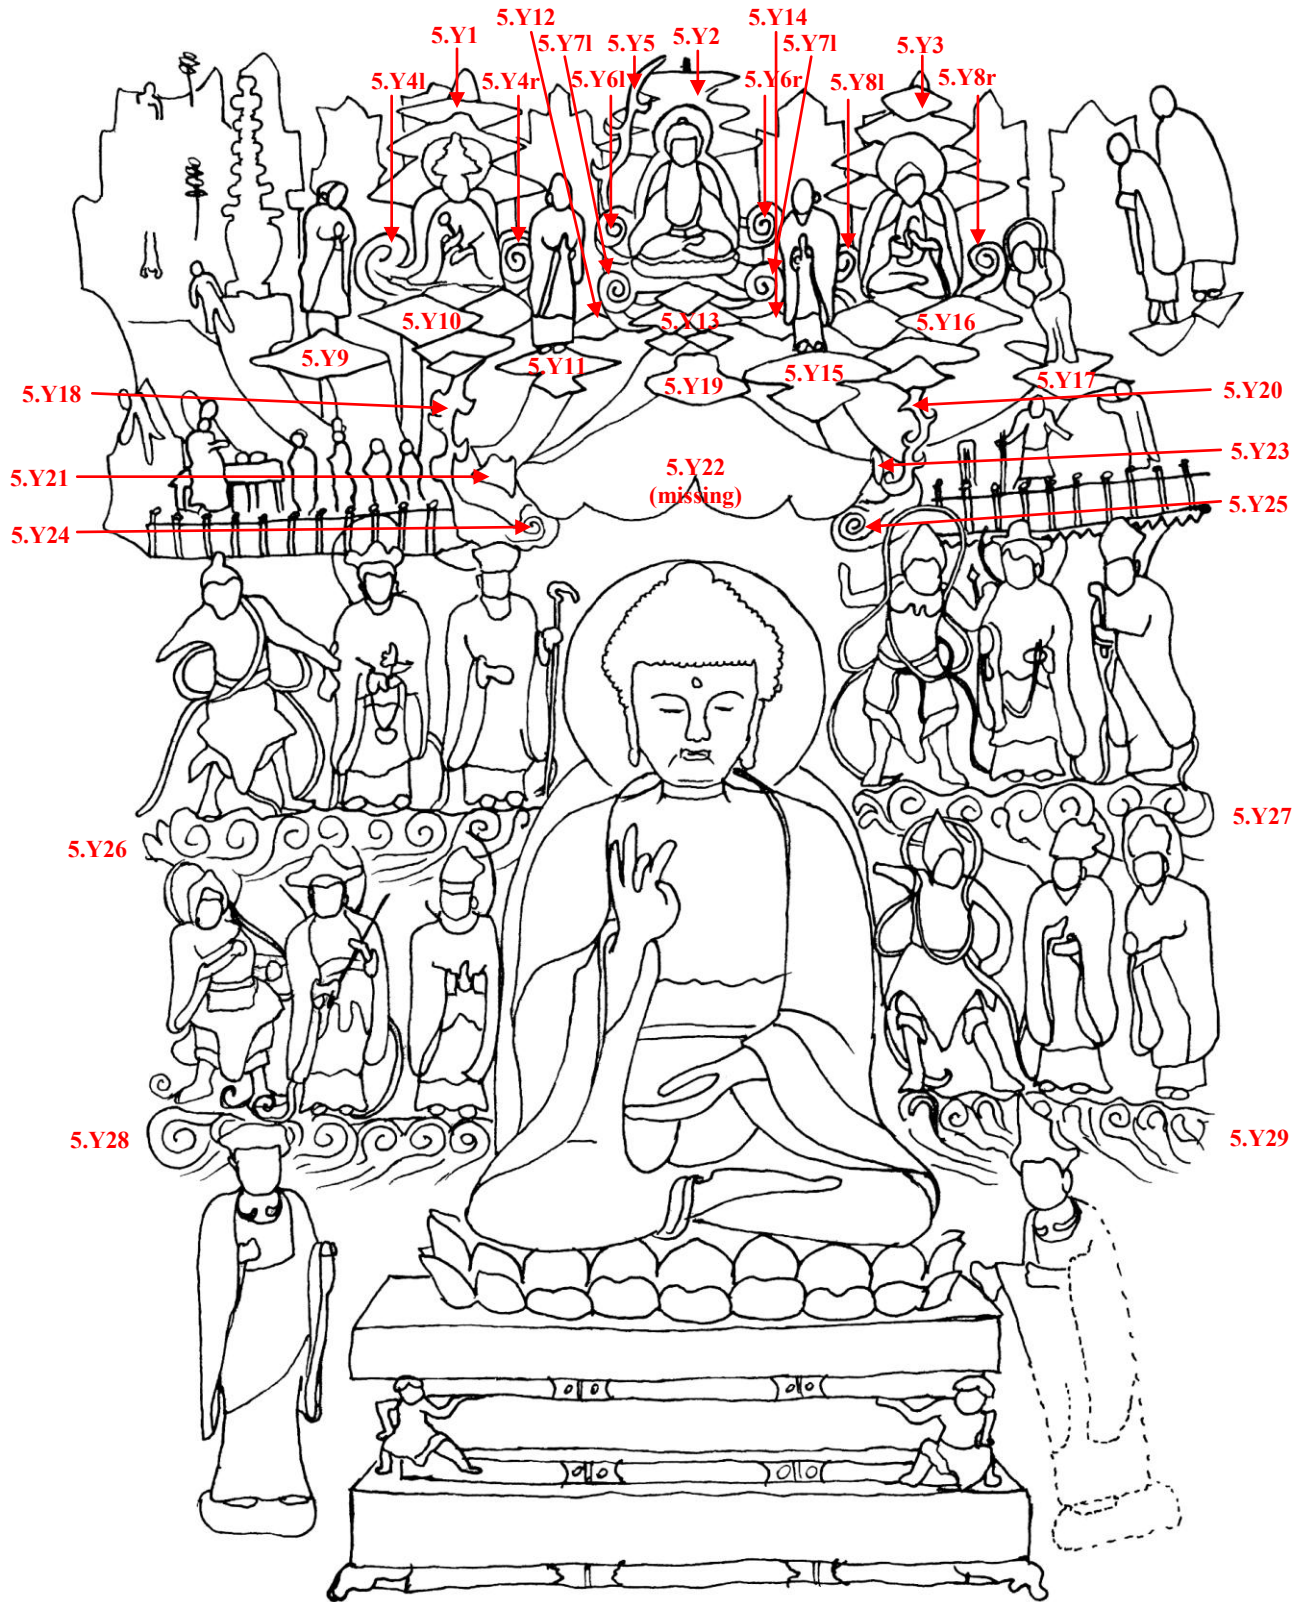
Fig 5

East wall, southern part: Numbering of clouds (Y=yun 云)

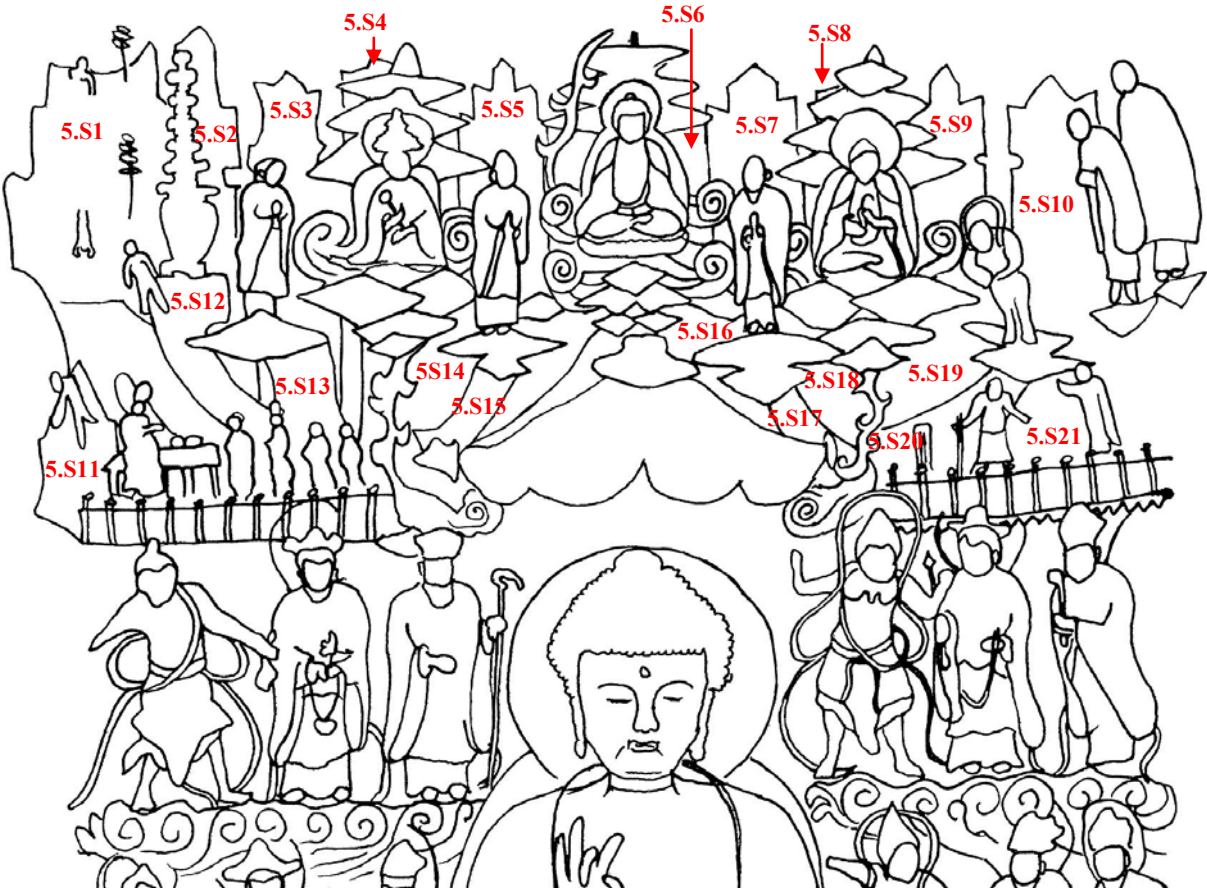
Fig . 6  
East wall, southern part: Numbering of mountains (S = *shan* 山)

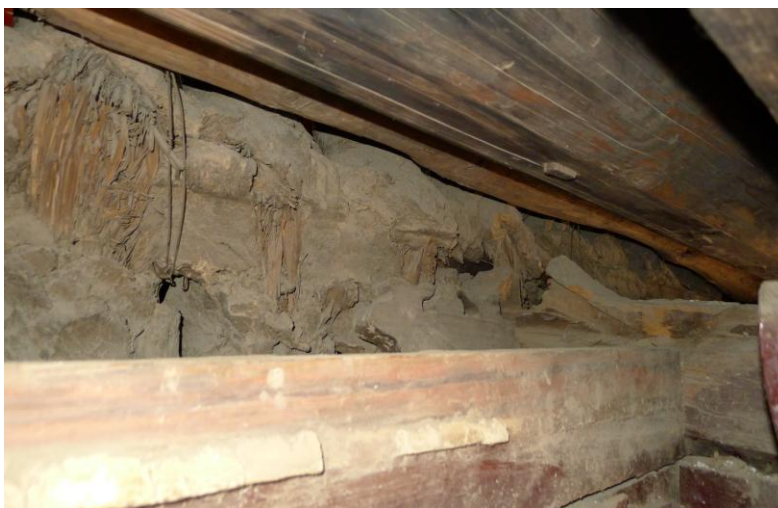
Fig. 14  
In short distances running reed bundles surrounding the upper pole.

The reed bundles run in short distances in front and behind the poles and are tied with hemp strings over and beneath them each time. They seem to remain even below the lower pole and end in an unknown height presumably they are connected with the clay wall in a specific way. Because of the resting and the securing of the two poles and because of their enclosing by reed bundles stability is given to the construction of the upper part of the ES wall.

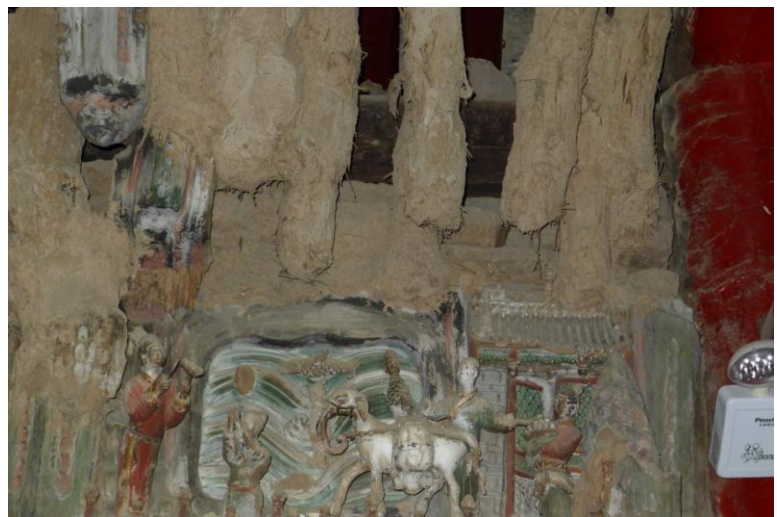
Fig. 16  
Detail of the PY wall with laying adobe bricks.

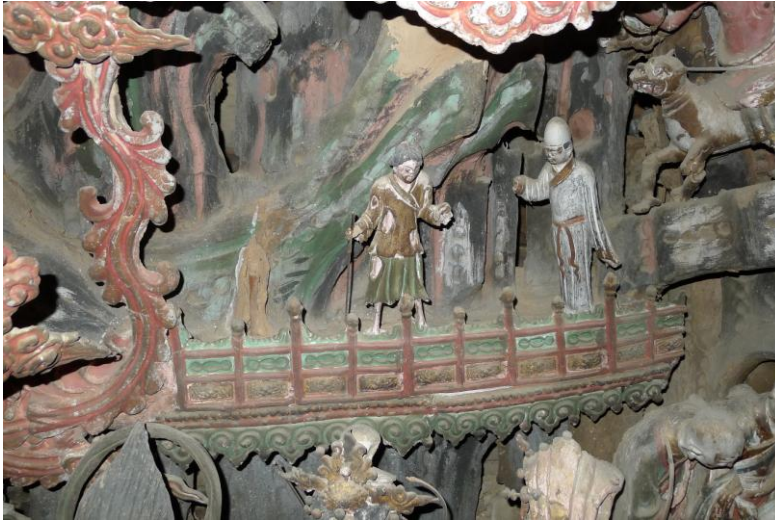
Fig. 19

Because of the nearly complete loss of one figure of the right scene the attachment of the figure to the ground by a wooden stick is visible. The identical method can be assumed for the other figures of the little scenes.

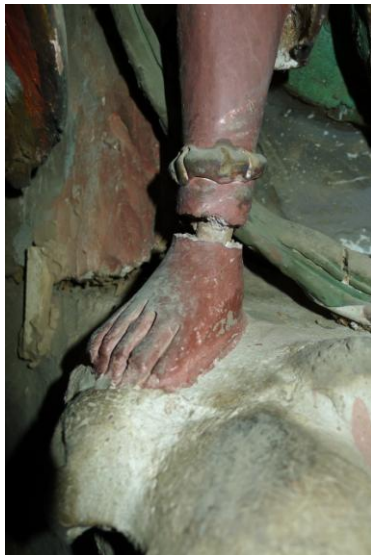
Fig. 20

*Tianwang* ES 5.27: The substructure of a wooden stick is visible.

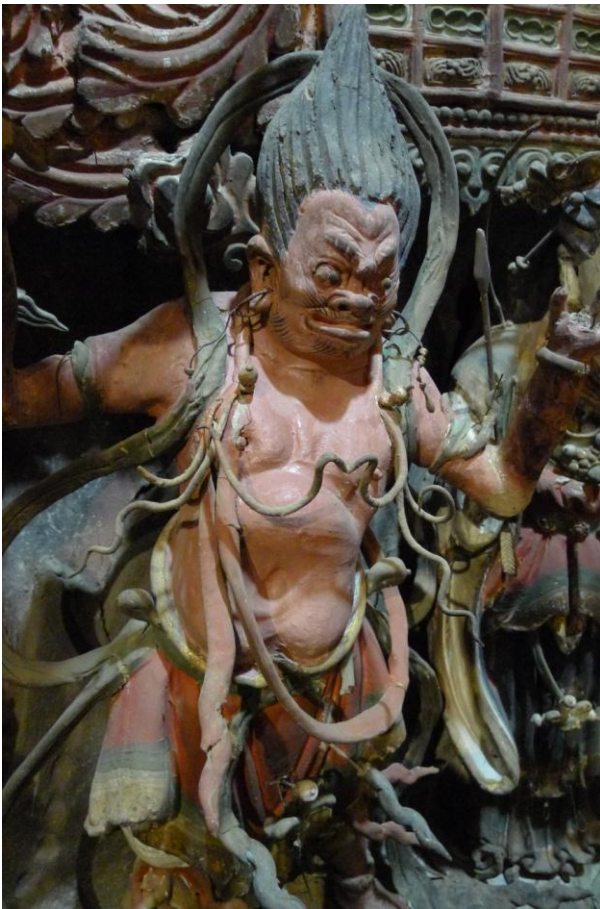
Fig. 26

*Tianwang* ES 5.21: There is a plastic modelling of face and body; the thicker *piaodai* are modelled over thin branches, the thinner ones are modelled over iron wires.

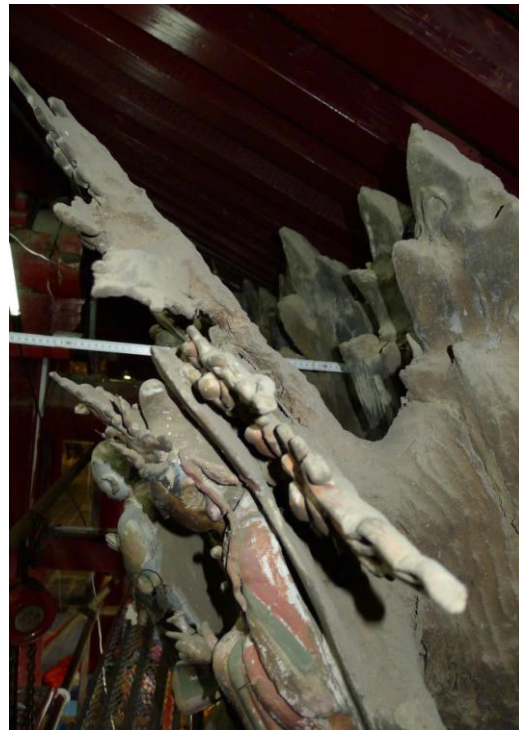
Fig. 33

The different levels of attachment are visible: Figure-gloriole-cloud-jacketed peg-mountain.

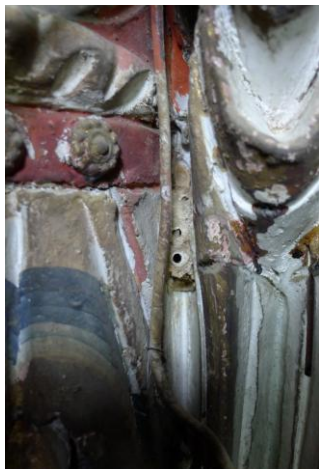
Fig. 49  
Vespiary adhering in  
drapery.

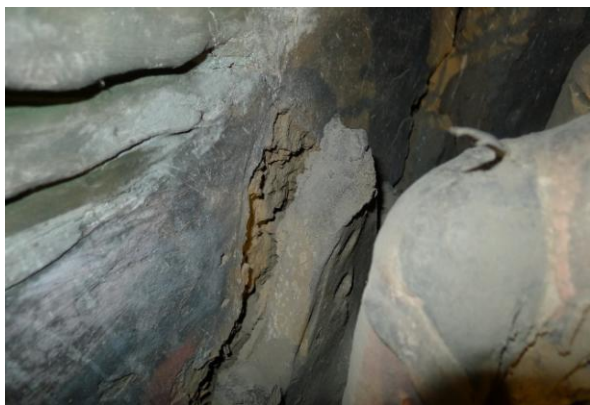
In the lower part of the wall there are cracks in the back of some figures in the row next to the Buddha and in the wall surrounding this part. Causes of damage can be vibrations by earthquakes or even by airplanes in a smaller scale, as well as this part could have been sunken into this bit over the last centuries because of the weight of the figure of the Buddha. Even high humidity can

Fig. 54  
Crack in the back of one figure of the two rows.

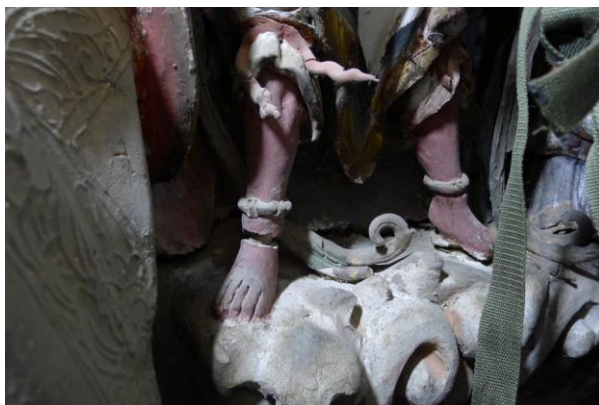
have stimulated, supported or increased this kind of damage as clay has got a decreased mechanical stability when it is slightly damp and hence there is an increased risk of breaking. But by now the cracks are stable and even the sculptures are not loose.

Fig. 55  
Horizontal crack in the wall in level with lower figures.

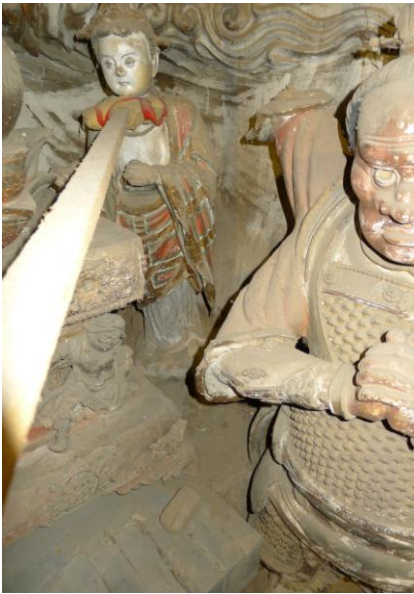
The surface of the dais in the right corner was broken. Therefore the *bodhisattva* had been sunken into the broken surface of the dais and did not stand upright anymore. He had tilted forwards and his right hand touched the pedestal. As a temporarily fixation a wooden stick between him and the lattice stabilised his position.

High humidity might be the cause of this damage or at least it might have stimulated, supported or increased this kind of damage because of the decreased mechanical stability of slightly damp clay. Even vibrations by earthquakes might be causes of damage.

Fig. 56  
Temporarily fixation of the sunken and tilted *bodhisattva* ES 5.31.

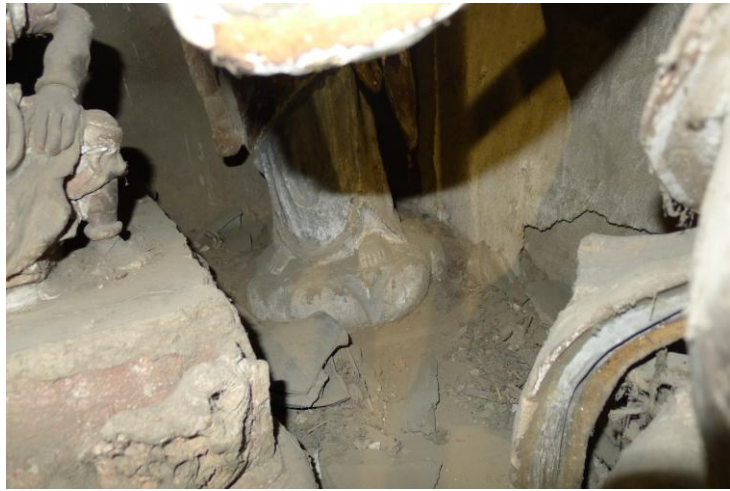
Fig. 57  
The surface of the broken dais was covered with lots of dust and debris; even broken tiles are visible.

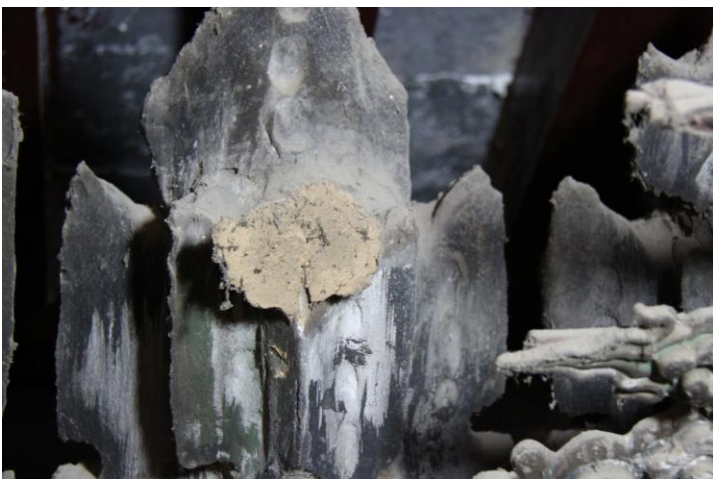
Fig. 58  
At cloud ES 5.53 an element, presumably a cloud, is lost.

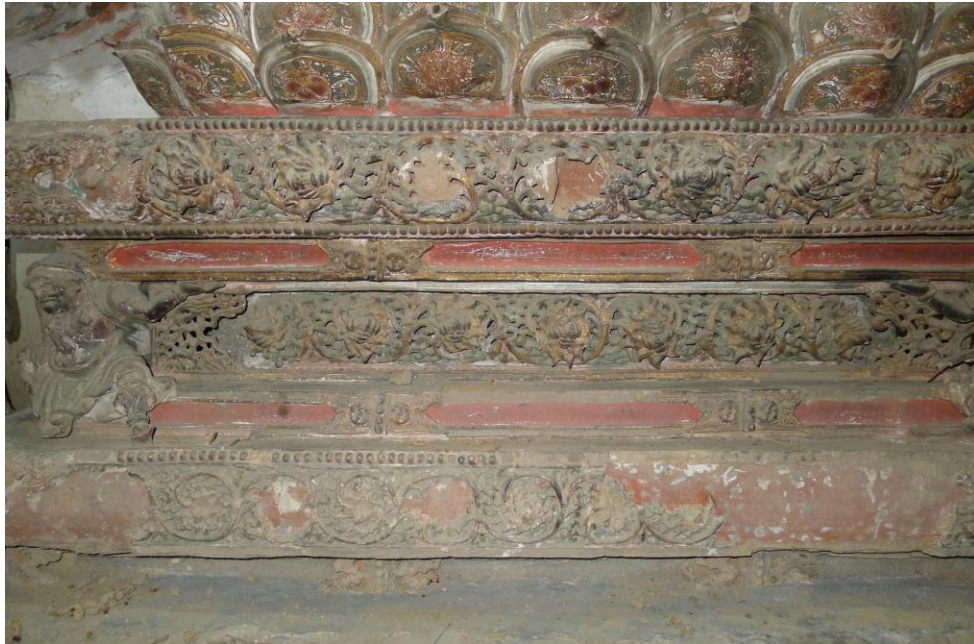
Fig. 60  
A lot of the clay modelled decoration of the pedestal is lost.

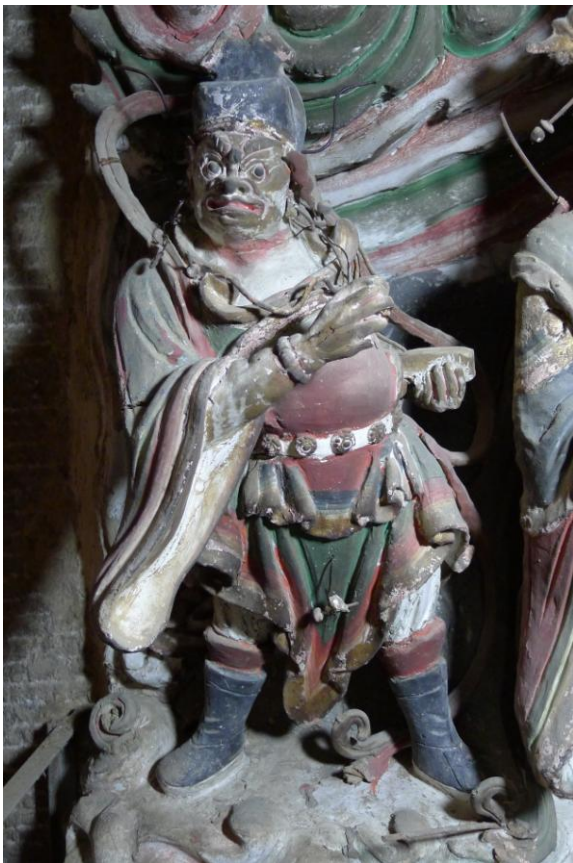
Fig. 61  
*Tianwang* ES 5.24: Lots of decoration like the *piaodai* in front of the legs is lost; the air-exposed iron wires show corrosion.

The corroded iron wires were isolated with Paraloid B 48 N, 15% in Ethyl Acetate. With a paint brush the material was applied to the surface of each iron wire.

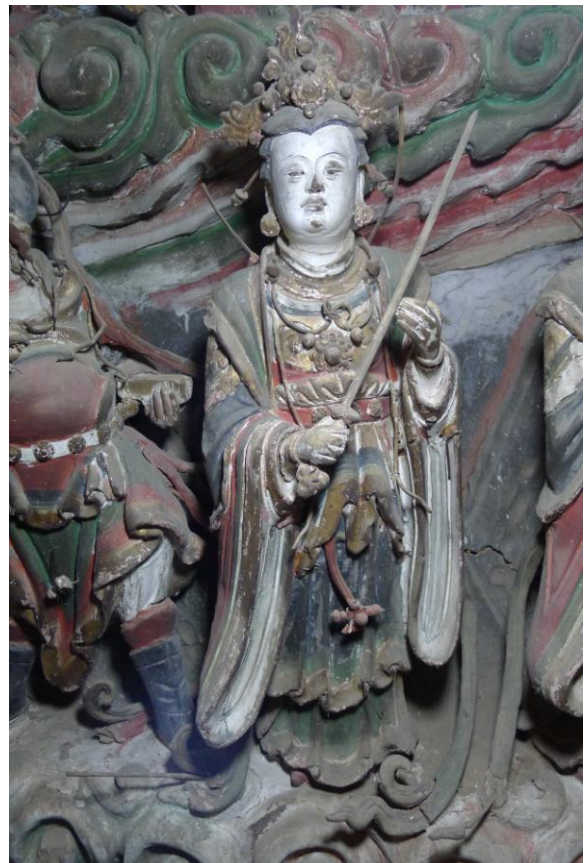
Fig. 62  
Figure ES 5.25: Lots of decoration like ornaments of the head gear or parts of the *piaodai* in front of the legs is lost. Even the gloriole is broken.

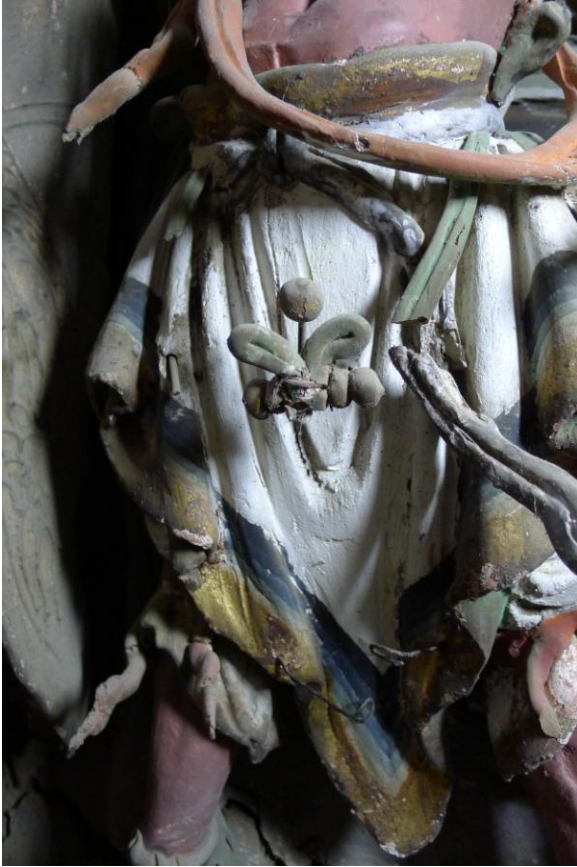
Fig. 63

*Tianwang* ES 5.27: The *piaodai* in front of the legs is nearly complete lost only a lanyard is remaining. In level with the knees two looped iron wires are remnants of that *piaodai*; they show corrosion. The *piaodai* surrounding the figure shows cracks.

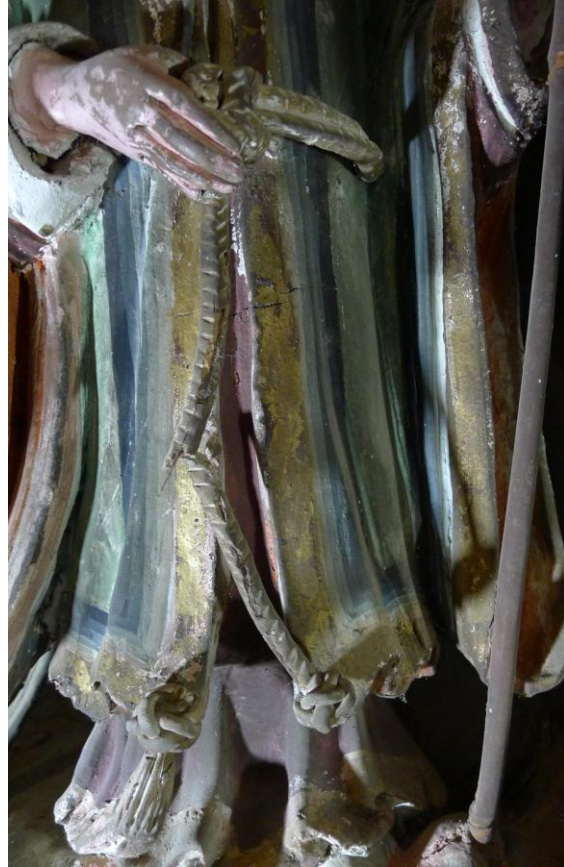
Fig. 64

Both pending cords of the belt are broken and at the left one the lower part and at the right one the upper part is lost. At the right one the strings of the tassel are lost, too, and the cord has even tilted. At the left cord the complete tassel is remaining.

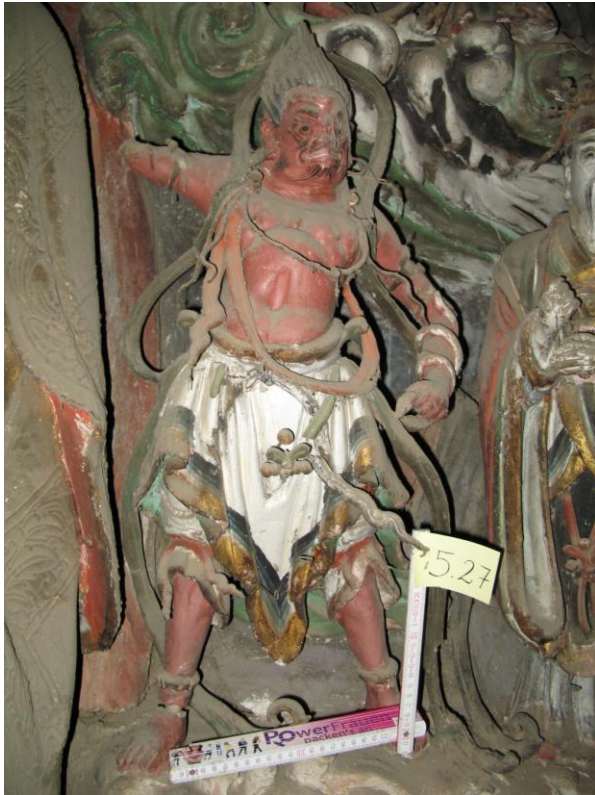
Fig. 65  
*Tianwang* ES 5.27 before cleaning.

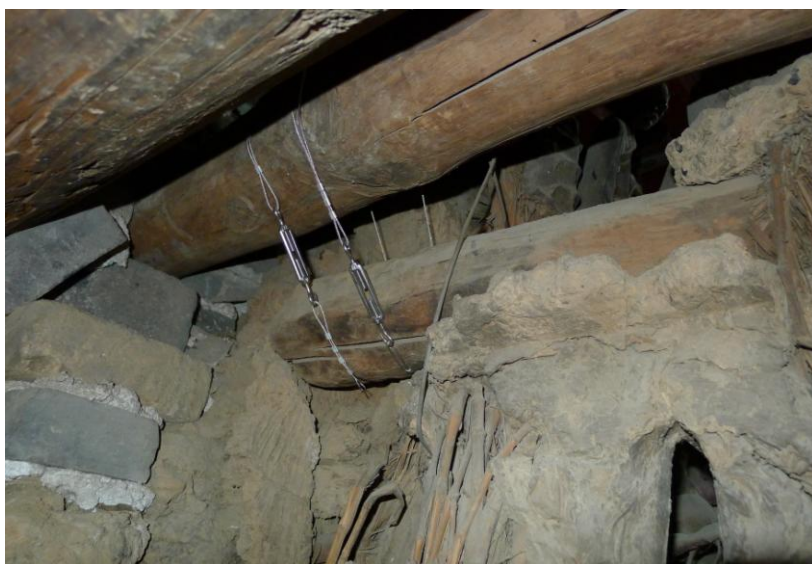
Fig. 69

In the corner between the east and the south wall there is a vertical crack. It is a result of the tilt of the upper part of the wall, i.e. the upper pole. Over years and centuries this part moved a little bit and pressed against the wall with the sculptures and reliefs of the south wall. That can have been caused by the weight of the mountain scenery as well as by vibrations of earthquakes. Even the replacement of the roof in 1981-85 which caused some changes of the wooden pole construction might have reinforced this tendency, because the right end of the upper pole does not rest safely on an element of the wooden pole construction anymore but hovers in the air. Even the left side of the upper pole could have moved a little bit forward, because the pole lies not in the absolutely middle of the two iron pins hit in the beam he is resting on.

The northern end of the upper pole does not lie on any element therefore it is connected with the beam inserted in 1981-85.

As the examination of the vertical crack in the right corner had proven this damage as a result of a slight tilt of the upper pole, the upper pole had to be secured to avoid any more tilt and press against the south wall. For its northern end rests safely in between two iron pins only the right end of the pole had to be fixed. The connection was done to the beam inserted in 1981-85, that rests stable and is not related to the roof. Thus a stainless steel hanging wire (1.5 mm diameter) was torn around both elements. In between the two looped edges of the wire which are secured with stainless steel eyes (4 pieces per end) a stainless steel turnbuckle was brought into to hold the ends of the wire together. The turnbuckle was slightly tightened for an appropriate tension of the wire. But the upper pole was not torn back. In the same way a second wire was installed to the pole and the beam.

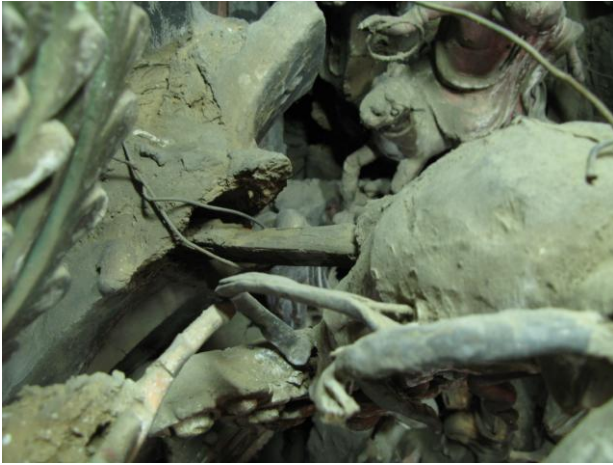
Fig. 75  
The *sudhana* ES 5.7 was reattached to the wall with a too long wooden peg.

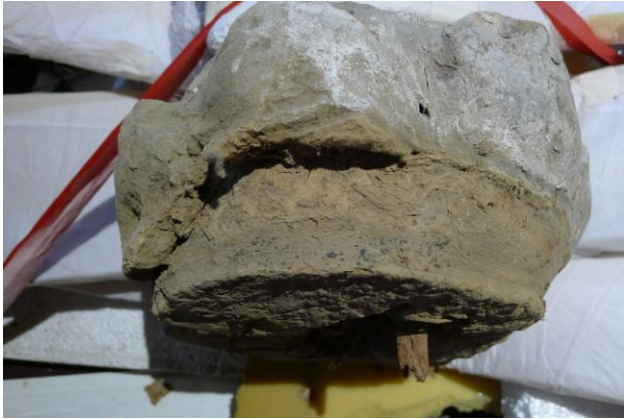
Fig. 93  
The plinth of *bodhisattva* ES 5.31 with the broken or decayed original wooden peg.

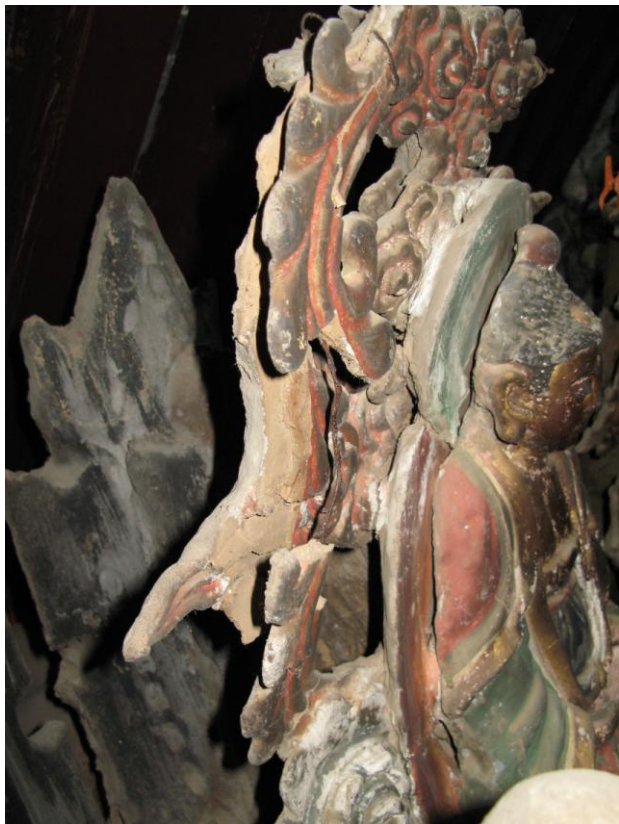
Fig. 101  
The adhesion of both parts of cloud ES 5.Y5 is loose, i.e. broken.

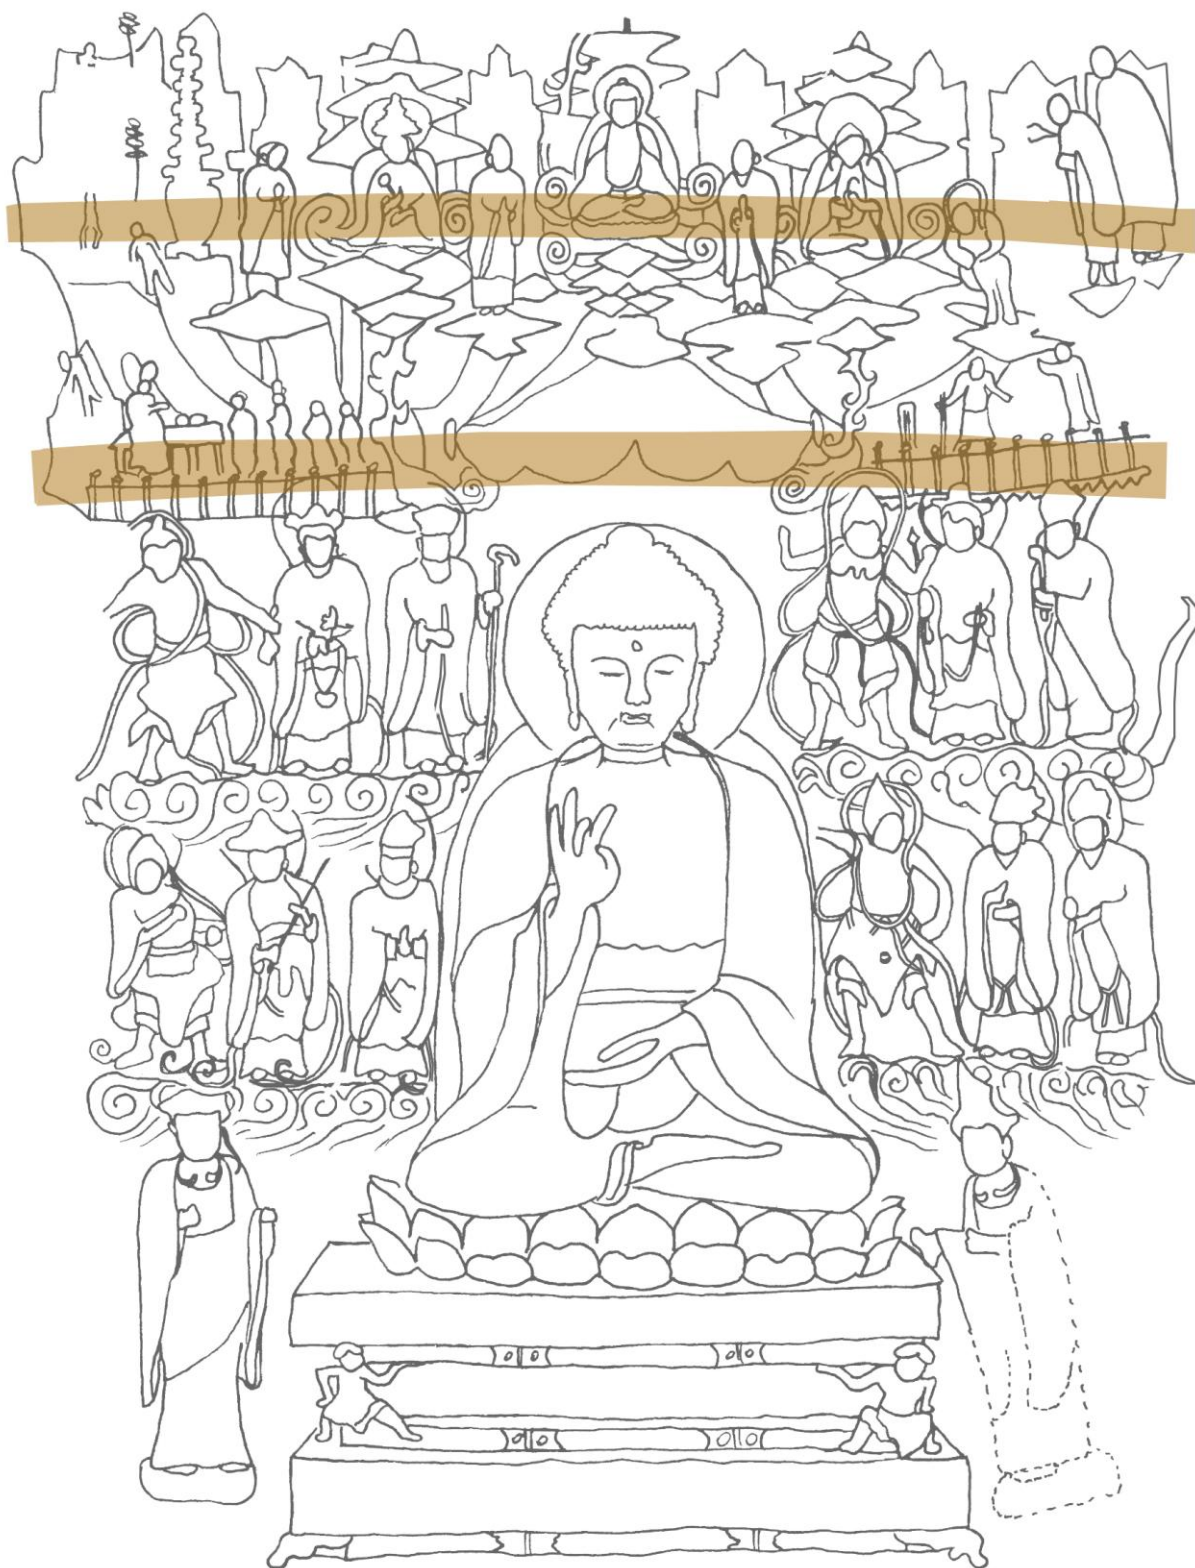
Fig. 106  
Position of upper and lower pole behind mountain scenery

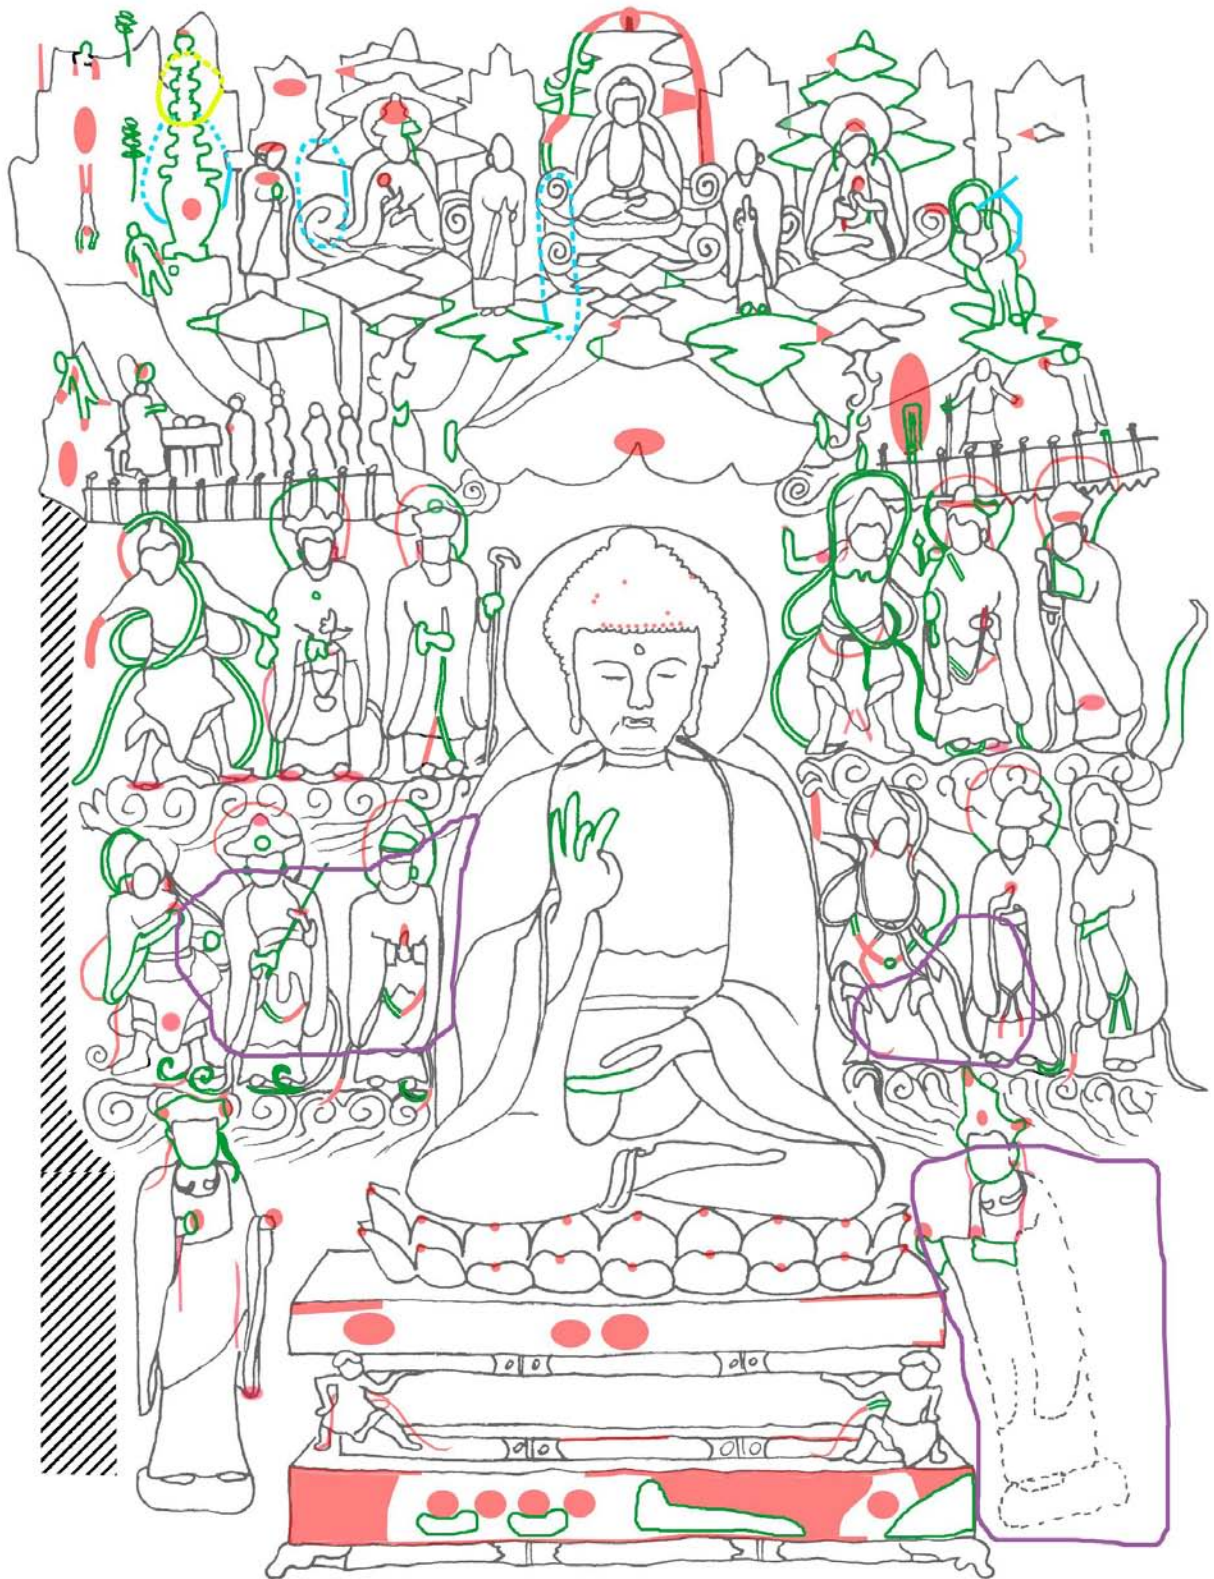
At the ES wall there are only some previous repairs to state; this is different to the EN wall. Most of the treatment was presumably done during the work phase of 1981-85. All previous repairs are mapped in fig. 107.

Following damage and their characteristics and figures or areas with special kinds of damage are described. All damage is marked in mapping fig. 107 and noted in *Tabular overview of damage and treatments*.

Fig. 107  
Previous repairs and situation of damage

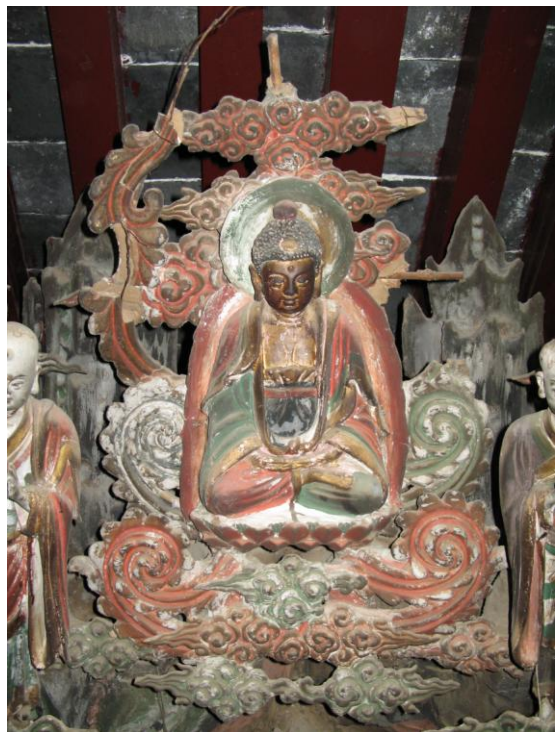
Fig. 112  
Buddha ES 5.4 with missing of the topmost cloud.

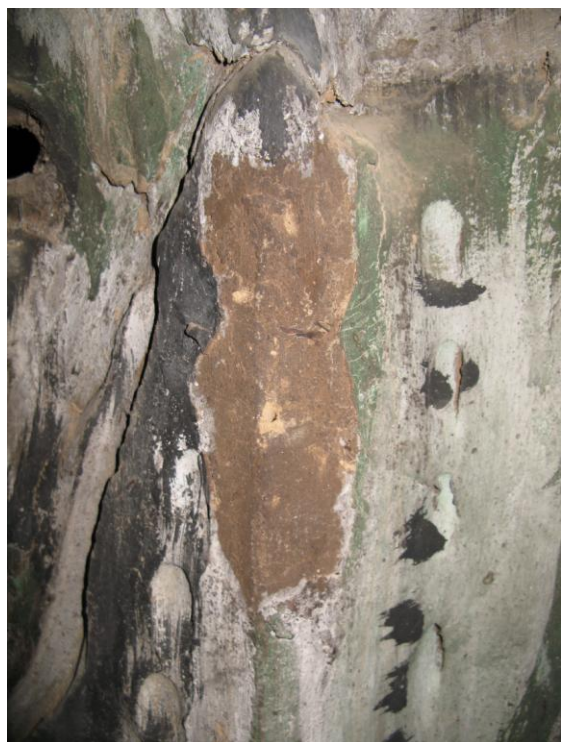
Fig. 114  
Missing part at mountain ES 5.S1.

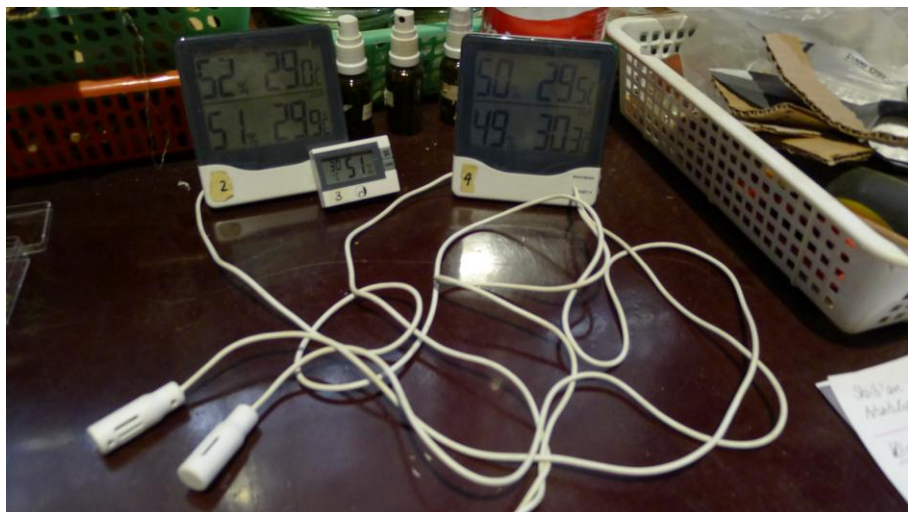
Fig. 116  
The three  
hygrothermometers with  
differing measuring data,  
even if positioned next to  
each other.

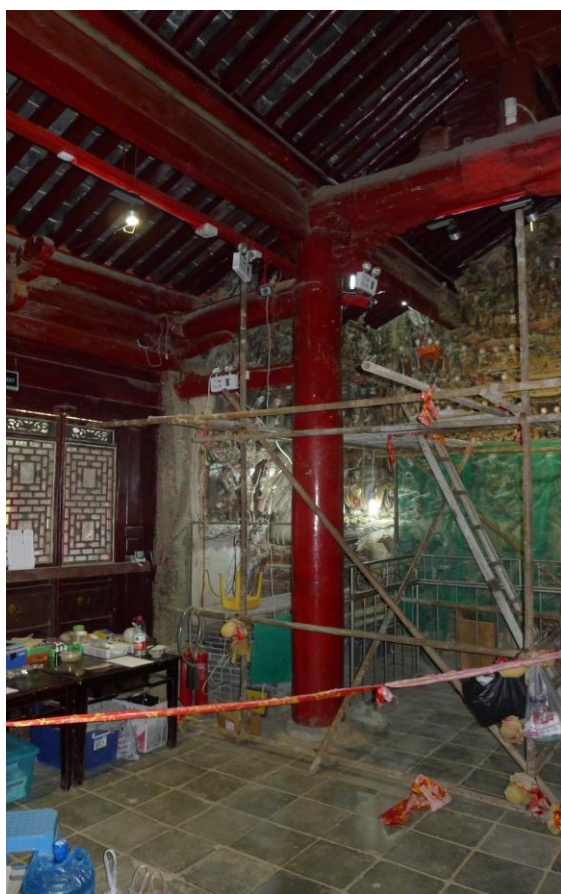
Fig. 117  
Analysers Nr. 1 and 2 positioned left next to the ES  
wall in the height of the little scene and of the lotus  
flower seat.
