Ziyang *Beiwusheng huiguan*

Final report

Part 1: Technique and materials

Research Project 01UG1001
„German-Chinese co-operation in the preservation of Cultural Heritage: Researches for the
conservation of selected monuments in the PR China”

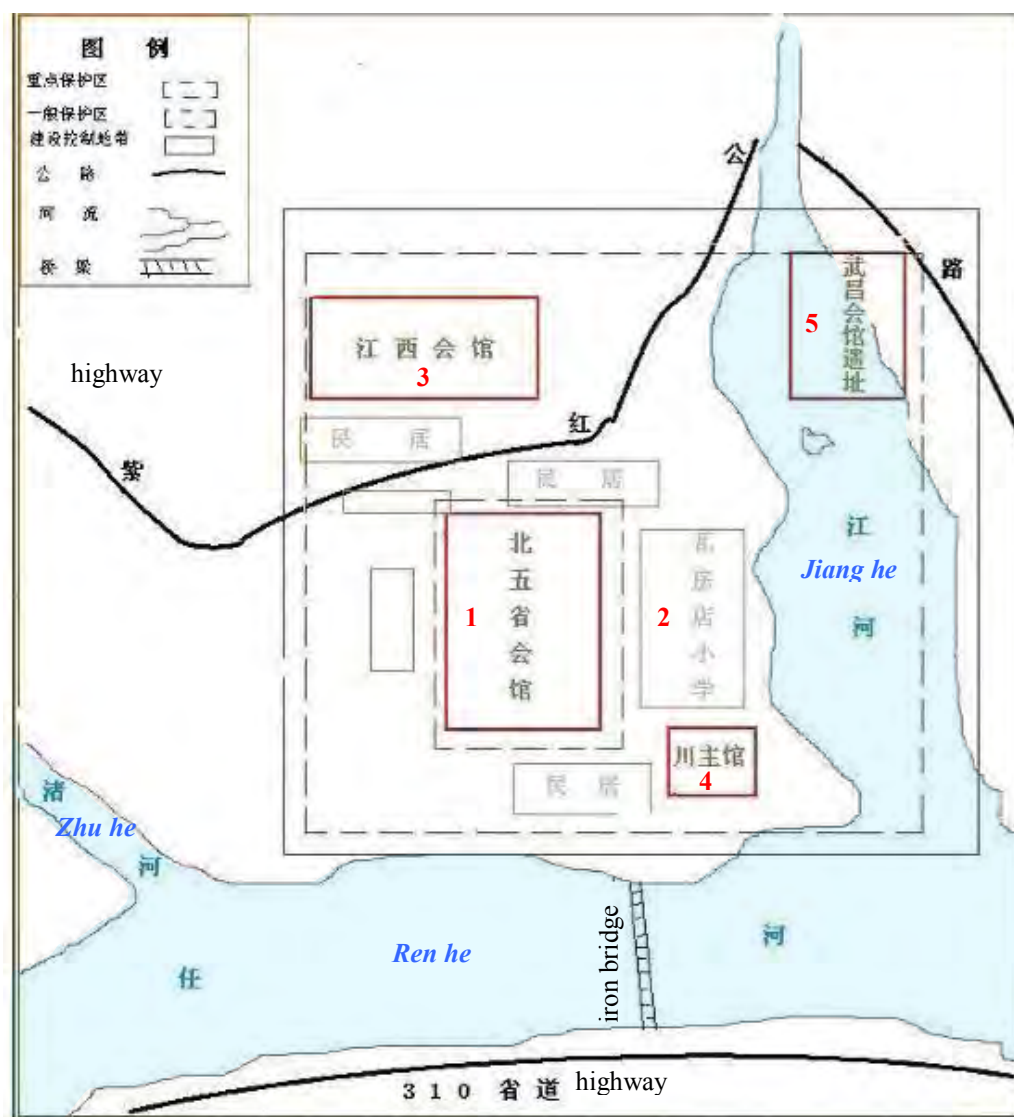
Fig. 3
Wafangdian, schematic plan.
[Ziyang *beiwusheng huiguan bihua baohu yanjiu*, p. 5]

- 1 *Beiwusheng huiguan*
- 2 Wafangdian primary school (formerly *taishan miao*)
- 3 Jiangxi *huiguan*
- 4 Chuanzhu *huiguan*
- 5 Wuchang *huiguan* ruin (not existing anymore in 2011)

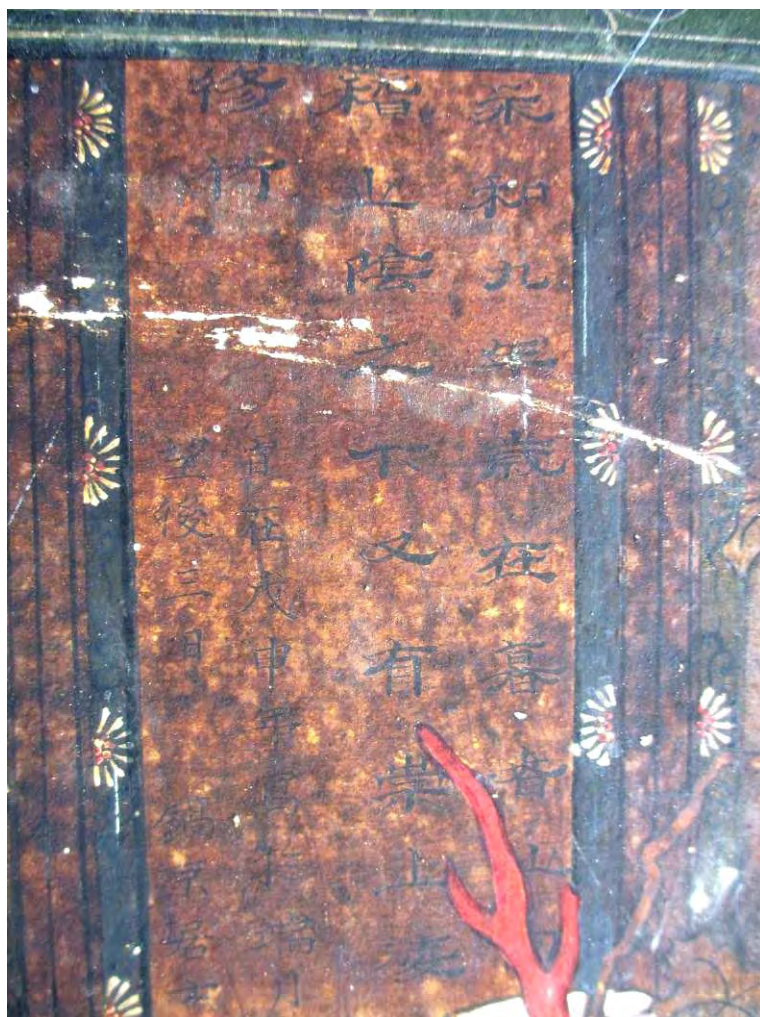
Fig. 16
Sanuo dong, painted screen
 behind the mother of the king
 with inscription giving the
 first month of the year as date
 for the “writing”.

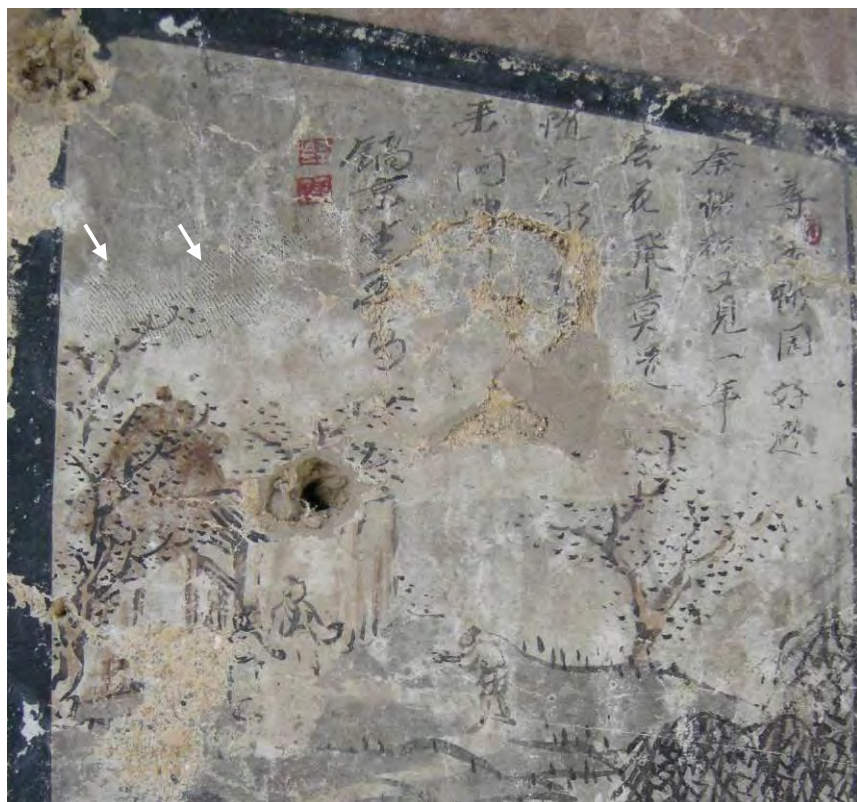
Fig. 17
Pingfeng xi, panel 7 d, detail
 of painted screen (height 15
 cm, width 12 cm) with
 inscription by the painter
 containing a date in ancient
 Chinese calendar, referring to
 the eight month of the year.
 In the upper left corner, the
 painter or another craftsman
 unintentionally left finger-
 prints in the grey wash of the
 background (white arrows).

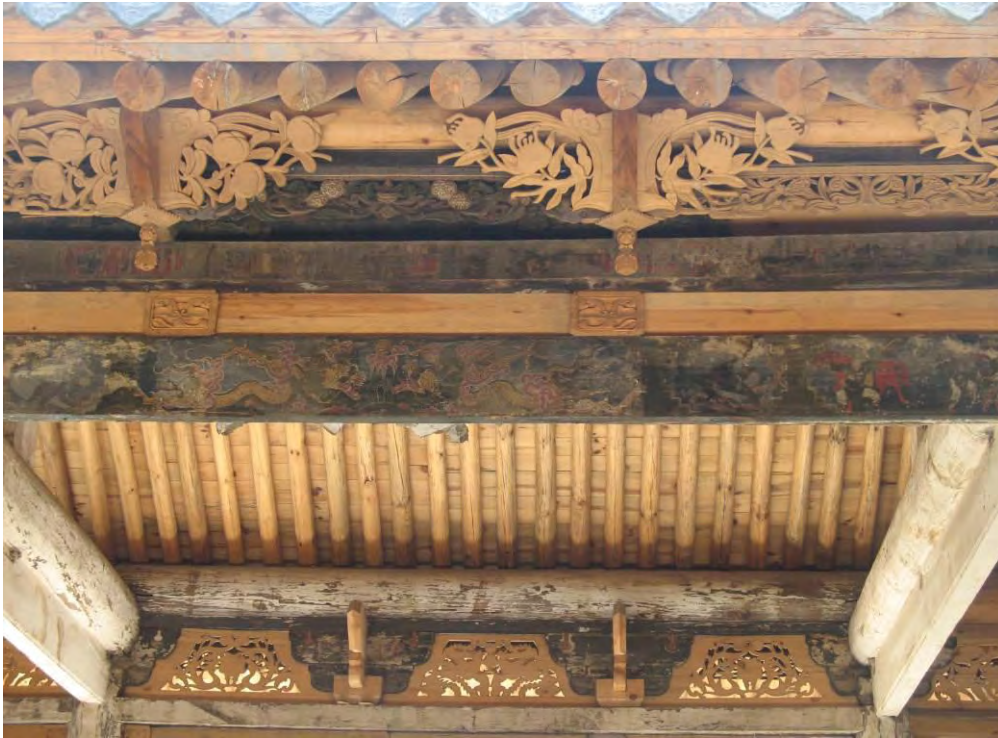
Fig. 19
Guodian, northern side (rear side), central bay. All original wooden elements are painted. Inside the hall traces of paintings can be recognised. Some parts are the beams are still covered with white-wash from the 1950's.

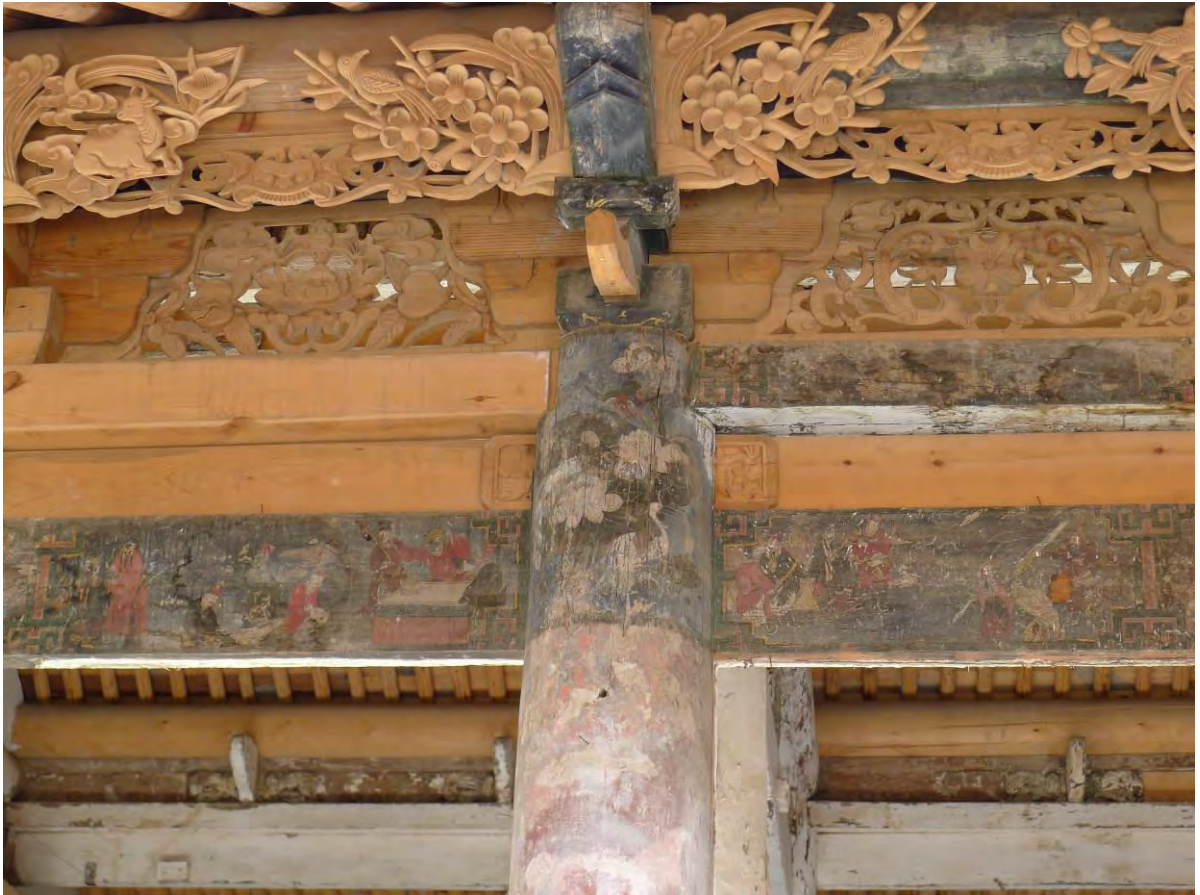
Fig. 22

Zhengdian, southern side (front), 2012, eastern column showing a crane under lotus flowers, and lintels painted with figurative scenes. All original wooden parts were painted with figures and ornaments as the few preserved parts show.

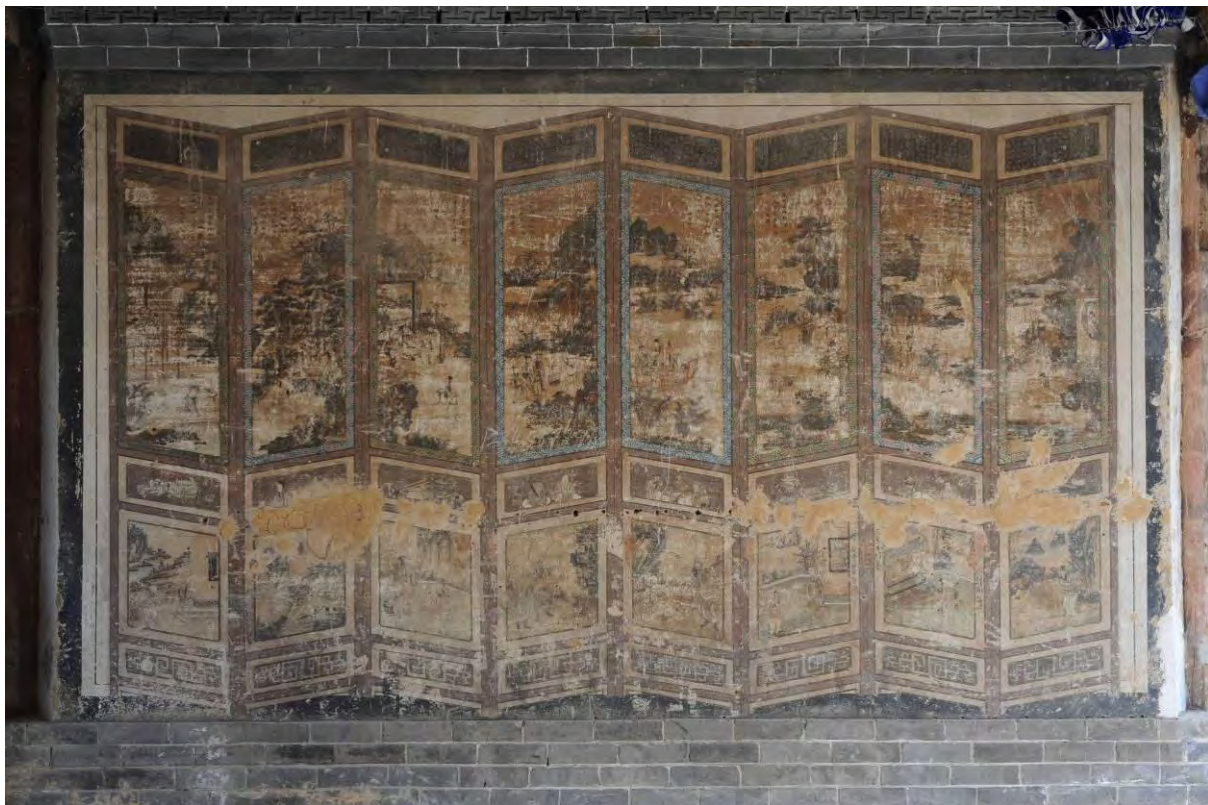
Fig. 24
guodian, pingfeng dong, before treatment
 [Shaanxi Institute for Conservation 2011]

Fig. 25
guodian, pingfeng xi, before treatment
 [Shaanxi Institute for Conservation 2011]

The gable walls of the *guodian* show painted folding screens or panel screens, in Chinese: *pingfeng* 屏风 (figs. 24 and 25). Movable screens, either consisting of one or several panels, were used in China as partition element of a room or background of a throne. A screen with landscape design, which is not foldable, is painted in panel 3 *b* of the *pingfeng dong* as background of a group of three men sitting at a table. In the panels 3 *b* of the *pingfeng xi* and in 1 *b* of the *pingfeng dong*, a painted panel door shows a design very similar to that of the folding screens.

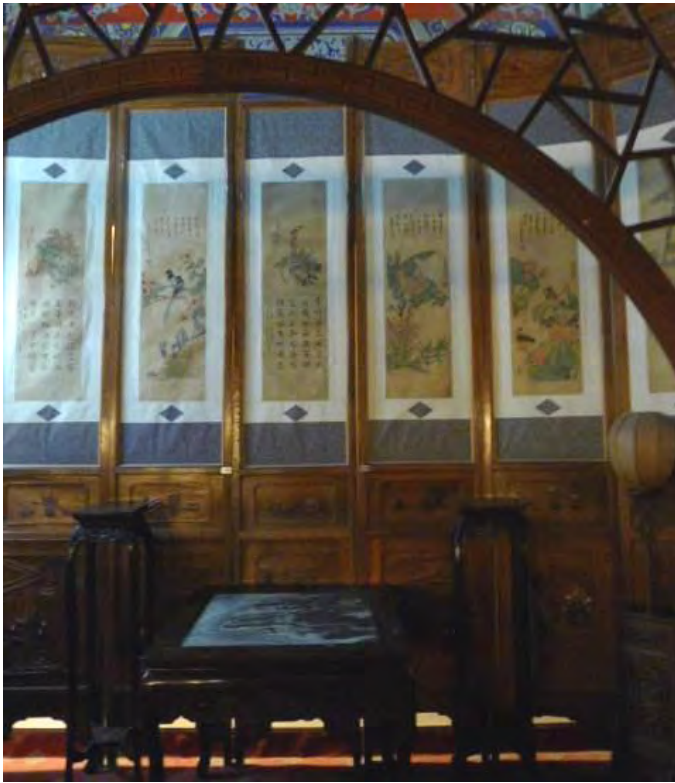
Fig. 29

Qing dynasty folding screen displayed in the top level of the drum tower in Xi'an.

The paintings in the large panels are mounted on a support and surrounded by textile borders.

Two folding screens preserved in the drum tower in Xi'an (fig. 29) and panels next to a door in the side wing building of the Great Mosque in Xi'an (fig. 30) show how this kind of screens could have looked like in reality: Folding screens and folding doors were made of a wooden construction. Carved decorations in smaller panels were set at the top (comparable to the *a*-panels in the painted *pingfeng*). Below the top panels, water-colour paintings are set into the highest panels (comparable to the *b*-panels). The damaged doors in the Mosque reveal a supportive lattice stretcher to mount the paper without borders. The paintings on the screens in the drum tower were probably mounted onto a paper support stretched over a wooden support. The paintings themselves are surrounded by textile borders with damask pattern. Smaller panels below (comparable to the *c*-panels) show still lifes as carved decorations and are surrounded by trims. The larger panels below them (comparable to the *d*-panels) show carved narrative scenes. There is no equivalent to the *e*-panels, but the carved legs zone is higher and more richly decorated.

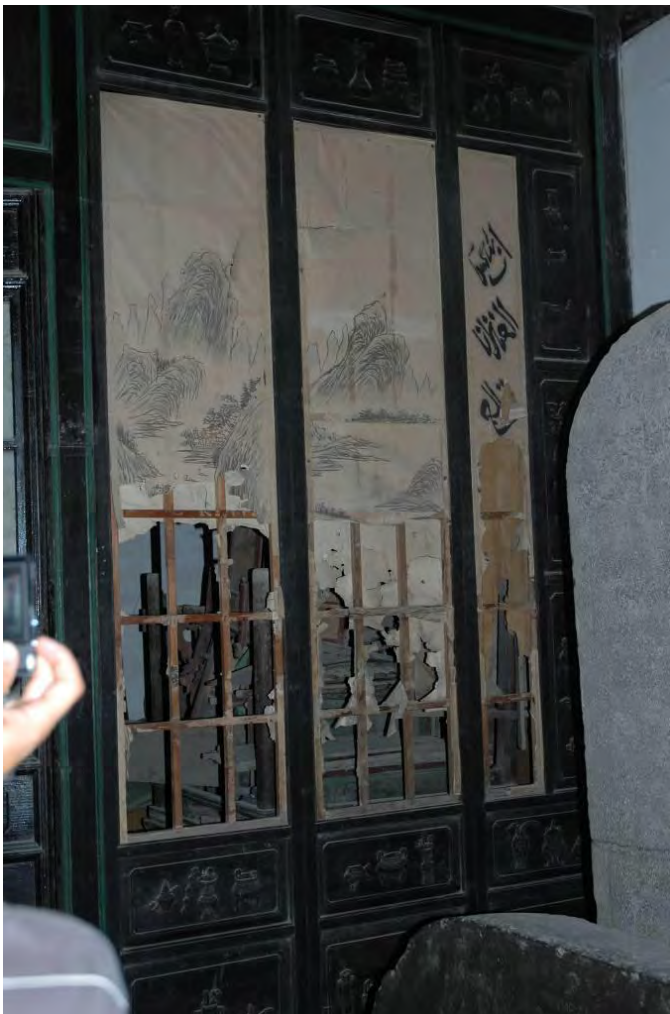
Fig. 30

Panel screen door in a side wing building of the Great Mosque in Xi'an: The paper was mounted onto a lattice-shaped wooden stretcher and then painted.

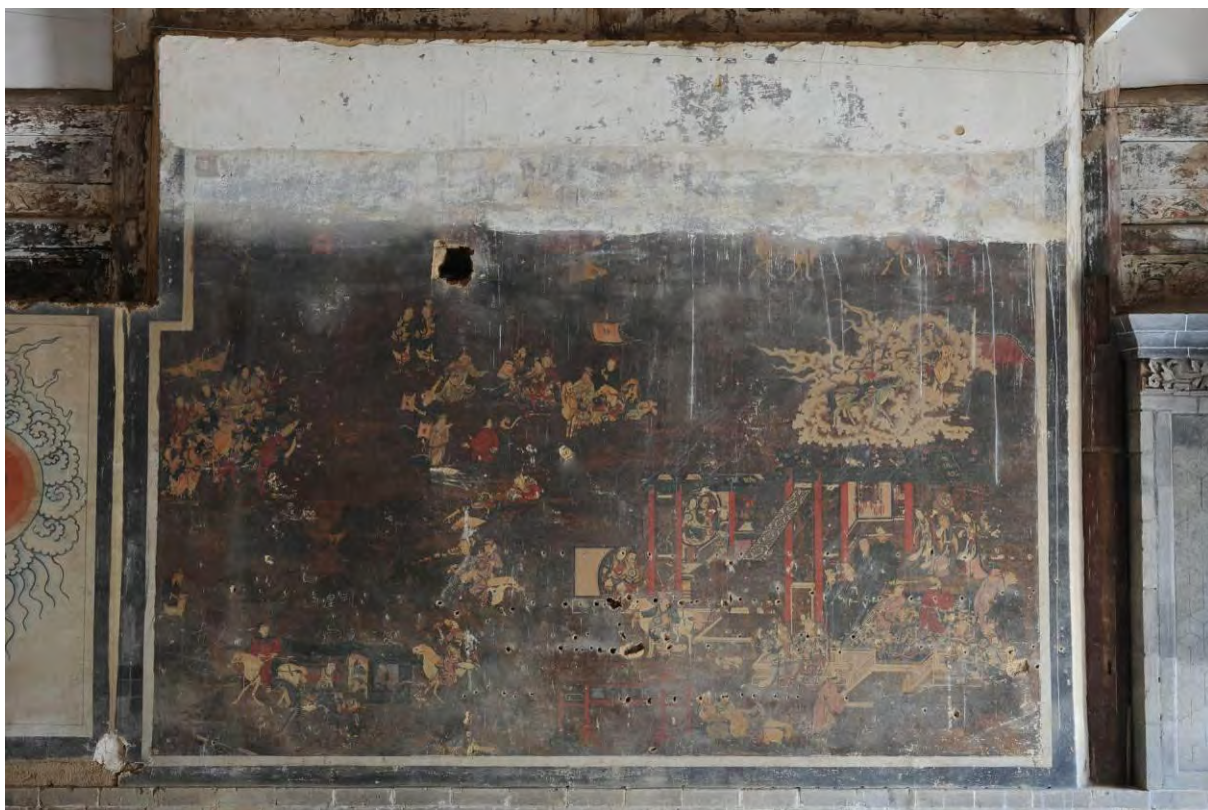
Fig. 34
zhengdian, sanguo dong, before treatment. On the left side, part of the adjacent *yunqi dong*
 [Shaanxi Institute for Conservation 2011]

Fig. 35
zhengdian, sanguo xi, before treatment
 [Shaanxi Institute for Conservation 2011]

The gable walls of the *zhengdian* (figs. 34 and 35) show the largest paintings of the halls, being 4.82-4.87 m wide and 3.80-3.85 m high, above the brick pedestal zone which measures 1.15 m. Between *yunqi*- und *sanguo*-painting, a column is hidden behind the wall: It becomes visible above the level of the upper edge of the *yunqi*-paintings. The rectangular framing of the *sanguo*-paintings has an offset here, receding towards the depiction of the *sanguo*-painting. Both walls show scenes from the *Romance of the Three Kingdoms*. Most of the figures and small scenes of the wall are not interpreted yet. In battle formations, the same type of uniforms or suits of armour appear in all groups and all flags and banners bear the inscription 帥 (*shuai*) in a roundel. The figures and some other parts appropriate for the orientation have been numbered. The numbers are given in figure 36.

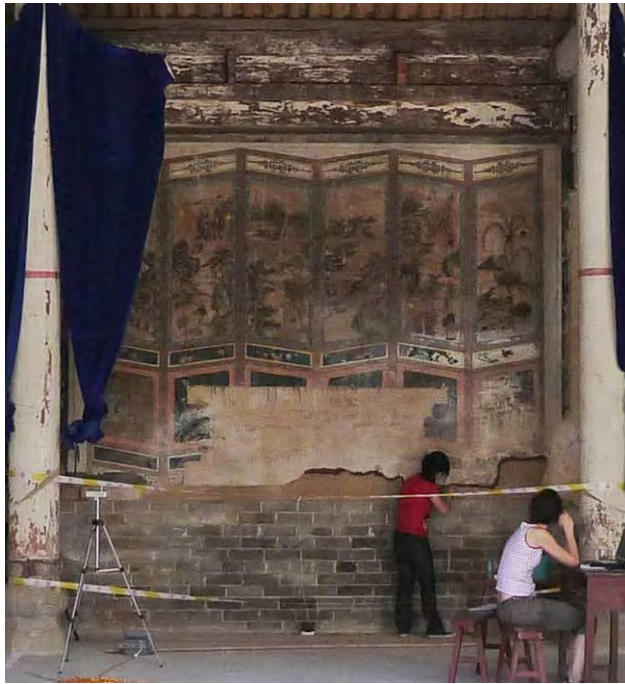
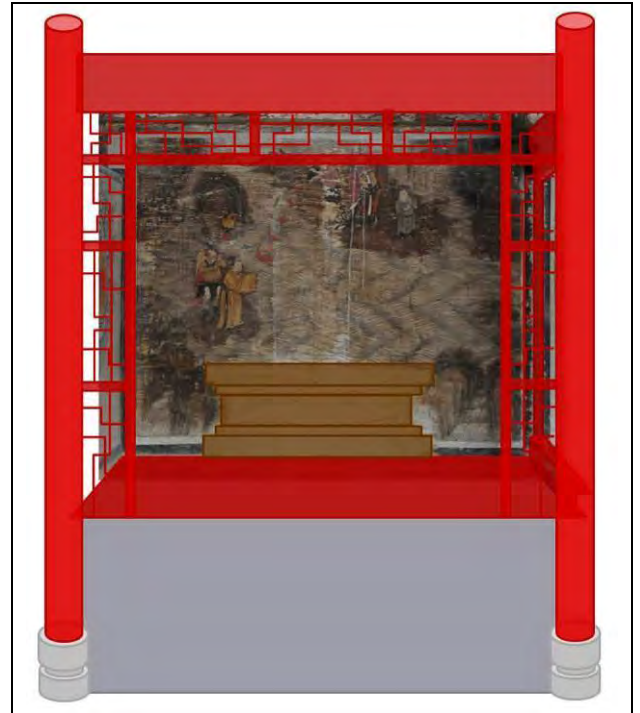
Fig. 48
'Niche' of the northern wall of *zhengdian* today and schematic reconstruction of the wooden decoration

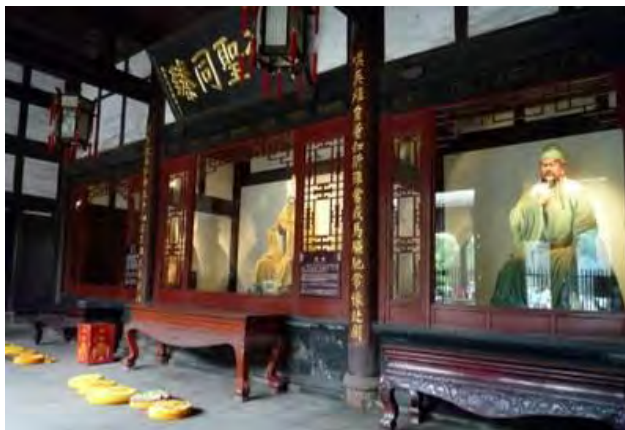
Fig. 50
Stage-like niche in the Daoist temple *siwangmiao* 四王庙 in Ziyang (originally built in the 18th century, rebuilt on higher grounds in the 1980's). The figure is sitting on a throne which could give a similar outline as the lost pedestal in the *zhengdian* of the *beiwusheng huiguan*.

There are various examples of statues *sitting* on pedestals in temple halls (fig. 49 and 50). Mr. Kang, however, remembered the clay statues *standing* in front of the highly decorated pedestals, but maybe the possibility of sitting figures should be discussed again.

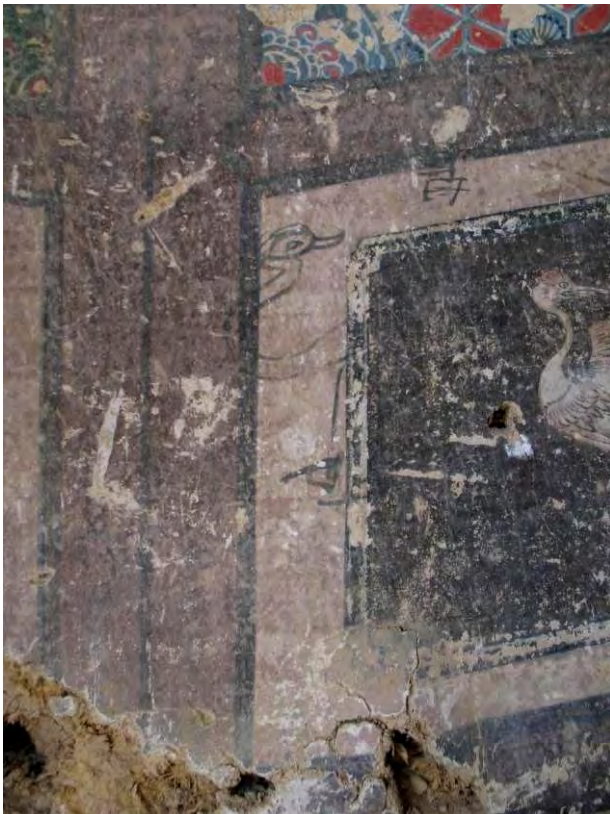
Fig. 52

Pingfeng xi, 5 *d*: Graffiti in ink and pencil, scratches (left side) and scorch marks (left side and faces), in the upper part rows of holes from pegs and nails, some of them roughly closed with clay

- rows of pegs driven into the wall maybe to use them as coat hooks or to hang up tools, some of them stabilised by shards of brick or slate (fig. 33, 52); the holes were closed again with clay (repair before 1952)

- rough repairs of holes in the wall with clay, maybe to prevent loose clay powder trickling down (fig. 33, 52)
- scratches (fig. 52) and other deliberately caused damage, for example scratching out eyes or faces

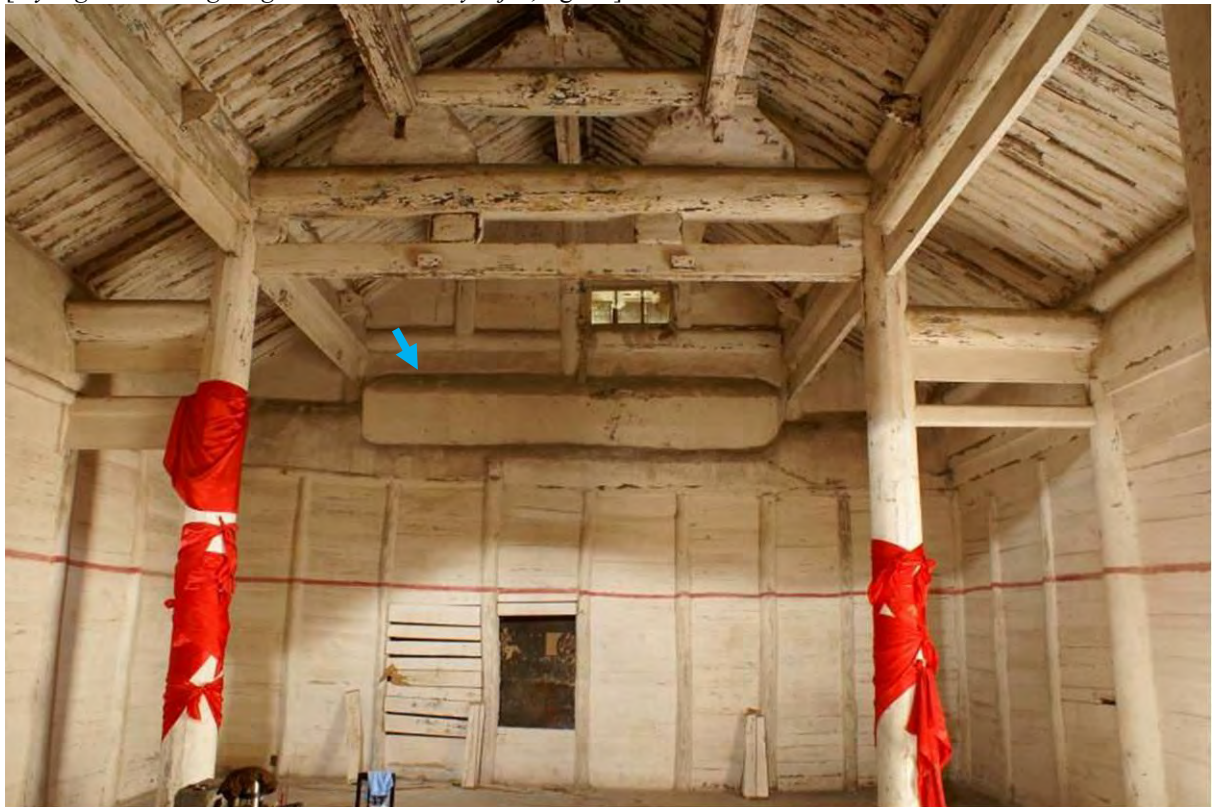
Zhengdian, view onto the *sanguo dong*-wall in 2008. The walls are still covered with the panelling. The upper part of the *sanguo dong*-painting protrudes above the panelling and is covered with white wash (blue arrow). Above that, a window has been broken into the gable wall.

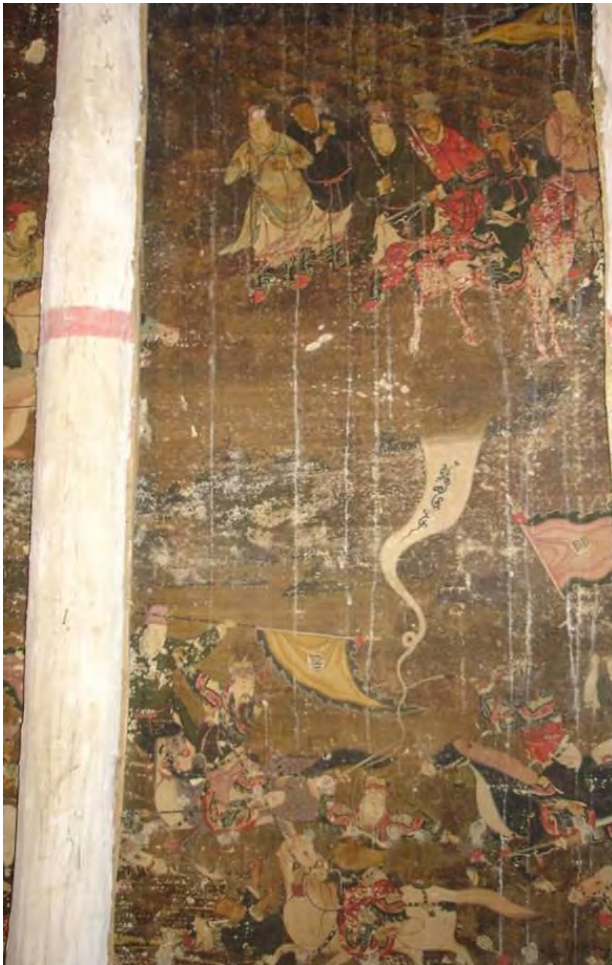
Fig. 55
Zhengdian, *sanguo xi*-wall during uncovering in 2006. The holes made by wooden pegs are closed with clay; runs of whitewash. [Shaanxi Institute for Conservation]

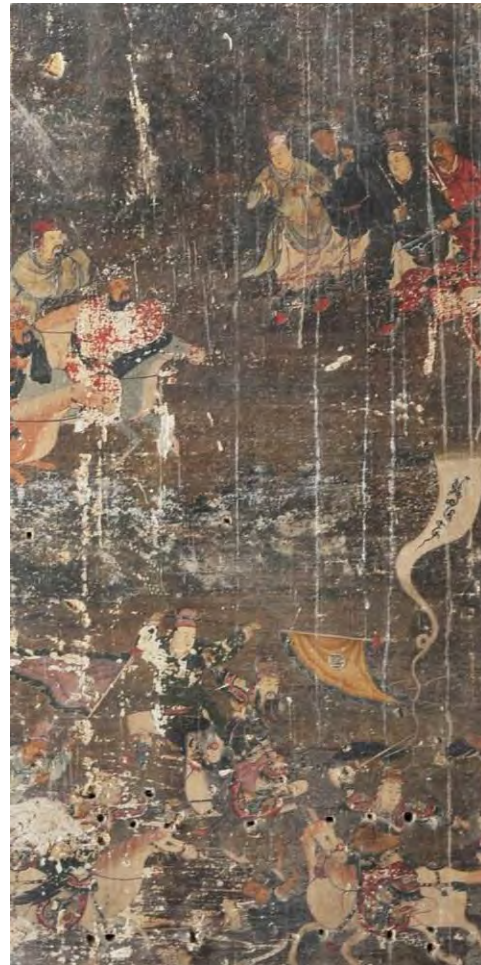
Fig. 56
Zhengdian, *sanguo xi*-wall in 2011 New runs of water probably date from the renovation of the roof in 2008.

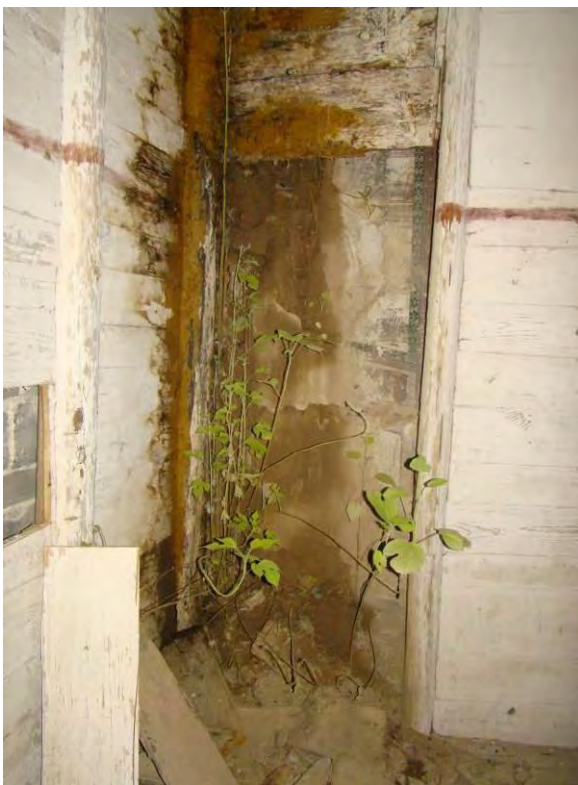
Fig. 57
Guodian, south west corner during uncovering of the paintings in 2006. The southern edge of the *pingfeng xi*-painting is damaged by water penetrating through the edge of the building. [Jiang Bo]

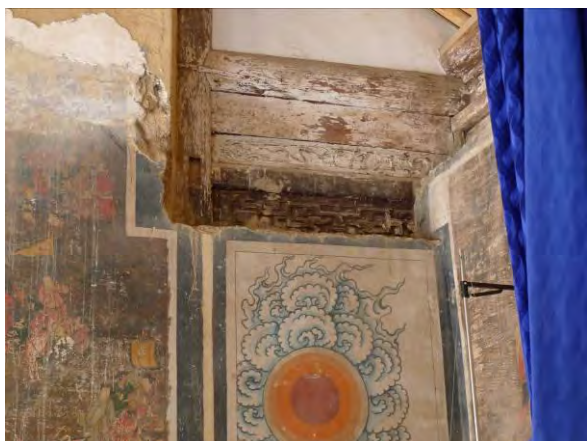
Fig. 72
Wooden construction above the *yunqi xi*, next to the *sanguo xi*

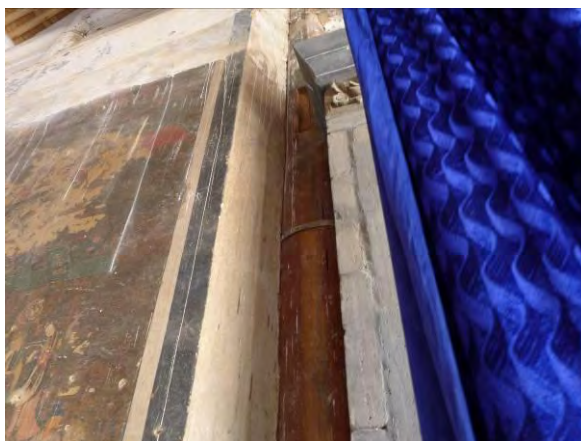
Fig. 73
Iron band proceeding underneath the mural of the *sanguo dong*

In the *zhengdian*, iron bands reinforce the connection between the column shafts and the horizontal beams or lintels, connecting the beams inside the gable walls (fig. 73 and 76). The bands are about 3 cm wide and attached with handmade, forged nails. The band is partly concealed behind the paintings. This means that the bands were applied before the walls were prepared to be painted.³³ Iron band reinforcements, nails and similar implements are not part of the traditional building technique, they were rather used as repair. This may mean that the wooden construction is older than the paintings. There is no proof, however, that reinforcements were never used during the erection of a building in historical times.

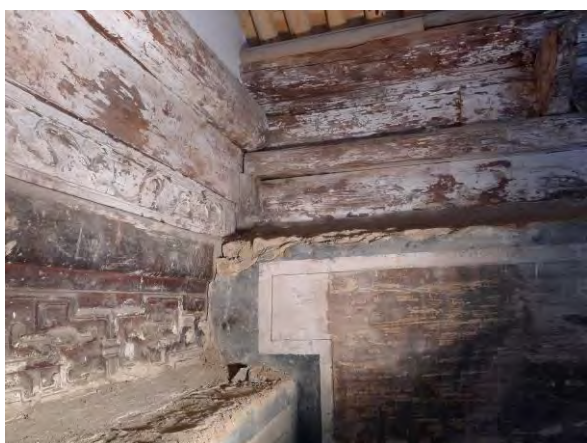
Fig. 74
Corner setting *yunqi xi*/ *tianguan cifu*, lower board concealed by *tianguan cifu*-wall

The lower panel, showing a *yunleiwen* ornament with incorporated dragons, is not painted, but covered with a glossy brown coating (maybe *qi* lacquer or tung oil). Although carved rather finely and painted, it is partly concealed behind the walls of the murals (figs. 74 and 75). This may indicate, too, that the wooden construction is older than the wall with the murals, but it is also possible that the design of the wooden elements was carried out without considering the exact position of the wall paintings: Carpenters, brick layers and painters probably were separate teams of craftsmen who may not have communicated the final design in detail.

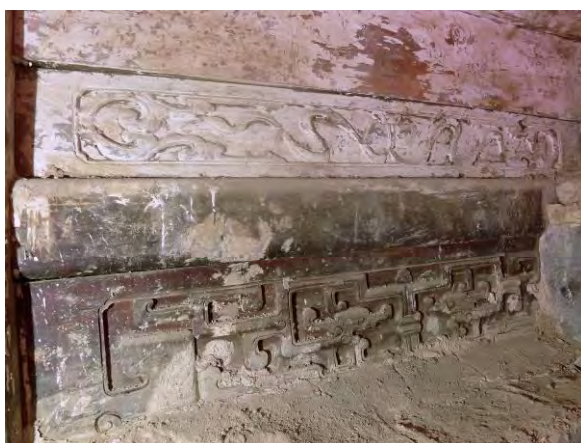
Fig. 75
Two carved wooden boards above *yunqi xi*, lower board partially concealed by the plaster of the murals

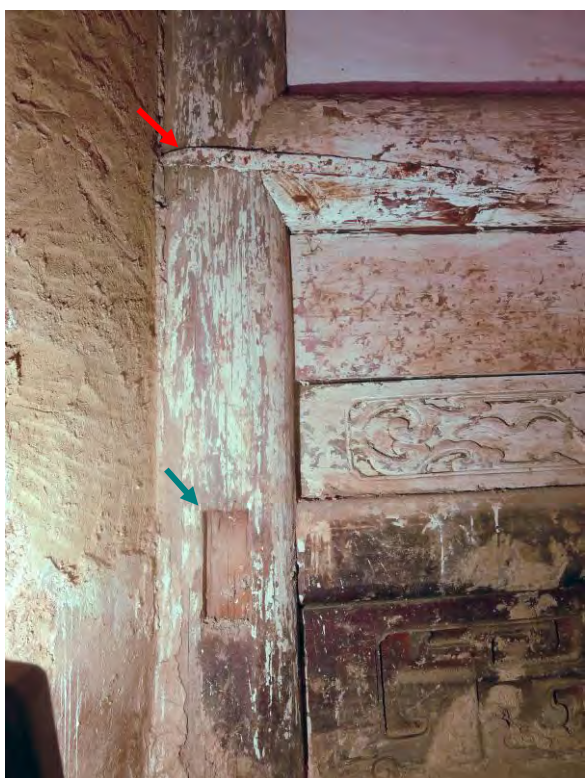
Fig. 76
Column between the *sanguo xi* and the *yunqi xi*-painting: iron band at column (red arrow) and mortise of lost lintel (green arrow).

A flat mortise in the column between the *sanguo xi*- and the *yunqi xi*-painting served to insert the tenon of a now missing lintel in W-E direction (fig. 76, green arrow; dimensions: 16.2 cm x 6.6 cm x 2.4 cm; 29 cm above the top edge of *yunqi xi*-wall). It once connected the column to the next one to the east. The lintel was part of the front decorations of the niches between the columns and the north wall (see above: *recollections of Mr. Kang Yongfu*, p. 50-51). The lower panel with the dragon/*yunleiwen*-decoration thus corresponded to the partition elements between the niches. This may explain the reddish brown coating as the partition elements are said to have been painted in that manner.

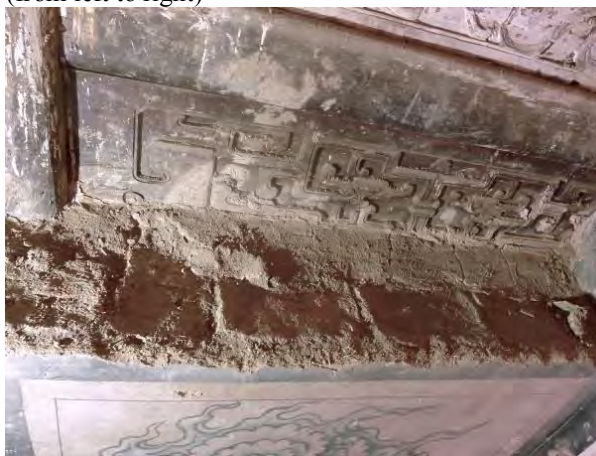
Fig. 77
Top edge of the *yunqi xi*-painting: Sequence of adobe bricks with one stretcher, one header, three stretchers (from left to right)

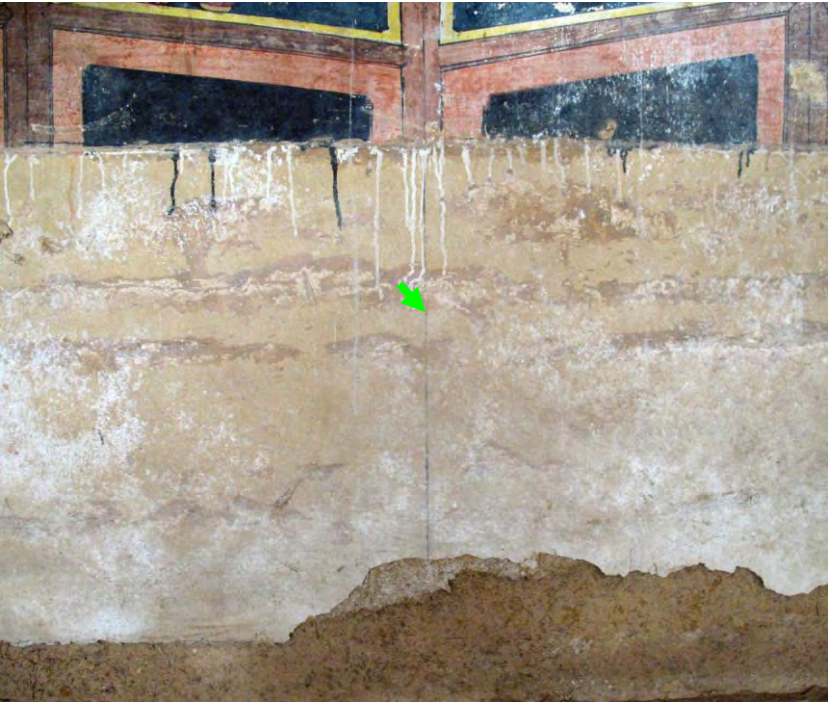
Fig. 79
Chalk line marking the centre of the *pingfeng bei*-painting or the vertical axis of the pedestal (green arrow). Runs from low viscose white ground, reddish and black paint at the upper edge of the lost pedestal.

The vertical elements between the *sanguo*- and *yunqi*-walls and the pedestals on top of the platforms were built-in after the plasterwork had been finished. Vertical black chalk lines were used to mark the borders between the *yunqi*- and *sanguo*-murals. Between the *yunqi*- and *sanguo*-murals, the holes of nails or pins to attach the strings are still visible. The strings were dipped into paint, pinned to the wall and gently snapped against the surface. Splashes beside the lines (fig. 80) prove that a liquid medium like ink was used and not dry materials like soot. Black 'chalk lines' also mark the vertical middle axes of the paintings of *tianguan cifu*, *pingfeng bei* and *long* on the north wall (fig. 79).³⁸

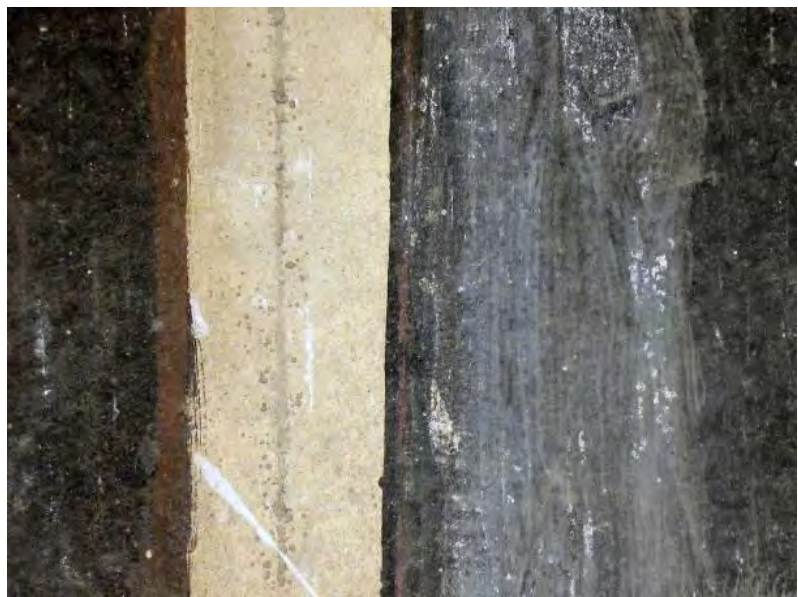
Fig. 80

Chalk line with black ink, on the strip between *yunqi dong* and *sanguo dong*-painting: splashes of liquid material next to the chalk line.

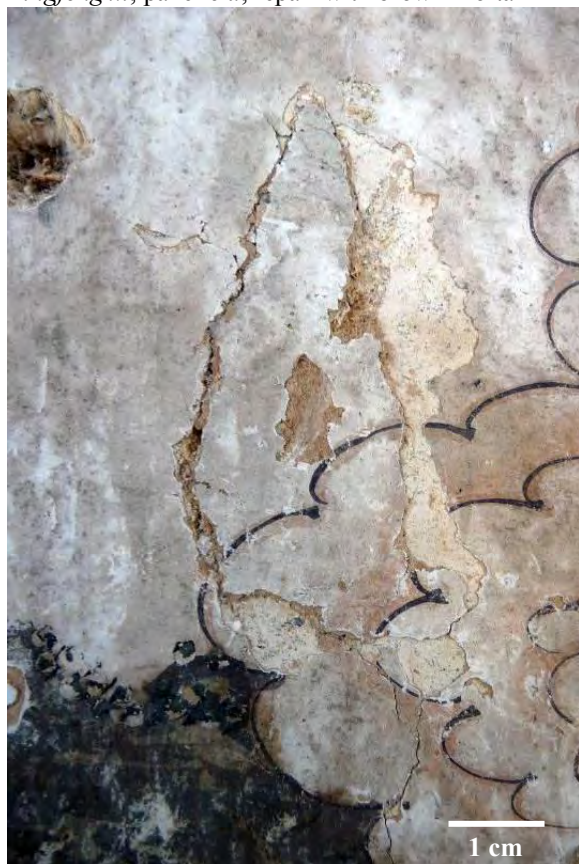
Fig. 81

Pingfeng xi, panel 6 *d*, repair with brown mortar

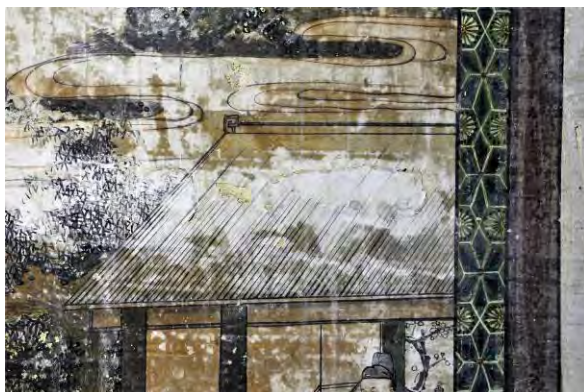
Fig. 82

Pingfeng xi, panel 8 *b*, horizontal repair in the roof, on which the paint layer is partially lost

The repair mortar is reddish brown and has a fine homogeneous structure without discernible fibres or other additives. Clay is assumed to be the main component.³⁹ Its colour, structure and composition are different from the light yellowish white fine coat. It also seems to have divergent adhesion and swelling properties: Paint layers are not as well-preserved on repairs as on surrounding areas, and along the edges of the repairs there are cracks and even losses (fig. 81). The repaired areas have no UV-fluorescence (fig. 82, 83) whereas other areas of the priming layer and the fine coat have a bluish white fluorescence. There may be a fluorescing binding medium in the fine coat that is missing in the repair plaster. The reddish brown colour corresponds to local loam deposits at the mountains behind Wafangdian. Maybe the kaolin containing whitish material used for the plasters was brought from farther away and the craftsmen ran out of material and thus used local clay for repairs carried out as a last step of preparations on the wall.

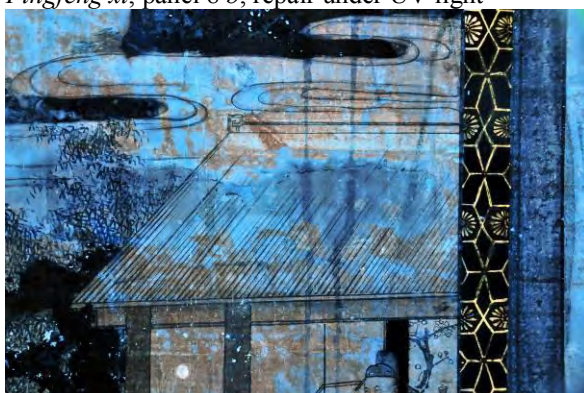
Pingfeng xi, panel 8 *b*, repair under UV light

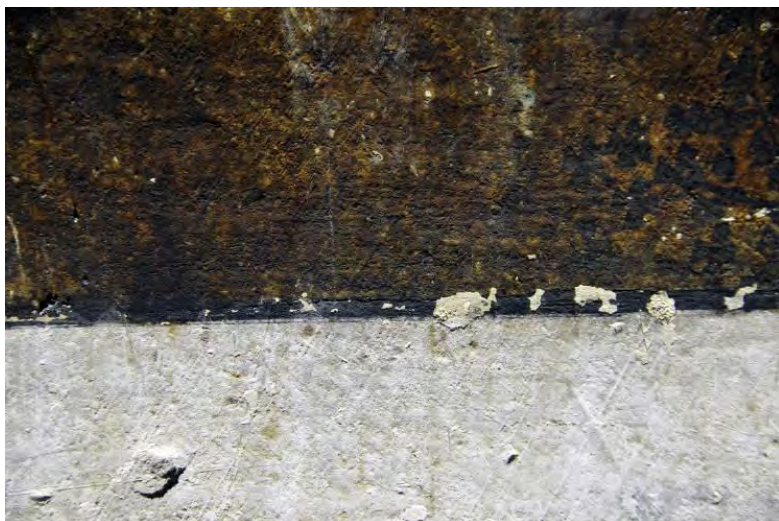
Fig. 86

Sanguo dong, detail in raking light: overlapping brush marks from the ground layer running diagonally in both directions. The lower part shows the white framing of the painting where the white ground is not covered with a pictorial layer.

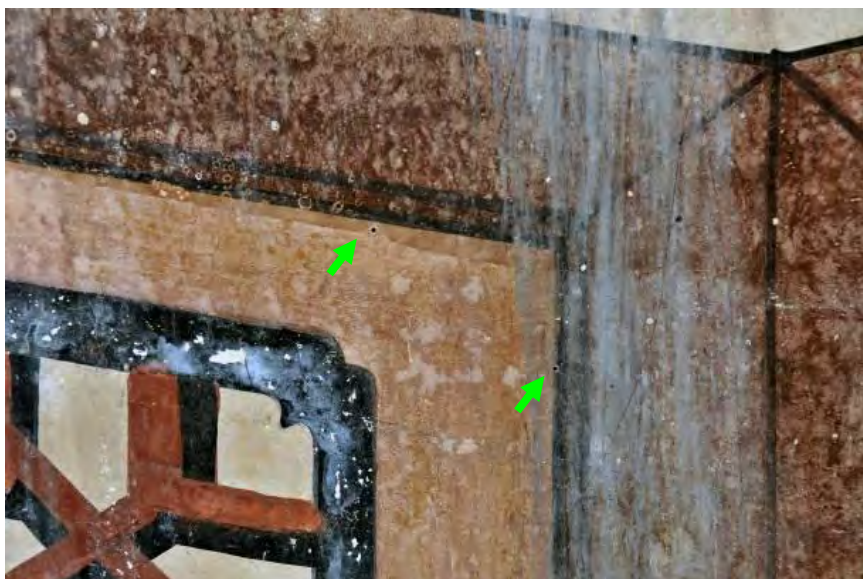
Fig. 87

Pingfeng xi, nail holes for pinning strings to mark the stiles (red) and the panel frames (green)

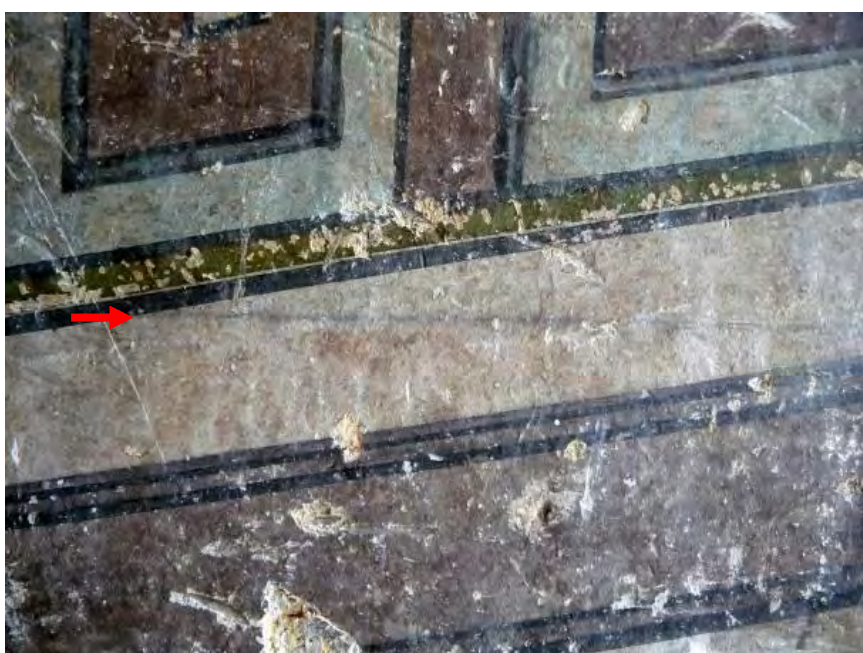
Fig. 88

Pingfeng xi, nail holes for pinning strings to mark the filling frames (green)

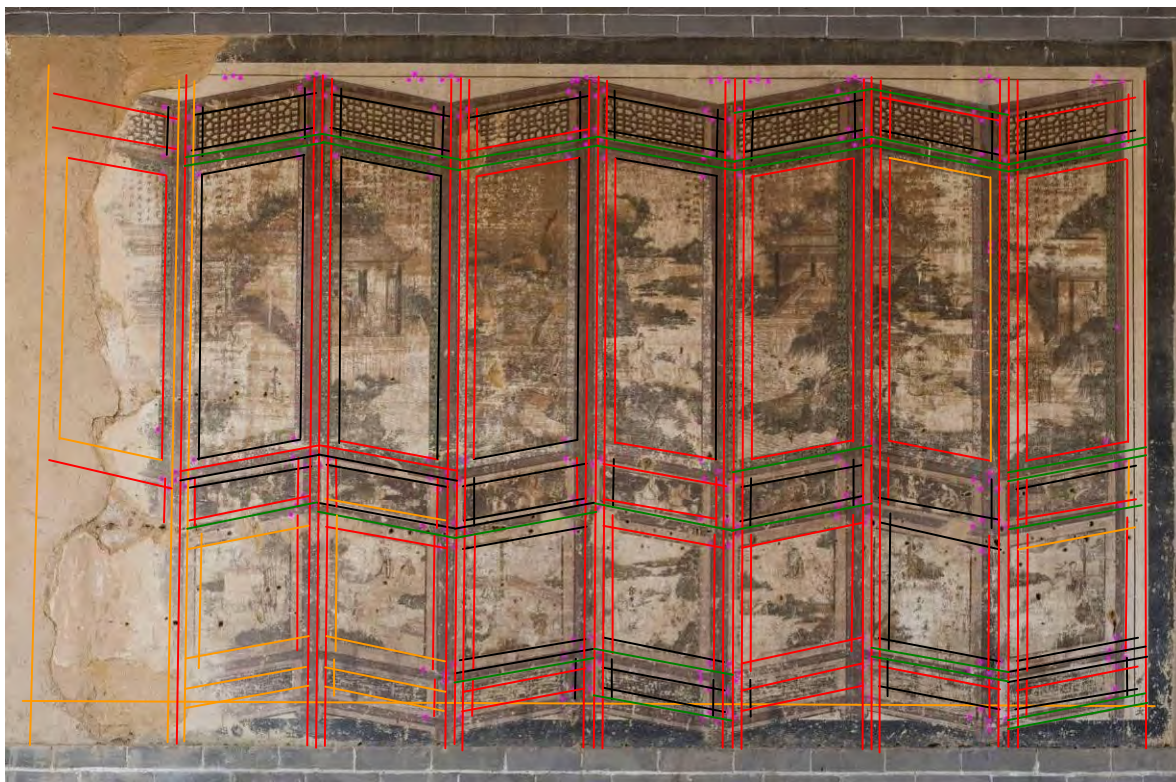
Fig. 92
Reconstruction of strings used for the construction of the folding screen, (photograph not rectified)
[Photograph: Shaanxi Institute for Conservation]

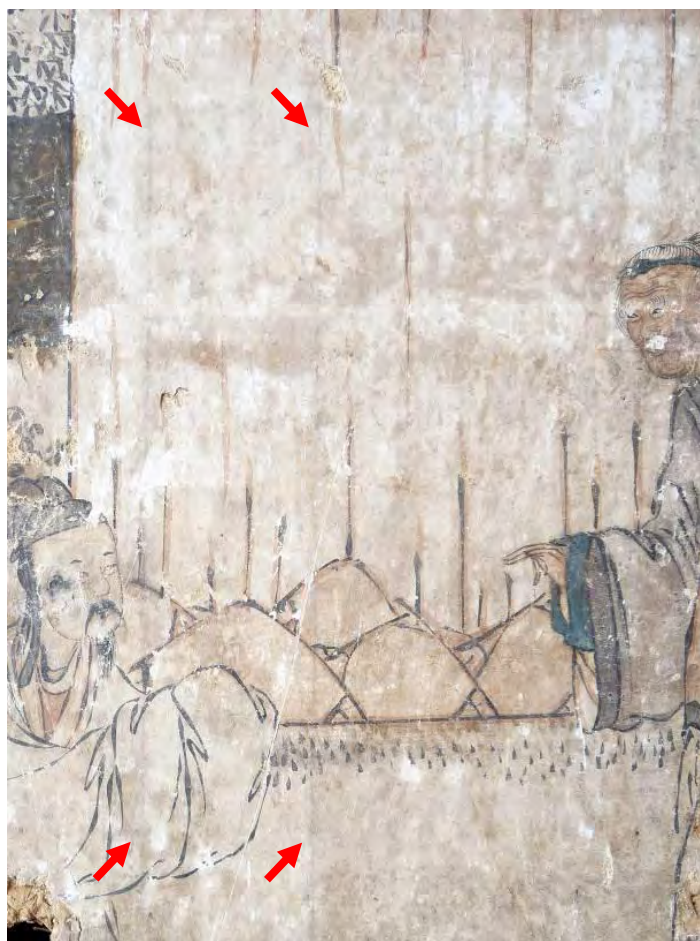
Fig. 94
Pingfeng xi, panel 2 d: two grey vertical lines running through a narrative scene of the panel filling 2 d

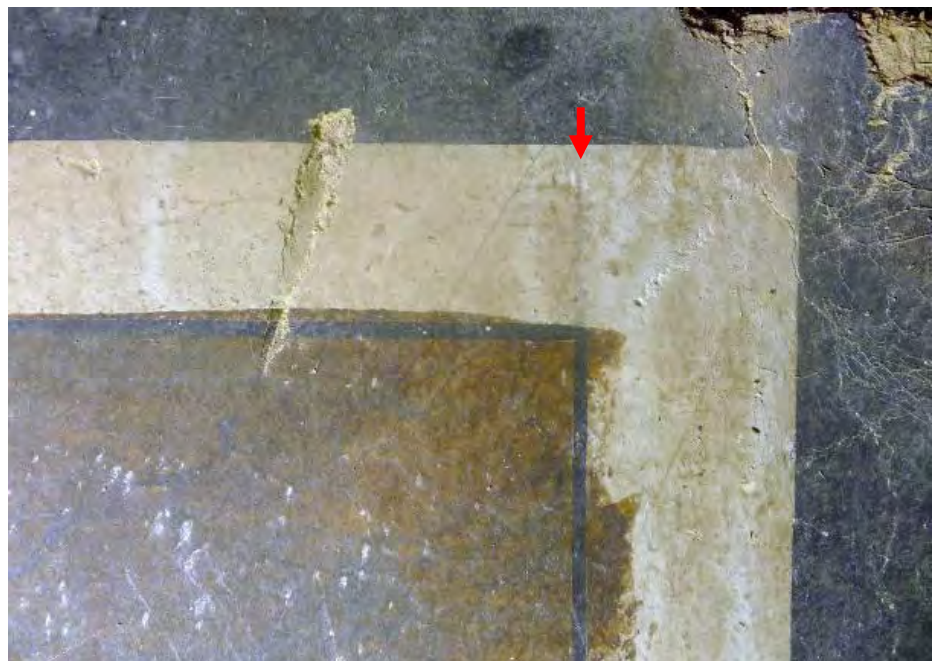
Fig. 96
Sanguo xi, offset on northern edge, vertical construction line (underneath a white layer?)

At the *sanguo xi*-wall, there is a faintly visible, vertical construction line running along the contour line of the framing and proceeding through the white framing (located at the northern edge of the *sanguo xi*-wall at the offset of the framing, next to the upper edge of the *yunqi*-painting). The dark line here seems to lie underneath the surface of the priming layer (fig. 96). This construction line may be a painted and not a chalk line.
