Ziyang *Beiwusheng huiguan*

Final report

Part 1: Technique and materials

Research Project 01UG1001
„German-Chinese co-operation in the preservation of Cultural Heritage: Researches for the
conservation of selected monuments in the PR China”

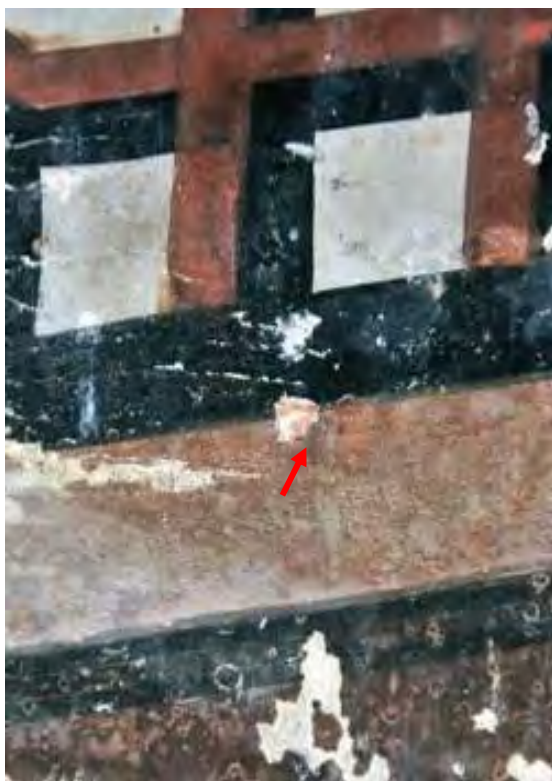
Fig. 97
Pingfeng xi, panel 2 *a*, decorative lattice: orange red underneath the priming layer

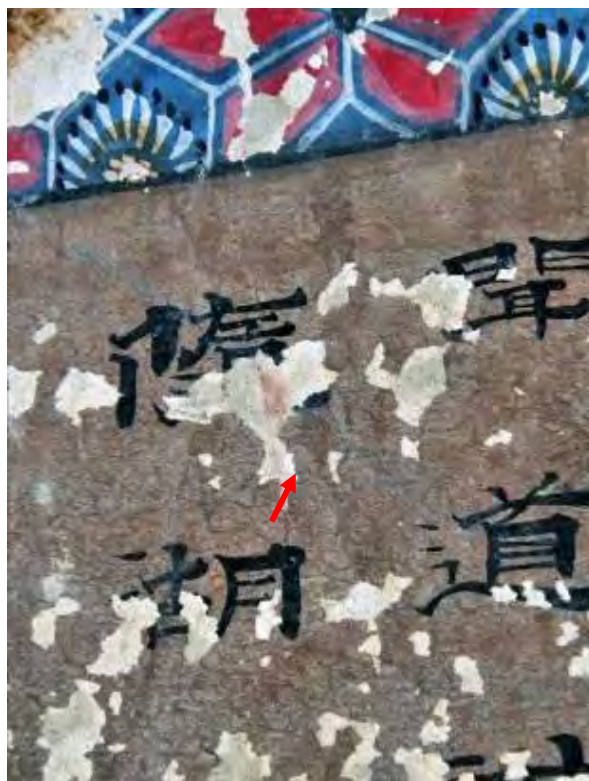
Fig. 98
Pingfeng xi, panel 4 *b*, dab of orange red on fine coat underneath the priming layer

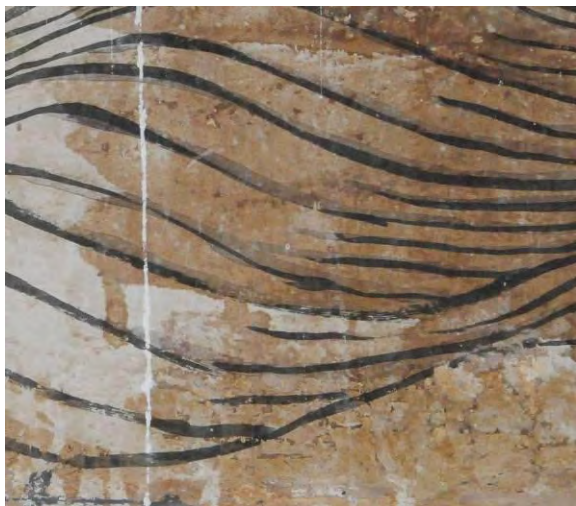
Fig. 100
long, greenish lines of preliminary drawing of waves underneath the black lines

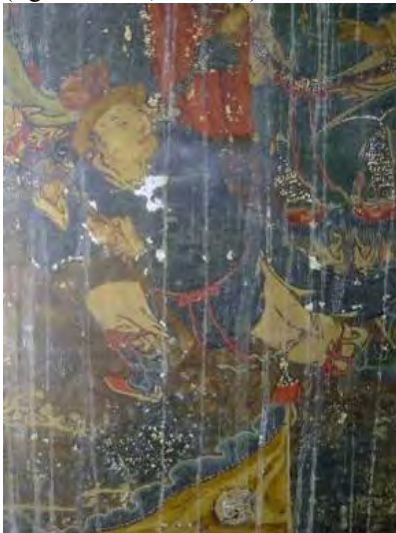
Fig. 101
Sanguo xi, northern edge: oarsman
(figure no. 77, h 22 cm)

In both paintings a detailed drawing of the depiction was made in black or dark grey before the colours were applied. These lines can partly still be seen through semi-translucent pictorial layers (fig. 104) or become visible in losses of the paint layer (figs. 101 to 103). In the waves of the *tianguan cifu*- and the *long*-painting, a detailed preliminary drawing can be observed, appearing grey in the *tianguan cifu*-painting (fig. 99) and greenish in the *long*-painting (fig. 100). The first drawing seems to lie underneath the last application of the white ground. It is possible that this is the case with the oarsman in the *sanguo xi*-painting as well. Sometimes, the black or grey lines deviate slightly from the final contours, for example in the waves of the *tianguan cifu*-painting and a yellow flag (fig. 104) in the *sanguo xi*-painting, but mostly they are either underneath the pictorial layer or included into the visible contours.

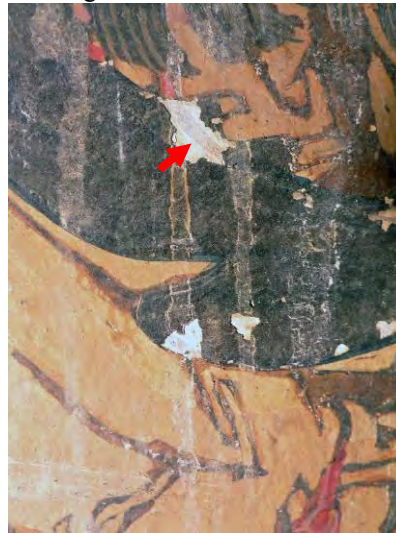
Fig. 102
Sanguo xi, left leg of the oarsman,
drawing visible inside a lacuna

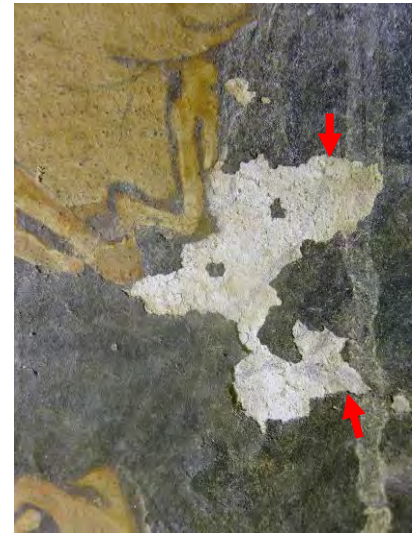
Fig. 103
Sanguo xi, oarsman, robe: drawing
visible inside a lacuna

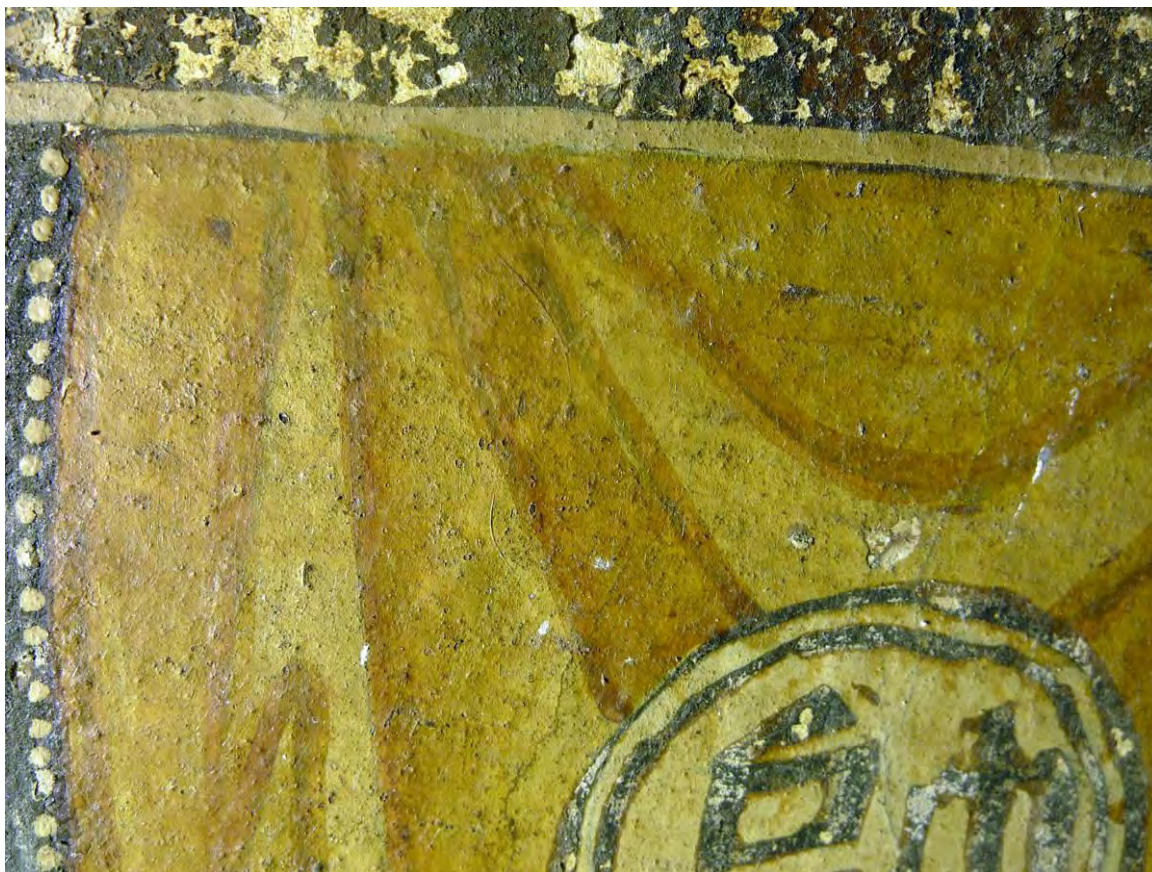
Fig. 104

Sanguo xi, black preliminary drawing visible through translucent yellow layer of flag: the black lines visible underneath the folds shaded with dark ochre glaze

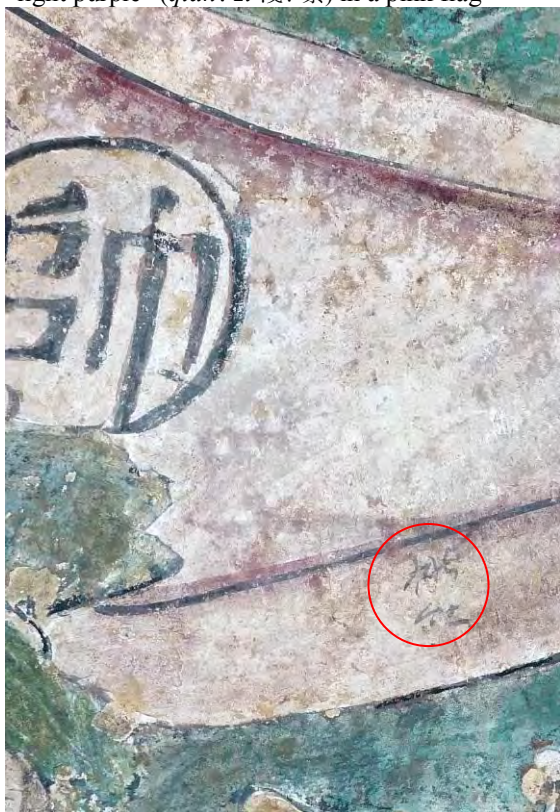
Fig. 105

Sanguo xi: Cursive Chinese characters reading “light purple” (*qian? zi* 淺? 紫) in a pink flag

After the removal of the whitewash from the topmost part of the *sanguo*-paintings, the original paint layer showed many lacunae and areas of reduced and abraded paint layers. In these layers, the Chinese restorers detected small characters of colour names, indicating the colour to be filled-in into the respective area, for example in a pale pinkish purple flag in the upper part of the *sanguo xi*-wall (fig. 105).⁴⁶ There seems to be different handwritings (cursive and grey, but also straight in black brush strokes). The characters were written with fine brushes or pencils. In some cases the inscribed colour and the existing one differ, for example in a green robe where “moon white” was indicated (fig. 106). The inscription of the colours can be seen as implemental aid of the painter, maybe by copying a template, but may also indicate that the colouration was done by a group of painters and the colour names served as guidelines set by the master.

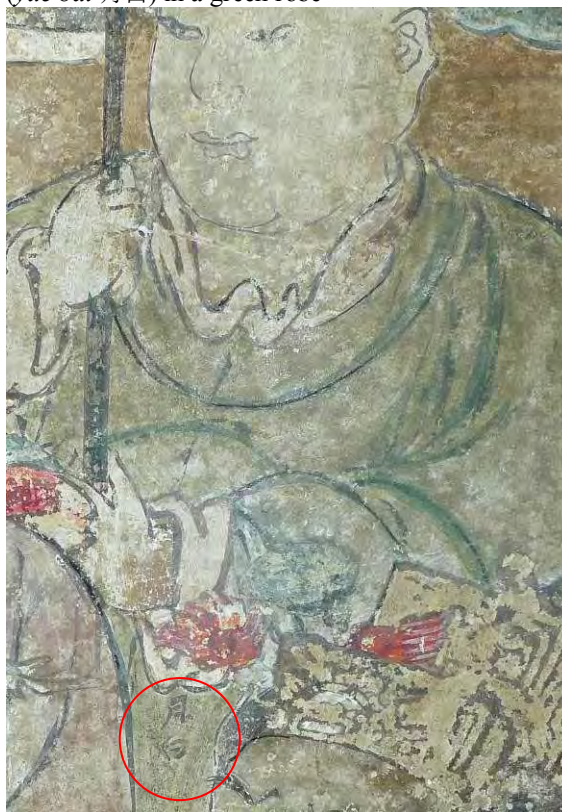
Fig. 106

Sanguo xi: Chinese characters reading “moon white” (*yue bai* 月白) in a green robe

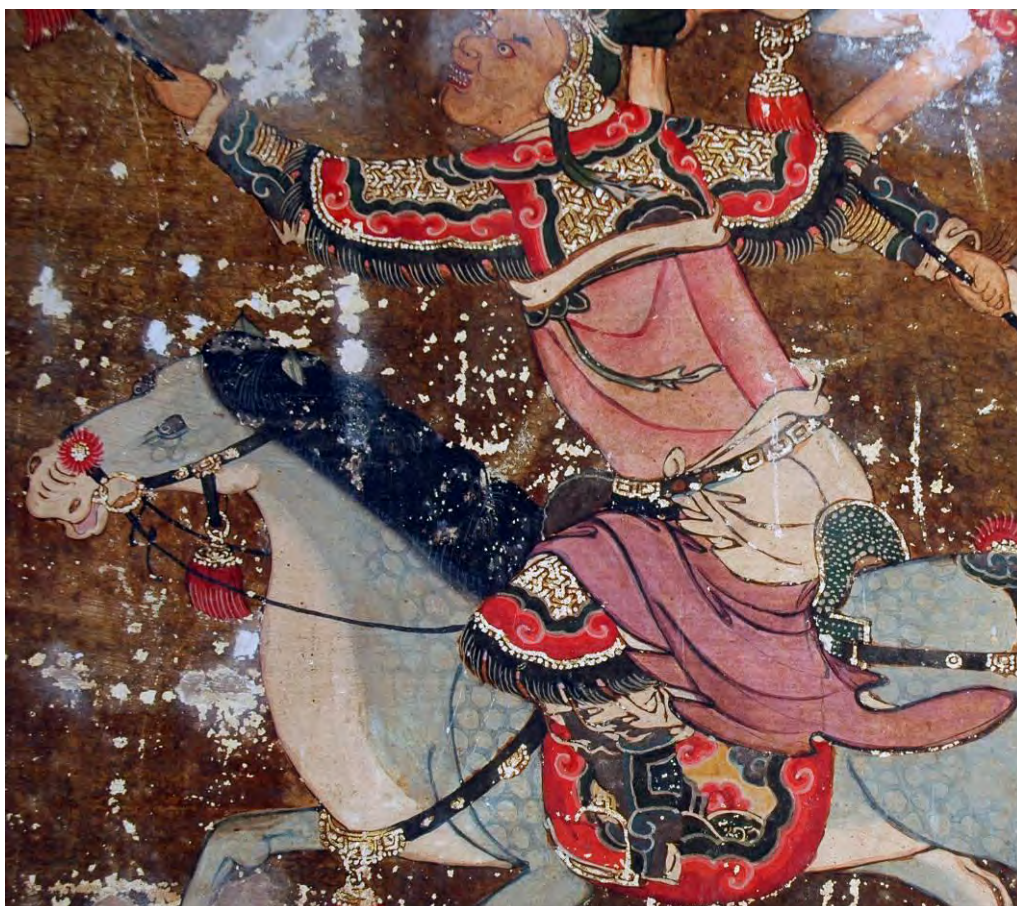
Fig. 107
Sanguo xi, right lower corner, horseman (figure no. 30) with a pink tunic, a purple “skirt” and a pale pink cloth around his buttocks

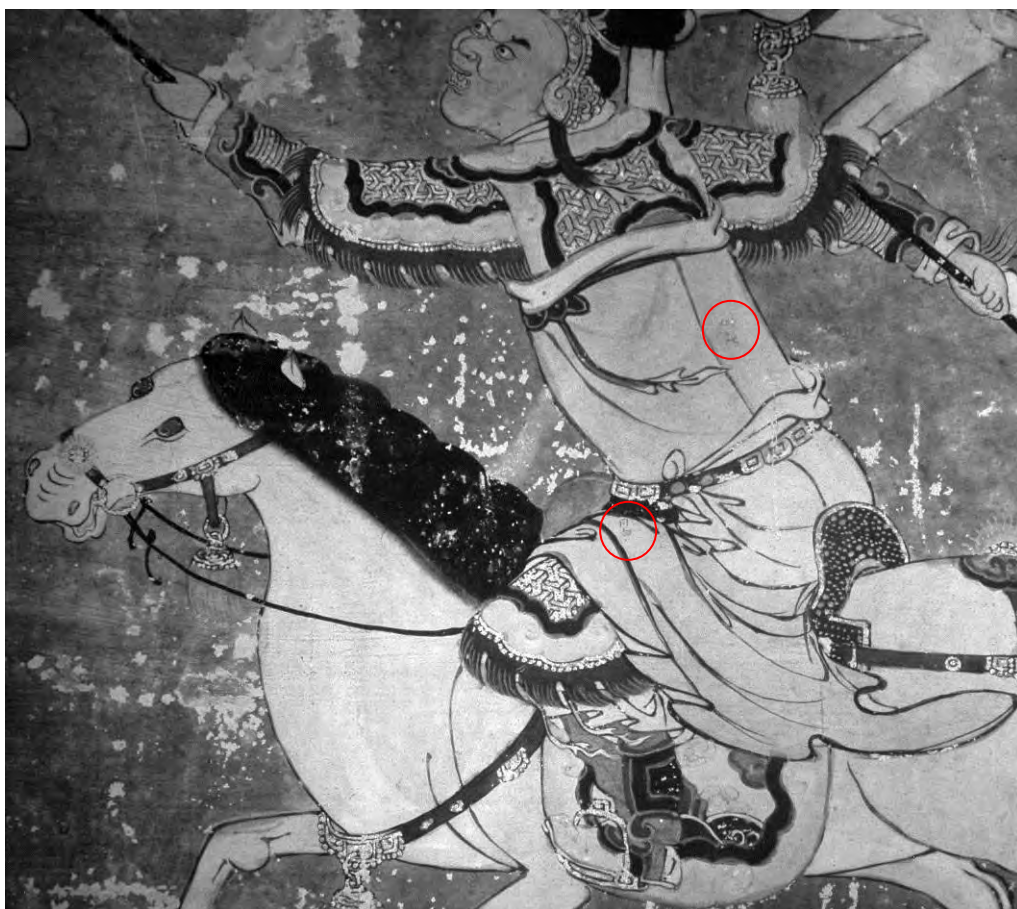
Fig. 108
IR reflectography of the horseman, revealing colour names in the tunic and skirt. Areas containing lead white (buttocks, horse) have no transmittance for IR radiation. Grey lines in the structure of the landscape next to the body of the rider are visible in VIS, but not in the IR reflectography.

Infrared reflectography was used for further examination of the *sanguo*-murals. The technique did not give results for all areas, depending on the colours and pigments of the pictorial layer: Red, pink and purple showed a good transmittance, while layers containing lead white were much less permeable. Some more characters regarding the colours could be detected (fig. 107 and 108). Lines of the preliminary drawing became visible or more distinct in the robes, the horses and the saddlery, sometimes deviating from the final drawing (fig. 109/110 and 113/114). The hair of the horses’ manes and tails was sketched with extremely fine, dark grey to black lines, before they were carried out in the horse’s coat colour (fig. 112). With IR reflectography drawings of details became distinct which are not recognisable because of the ageing of the brown layers in the background, like waves or clouds in the background (fig. 116) or folds of dark green garments. The fine drawing indicating grass, however, that is faintly visible underneath the brown layers as greyish lines, is not visible in the IR reflectography pictures. Under UV light, too, the fine drawing, is almost invisible.

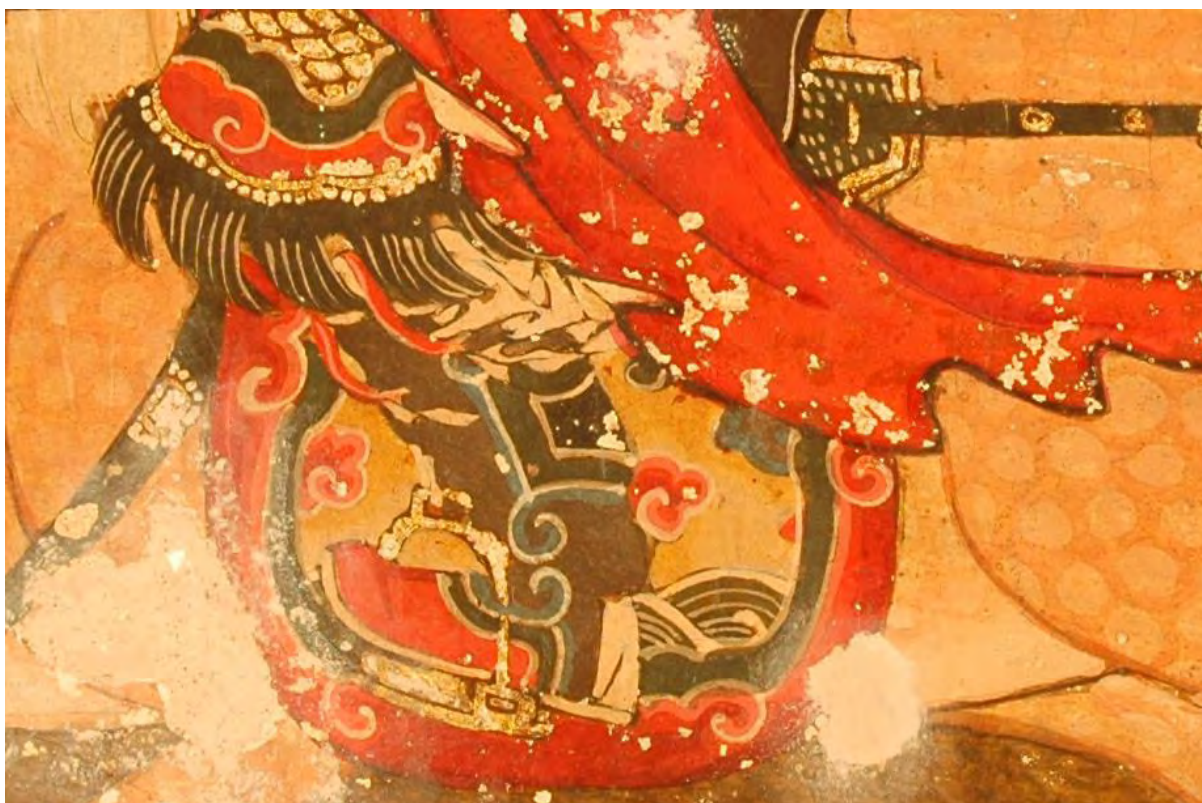
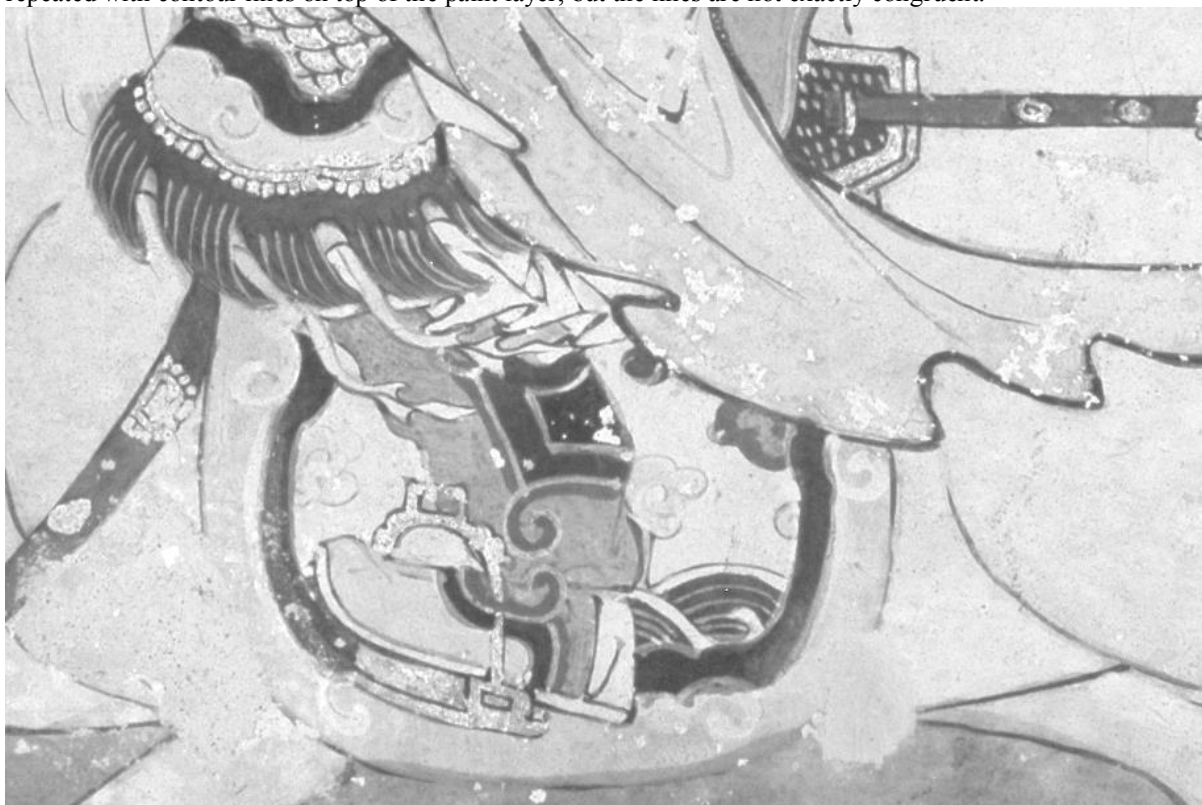
Fig. 109

Sanguo xi, right lower corner: leg and knee of a rider on a pink horse (figure no. 31)

In the IR-reflectography, fine grey lines of underdrawing are visible in the cloud-ornaments on the saddle and the knee, the wrinkles in the dark bootleg and the red footpart of his boot. In the red robe, the fine drawing was repeated with contour lines on top of the paint layer, but the lines are not exactly congruent.

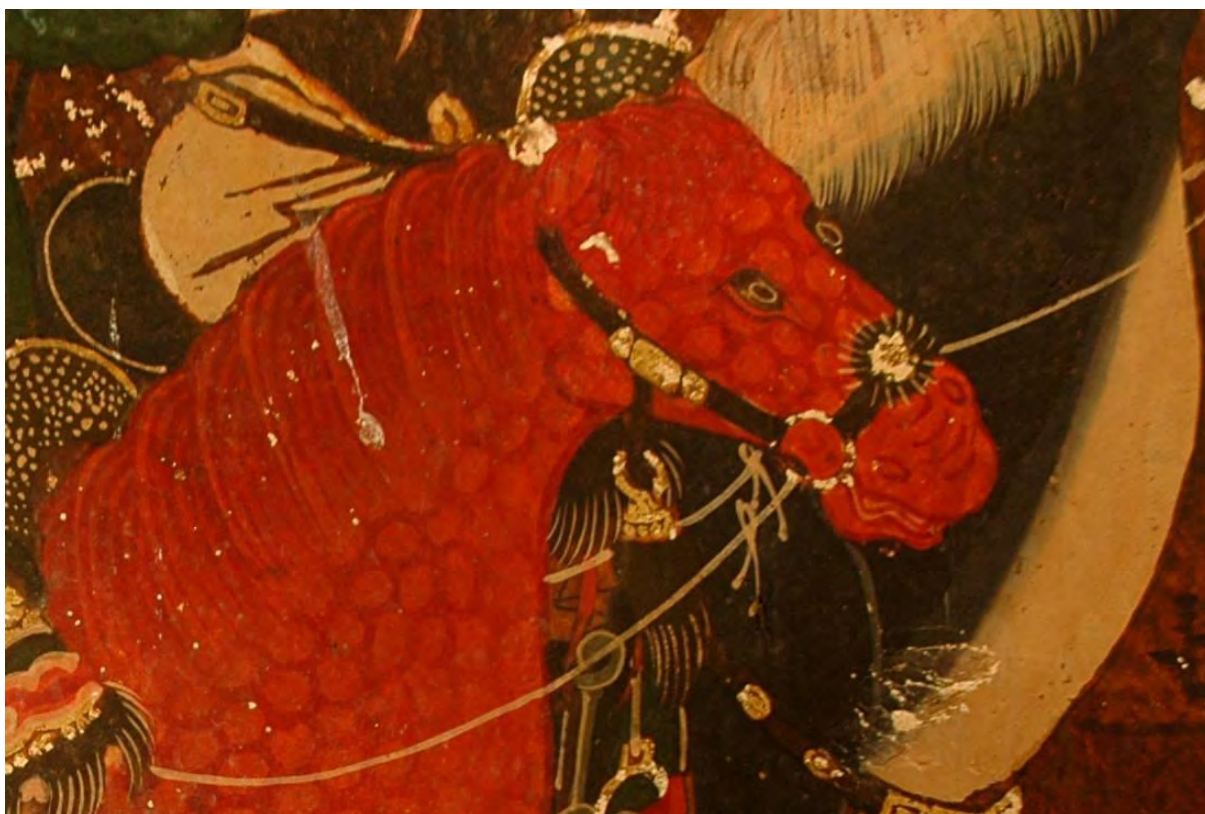
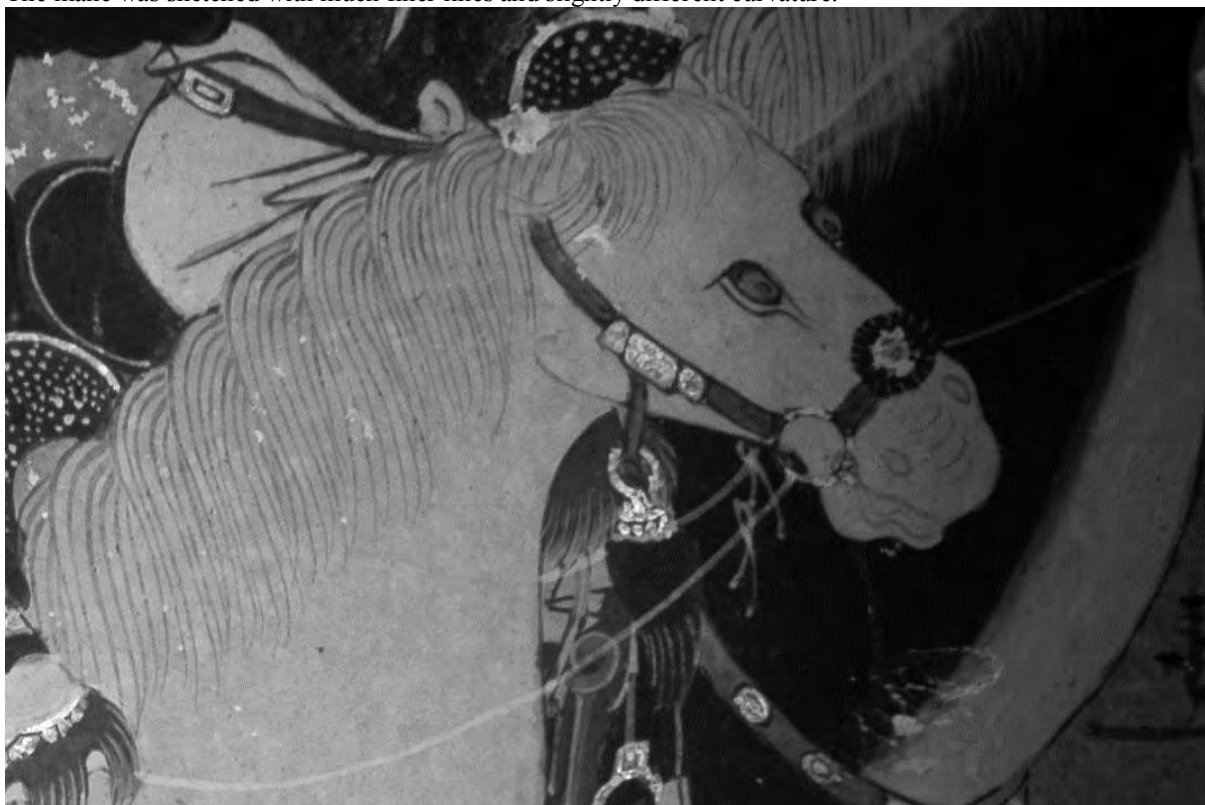
Fig. 111

Sanguo dong, Guan Yu on his red horse (figure no. 35), left (northern) edge of the painting

The red paint of the horse shows good transmittance for IR-radiation. Differences between the drawing and the visible painting can be seen in the nostrils, the wrinkles on the nose and the shape of the chin bone of the horse. The mane was sketched with much finer lines and slightly different curvature.

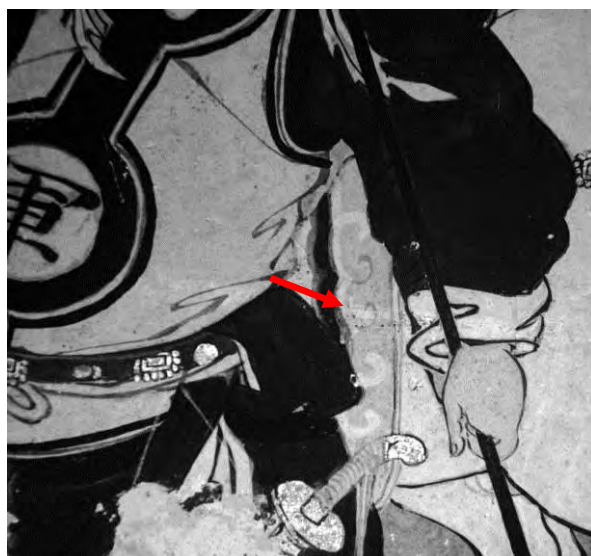
Fig. 114
IR: The preliminary drawing becomes more distinct; the spiral ornaments (arrow) were not painted with opaque colours.

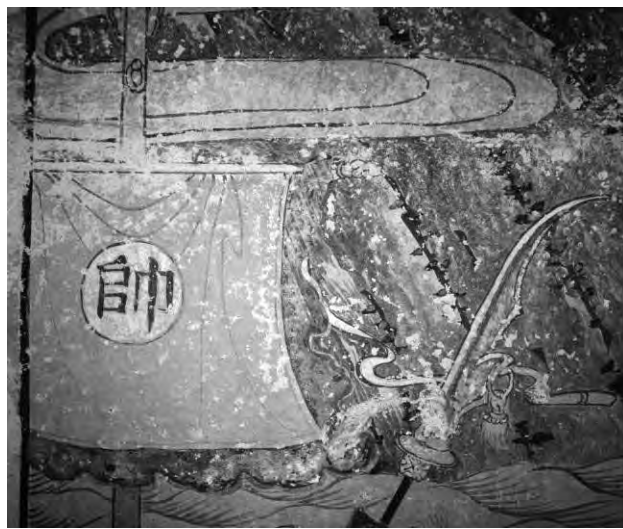
Fig. 116
Preliminary drawing in the flag, the drawing of cloud and the waves are more distinct

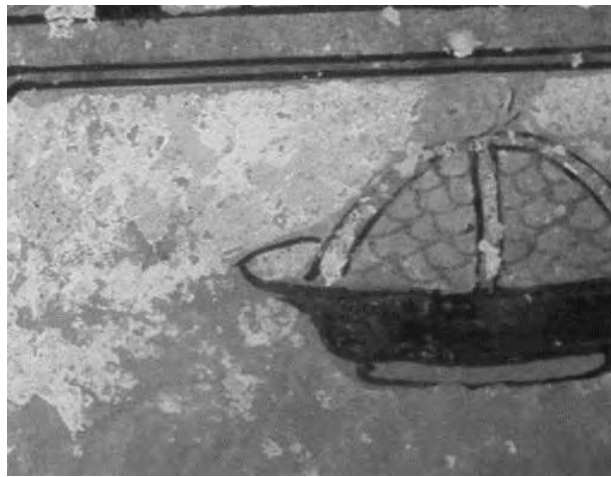
Fig. 118
IR: Scale-like structure of the cover

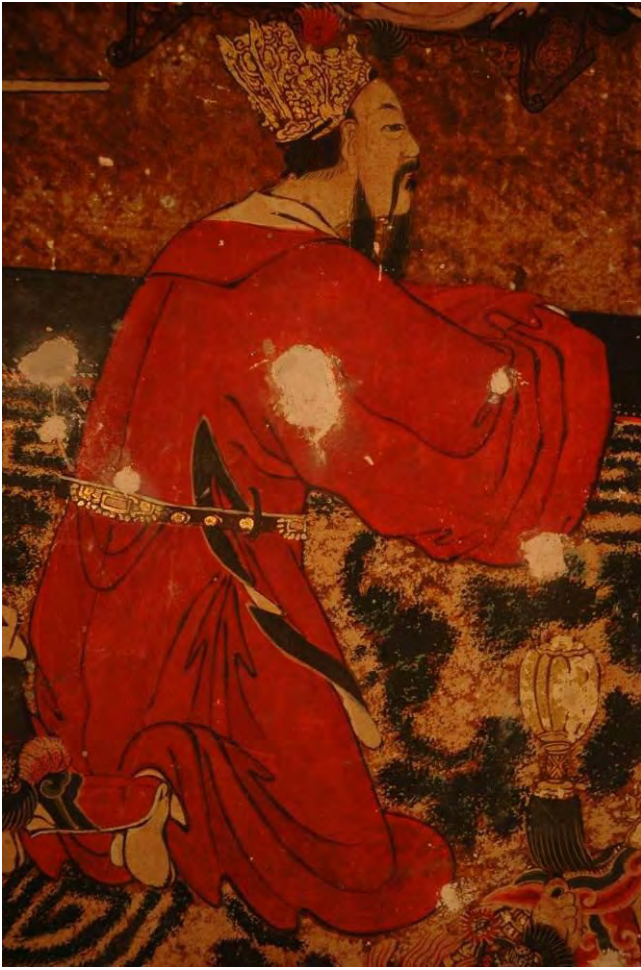
Fig. 119
Sanguo dong, Liu Bei (figure no. 12) kneeling in the *ganlusi* hall. Black contours painted on top of red paint layer

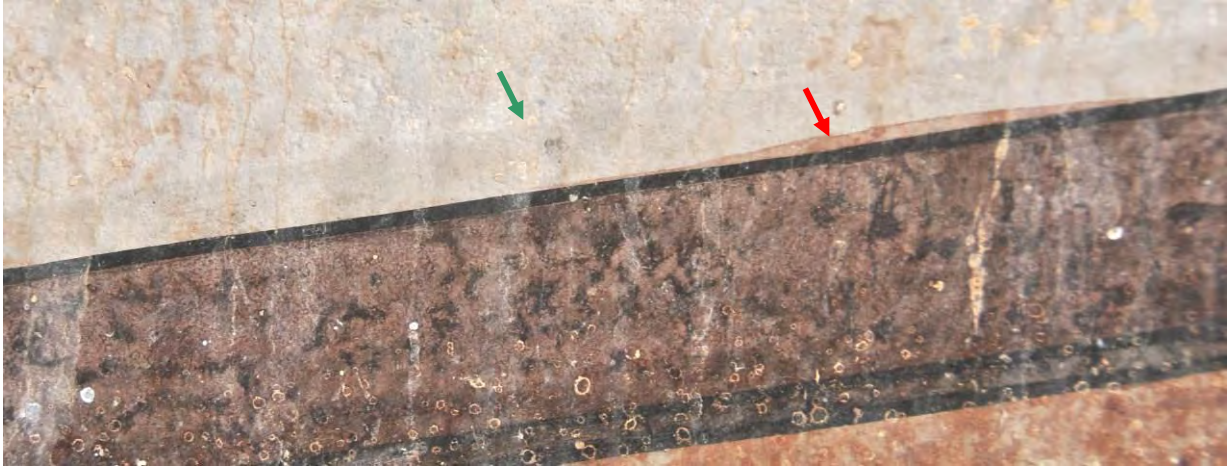
Fig. 114

Pingfeng xi, top above panel *a*: light brown next to the contour of the dark brown frame (red arrow); transparent layer next to the outline of the folding screen (green arrow)

There is a margin of transparent material following the outlines of the folding screen (fig. 114, green arrow). Under UV light, the material does not differ from the light bluish

The first layer applied to the framework was a light pinkish brown wash. It is visible in few places where the layers do not overlap precisely (fig. 114, red arrow).⁴⁸ It could not be ascertained if a light reddish brown wash or the delineation was applied first.

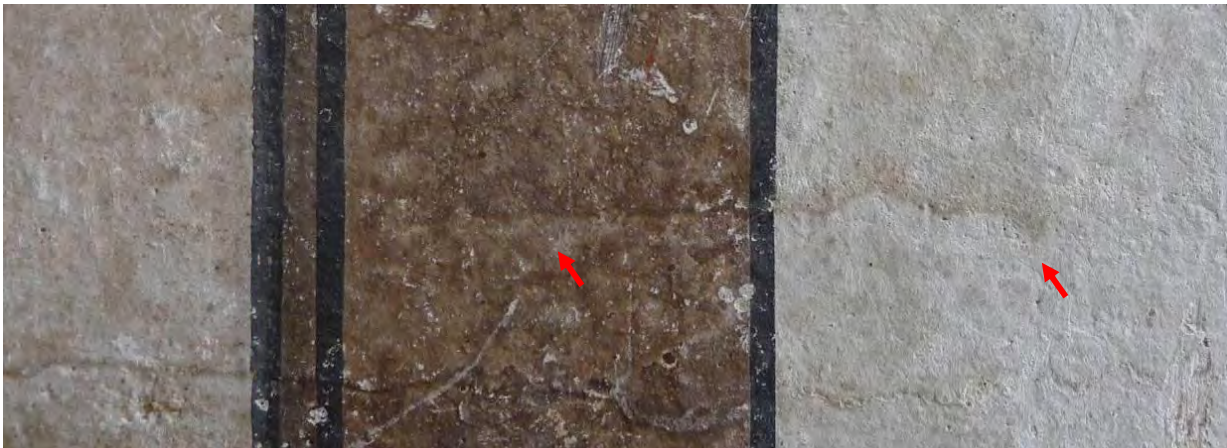
Fig. 115

Pingfeng xi, next to panel 8 *d*, end of a brush mark from applying the isolation layer. The mark is visible through the brown paint layer of the framework (red arrows).

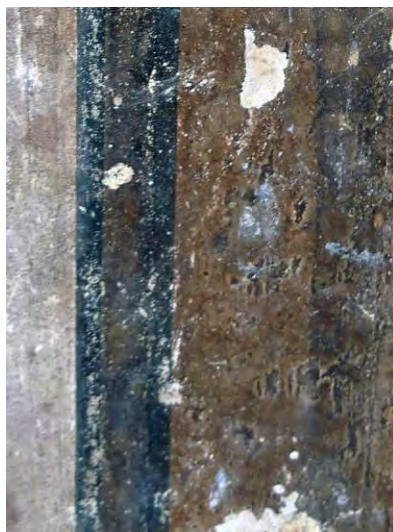
Fig. 117
Pingfeng xi, brown washes have accumulated in irregularities of the ground.

The brown colouration was applied after the black lines were drawn. It consists of at least two semi-translucent washes, the lower one being lighter in colour. Two layers are recognisable as their edges are not superimposed precisely in all parts (fig. 116) and could also be distinguished in cross sections. Iron oxide and a fine-grained black (probably flame carbon) were identified as pigments.⁴⁹ In many areas the layer is blotchy and has accumulated in irregularities of the ground (fig. 117). Reconstruction tests showed that the same phenomenon occurred when two layers of a wash were applied to a slightly irregular ground (fig. 118).

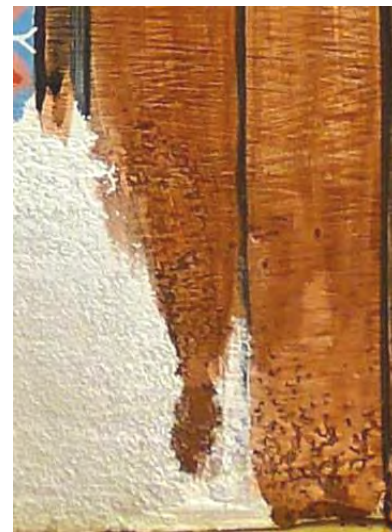
Fig. 118
Reconstruction test: irregularities of the ground became visible after second application of brown wash.

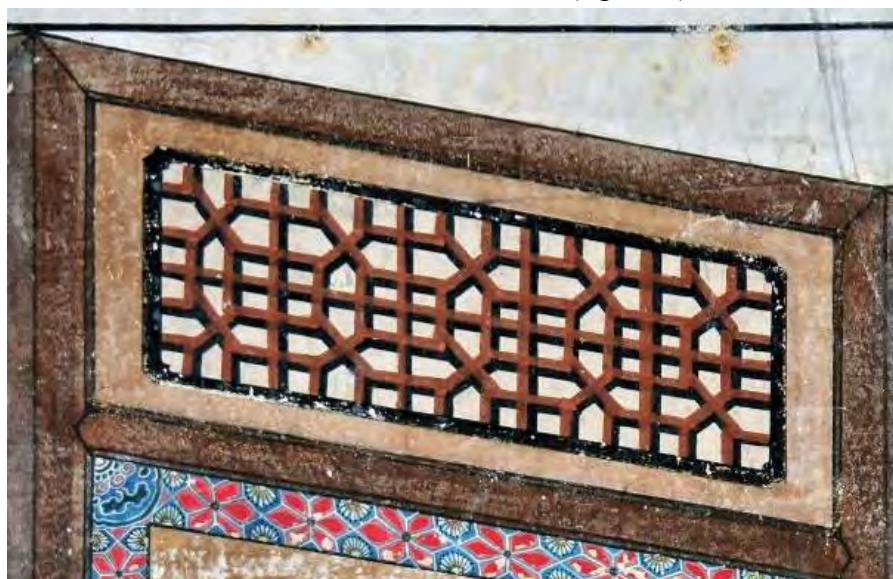
Fig. 119
Pingfeng xi, panel 5 a, the bevelled edges of the frame are shaded to give the impression of three-dimensionality

The bevelled edges of the framework are shaded with a deep greyish brown wash which probably was applied onto the darker brown wash of the framework (fig. 119).⁵⁰

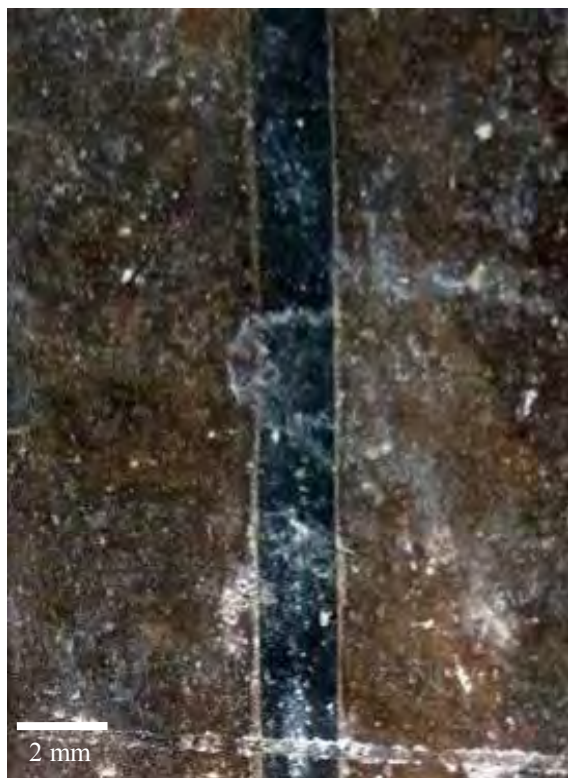
Fig. 120
Pingfeng xi, black delineation accompanied by white margins.

The black contours of the framework often have a very thin white margin towards the brown washes filling the framework. At first glance, the white margins seemed to be scribed or traced with a sharp tool (fig. 120), but closer examination revealed that they result from the absence of brown paint.

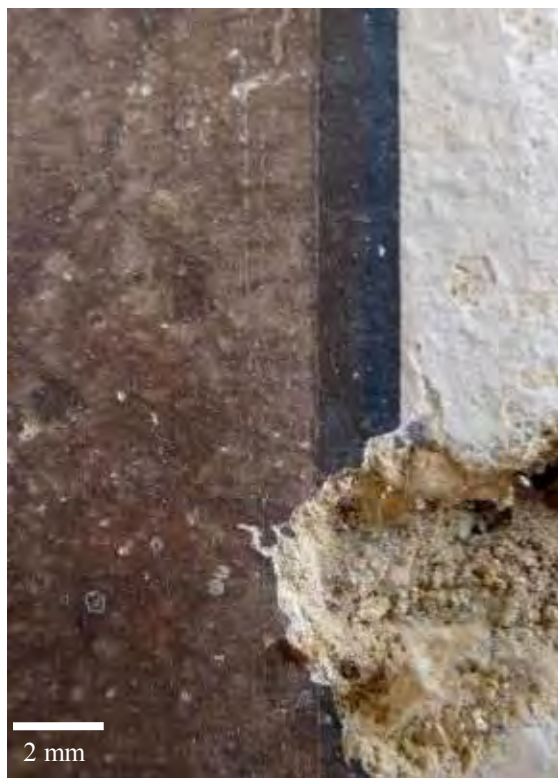
Fig. 121
Pingfeng xi, northern edge of frame 8, next to *c*-panel:
The second application of brown overlaps the black line and the white margin.

Reconstruction tests showed that it is possible to create white margins by omitting a very thin strip when applying the brown next to the black (fig. 122, right side). This, however, is only possible if the direction of the application is parallel to the black lines. In some cases, however, the brown wash(es) run *across* the black line, and sometimes overlap it. Closer examination also showed that sometimes there is lighter margin that has been covered by the second application of the brown wash (fig. 121).

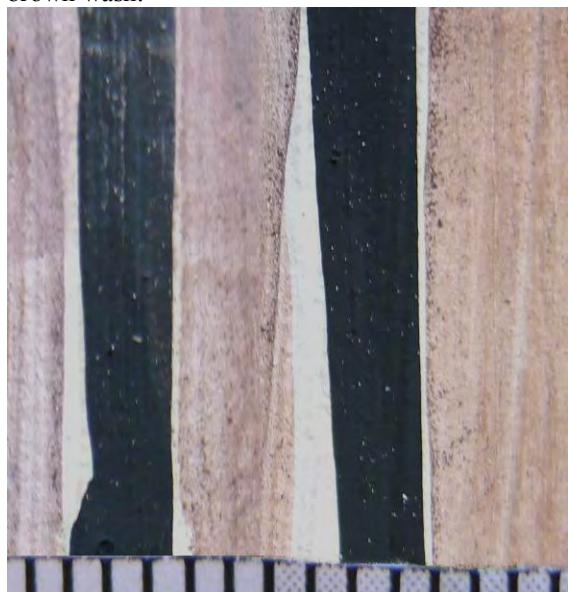
Fig. 123
Reconstruction test. White margins resulting from the “repelling effect”: The brown wash was brushed across the black line.

This indicates that the thin white margins result from a “water-repelling effect” as it is used in batik dyeing: If a line is painted with a non-aqueous medium, a water-based material afterwards will not adhere on the lines and thus prevent the ground from being stained. The effect could be reproduced by using a fatty medium for the black lines (flames carbons in egg yolk) and by painting a wash with a binding medium diluted with water (gum arabic or diluted egg yolk) over it (fig. 122). The effect became even more distinct if the sizing of the ground layer with animal glue was applied after the black line had been drawn. Like on the murals, the white margins are not as straight as if scribed, and they slightly vary in broadness (fig. 123).

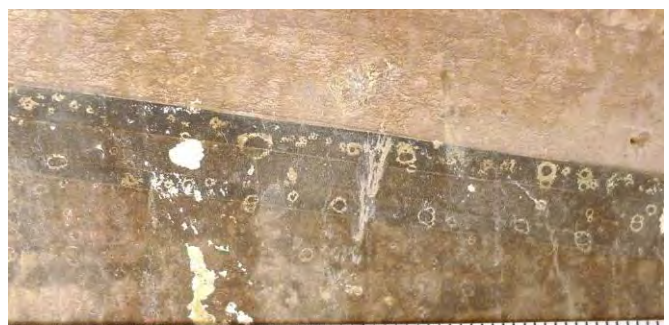
Fig. 125

Reconstruction test with rings caused by small air bubbles forming during the application of the ground layer

Very often, tiny white “circles” are visible in the framework, mostly in the black contours and the brown washes (fig. 124), consisting of small ring-like lacunae (up to 2 mm in diameter). Sometimes they also appear in groups. Reconstruction tests indicate that these rings are connected to air bubbles which formed during the application of the upper layers of the ground layer: after the bubbles had burst, a ring with a raised ridge remained (fig. 125). These ridges may have flaked off or have been abraded later on. If this consideration is right, the walls have not been polished after the final application of the ground layer.

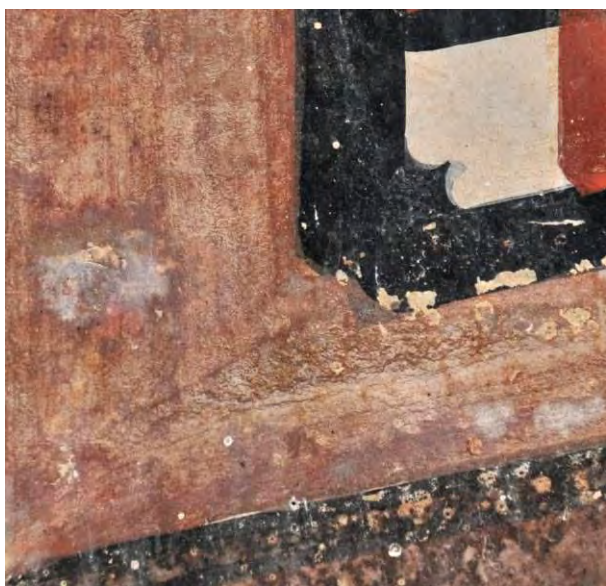
Fig. 126

Pingfeng xi, *a*-panels: at the panel frame, the light pink paint, which is of a coagulated consistence, overlaps the black delineation of the framework and filling frames.

The paint layer is translucent, but slightly turbid. In many parts, it has an inhomogeneous texture as if the paint coagulated or did not contain enough binding medium (fig. 126). The cross section revealed that the incoherent paint layer consists of clusters of pigments in a medium that seems to have penetrated into the priming layer.⁵²

The pink paint layer overlaps the black delineation of the framework and the filling frames whereas it is overlapped by the black colour of the filling frames (fig. 126).

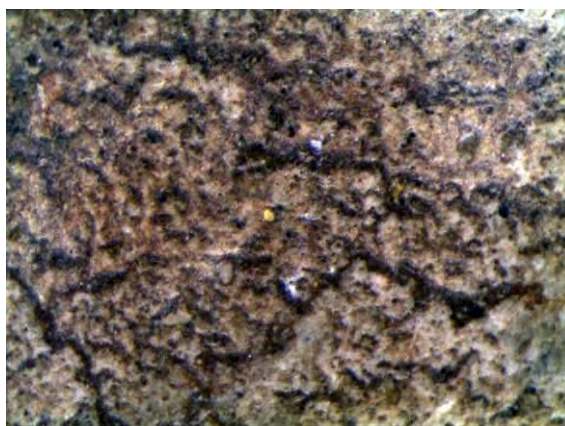
Fig. 127

Pingfeng xi, panel frame of panel 2 *d*: yellow particles in streaks of paint with coagulated accumulations of pigments (the longer side of the photograph is equivalent to 4 mm)

On-site microscopic examination of the pink paint that ranges between red, yellowish and brown, revealed the presence of rather large yellow bright particles imbedded between reddish brown clusters (fig. 127). They were identified as clusters of orpiment, red lead and a very fine brown iron oxide that is identical with the pigment used on the framework.⁵¹

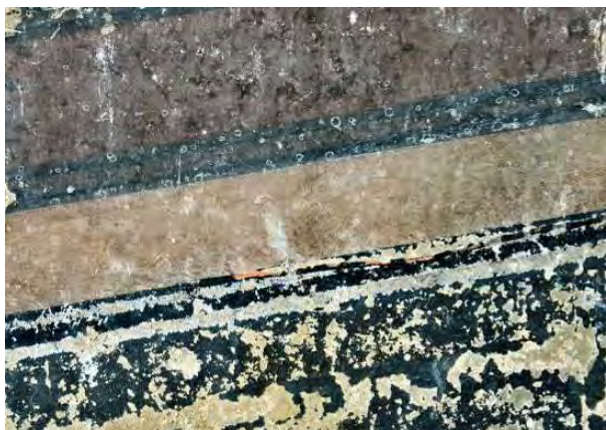
Fig. 131

Spot no. 3, panel frame of panel 4 *d*: Photographed under the microscope, the longer side of the photograph is equivalent to 4 mm.

- 1. Below panel 2 *e*, underneath the black contour line of the filling frame (fig. 130)
- 2. Panel 4 *e*, underneath the black contour line of the filling frame (fig. 129)
- 3. Panel 4 *d*, next to the contour of the framework (more yellow than red, fig. 131)
- 4. Panel 3 *e*, lower rail, next to the contour of the framework.

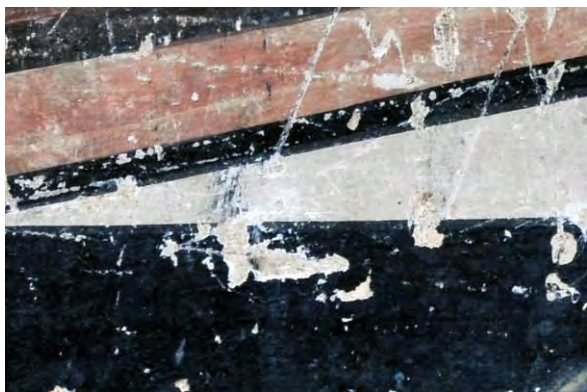
Fig. 132

Pingfeng xi, lower edge, back framing and border of *f*-panel: the black paint is of deeper colour than the contour lines

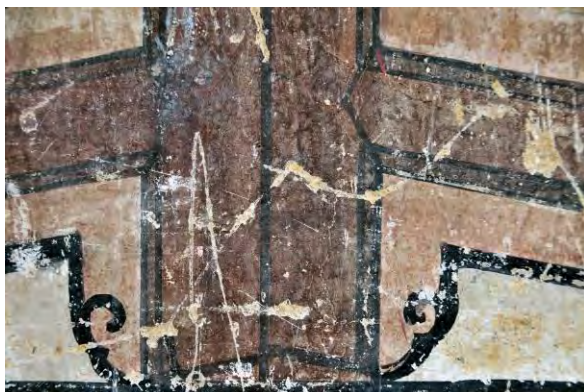
Fig. 133

Pingfeng xi, trim along the legs: The black paint overlaps the light pinkish paint of the frame.

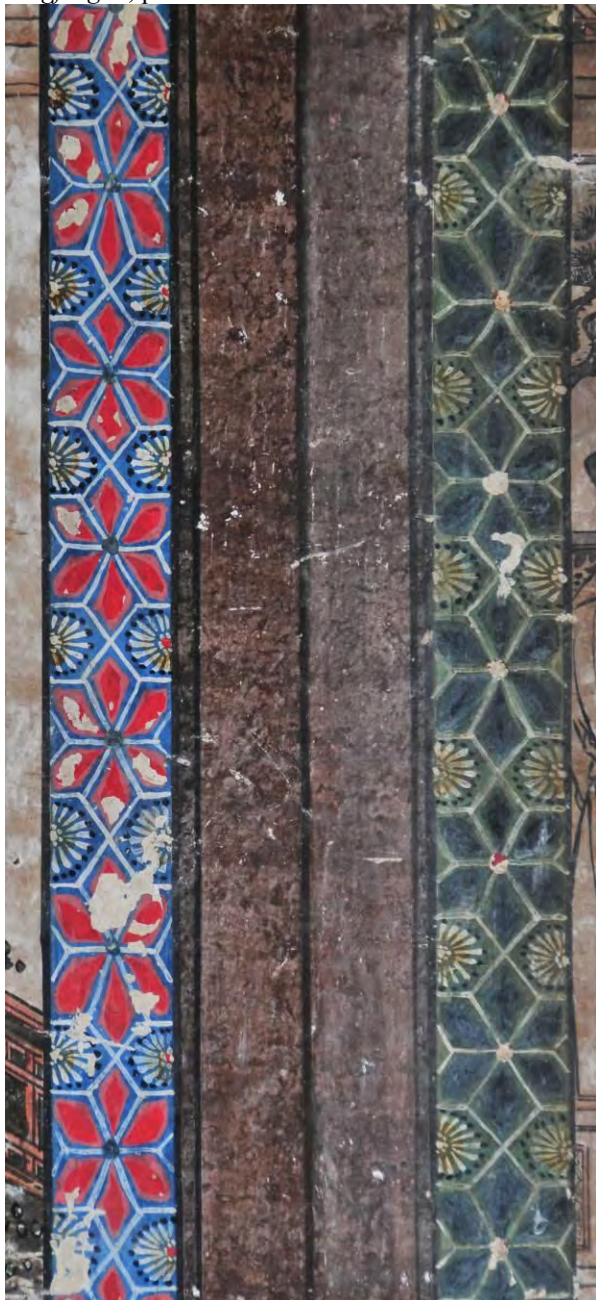
Fig. 134

Pingfeng xi, panel 2 *b* to 3 *b*: star borders

The *b*-panels are framed with 3.3 cm wide borders showing colourful geometrical patterns based on six-pointed stars (fig. 134). Interspaces are filled with stylised blossoms. The corners are decorated with a multi-coloured cloud ornament (fig. 135 and 136). The colours used for the ornament alternate in two colour schemes (table 8).

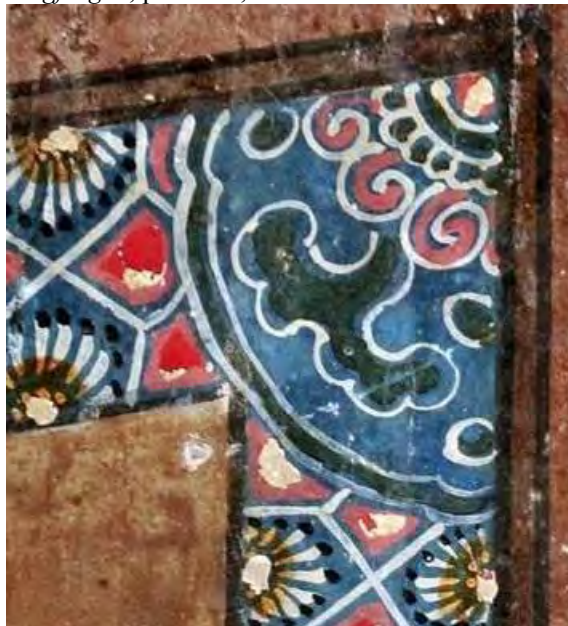
Fig. 135

Pingfeng xi, panel 4 *b*, corner ornament of star border

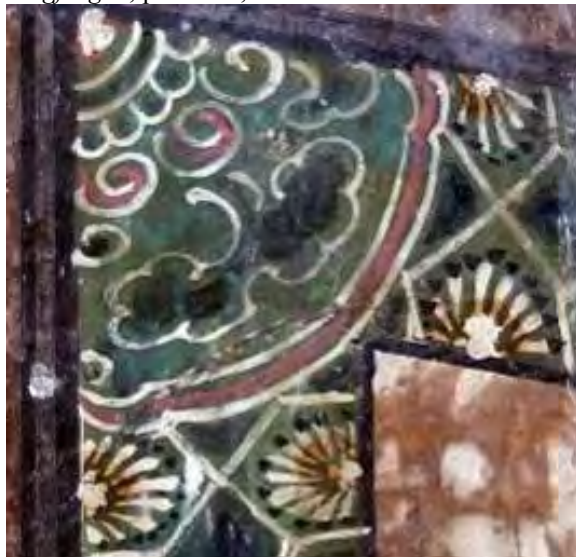
Fig. 136

Pingfeng xi, panel 3 *b*, corner ornament of star border

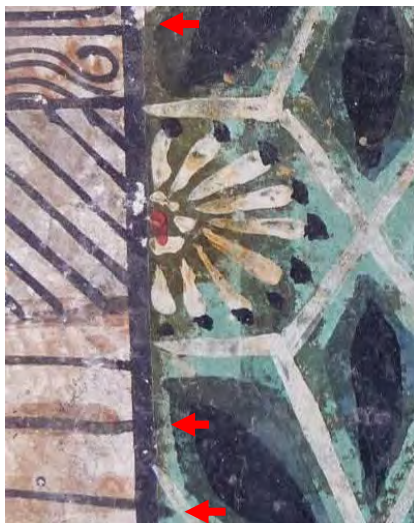
Fig. 137

Panel 1 *b*: black lines overlapping onto the star border (arrows)

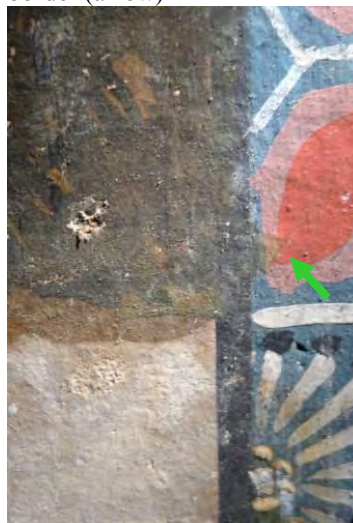
Fig. 138

Panel 7 *b*: green wash overlapping onto pink of star border (arrow)

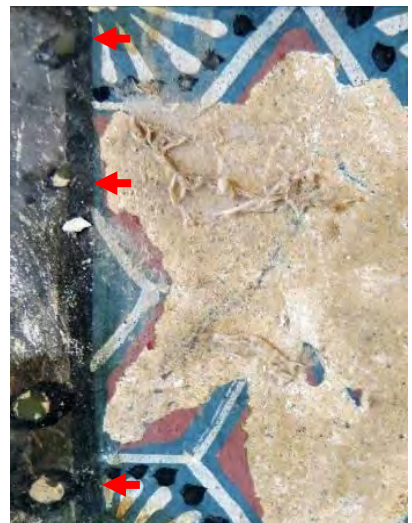
Fig. 139

Green dots on the black outline from floral frame (arrow)

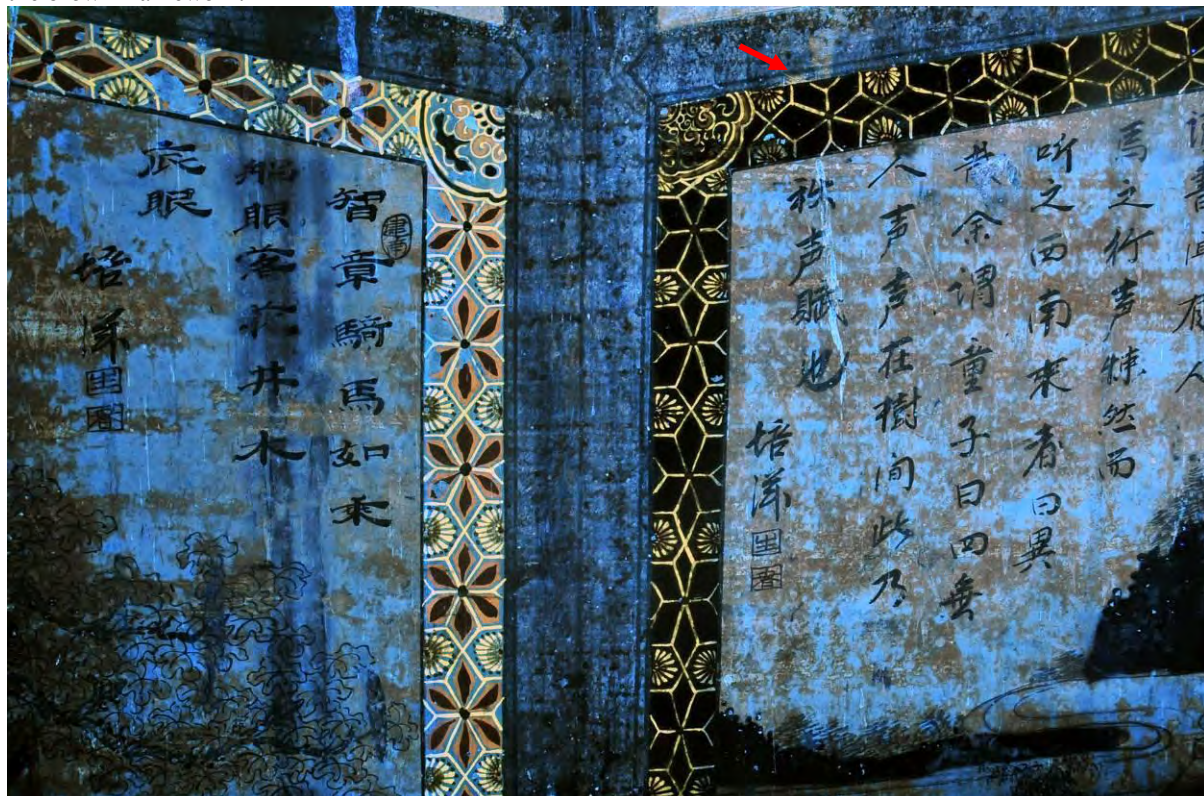
Fig. 141

Pingfeng xi, borders of panels 5 and 6 *b* under UV light. In the upper left corner of panel 6 *b* (arrow), a mistake made by the painters is visible: Some of the lead white-containing paint from the border seems to be spread on the brown framework.
