Ziyang *Beiwusheng huiguan*

Final report

Part 1: Technique and materials

Research Project 01UG1001
„German-Chinese co-operation in the preservation of Cultural Heritage: Researches for the
conservation of selected monuments in the PR China”

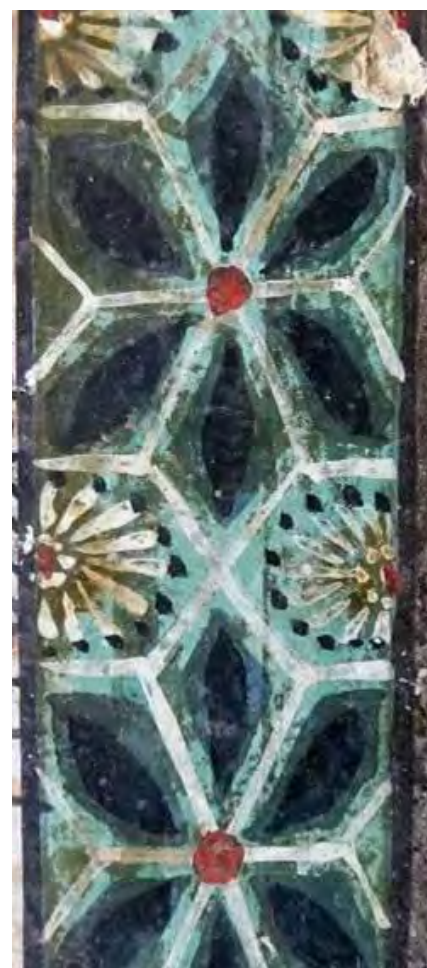
Fig. 142
Pingfeng xi, border of panel 1 b: The coating or glaze on top of the paint layer is reduced and partly lost, exposing the bright paint layers underneath.

The UV-fluorescence of the star borders (fig. 140 and 141) is dominated by the fluorescence and reflectance/absorption of the pigments, mainly lead white (strong yellow to whitish fluorescence)⁵⁶ and the copper pigments (absorption of UV light). The yellow glaze may have a brownish fluorescence.

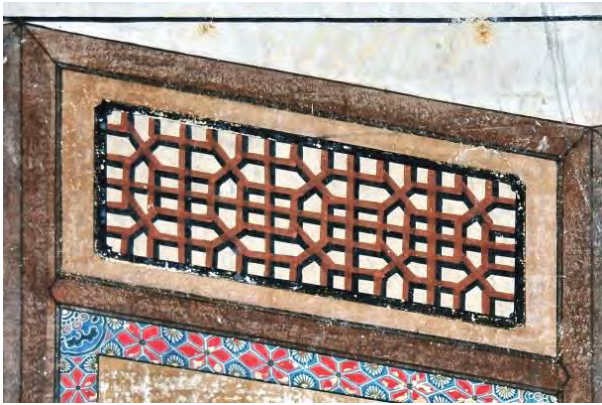
Fig. 145
Pingfeng xi, panel 7 *a*: lattice with white background and black filling frame

The panel fillings show a latticework with a geometrical design of interlaced octagons. The strips (bars and lines) are reddish brown, shaded in black on a white background (fig. 145). The steps of the painting process can be reconstructed as follows (also see: fig. 144):

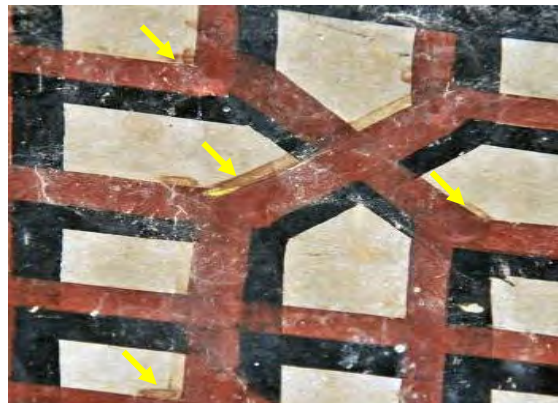
Fig. 148
Pingfeng xi, panel 3 *a*, yellow or orange lines originally highlighted the reddish brown lattice

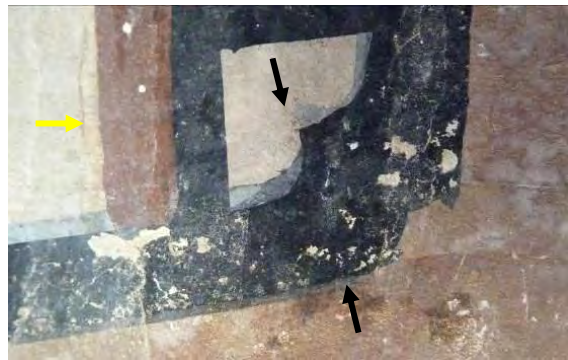
Fig. 150
Pingfeng xi, corner of *a*-panel: Black delineation visible through the lead white of the background and through the light pink paint of the panel frames (black arrows).

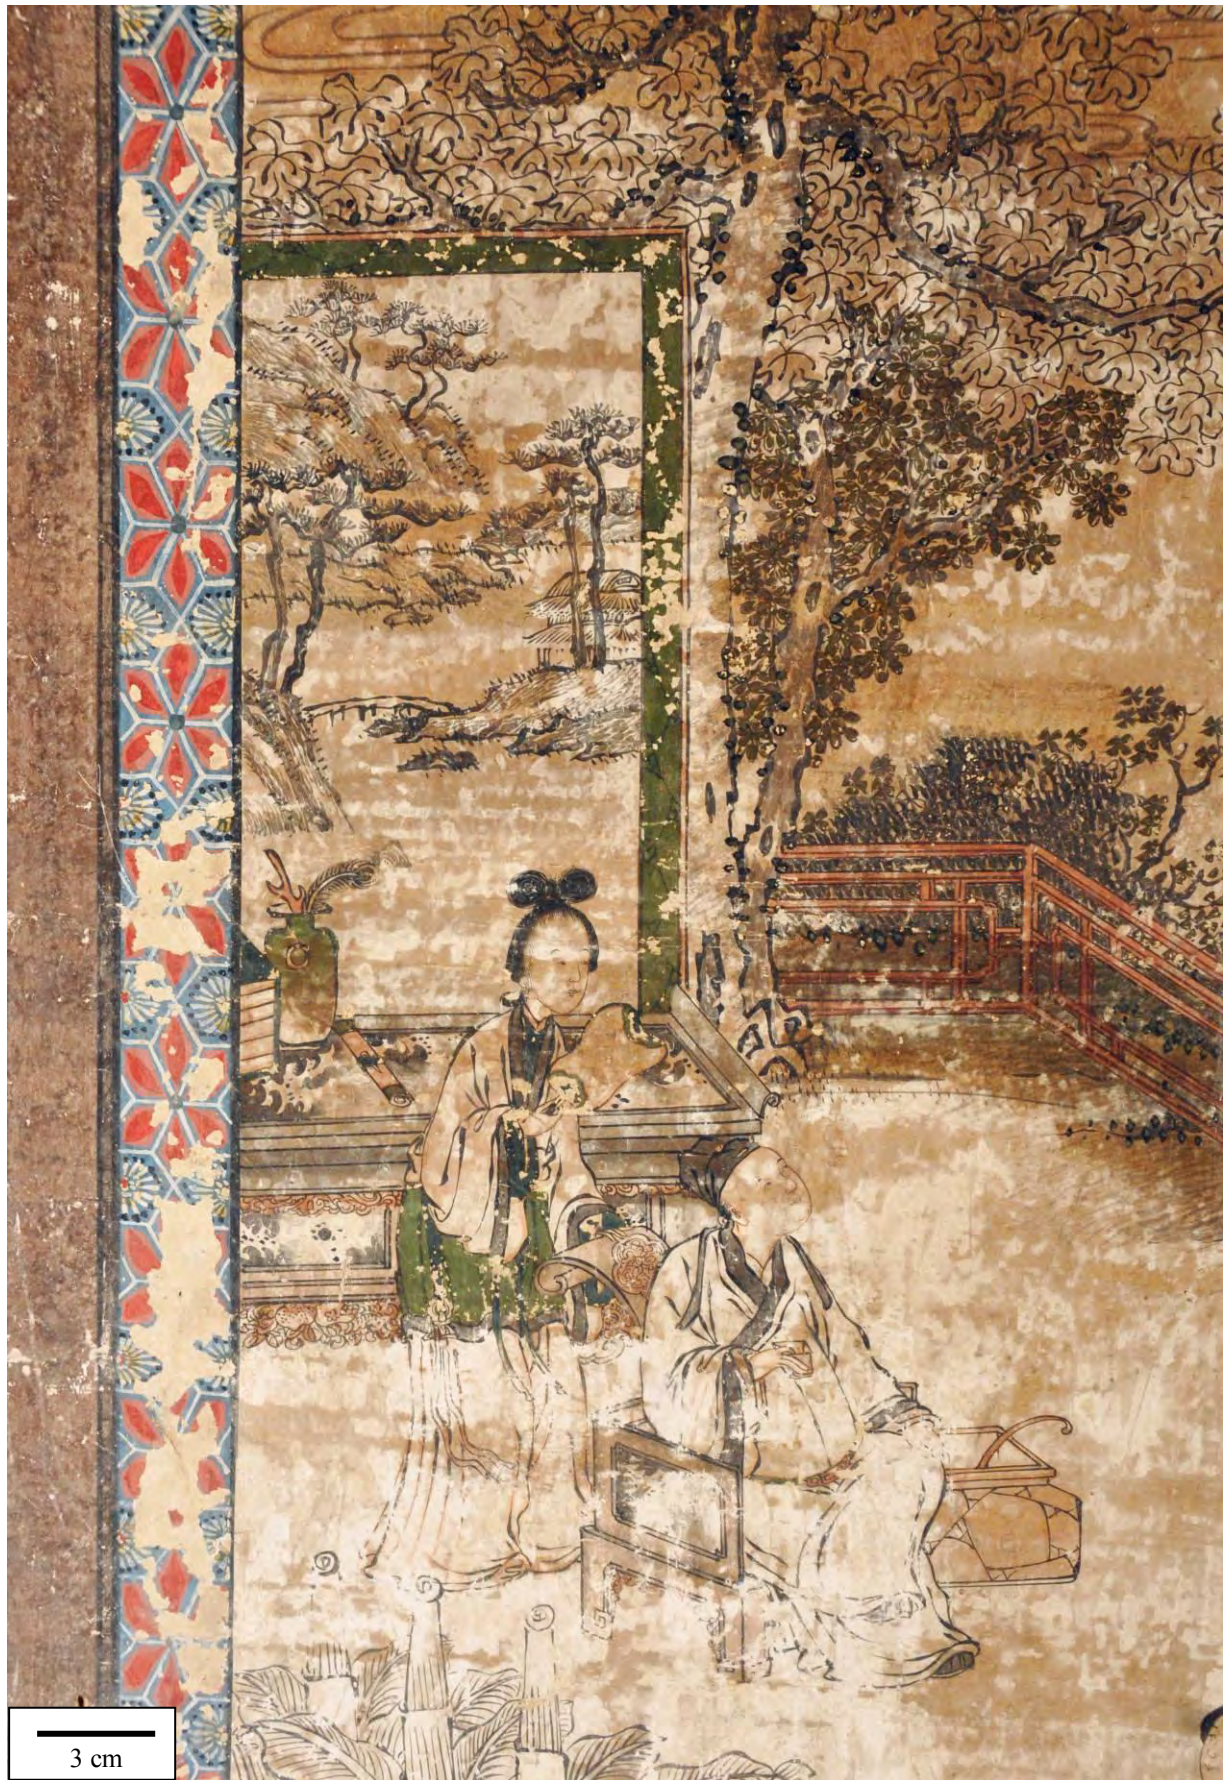
Fig. 151

Pingfeng xi, panel 2 *b*, poet Cui Zhongshi looking into the sky: carved and lacquered wooden chair; table with inlays of rare stones, a vase with a coral (or antlers?) and a peacock feather, a painted screen. Next to the poet a marbled pink vessel. The lady is holding a three-coloured fan. In the foreground banana trees

In various small objects as teapots, flower vases and small cabinets, scrolls and ink wells, painted screens and fans are embellished with the same devotion (figs. 156 and 151). They often show combinations of colours in stronger contrasts, like red, grey, green and blue. In the panels 2 *b* (fig. 151) and 4 *d* (fig. 184), brush paintings are depicted, including inscription and red seal of the painter's name in panel 4 *d*. Objects are standing on tables with inlays of rare stones. Basins in the panels 1 *b* and 2 *b* show a 'marble pattern' with black veins on a pink or red ground. Furthermore there are tools and weapons, as a hoe (panel 3 *d*) and a sword (panel 4 *b*) showing a green sheath with a red border.

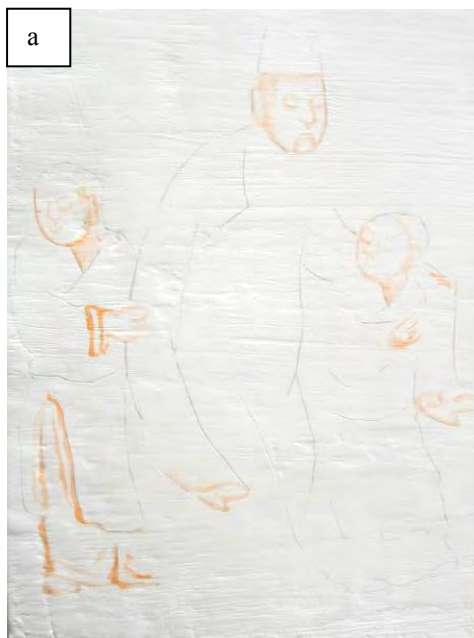
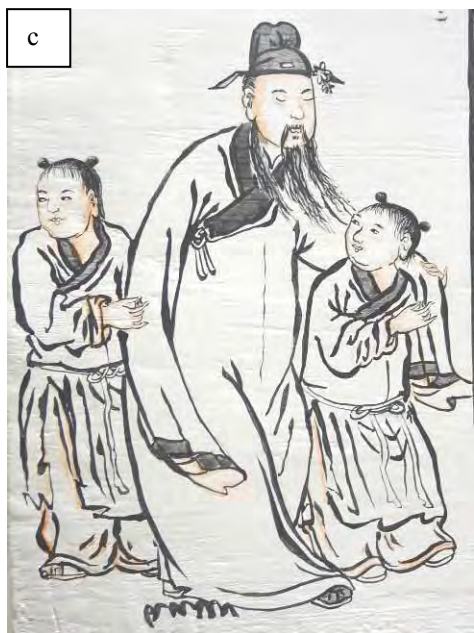
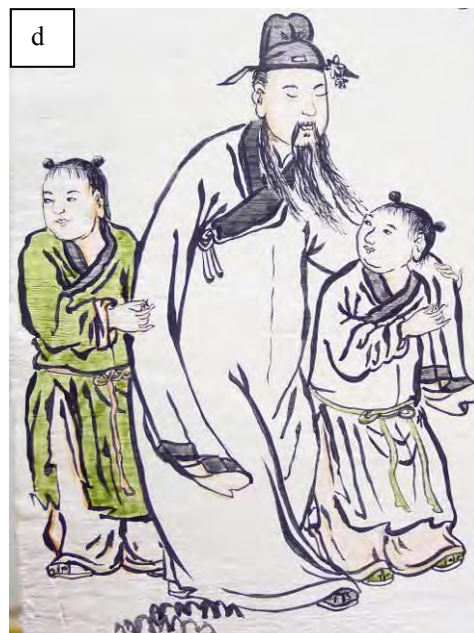
Test to reconstruct the painting process:

- a pale red lines and shades on traced outlines
- b grey washes
- c red and black drawing and shading finished
- d after application of coloured washes (green, red and pink)

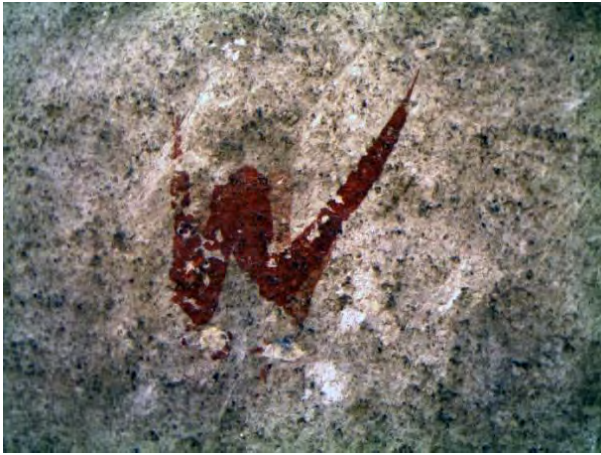
Fig. 153
Pingfeng xi, panel 3 d, bat painted in dark red over a pale red line

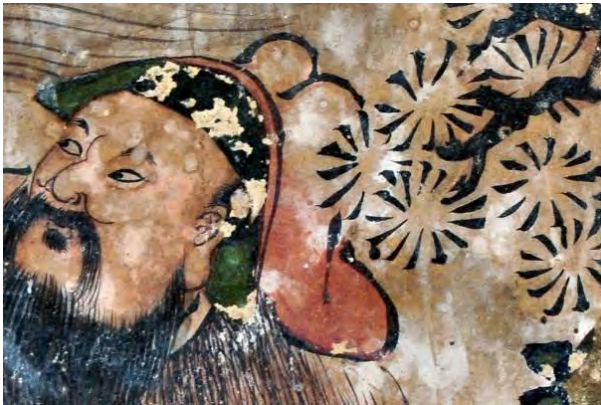
Fig. 154
Pingfeng xi, panel 4 b, hat of a man: pale orange red lines accompanying black contours are covered with the red paint layer

Red was used as a translucent wash (fig. 154), but also as a more opaque dark red (fig. 153). A translucent red was used for parts of clothing and architecture (for example the gable in fig. 181), objects and furniture. It is darker than the pale red lines, looks more like a glaze than a wash and seems to be sensitive to water: On the hat of the man with the fur coat (fig. 154), lighter spots may be watermarks.

Medium or light *brown* translucent parts are found in the architecture (decorations on the roof ridges, fig. 181), objects and parts of the landscape (mountains in panel 4 *b*, fig. 202), and seldom in cloths (fur coat of man in panel 4 *b*, fig. 154). Areas painted in light brown, like the ridge decorations of a roof, look brown under UV.

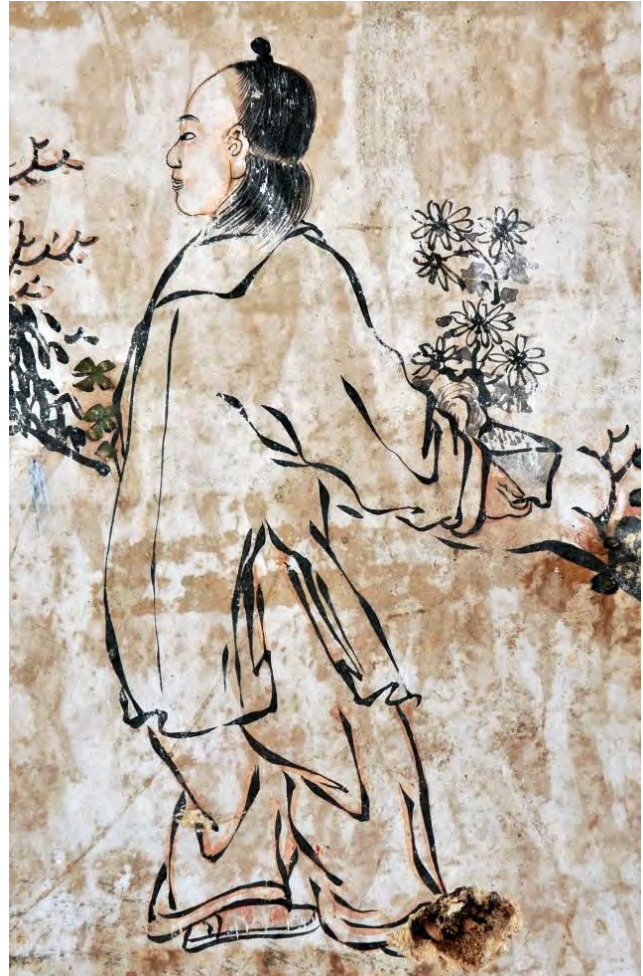
Fig. 155
Pingfeng xi, panel 5 b, boy carrying a bonsai tree: Pale red lines contour flesh tones, cuffs and trousers, but not the robe. Height of the figure: ca. 12 cm.

There is a great variety in vegetation with trees, shrubs, grass and single leaves, but there are almost no flowers: The only blossoms to be found are those on the bonsai tree the boy is carrying in panel 5 *b* (fig. 155), and on painted screens or scrolls in panels 4 *d* and 8 *b* (maybe peach trees; fig. 184). Some plants, however, are painted rather realistically as stone pine trees (e. g. panel 5 *b*: fig. 194 and 7 *b*), bamboo (e. g. panel 2 *b*, 3 *b* and 6 *b*, fig. 198), water lilies (panel 6 *b*, fig. 197), banana trees (e. g. panel 2 *b*), plants looking like azalea (panel 5 *b*, 6 *b* and 7 *b*, fig.), willows (panels 6 *b*, 8 *b*, 2 *d* and 7 *d*), a tree with leaves like an acacia tree (panel 5 *b*, fig. 192), plants resembling magnolia, rubber or ficus trees, and trees with five-lobed leaves (fig. 151, background, and fig. 187), or a tree with leaves growing in circular bushels like an aralia (panel 4 *b*, fig. 195). Grass is painted less realistically with black vertical strokes connected to each other, like rows of flat spirals (fig. 190).

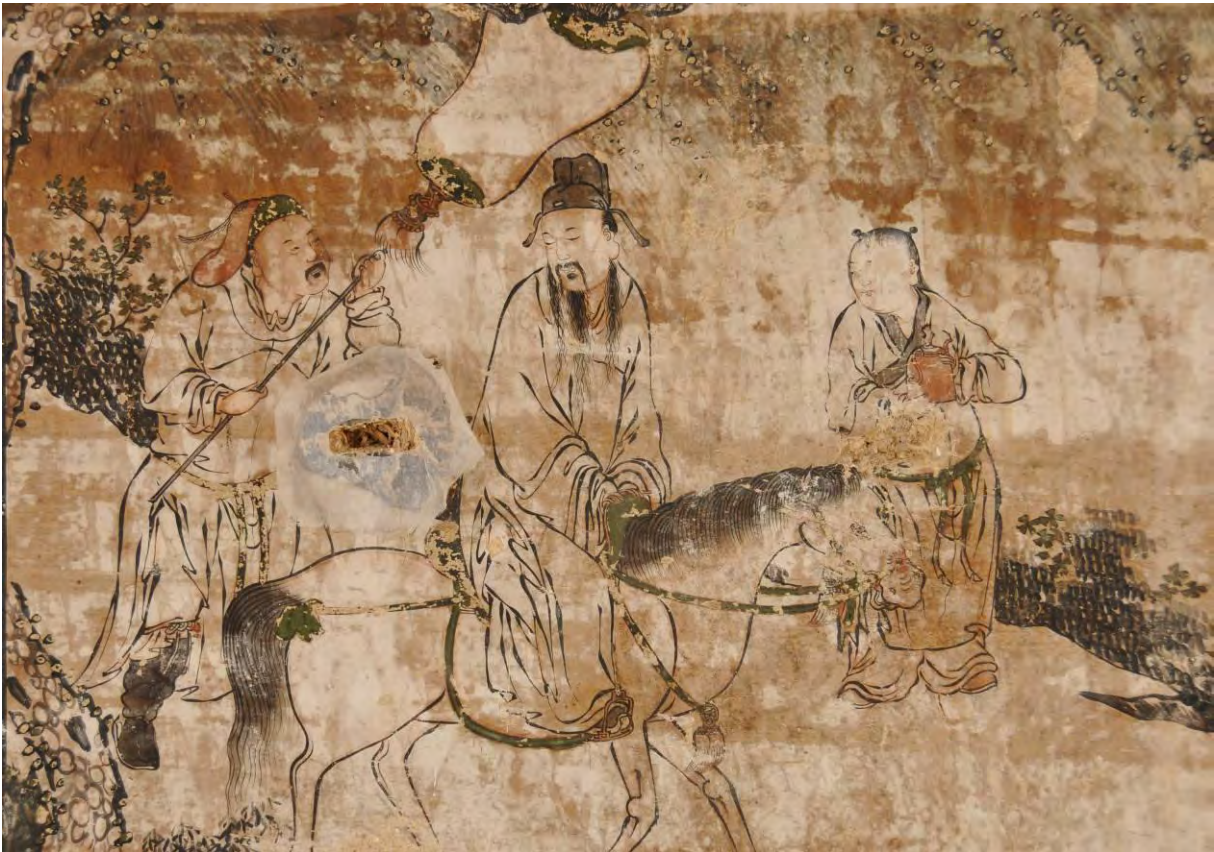
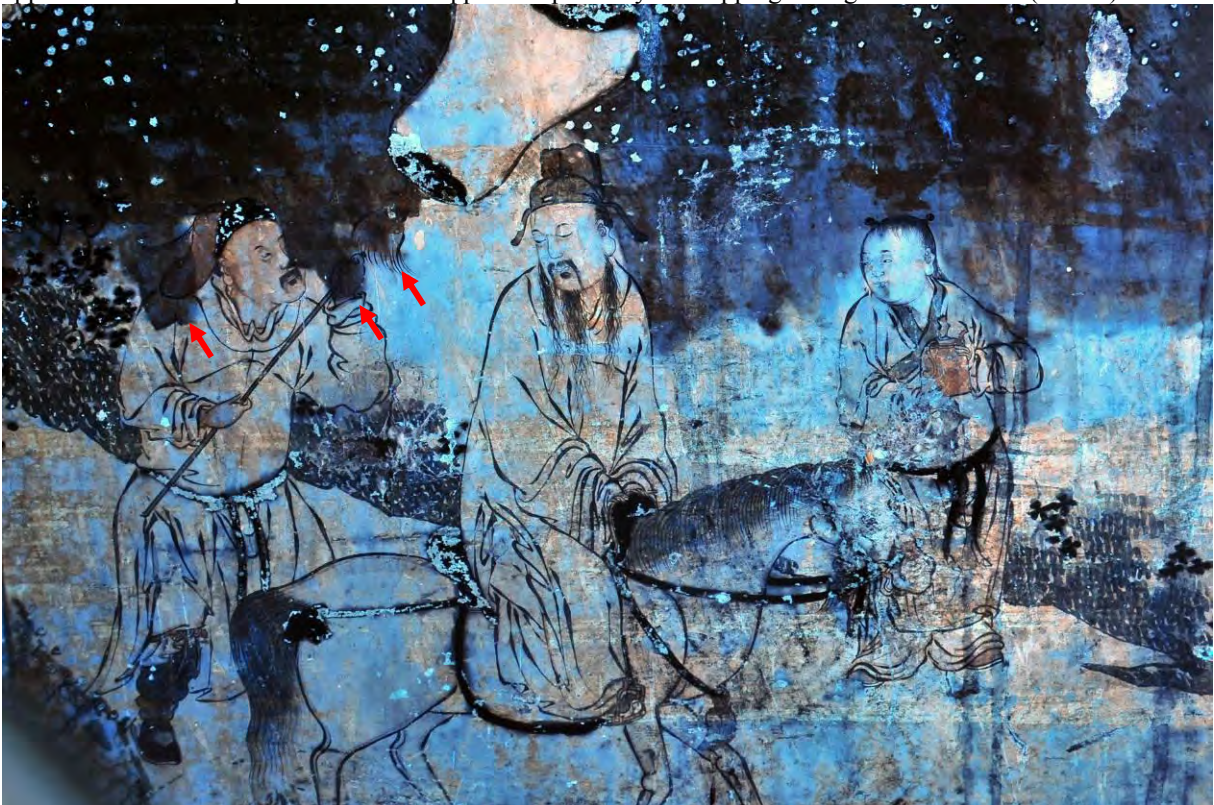
Fig. 156

Pingfeng xi, panel 7 *b* in 2012, VIS: The washes of the landscape and the streaks of coating and/or sizing both appear brownish.

Fig. 157

Pingfeng xi, panel 7 *b*, UV: The coating can be distinguished from the greenish wash of the scenery which appears dark brown up to black and was applied imprecisely overlapping the figure of a servant (arrows).

Under UV light, green and blue areas and greenish brown washes in the landscape and in the robes appear black (figs. 177, 178 and 156-163). This is probably caused by the use of copper pigments and thus indicates areas which originally were green (or blue). Parts of the landscape, looking olive-green today, show a haze around the green details (fig. 160). Under UV light, the olive green and the haze appear black (fig. 161). UV light can be used to distinguish the originally green areas, now turned brownish by discolouring, from those painted brown or changed into brownish by the coating/sizing as green areas appear black under UV light because of the use of copper pigments while other colours appear brown or grey (see roof ridge in figs. 162, 163 and streaks of brown coating/sizing in figs. 156/157 and 158/159).

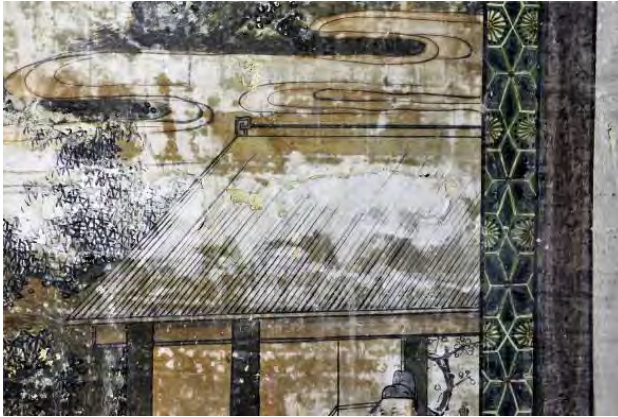
Fig. 158
Pingfeng xi, panel 8 b, VIS: The black columns and the black-appearing frame of painting inside the house seem to have the same colour.

Black lines appear dark grey under UV light. In panel 8 *b*, the black columns of the pavilion (grey under UV light) could be distinguished from the now framing of a painted screen inside the pavilion: it appears black under UV light and originally was green (figs. 158/159).

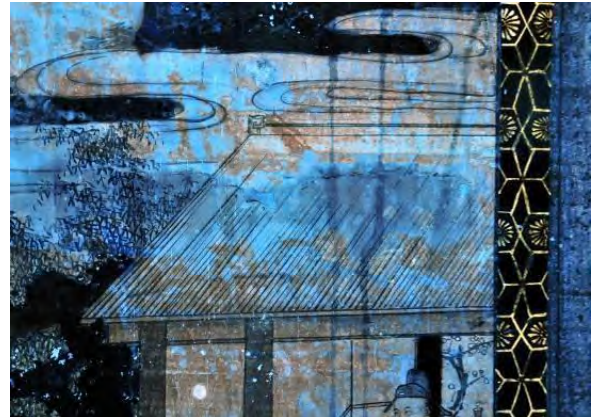
Fig. 159
Pingfeng xi, panel 8 b, UV: The originally green frame appears black, the black columns appear grey.

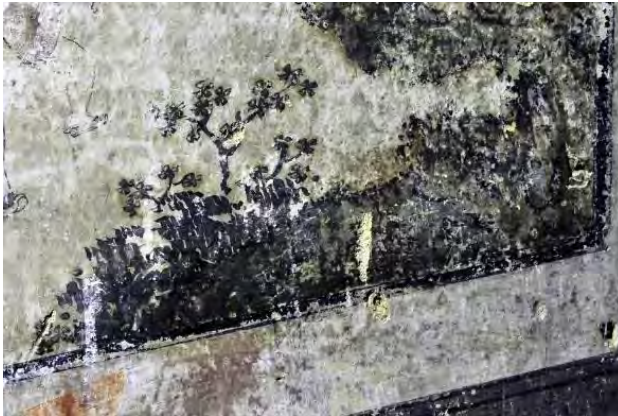
Fig. 160
Pingfeng xi, panel 8 d, VIS: brown haze around the green leaves.

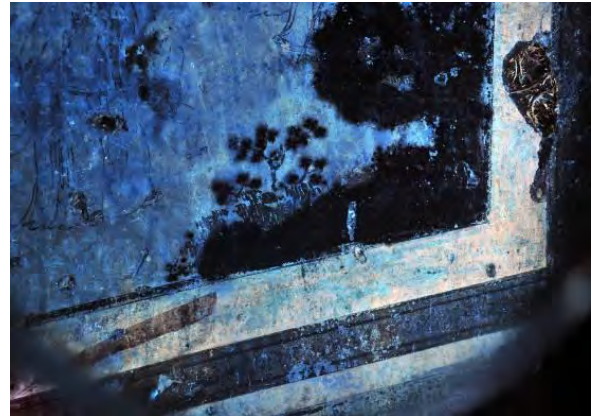
Fig. 161
Pingfeng xi, panel 8 d, UV: Green vegetation and brown haze appear black.

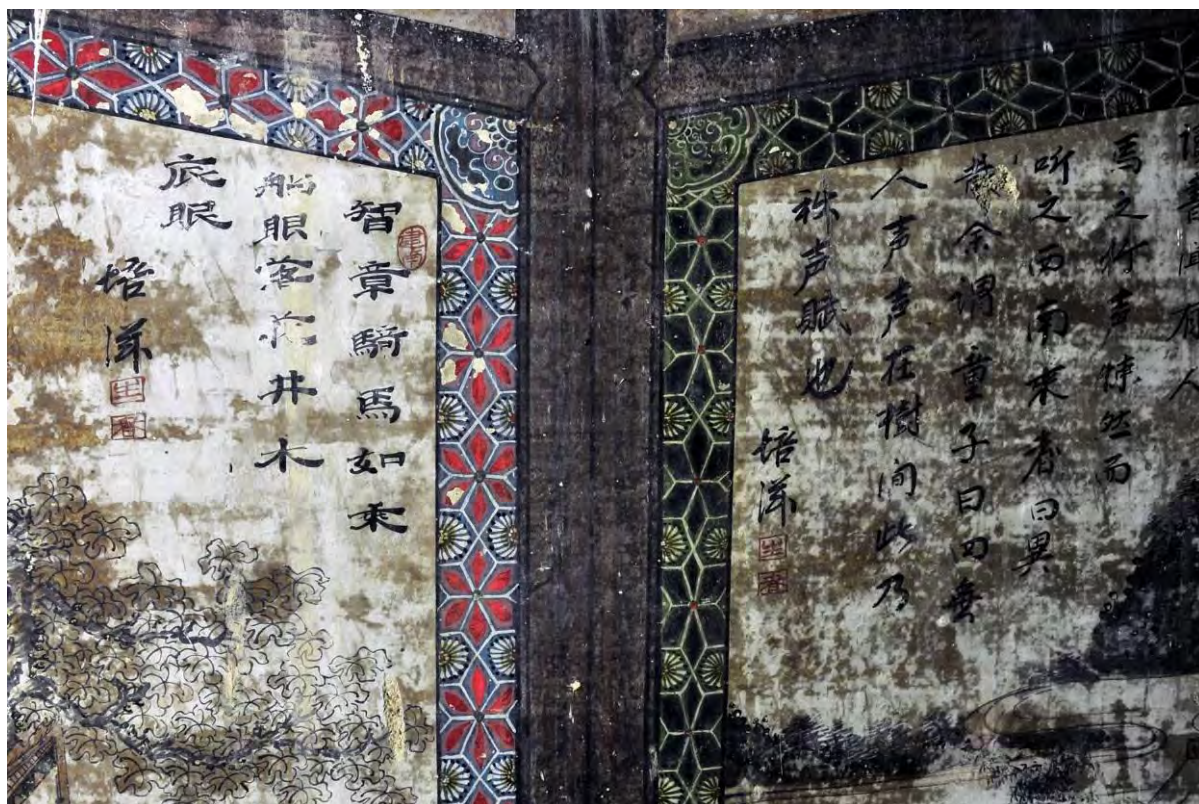
Fig. 164

Pingfeng xi, panel 5 b/6 b, VIS: A brownish layer is visible in the background of the b-panels, emphasizing the horizontal brush marks of the white ground layer.

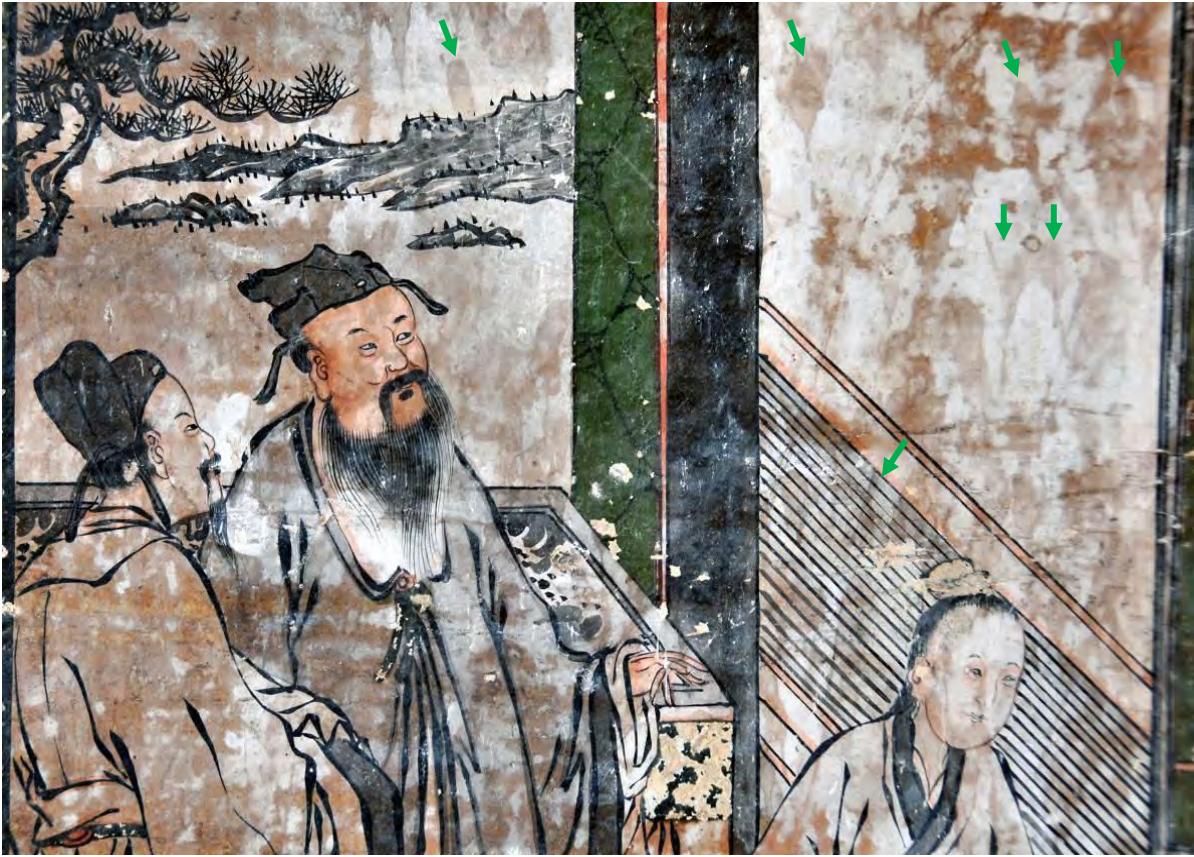
Fig. 166

Pingfeng xi, panel 3 b. The transparent medium appears brownish (lower left part), splashes of dripped down material are above the head of the sitting scribe (green arrows).

Additionally splashes of transparent material are recognisable in the *b*- and *d*-panels, running vertically or in a slightly inclined angle (fig. 166). In VIS they are greyish or brownish, darker than the ground layer, but lighter than the brownish material. Tests to reproduce the effect showed that drops and splashes of corresponding shape only occur if the material hits the surface from above, i.e. coming down vertically (fig. 167). It is not recognisable at what time they occurred, they may be part of the original painting process.

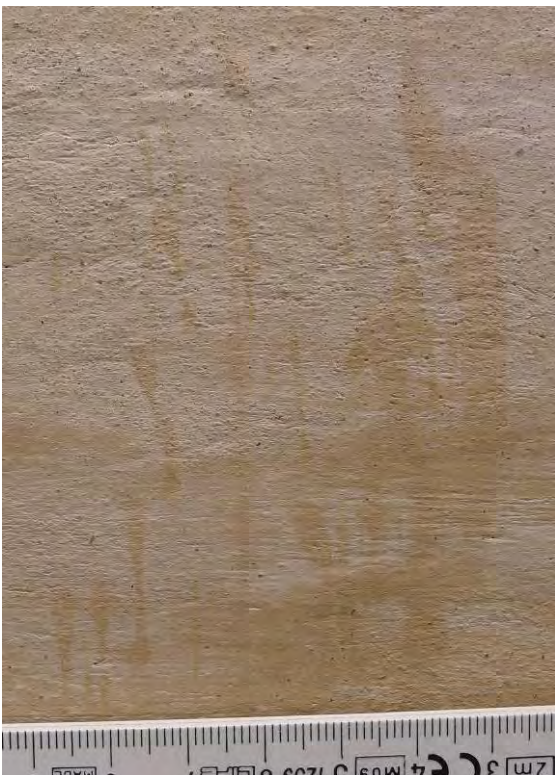
Fig. 168

Pingfeng xi, panel 6 b: discolouration by transparent media; coating on top of red characters; drips of transparent material (green arrows).

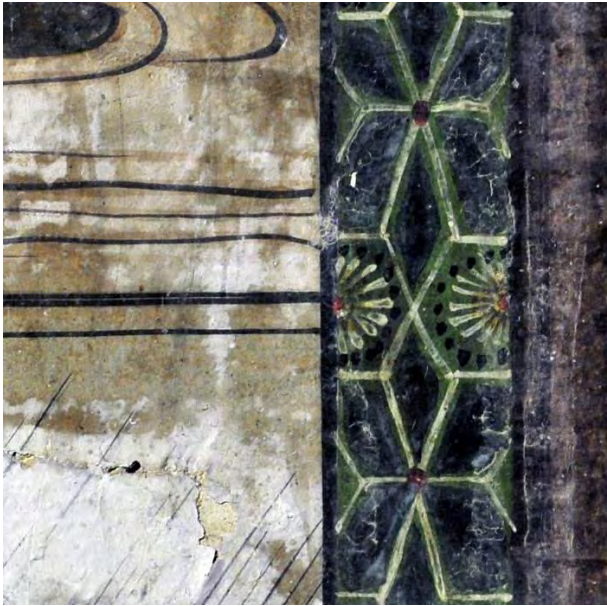
Fig. 169
Pingfeng xi, panel 8 *b*: detail above the roof, VIS

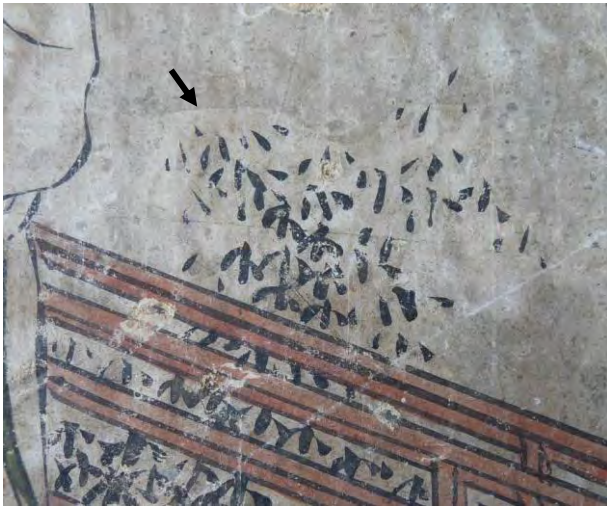
Fig. 171
Pingfeng xi, panel 4 *b*, next to the stepmother: The plant was omitted when applying a shade (arrow) which today has the same light grey colour as the transparent material in the background.

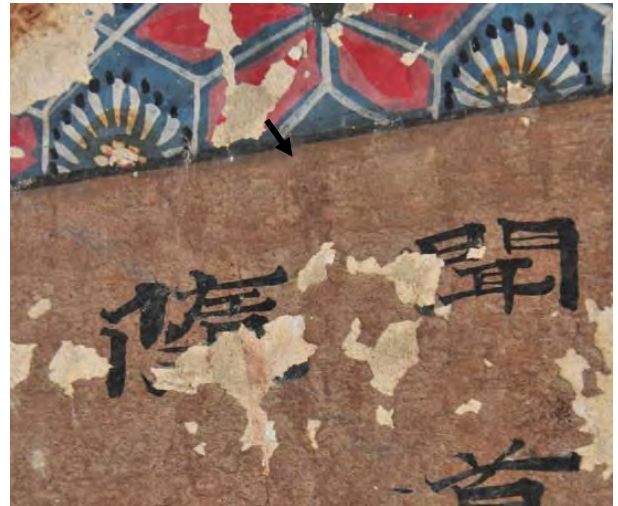
Fig. 172
Pingfeng xi, panel 4 *b*: glaze or coating brushed in the sky, overlapping onto the star pattern of the border (black arrow).

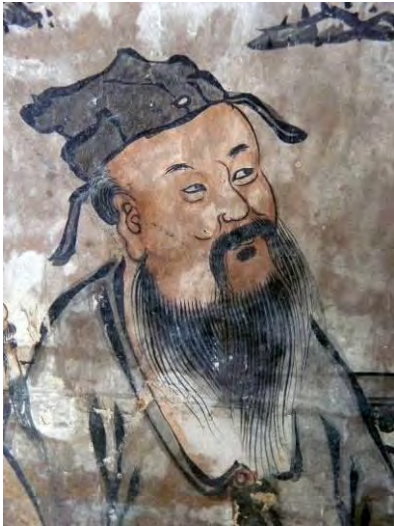
Fig. 173
Pingfeng xi, panel 3 *b*, man with officials' hat: pink flesh tone shaded at the forehead, around ears, eyes and mouth. The robe is coloured with a light grey wash.

Pale red lines emphasise the modulating of faces and hands (fig. 173 to 175). At many figures, the modulation of the flesh tones comprises only these red and black lines, while the white ground layer represents the skin colour. Other faces are coloured with light pink (fig. 173), thus different tints of skin colours were depicted. The face of an old lady (fig. 176) has a pink skin colour and greyish brown shades. The poet in panel 5 *b* (fig. 174) shows a very light partial modelling in light pink. Lips were not coloured red, but shaded with grey.

Parts of the clothing are coloured with washes in grey, pale red or brownish green. Folds are sometimes additionally shaded along the black lines. Most of the robes are white (= ground layer) or shaded light grey (fig. 173), some are olive-green (fig. 177).⁶⁸ Borders are often grey (fig. 174), but some are green or blue. Undergarments visible only in small areas are red, green, blue or grey. Belts and the strings of the belt pendants are often coloured. Pink (pale red) may represent gold in suits or armour or staffs.⁶⁹ Blue is restricted to small areas as diadems, borders of robes or belts. Opaque green is only used in equally small areas.⁷⁰

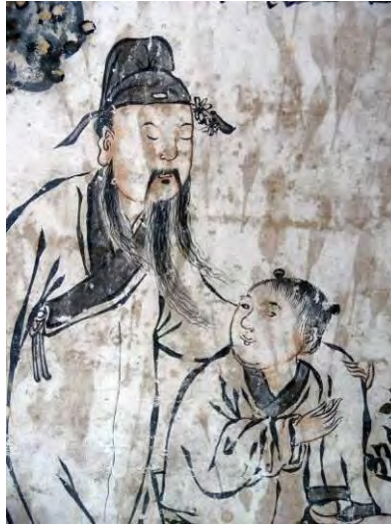
Fig. 174
Pingfeng xi, panel 5 *b*, poet and boy: sparingly applied colouring: The flesh tones are almost white, the robes only accentuated with grey borders. Splashes of transparent medium in the background.

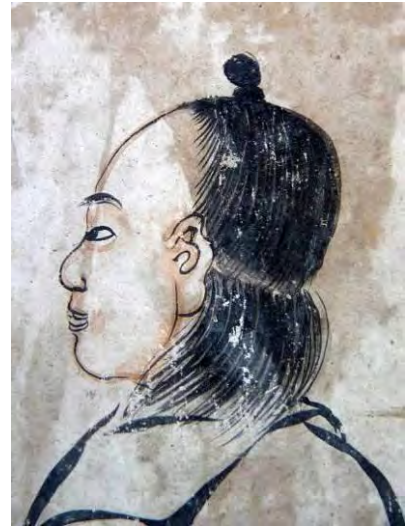
Fig. 175
Pingfeng xi, panel 5 *b*, boy carrying a bonsai tree: face outlined in black and orange-red with few orange-red shades. Hair painted with dark grey wash and black lines.

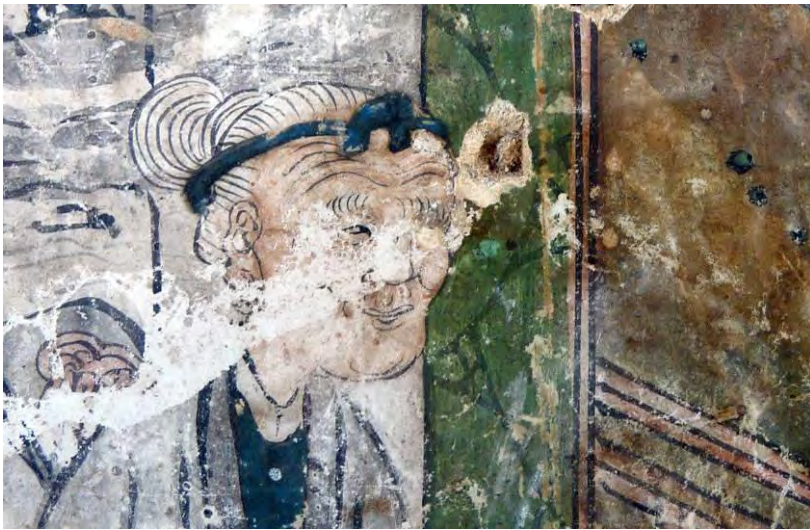
▲ Fig. 176
Pingfeng xi, panel 7 *d*, old lady: pink flesh tone with grey shading. Blue diadem and undergarment, robe with grey wash. Marbled green border of painted screen and olive green mountain. Railing in front of mountain with red glaze.

The architecture is set out in pale red and/or black lines. Straight lines were drawn with rulers (fig. 180). The pale red lines are less uniform in thickness and straightness than the black ones. Like the figures, the architecture is coloured to a varying extent. Railings and parapets are sometimes filled in translucent red (fig. 183). Columns are black; facades and roofs are coloured in grey, red, brown and green, scarcely also blue, in different combinations. Details of the architecture and their furnishing are embellished with dedications: Ornaments are painted on parapets and column bases, small panel doors have ornaments, decorations are put on roof ridges. Lines and colours were used to represent different materials as wooden planks of a gable, grey roof tiles and decorated glazed ridge decorations (fig. 181). Different kinds of precious stones are imitated (fig. 184).⁷² Paintings on scrolls or screens are framed by green borders with a marble pattern showing veins in dark green or black painted on top of the green (fig. 176).

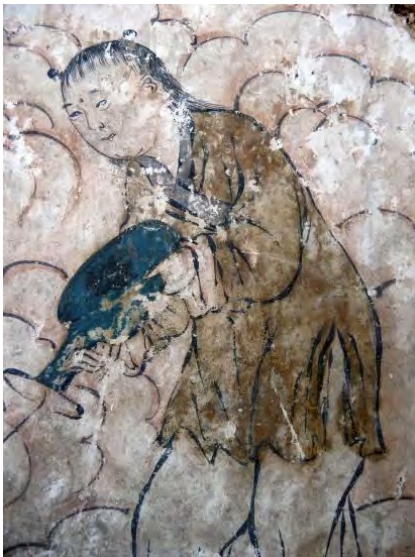
◀ Fig. 177
Pingfeng xi, panel 3 *d*: boy with translucent greenish brown robe (originally green), holding a blue jug. The clouds are shaded in light red.

⁶⁸ Fig. 177 shows the boy in the clouds in panel 3 *d*. Other examples are the robe of the stepbrother in panel 4 *d* and the robe of the boy leading the drunken poet in panel 5 *b*.

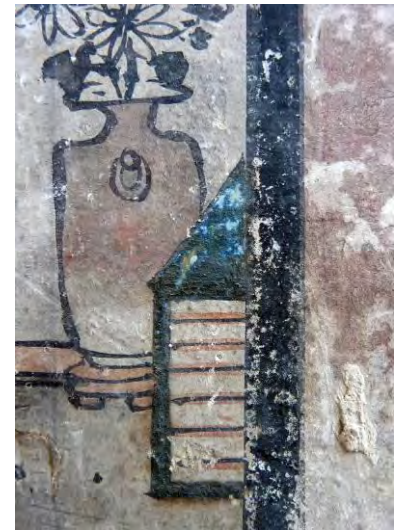
Fig. 179
Pingfeng xi, panel 8 *d*: The blue pastose paint of the cabinet has a darkened surface

Opaque colours occur in *blue* and *green* areas. The paint is thick and pastose. The pigment seems to be rather coarse (figs. 176 and 179). The surface looks dull, greyish or brownish up to almost black today, but in damaged areas a bright blue and a bright green are visible. Under UV light, the areas appear black, indicating the use of copper pigments. The opaque blue and green were used only in small areas, as details of clothes and furniture (blue chest of drawers; marbled green frames of screens). Figure 176 shows the translucent and the opaque green next to each other: The bright green, marbled frame of a screen was painted with an opaque green, the olive-green mountain with a translucent brownish green.

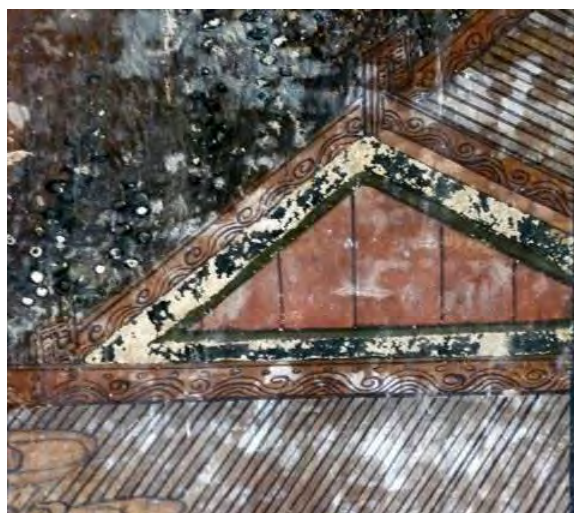
► Fig. 181

Pingfeng xi, panel 6 *b*, roof: red wooden panels at the gable, framing in dark blue and green edges; brown ornaments on the roof ridges. Rows of roof tiles indicated with strips of darker grey alternating with lighter grey.

Grey may have been achieved by diluting black paint to different extent. Different shades of grey were used for lines and colouration of clothes (figs. 173 to 175), furniture and objects, and extensively in plants and architecture (fig. 181).

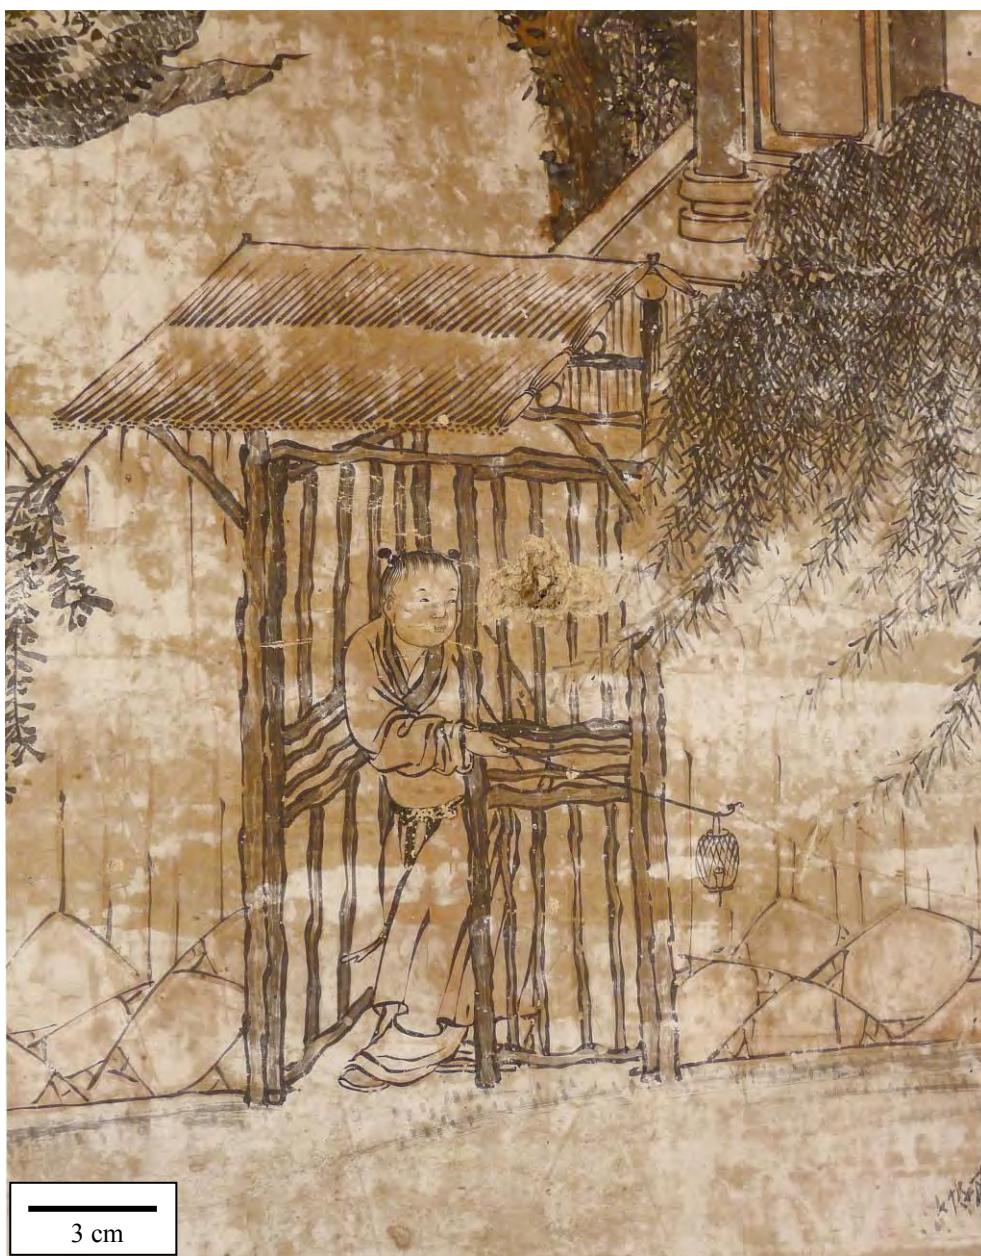
Fig. 182

Pingfeng xi, panel 8 *b*, boy leaving the close by night with a lantern: the original shading of the robe, the thatched roof, the wall and the pavilion are difficult to recognize due to discolouration of coating (and sizing?).

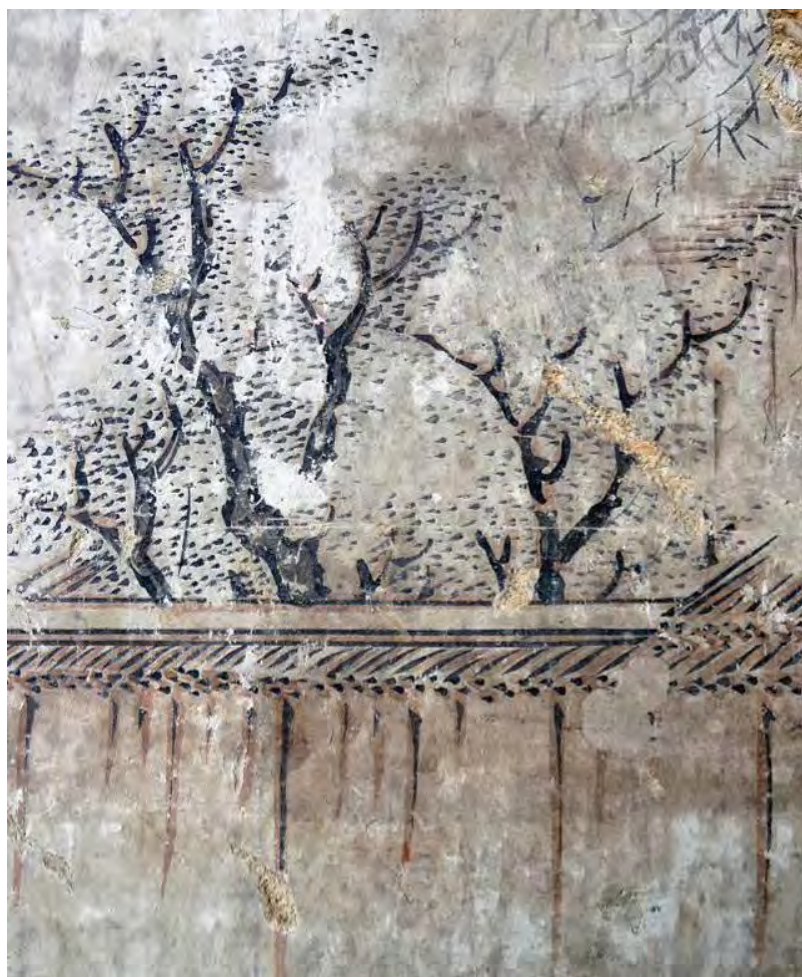
Fig. 186
Pingfeng xi, panel 2 *d*, trees behind a garden wall: light red and black drawing, mottled grey trunks; leaves in grey and black

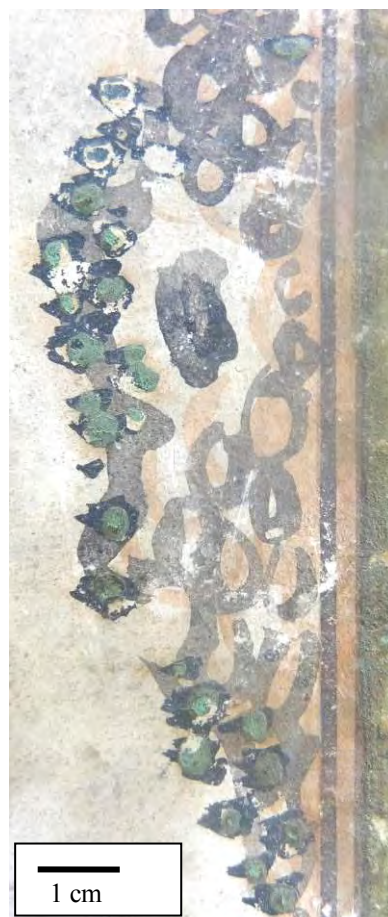
Fig. 185
Pingfeng xi, panel 7 *d*, next to green marbled border of a screen: plant drawn in pink and grey, black and green dots as highlights

After the paintings were finished, small black circles or dots (up to 0.4 cm in diameter) were applied and “highlighted” with thickly applied green dots on the plants and landscape. Size and style differ from the leaves painted with opaque green. These dabs and green dots are placed all over the scenery, covering rocks, branches and hill sides. They are independent of the type of plant and thus seem inconsistent of a design in which individual species are carefully characterised. Sometimes they give the impression of small leaves, but they can also be found on pine trees, and in the background they appear like shrubs on the hills of the distant lakeshore (fig. 194). It seems unlikely that they were applied by the same artists who painted the trees. Like the blue and few opaque green areas, the green dots, too, are superficially darkened. A lot of dots have flaked off, maybe due to the thick application (fig. 185 and 197, shore at lower edge).

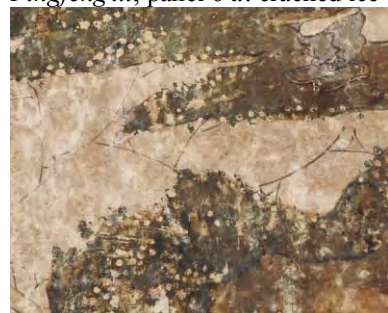
Fig. 192
Pingfeng xi, panel 5 *b*: acacia

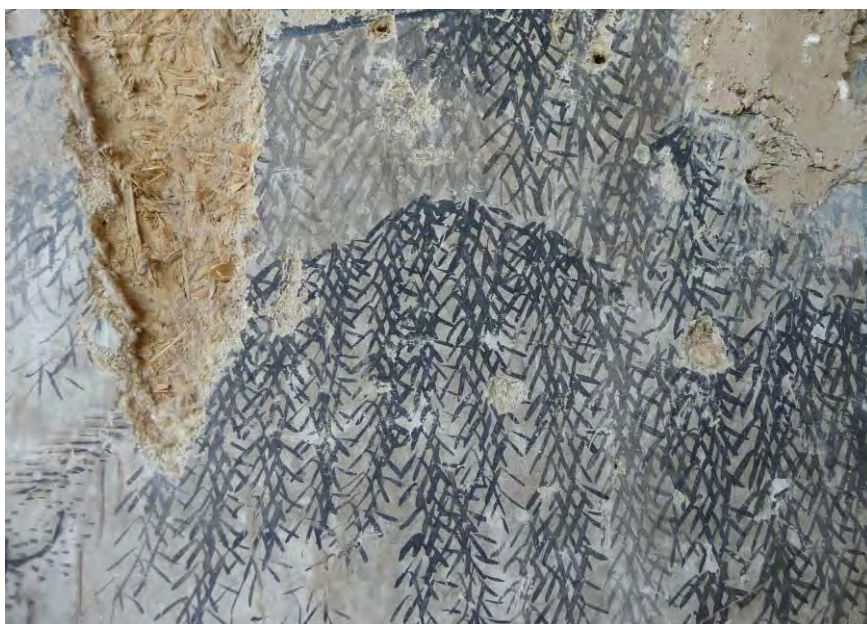
Fig. 193
Pingfeng xi, panel 2 d: willow twigs drawn in several shades of grey and emphasized in black

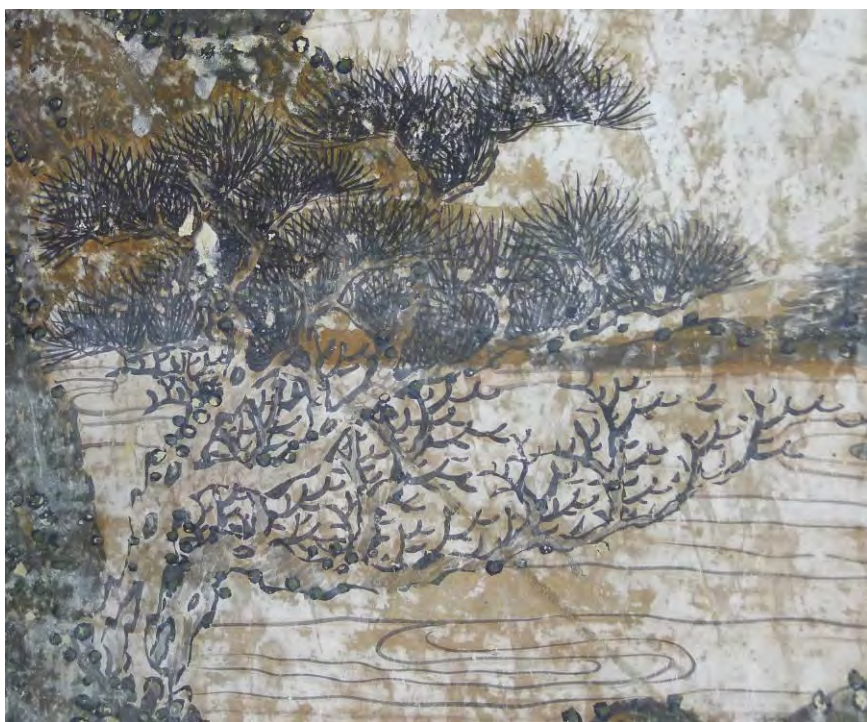
Fig. 194
Pingfeng xi, panel 5 b: defoliated tree and a pine tree. The structure of the bark is indicated with grey lines and scribbles. Green dots put on dabs of black cover the branches of both trees.

Painted sceneries show rocks and hills, water and vegetation. The water is painted with black lines indicating calm flowing water (fig. 194), waves (fig. 187) or froth (fig. 188). The cracked ice of the frozen lake in panel 6 *d* is depicted like the marble with ‘veins’ indicating cracks (fig. 189).

Plants and trees are outlined or are completely drawn in black or sketched with light red first (fig. 186). Thicker trunks and branches are outlined in black and filled with grey or red lines or circles (fig. 194) indicating the structure of the bark. Some tree trunks are also coloured red or reddish brown before applying the bark structure (tree on the southern edge of panel 3 *b*). Around the aralia-like tree in panel 4 *b*, the background is shaded with washes, omitting the leaves. Thus the leaves are standing out light in front of a background which was shaded in green (now brown) and in light grey (fig. 195). A similar, even lighter grey shading could be observed in panel 4 *d* where a light grey shade is omitting the plant behind the railing next to the stepmother. In other paintings, the green shading of the landscape did not omit the trees, like the pine tree in fig. 194.

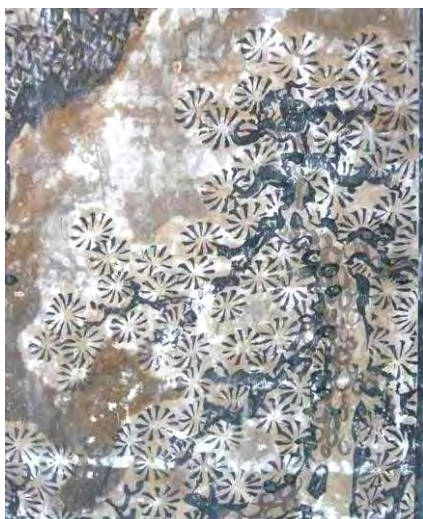
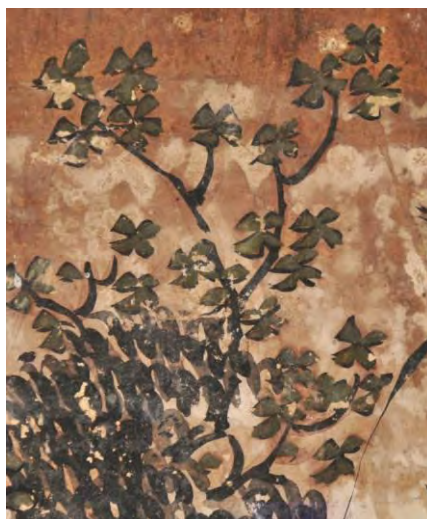
Fig. 195 (left)
Pingfeng xi, panel 4 b: tree resembling an aralia tree

Fig. 196
Pingfeng xi, panel 7 b: azalea (?) and grass
