Ziyang *Beiwusheng huiguan*

Final report

Part 1: Technique and materials

Research Project 01UG1001
„German-Chinese co-operation in the preservation of Cultural Heritage: Researches for the
conservation of selected monuments in the PR China”

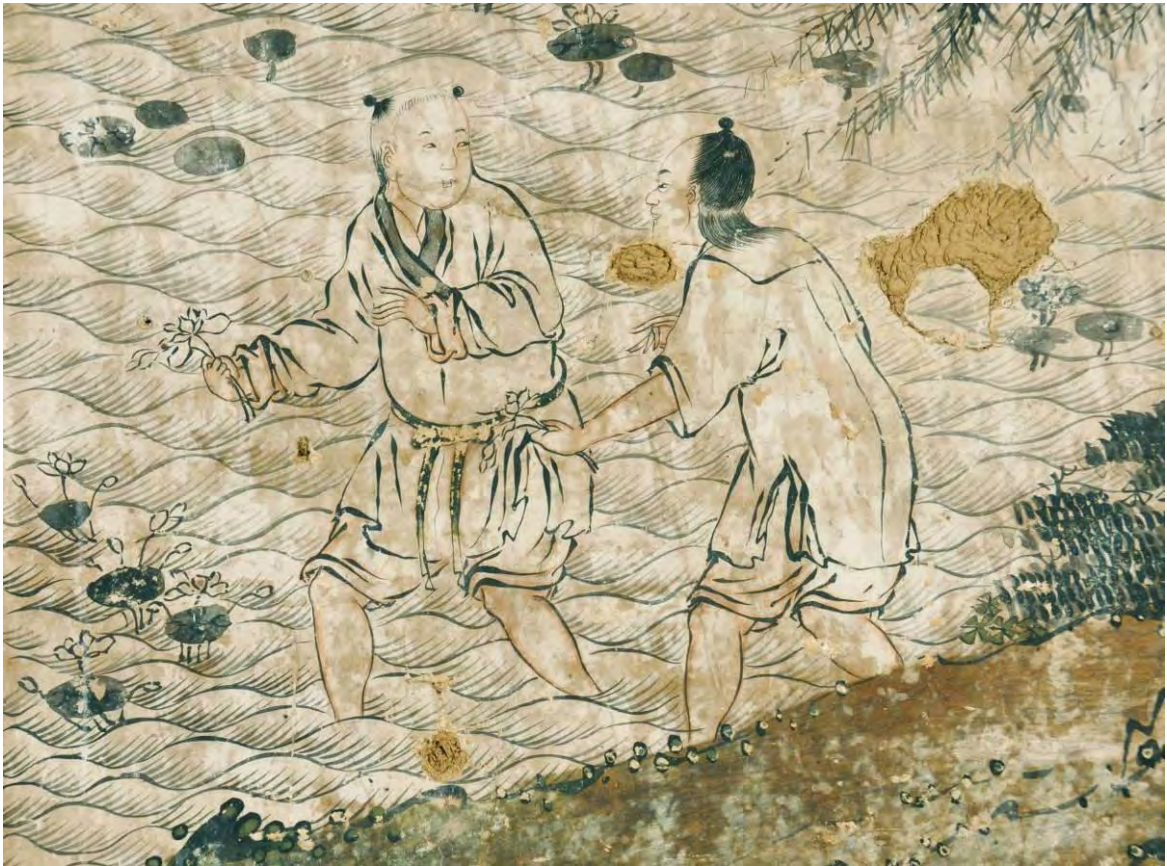
Fig. 197

Pingfeng xi, panel 6 b: two boys picking water lilies under a willow tree

After the paintings were finished, small black circles or dots (up to 0.4 cm in diameter) were applied and “highlighted” with thickly applied green dots on the plants and landscape. Size and style differ from the leaves painted with opaque green. These dabs and green dots are placed all over the scenery, covering rocks, branches and hill sides. They are independent of the type of plant and thus seem inconsistent of a design in which individual species are carefully characterised. Sometimes they give the impression of small leaves, but they can also be found on pine trees, and in the background they appear like shrubs on the hills of the distant lakeshore (fig. 194). It seems unlikely that they were applied by the same artists who painted the trees. Like the blue and few opaque green areas, the green dots, too, are superficially darkened. A lot of dots have flaked off, maybe due to the thick application (fig. 185 and 197, shore at lower edge).

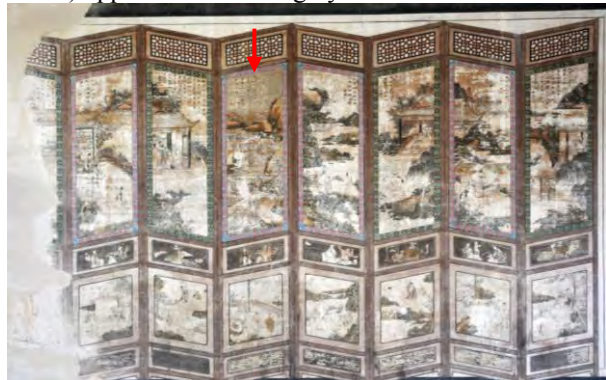
Fig. 201
Pingfeng xi after retouching in 2013: panel 4 b (red arrow) appears darker and greyer

Panel 4 *b* visually deviates from the other *b*- and the *d*-panels. While in the other paintings background and sky appear white or have discoloured by the coating, in panel 4 *b* the sky looks grey (fig. 203), and the landscape appears darker and more opaque than elsewhere. In the sky, losses have occurred with distinguished edges. As the paint layer flaked off from the finish coat, the losses are rather deep. This is a type of damage that is rarely found in the other parts of the wall, where most of the losses occur within the ground layer and show soft and undistinguished edges. The lower part of panel 4 *b* shows the same type of superficial losses as the main part of the wall (fig. 149).

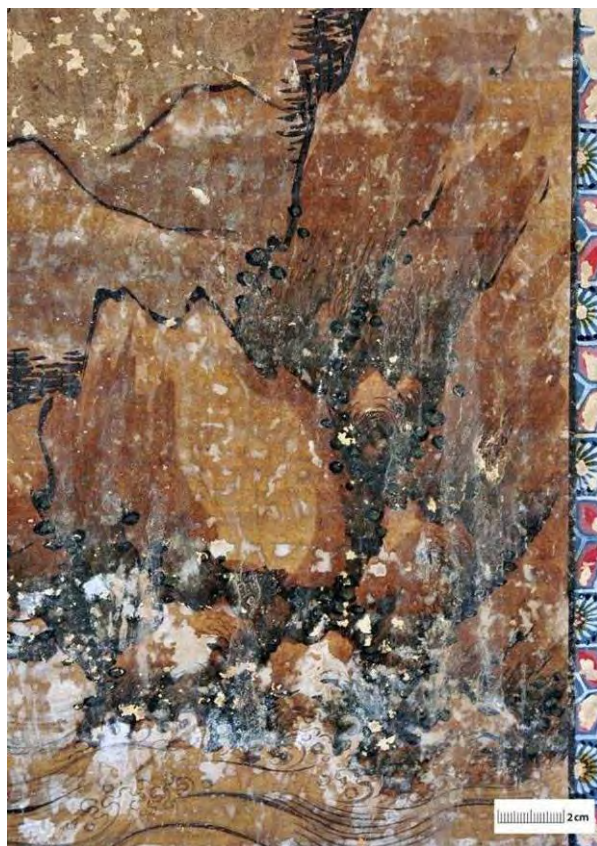
Fig. 202
Pingfeng xi, panel 4 b: landscape shaded with grey and two brown hues, and green dots

Hills and mountains were sketched in black and then coloured and shaded with brown and olive-green translucent washes (fig. 202). The brownish washes appear dark under UV light, indicating the use of copper pigments: originally the landscape was green, not brown. In panel 7 *b* showing the drunken poet on a horse, the wash was applied imprecisely, covering parts of the face, hat and shoulders of the servant holding the fan. This is just recognisable in visible light (VIS), proving that the wash was very light in colour (figs. 156 and 157).

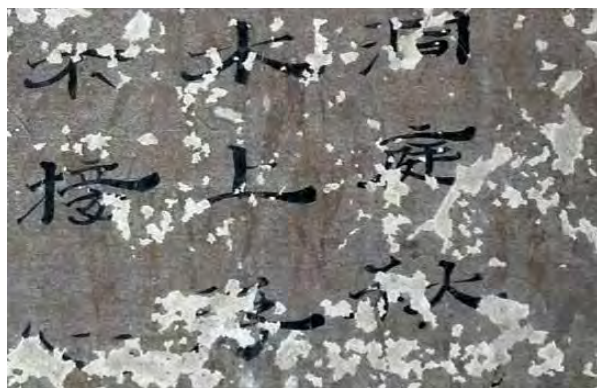
Fig. 203
Pfx, panel 4 b, sky: brittle flaking, exposing finish coat

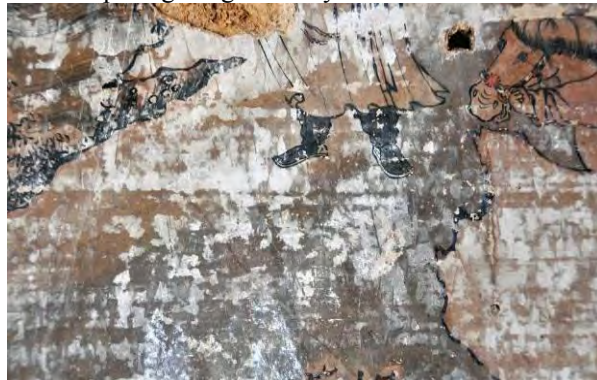
Fig. 204
Pingfeng xi, panel 4 b, lower part: horizontally oriented losses exposing the ground layer

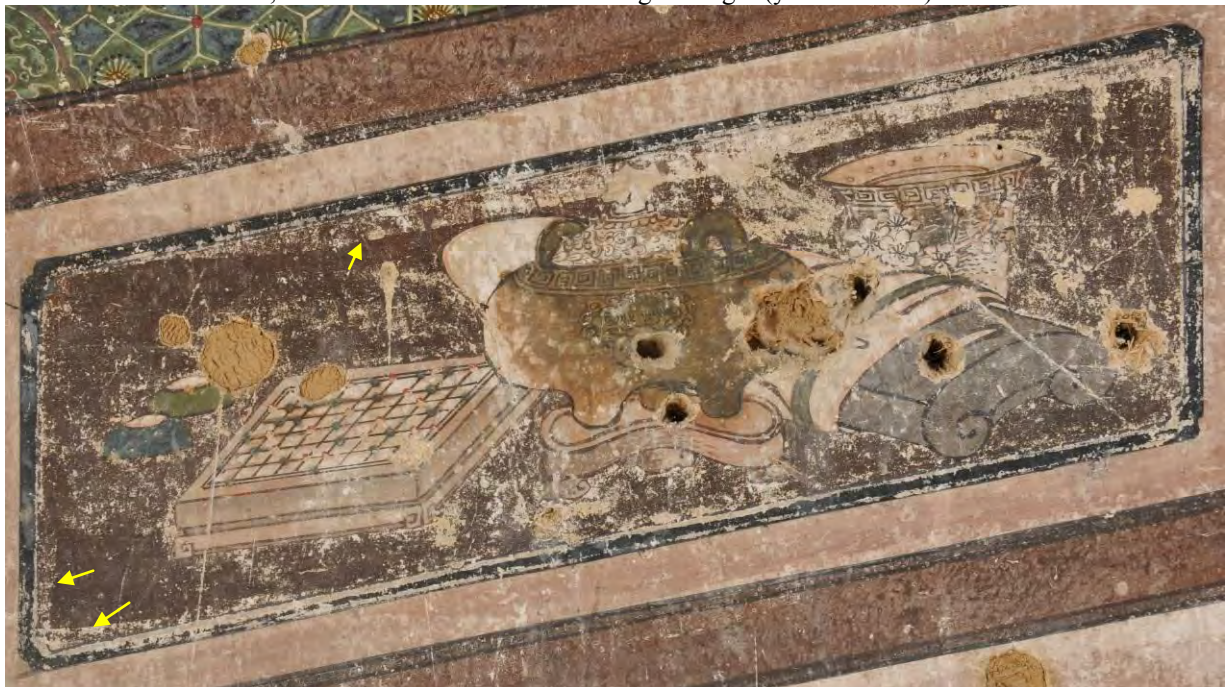
Fig. 210

Pingfeng xi, panel 8 *c* in August 2012: still life with chess board, censer, wrapped *qin* zither (?) and a vessel decorated with blossoms; areas with reduced adhesion along the edges (yellow arrows).

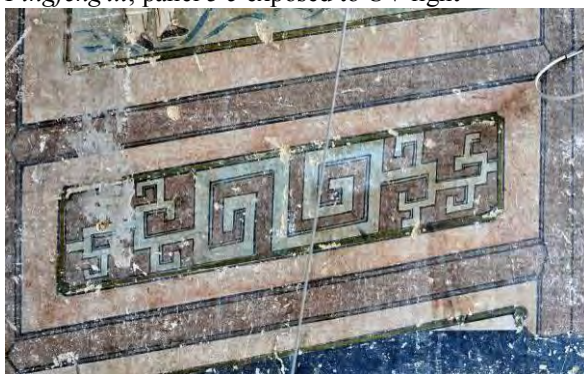
Fig. 214
Pingfeng dong, panel 6 e: *yunleiwen* ornament in pale blue with brown background

Similar *yunleiwen* ornaments are depicted on the *e*-panels of the *pingfeng dong* (fig. 214): The slightly varying ornaments stand out in pale blue in front of a brown background in the same colour as that of the framework. Double contours in black indicate a relief effect, as if the ornament was carved (although the perspective is incoherent). The *yunleiwen*-ornament was omitted when the brown background was applied⁷⁷, like the figurative depictions in the *c*-panels.

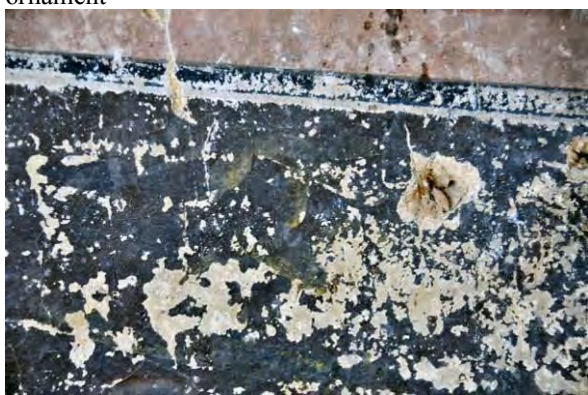
Fig. 215
Pingfeng xi, panel 5 e: traces of the yellow floral ornament

Closer examination revealed traces of ornamental decoration which today are almost invisible consisting of fragmentary strokes of yellow paint applied onto the dark brown ground (fig. 215). Where the yellow paint has flaked off, a whitish haze is preserved on the dark background, maybe an accumulation of the binding medium. Exposed to UV light, the yellow strokes have a yellow fluorescence. Style and colour of the fragmented ornament resemble the floral decoration of the *e*-panels in the *pingfeng bei*-painting (fig. 216).

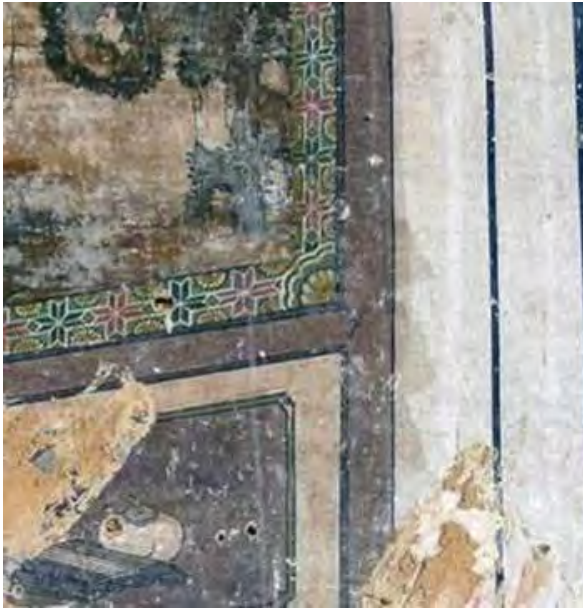
Fig. 219

Pingfeng dong, southern edge of panel 8: Brush strokes from applying a transparent material are visible next to panel *c*.

screen (figs. 219, 220 and 222). Under UV light, the brush strokes of the sizing appear bluish white, but they have brownish spots where the layer is thicker (fig. 221).

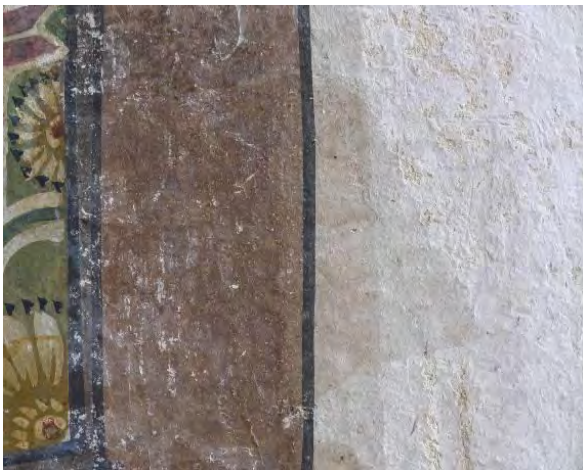
Fig. 220

Pingfeng dong, lower southern edge of panel 8 *b*, sizing below paint layer: Visible brush strokes appear darker due to higher saturation of the ground layer.

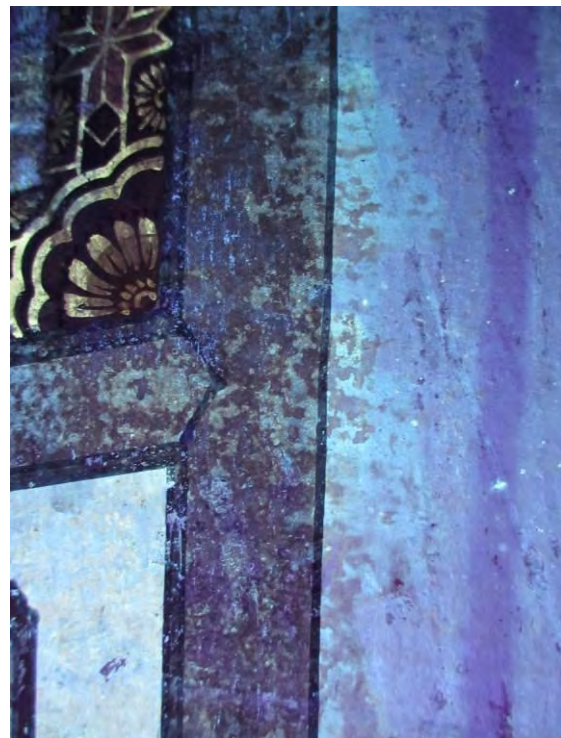
Fig. 222

Pingfeng dong, framework at the lower southern edge of panel 8 *b*: The end of a brush stroke of the sizing continues underneath the brown wash (the arrows mark the margins of the brush stroke).

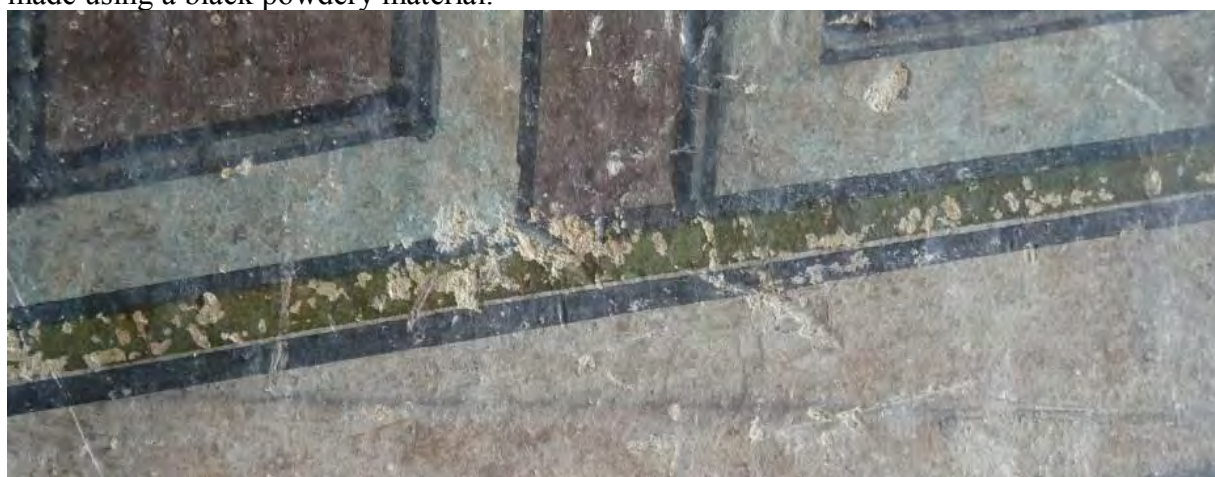
Fig. 224
Pingfeng dong, black horizontal chalk line marking the black contour of the white framing; green filling frame of an e-panel.

The 10 to 11 cm wide black framing and the black line bordering the white framing were painted like at the *pingfeng xi*-painting. At the lower edge, a black line is still visible that was used to mark the black contour of the white frame (fig. 224). The chalk line may have been made using a black powdery material.

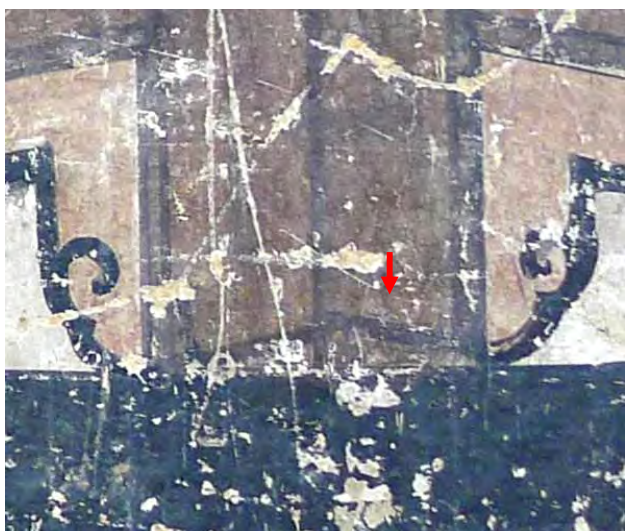
Fig. 225

Pingfeng xi, frame 6 to 7, legs: black trimming and problems with perspective (arrow)

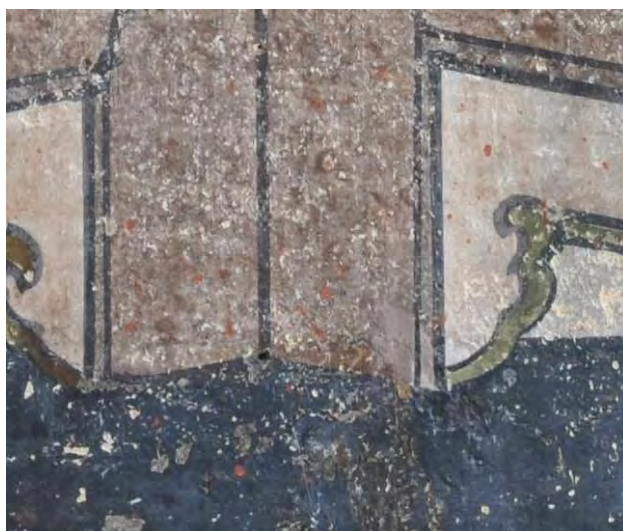
Fig. 226

Pingfeng dong, frame 6 to 7, legs: green trimming and perspective depiction of the end of the stiles.

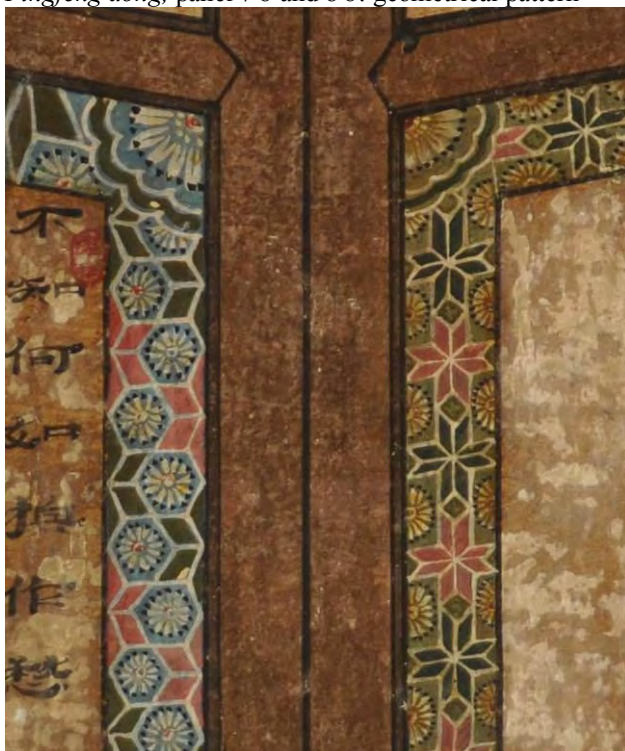
Fig. 227

Pingfeng dong, panel 7 b and 8 b: geometrical pattern

The *b*-panels are framed with 3.3 cm wide borders showing geometrical patterns (figs. 227, 228). There are four different patterns with three ground colours (light green, dark green and blue, table 11) whereas in the *pingfeng xi*-painting there is only one pattern in two different colourations. Only the pattern on the frames 3 and 6 has a design similar to the ones on the *pingfeng xi*-painting. The corner ornaments are quarters of blossoms. At the borders with green ground (frames 2, 3, 6 and 7), the blossoms are shaded with a yellow glaze.

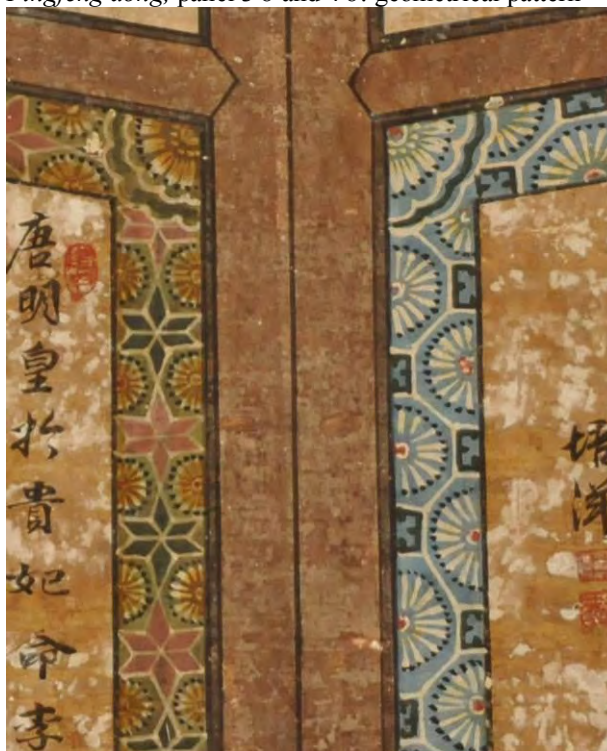
Fig. 228

Pingfeng dong, panel 3 b and 4 b: geometrical pattern

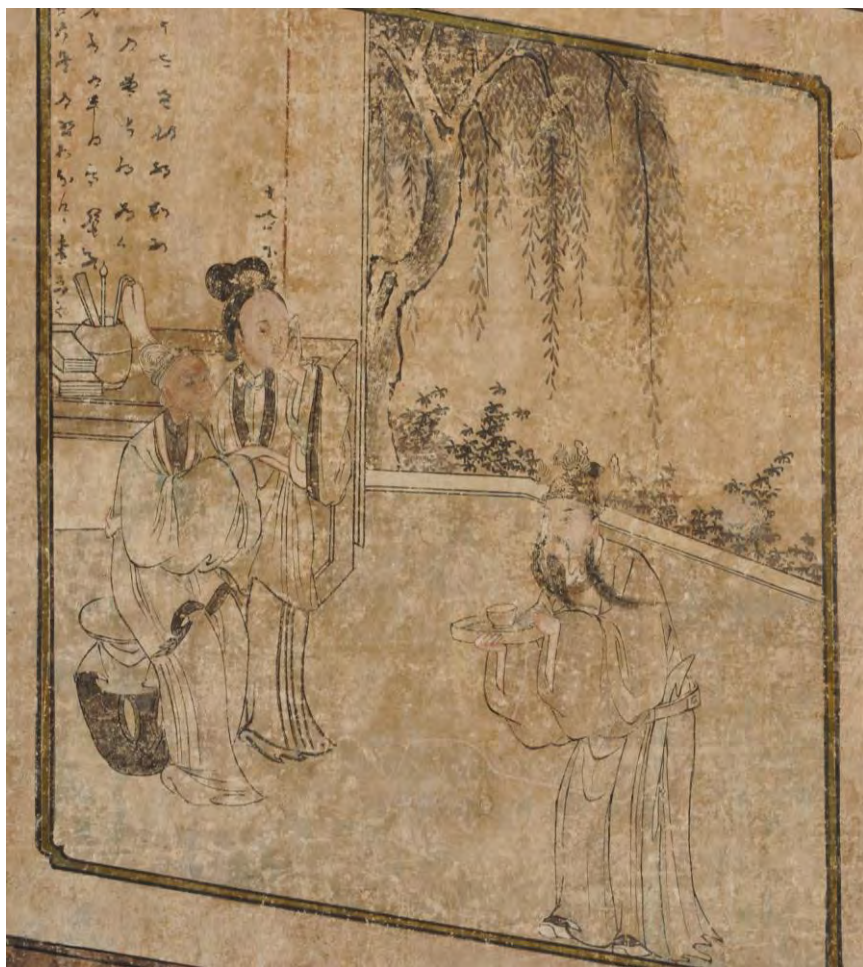
Fig. 238
Pingfeng xi, panel 8 d: flesh tone in opaque pink; staff
highlighted with white; strangely bent hand

The *d*-panels differ from the *b*-panels in style and technique: The composition is simpler; the drawings are less refined and show broader strokes (fig. 237). The figures are stiffer in their postures and movements and often show peculiarly bent hands (fig. 238). They appear less artistic although they are rich in details.

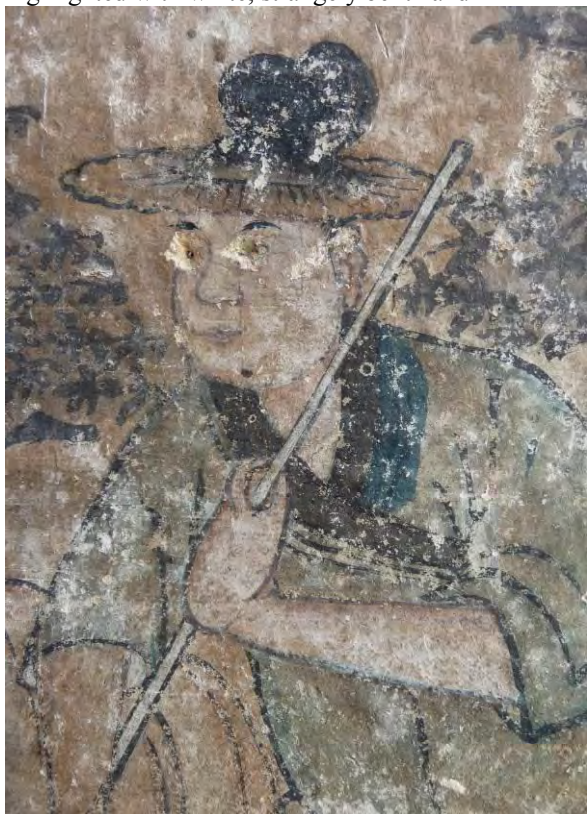
Fig. 239
Pingfeng xi, panel 5 d: face in opaque pink, light
blue and white highlights (cap and collar)

Technically they show a considerable deviancy. Light tones and highlights are only partly omitted during the painting process: Mostly they were mixed with white and applied in the final steps of the painting process. White highlights can be seen on the clothes like single folds or belts, but white was also applied to indicate white parts of the clothing as shoe soles, trousers, sleeve cuffs and collars. Larger white parts are shaded with pink (fig. 239, collar). Highlights were also set in light blue on pale blue parts of the clothing (fig. 239, cap). The flesh tones were mixed with white and red and applied overlapping and in parts omitting the black drawing. Eyes, eyebrows and hair were painted with black on top of the flesh tones. The lips are coloured pink to red, with the exception of the faces of very old persons. The skies in the background of the scenes are sometimes shaded with light blue (fig. 240). The vegetation does not show green dots.

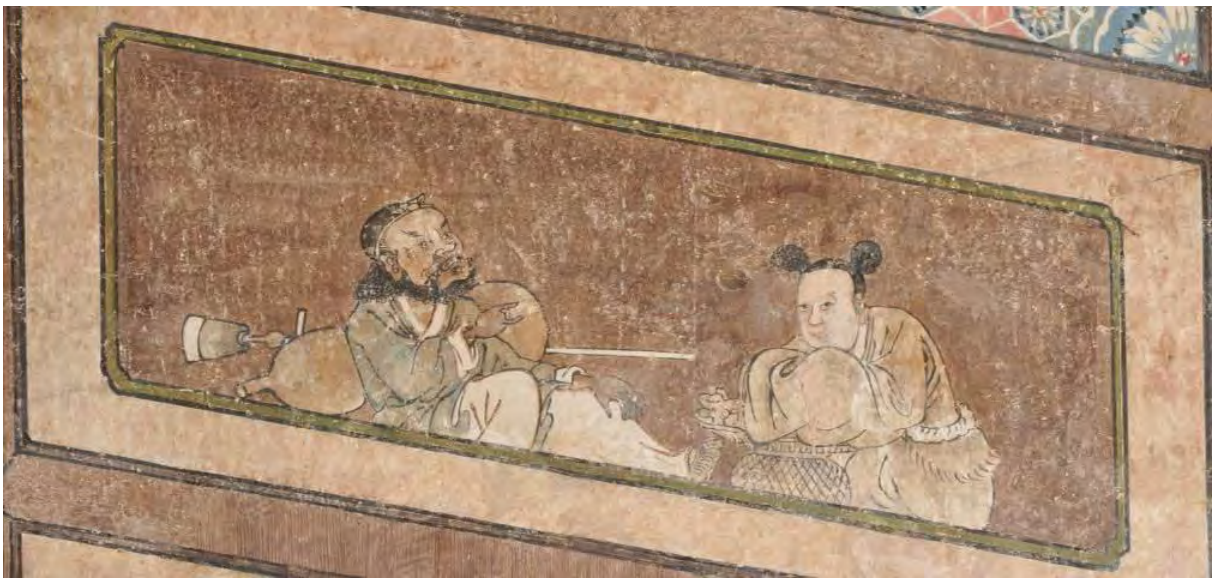
Fig. 241

Pingfeng dong, panel 7 *c*, after retouching in 2012

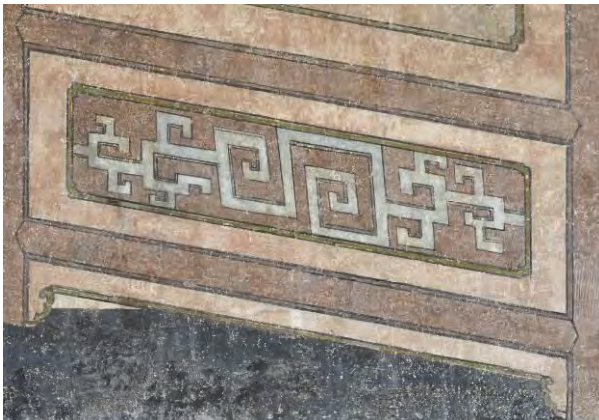
Fig. 242

Pingfeng dong, panel 5 *e*, after retouching

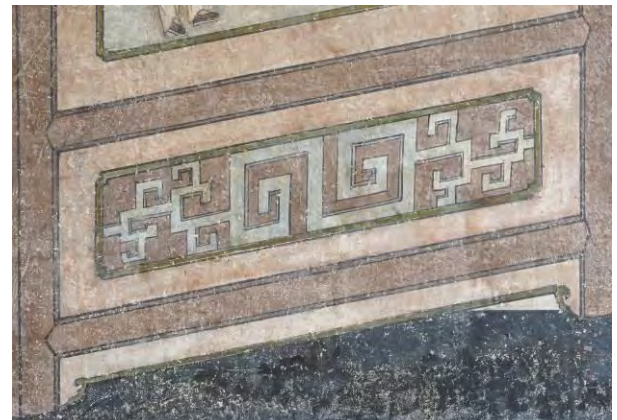
Fig. 243

Pingfeng dong, panel 6 *e*, after retouching

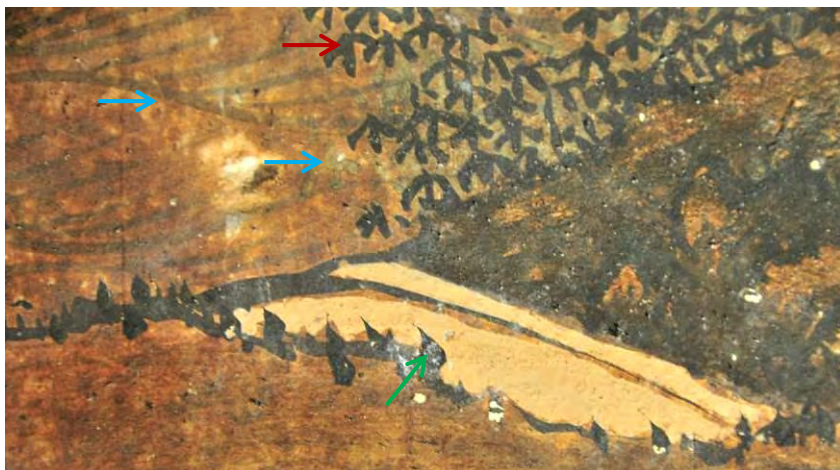
Fig. 244
Sanguo dong. Lower edge, left side: Shore of river with small waterfall accentuated in white. Wave and plants were sketched in grey before the isolation layer was applied (blue arrow), and accentuated in more opaque paint on top of the isolation layer (red arrows). After filling in the opaque white, black dots (green arrows) and green dabs (missing here) were added to the landscape.

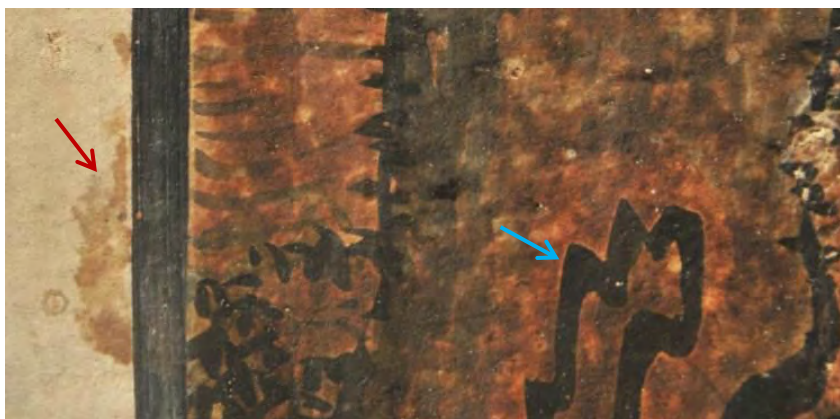
Fig. 245
Sanguo dong: Left edge: The isolation layer overlapping the outline of the painting formed a white margin along the outline (red arrow). The washes/glazes applied for the landscape provoked the same effect on the black contour lines drawn after the isolation layer had been applied (blue arrow).

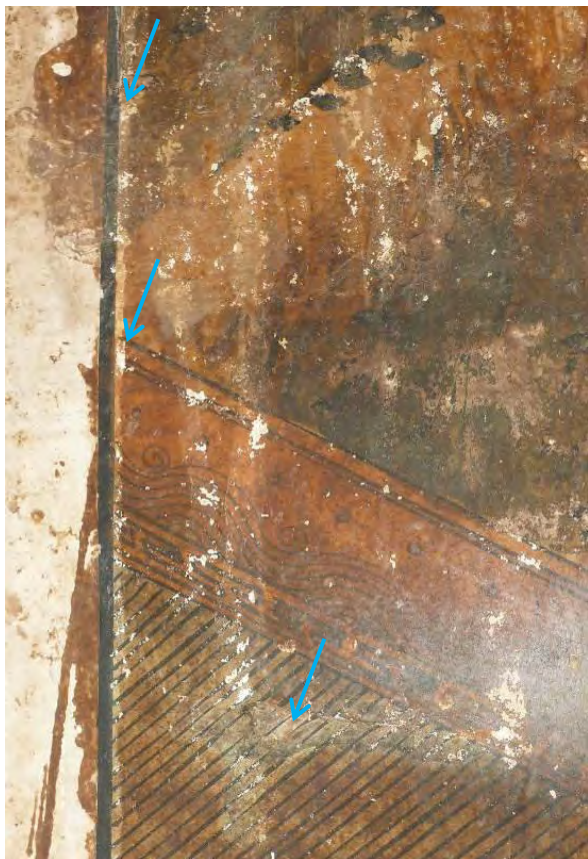
Fig. 246
Sanguo xi: coloured washes in roof tiles, roof ridge and mountains underneath a brown layer

washes gave the first colour impression. Today they are only visible in very small areas that were not covered with brown layers. Reddish brown, brown, blue and bluish green can be distinguished (fig. 246 and 247). The architecture and objects like the chariot or the boats were coloured with washes of different shades (red, brownish, grey and bluish grey). These washes are almost concealed underneath brown layers nowadays, but in parts they become discernable with infrared reflectance (fig. 262 and 263). The colouration of the architectural elements and the roof tiles, depicted as strips with alternating shades of grey, correlate with the paintings in the *b*-panels of the folding screens in the *guodian* (*pingfeng xi* and *pingfeng dong*). In this state of colouration, the *sanguo*-paintings probably resembled the *b*-panels of the folding screens in the type of drawing and delicate colouration. Plants and architecture may even have been painted by the same painter.

Little care was taken to restrict the application to the paintings or to avoid runners and drops on the white framing (fig. 246, next to the roof, and fig. 247). Regarding the richness of details and embellishments in the natural scenery, architecture and objects it seems implausible that these finely designed parts should be deliberately concealed underneath a brown layer to an extent that made them almost unrecognisable. As it is almost impossible to distinguish water from mountains, or grass and chariot wheels, horse manes, the bodies of the deer, boats, clouds, roofs and parapets from the background, the legibility of the scenes is impaired. This indicates that originally the isolation layer must have been colourless or only very slightly tinted. The discolouration of the isolation layer was the biggest change in the visual impact of the paintings that occurred by ageing.

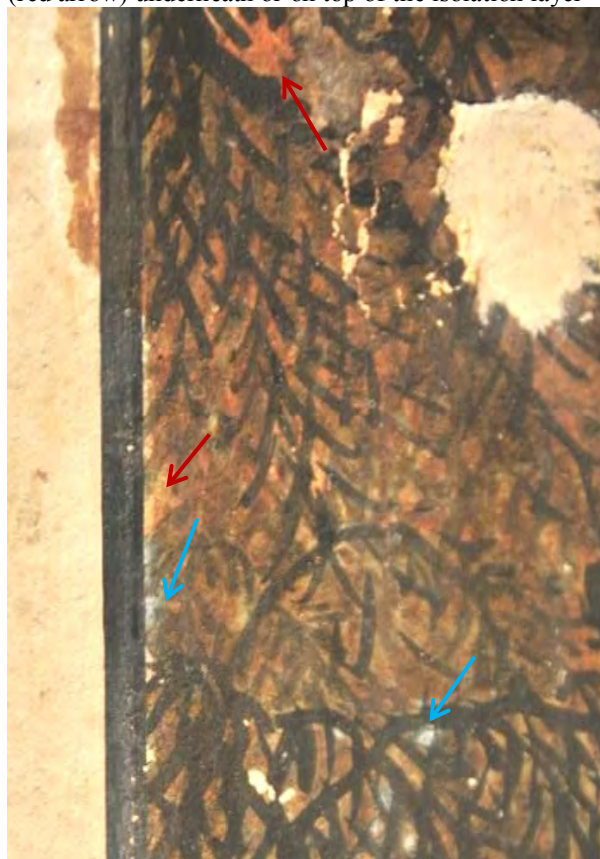
Fig. 247
Sanguo dong: bluish-green washes underneath the brown isolation layer (blue arrows), brown washes (red arrow) underneath or on top of the isolation layer

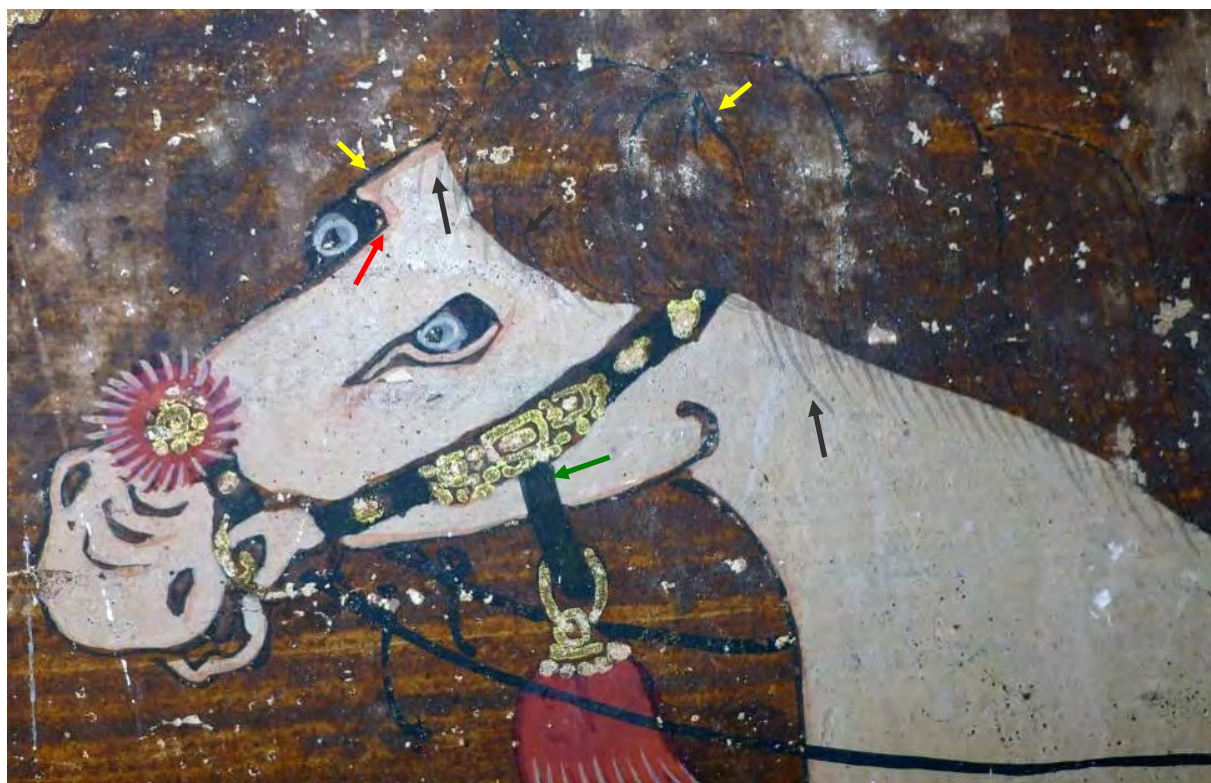
Fig. 249

Sanguo xi: Black delineation (yellow arrows). Opaque colours (the horse's coat) omitting the delineation with red, grey and green washes for shading (green and red arrow). The grey mane on top of the opaque colours is only visible on the white horse coat (black arrow). The reins were painted last.

(1) The first step of the painting process was the **delineation**. The fine lines are black up to grey (= diluted black paint) and give a very detailed and precise drawing including almost all the details of the depiction (fig. 249 and 263). The delineation remained visible in parts of the paintings. Only in few parts the execution of the paint layer deviated from the delineation.

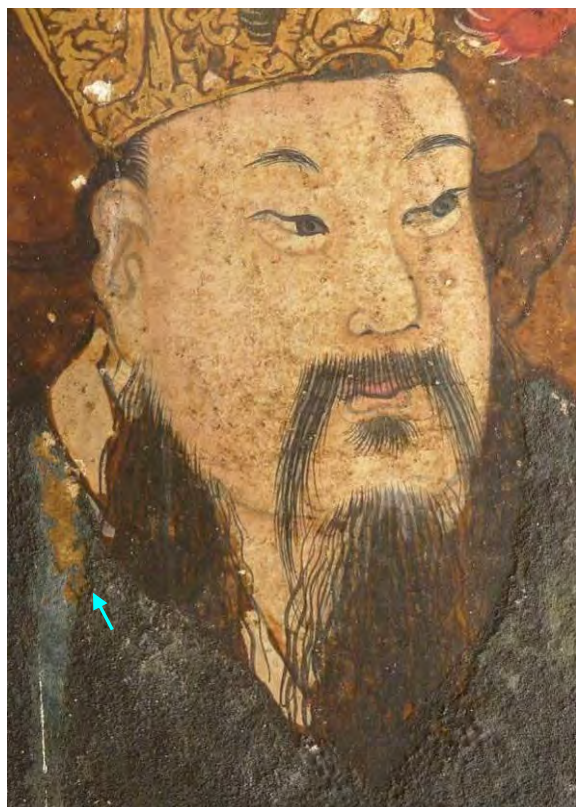
Fig. 250

Sanguo dong, upper part: Underneath the thickly applied green of the robe the first delineation coloured with an olive green wash becomes visible.

(4) The application of non-translucent paints was probably started with painting the **flesh tones**. A semi-translucent, non-pastose paint was used, possibly to avoid the fine delineation to be covered. The eyeballs were painted white and sometimes shaded with bluish grey (fig. 250, 254 and 253); then the irises, eyebrows and nostrils were accentuated with black lines and the lips coloured in reddish pink. A binding medium layer of irregular thickness was applied to the flesh tones. In parts it seems to lie underneath the opaque paint layers (figs. 266/267), but at the *sanguo xi*-painting it appears to lie on top of them (fig. 255).

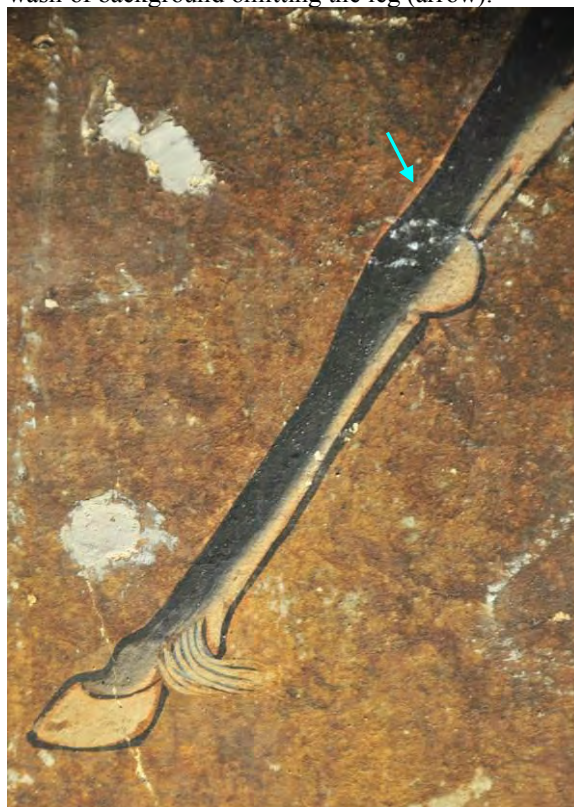
Sanguo dong, lower northern corner, black horse from chariot: Black contour repeated on the isolation layer and filled in white, grey and black. Olive green wash of background omitting the leg (arrow).

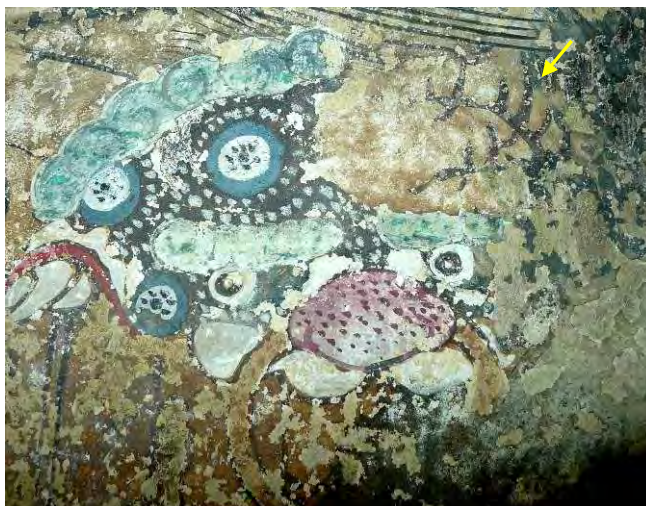
Fig. 252

Sanguo xi, upper part, "lion head" on the prow of a boat: Black delineation (yellow arrows) visible in lacunae. In the boat and the waves the delineation remained visible.

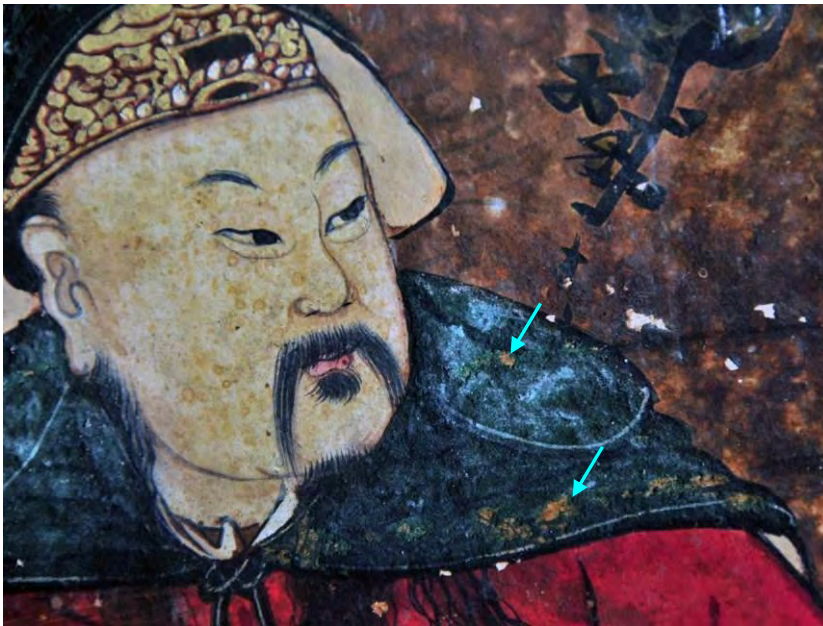
Fig. 253

Sanguo dong, northern corner, flight in the chariot, head of Liu Bei (figure no. 26): Underneath the green of the cape the brown isolation layer is visible (arrows). Blotchy coating on the face. Height of the face: ca. 4 cm.

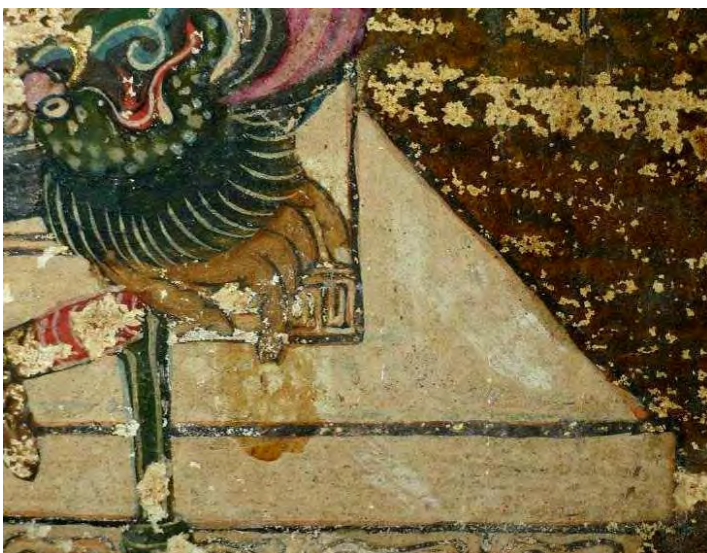
Fig. 255

Sanguo xi, hand of guard at the terrace (figure no. 8) in front of the pavilion: The protective coating of the hand ran down over the opaque paint of the terrace. The white paint of the terrace was applied twice. Black lines were shaded with pink.

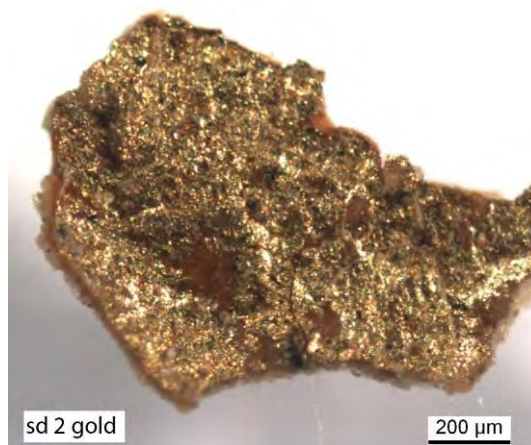
Fig. 256

Sanguo dong: Sample taken from a weapon showing gold leaf and reddish mordant

(6) The **gilding** was put on a reddish mordant, containing fine cinnabar⁸¹ in a mixture of glue and polysaccharides.⁸² Gold is only applied in small areas. For larger areas, like weapons, leaf gilding can be proved (fig. 119, gilded head of staff next to Liu Bei). The typical edges and wrinkles of cut gold leaves are visible (fig 256). But small gilded decorations, e. g. at the harnesses of the horses (fig. 249), on belts, caps (fig. 254) or suits of armour, seem to have been made with leaf gilding as well, even though the golden lines and dots are very small (fig. 254).

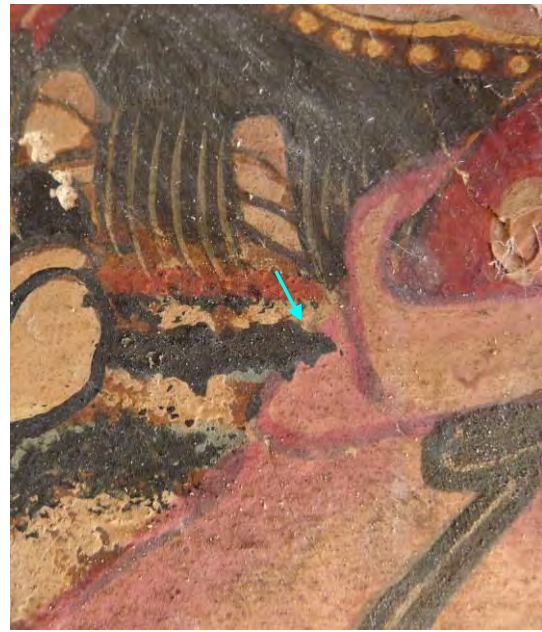
Fig. 258
Sanguo dong, enlarged detail of the pavilion: the carpet was painted after the terrace and the figures had been finished

(9) **Washes** and **glazes** were used to shade the opaque colours in figures, objects and architecture. Some parts, like a bright ochre table cloth in the *sanguo xi*-painting or pinkish horse coats, were underpainted with opaque lead white and coloured and modulated with glazes. Opaque and translucent paint layers may have been applied as subsequent steps for smaller units, like single figures or objects: The opaque paint of the carpet pattern in the *ganlusi*-hall (*sanguo dong*-painting) overlaps the glazes on the figures' robes, showing that the carpet was painted after the figures had been completed (fig. 258).

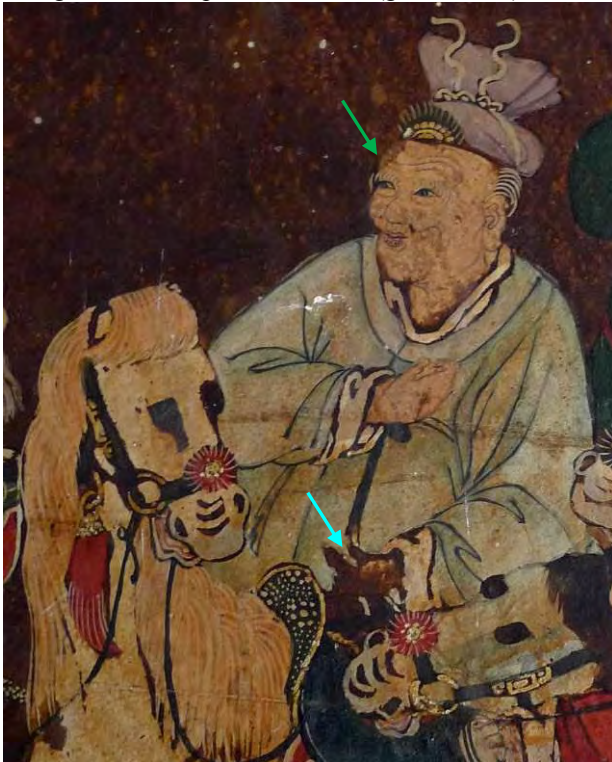
Fig. 260
Sanguo dong, soldier, figure no. 43 from the group with Guan Yu and Zhang Fei at the left edge of the painting: One hand remained unpainted by mistake.

There are few “*mistakes*” within the colouration of higher parts less visible for observers: The painters forgot to colour hands and other small details, background washes are overlapping on to the figures. Such mistakes were less visible before the isolation layer(s) turned brown (figs. 259 and 260).

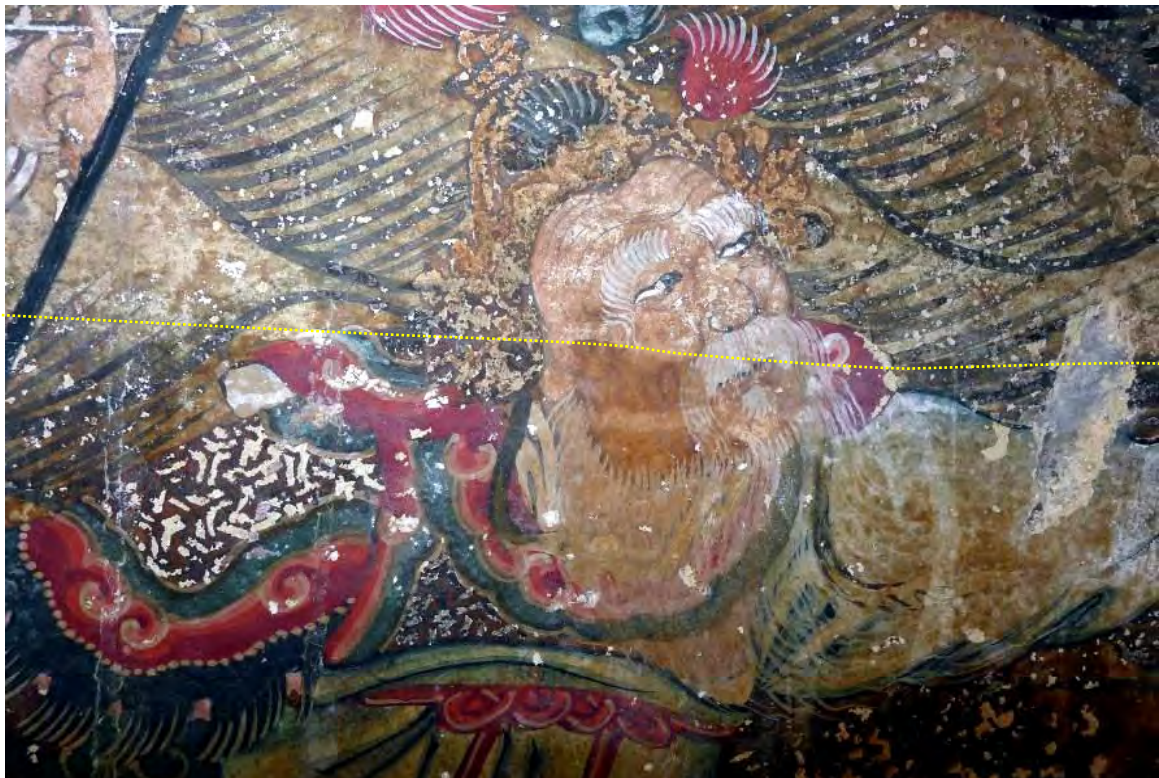
Fig. 262

Sanguo dong, entrance gate of *ganlusi*-hall: Brown layers obscure the intended chromaticity.

Because of the discoloration of the isolation layer, many details of the paintings are concealed and invisible today. Infrared reflectography can be used to see the drawing and some shades of colour clearer (fig. 262/263). The examination under UV light also revealed details not discernible in VIS like the accentuations in a horse mane or the differences between mane, tail and coat of a horse now looking completely white (fig. 266/267).

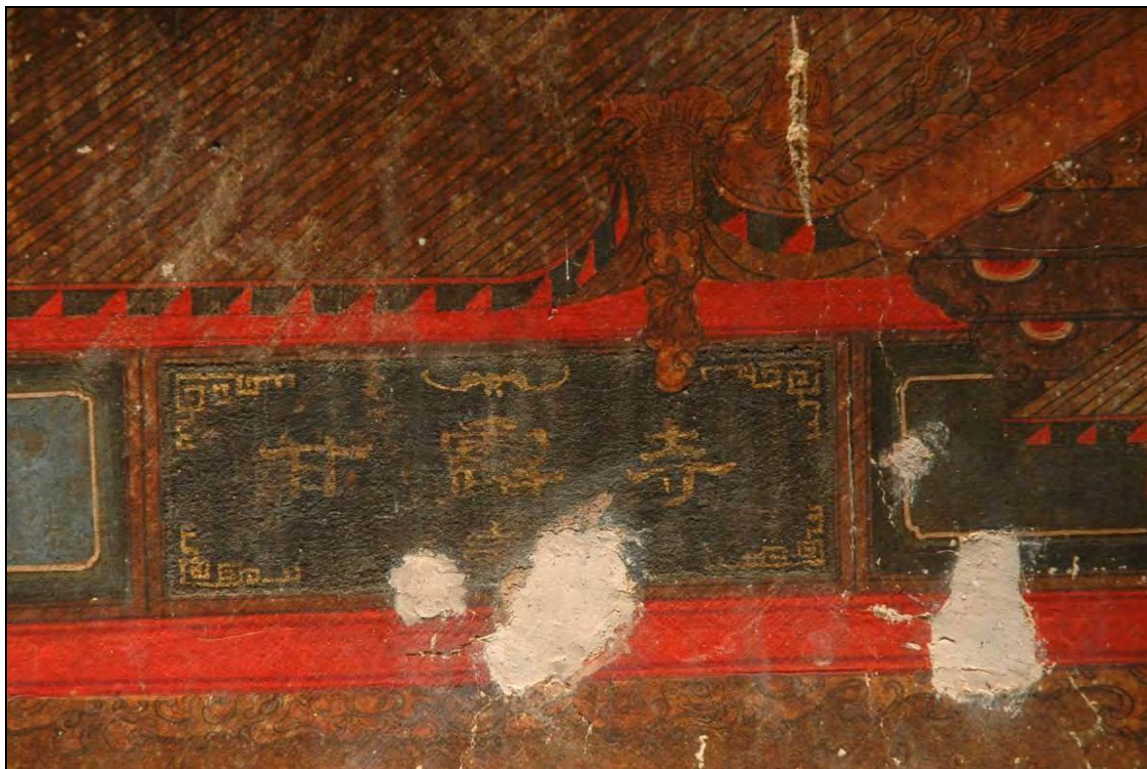
Fig. 263

Sanguo dong, IR reflectance: The delineation and shading of roof tiles and ornaments become visible.

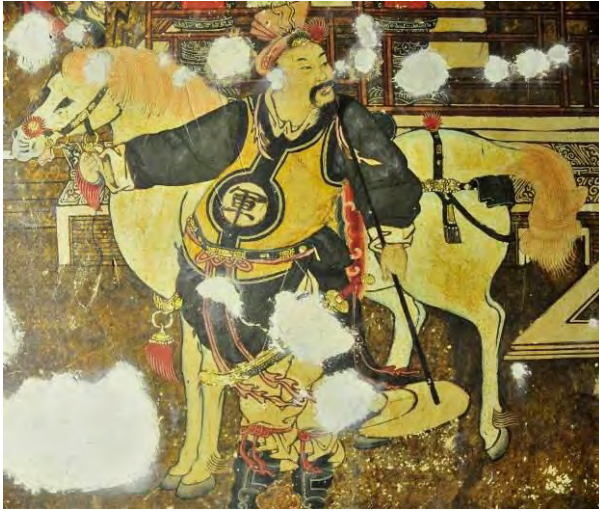
Fig. 264
Sanguo dong: soldier (figure no. 23) with horse, VIS
(during filling)

Under UV light uniformly white parts like horse coats or robes show different fluorescence colour, appearing partly white and partly brownish. Shapes become perceptible which deviate from the visible ones (figs. 264/265 and 266/267). They seem to indicate some *changes*, but it was not possible to assign the two fluorescence colours to layers/coatings recognisable in visible light.

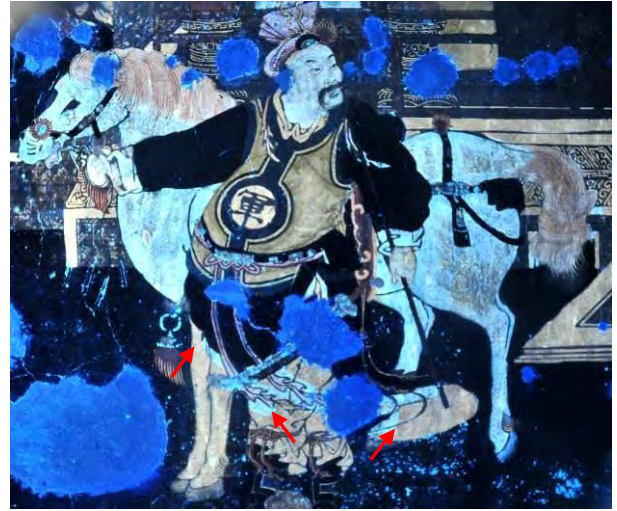
Fig. 265
Like fig. 264, UV: Changes in the robe can be recognised by UV fluorescence (red arrows); the forelegs of the horse have a different fluorescence. The grassland appears dark under UV light, while the architecture is light brown.

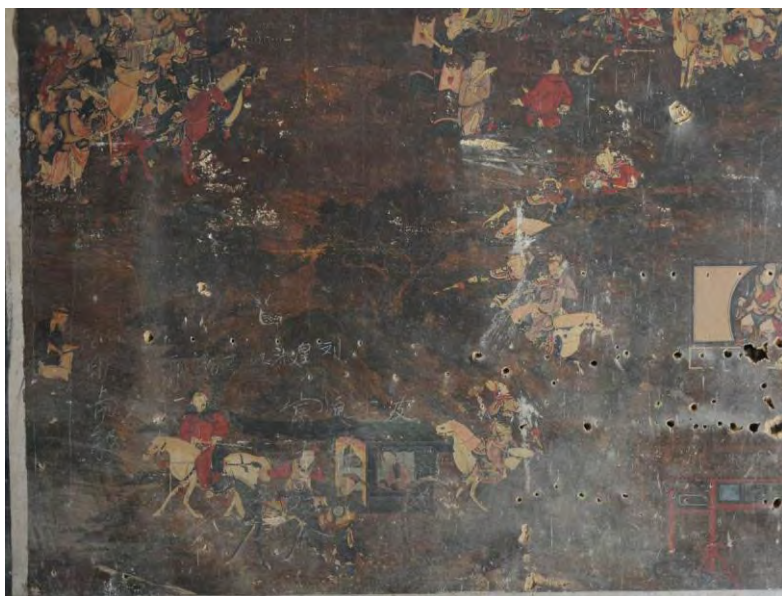
Fig. 269
Sanguo dong: lower left edge in VIS, 2011
[Shaanxi Institute for Conservation]
