Ziyang *Beiwusheng huiguan*

Final report

Part 1: Technique and materials

Research Project 01UG1001
„German-Chinese co-operation in the preservation of Cultural Heritage: Researches for the
conservation of selected monuments in the PR China”

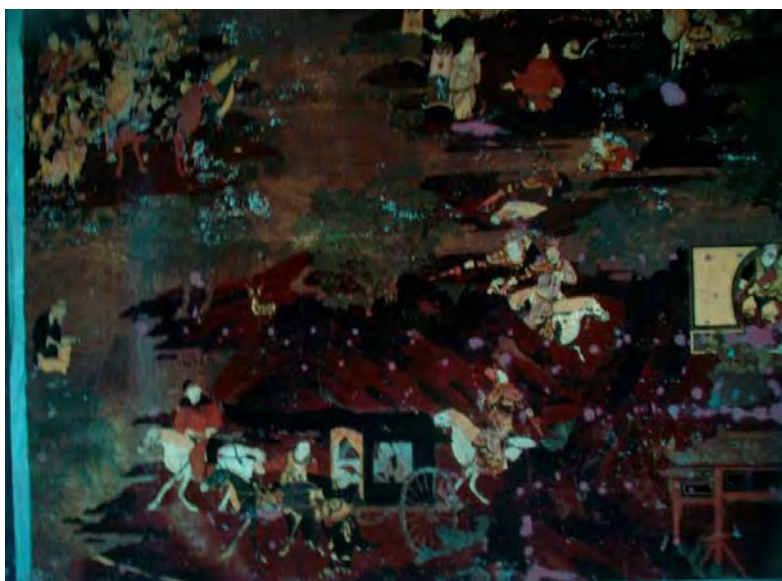
Fig. 270
Sanguo dong, lower left edge: In UV light, different tones are clearly visible in the landscape (picture taken without filter and blurred due to long exposure time)

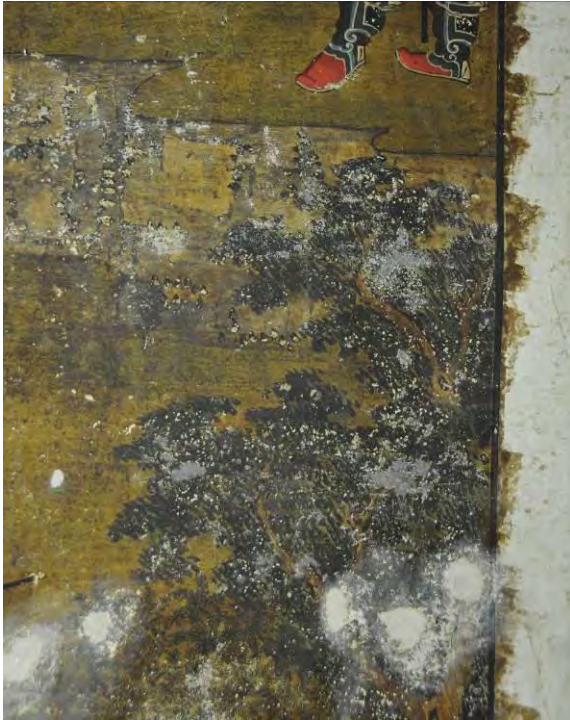
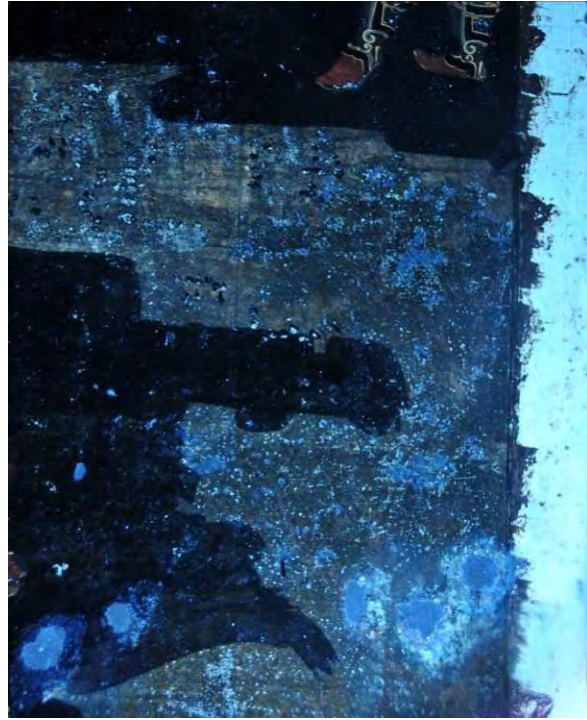
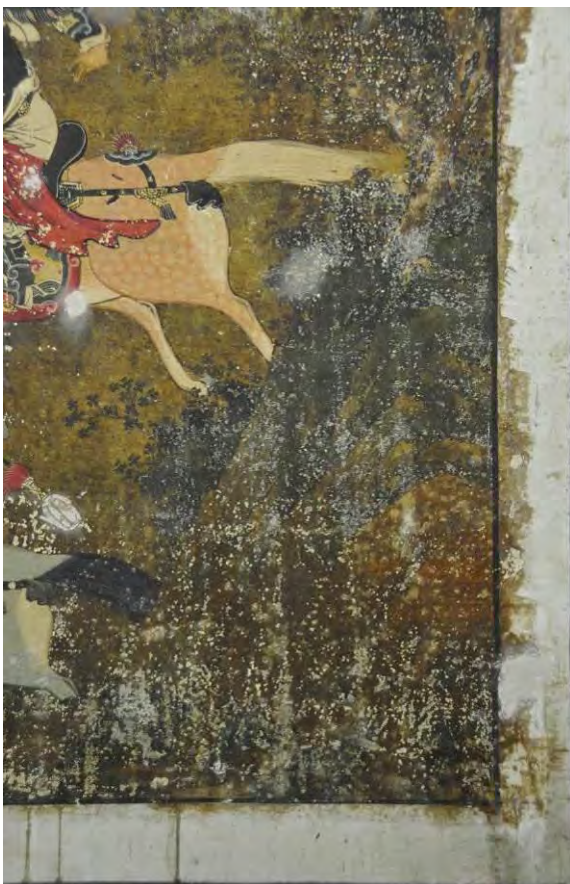
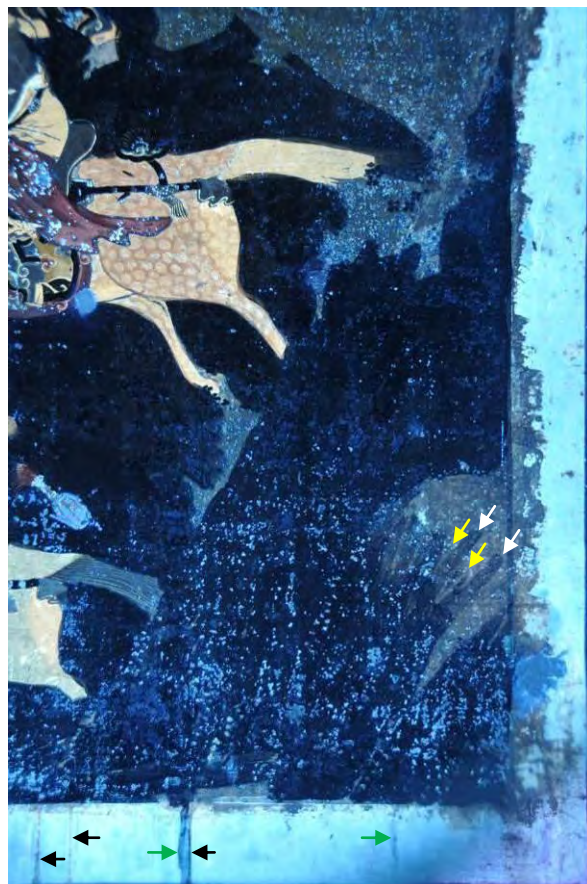
Sanguo xi, right edge, VIS and UV: Two shades of brown in the rock (white and yellow arrows); olive green glaze appears black in UV light (copper pigments). Traces of bright green wash (green arrows) and olive green glaze (black arrows) running down at the lower edge.

Samples from the landscape contain malachite and black, and often Prussian Blue. Graphite found in the waves may indicate sketching with pencils. Red pigments found in the waves and in a sample of the grassland next to Guan Yu's red horse either come from shading or were spread from other paint layers. Prussian blue and botallackite were identified in a sample coming from a part of a boat that likely depicts wooden planks (i.e. brown). This may mean that yellowish or brown components (dyestuffs or coloured binders) were used that cannot be identified as they cannot be distinguished from the discoloured binding medium.

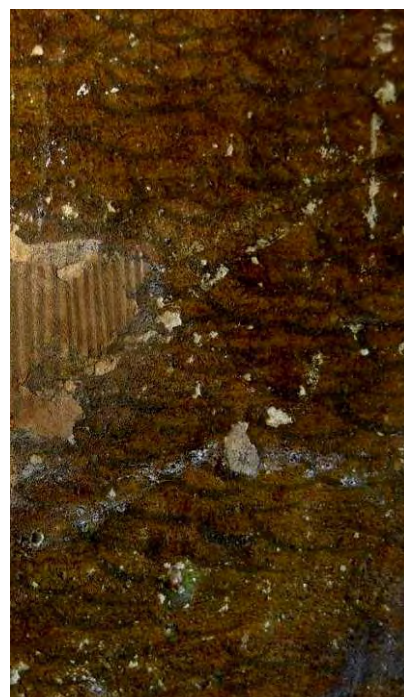
Fig. 275
Sanguo dong: crescent-shaped lines characteristic of the grassland; width of section corresponds to ca. 3 cm (vertical lines on the left belong to the retouches carried out in 2012).

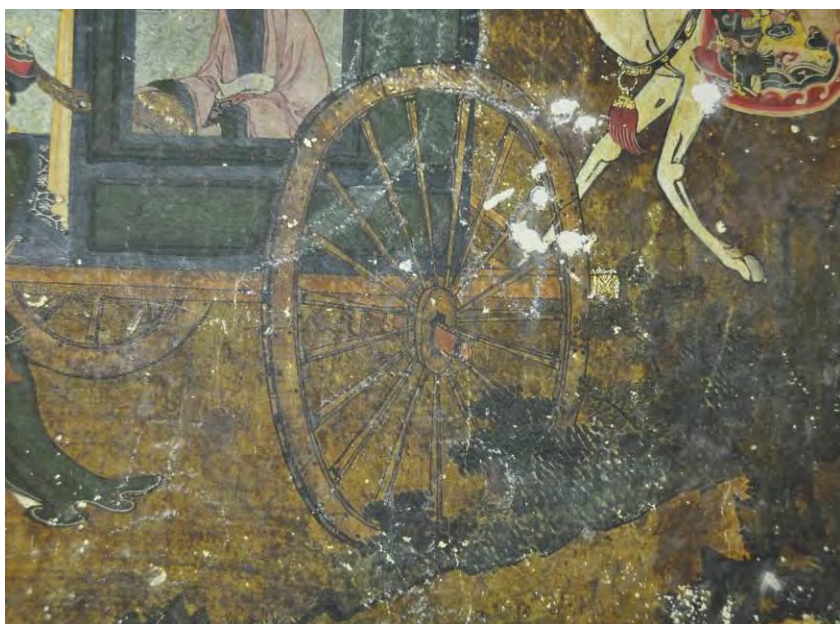
Fig. 278
Sanguo dong, lower left edge:
chariot

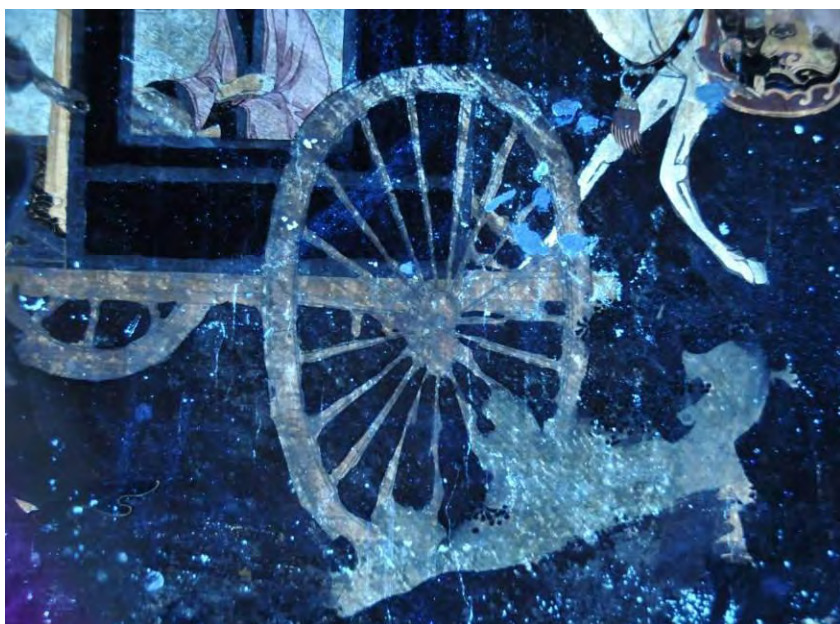
Fig. 279
Sanguo dong, like fig. 278,
UV light: The chariot and the
patch of grass stand out lighter
against the grassland which
was shaded with a copper-
containing green. The wheel
and floor of the chariot look
slightly reddish due to the use
of brown or red pigments; the
axis is even redder. The filling
of the door shows the deep
black typical of green copper
pigments.

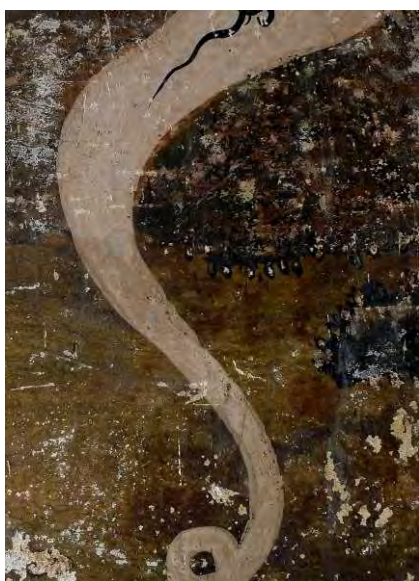
Fig. 280
Sanguo xi, lower part of “red
light”, VIS: Olive green glaze
of grassland brushed over the
light is almost invisible.

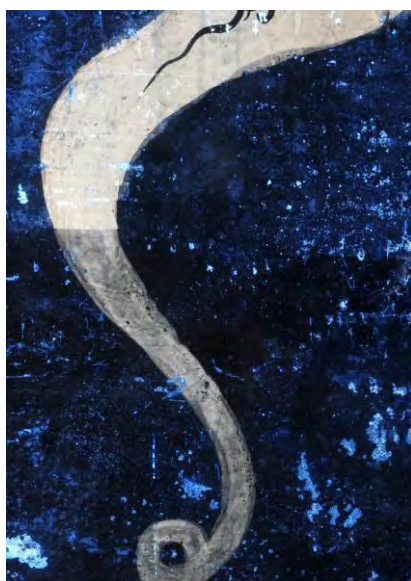
Fig. 281
Sanguo xi, lower part of “red
light”, UV: Olive green glaze
becomes more discernible in
UV light.

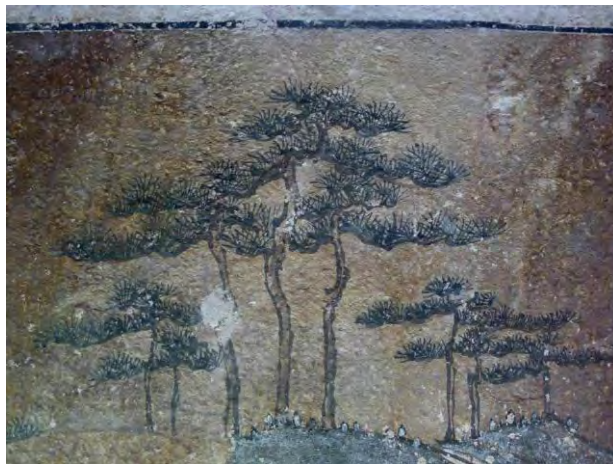
Fig. 282

Sanguo dong, upper edge, northern part: Pine trees in front of the 'honey-coloured' sky, landscape with green dots.

The sky is lighter than the landscape. No blue hues are visible today (fig. 282), but they may be concealed by the brown isolation layer. The skies on both paintings are yellowish brown ('honey-coloured'), appearing light brown under UV light.

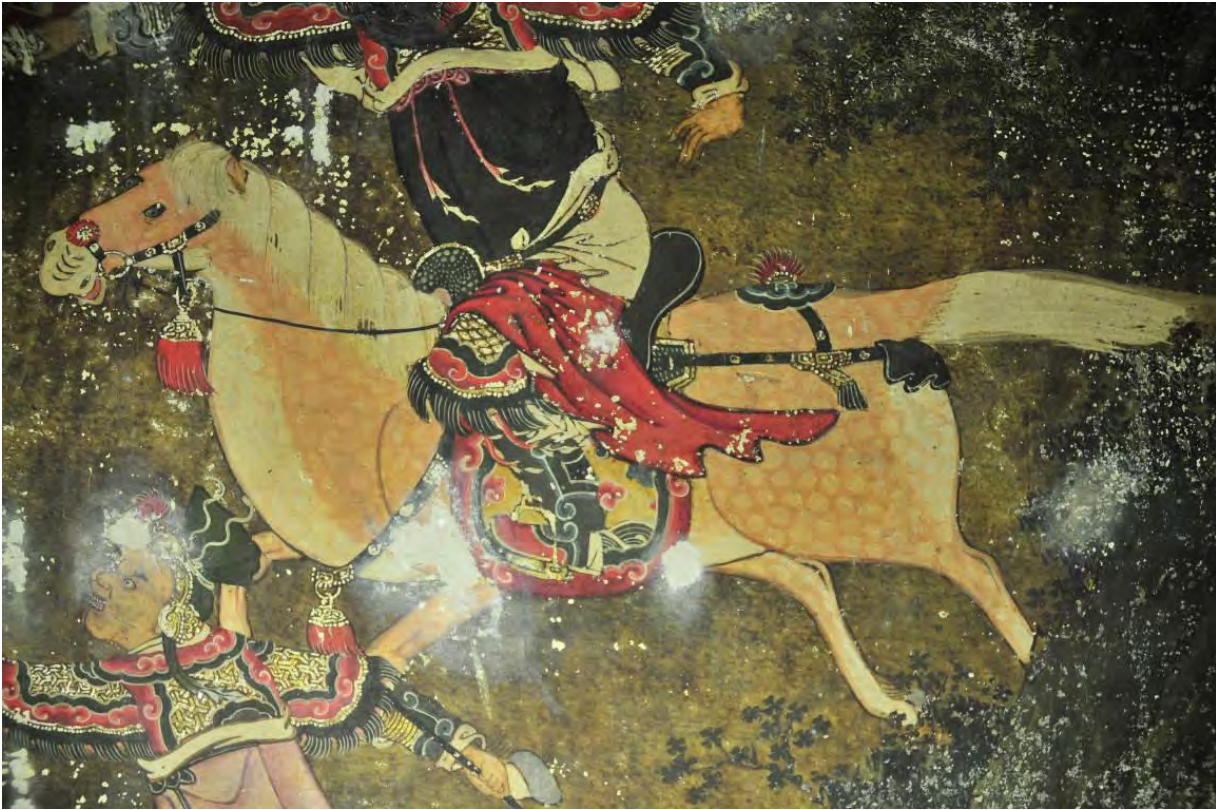
Fig. 283

Sanguo xi, lower right edge, horse of figure no. 31: horse coat painted in white (lead white) and an orange pink (cinnabar, red lead and yellow iron oxide); pattern of circlets as structure of the horse coat

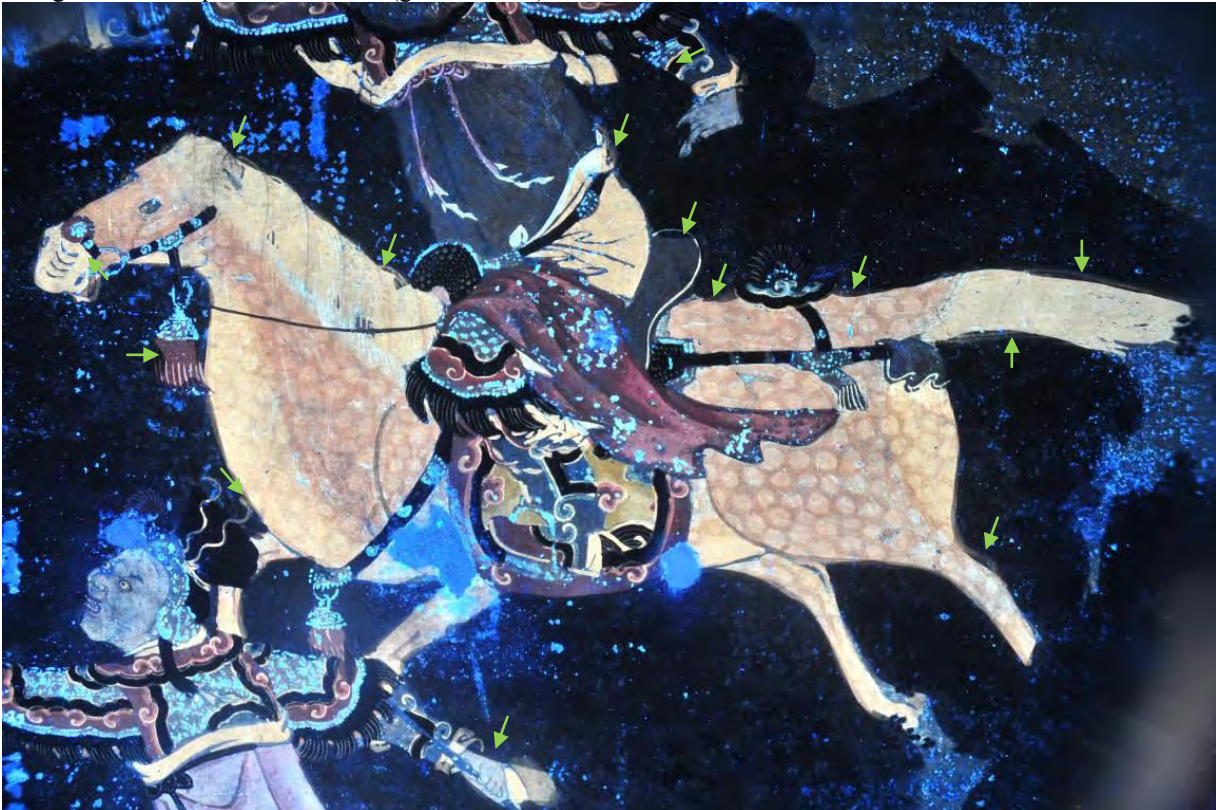
Fig. 284

Sanguo xi, like fig. 283, UV: The circlets in the horse coat stand out more clearly. The olive green glaze in the background overlaps onto the horse (green arrows).

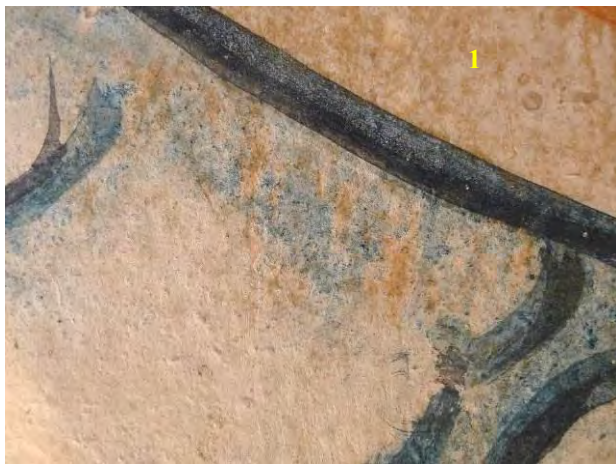
Fig. 286

Yunqi xi, outer contour of pearl and clouds: blue shading of clouds containing blue and black particles; black contours on top of blue contours of cloud

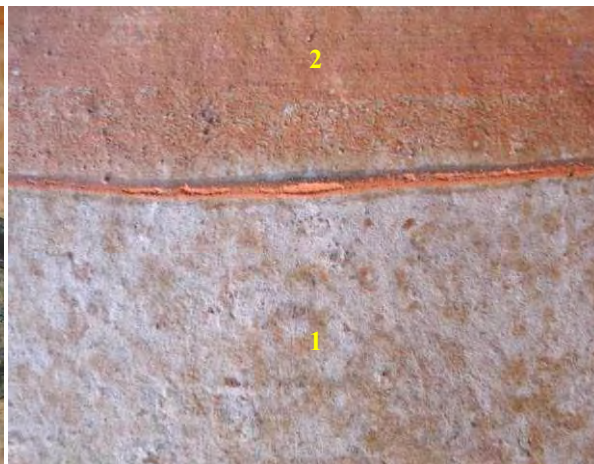
Fig. 287

Yunqi xi, ring 1 to ring 2: bulge of low viscose paint accumulated at the outer edge of ring 2

Ring 2 is light orange. The paint, consisting of diluted red lead, was applied twice, but is still slightly transparent (fig. 288 and 289). At the lower edge, it partly formed a thick ridge showing that it had a low viscosity (fig. 287). The slight pinkish appearance is caused by the transparency, but may also indicate a slight alteration (blackening) of the red lead.

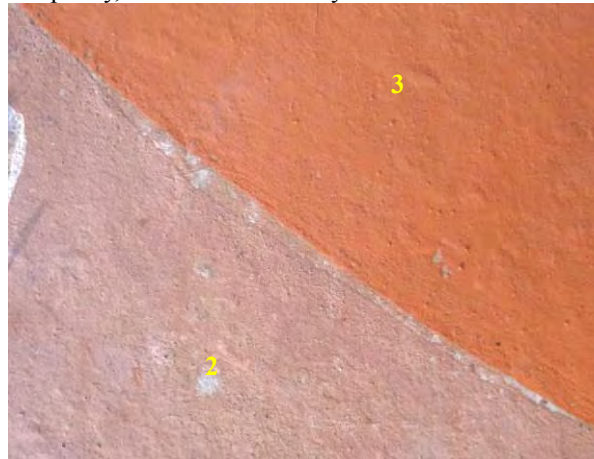
Fig. 289

Yunqi xi, ring 2 to ring 3: The difference in colour between ring 2 (here appearing pink) and 3 is a result of opacity, as both contain only red lead.

Ring 3 is darker orange. The red lead was applied as a thicker opaque layer (fig 289).

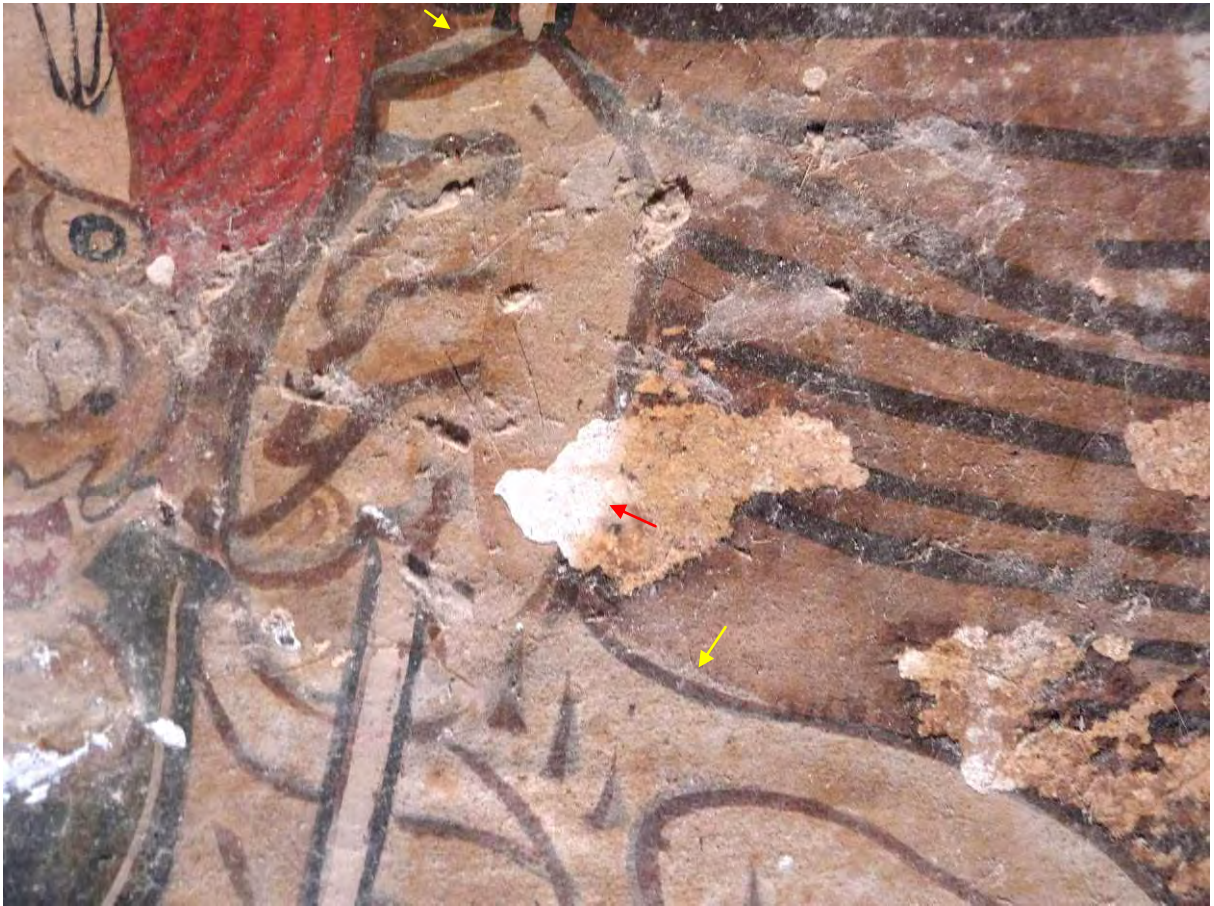
Fig. 277

Tianguan cifu, hand of demon: The delineation is still visible, repeated in dark brown at the hand; the brown glaze omitted the hand (yellow arrows) and stained the ground layer brown (red arrows).

- (5) “Brown glaze”: A wash or glaze was applied to the landscape and clouds, omitting the figures. It penetrated into the pictorial layer and stained the ground layer (fig. 277). It is not clear if it originally was colourless or tinted, but it can be assumed that it was not dark brown, because otherwise it would have concealed the vivid colours of the washes. The fact that it appears like a shade behind the “demon with mask” may indicate that it was slightly coloured, whereas the imprecise overlapping of the layer on smaller elements like the staff or cloud tips (fig. 281) implies that the material was only faintly visible (if at all). The binding medium of the brown layer may be water-sensitive as water-marks have formed which seem to have dissolved the layer. Under UV-light the layer appears brown, in a lighter to darker tone of brown depending on the thickness of the application.

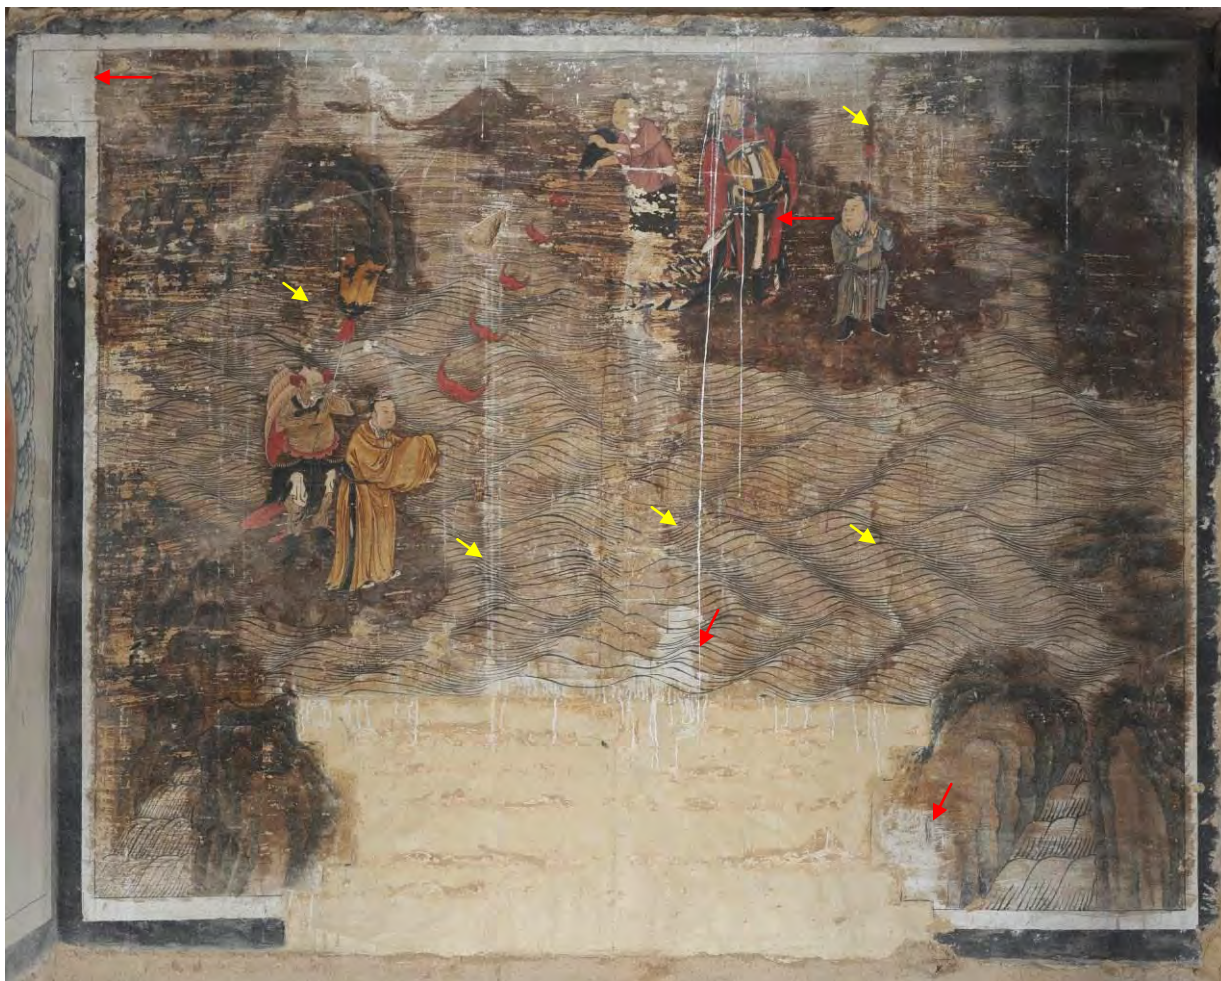
Fig. 279

Tianguan cifu, landscape covered with brown appearing glaze or coating: coating applied in horizontal brush strokes in five columns slightly overlapping each other (yellow arrows), omitting the upper left corner and small parts next to the pedestal (red arrows) [Shaanxi Institute for Conservation]

- (8) “Brown coating”: A binding medium layer was applied to the whole painting. The work was carried out with broad horizontal brush strokes from top to bottom in five adjacent “columns” which overlap slightly (fig. 279, yellow arrows). There are some splashes and runs where the material dripped or ran down the wall. Few areas were omitted during the application: the ledge of the upper left edge, a part next to the centre above the lost pedestal and another area at the right side of the pedestal (fig. 279, red arrows; fig. 283). This implies that the omitted areas were not easily accessible at the time of the application of the material, probably because the wooden construction of the niche and maybe a figure on the pedestal obstructed the space. This may mean that the application of the brown coating was a later intervention or at least carried out after the niche had been furnished. It can be assumed that the material was less brown in the beginning. Losses occurred where the brown coating was applied to the ground layer (i.e. depiction of water) or the landscape (countryside and cloud), following horizontal brush marks. These brush marks seem stem from the ground layer, not from the brown coating, though both are often overlapping. Under UV light the brown coating is brown, the brightness depending on the thickness of the application. Brown glaze and brown coating seem to have the same UV fluorescence (or both no fluorescence).

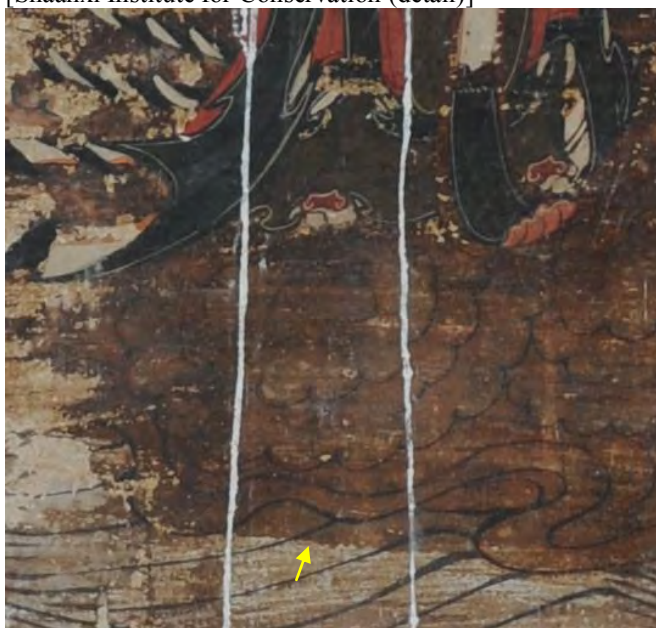
Fig. 281

Tianguan cifu: “brown glaze” imprecisely applied to staff, *ruyi* and cloud (yellow arrows)

- (2) The black delineation of the background was repeated with darker and thicker lines.
- (3) Landscape, clouds and at least parts of the figures were coloured with transparent to semi-translucent washes or glazes. The cloud on which the heavenly official is standing was painted reddish pink with shades in darker colour. The headdresses of the figures, the ornament on the staff of the boy and the *ruyi* were coloured with ochre yellow (fig. 281).

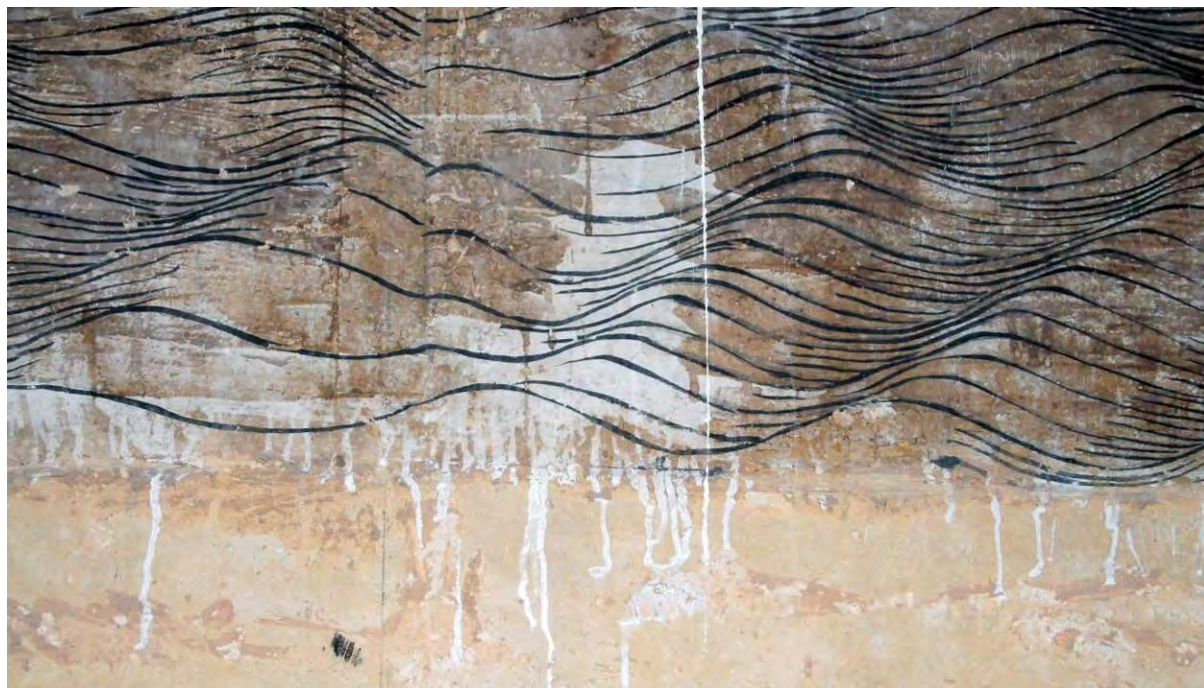
Fig. 283

Tianguan cifu: area above the pedestal omitted during the application of the brown coating (the centre of the pedestal is recognisable by the black chalk line)

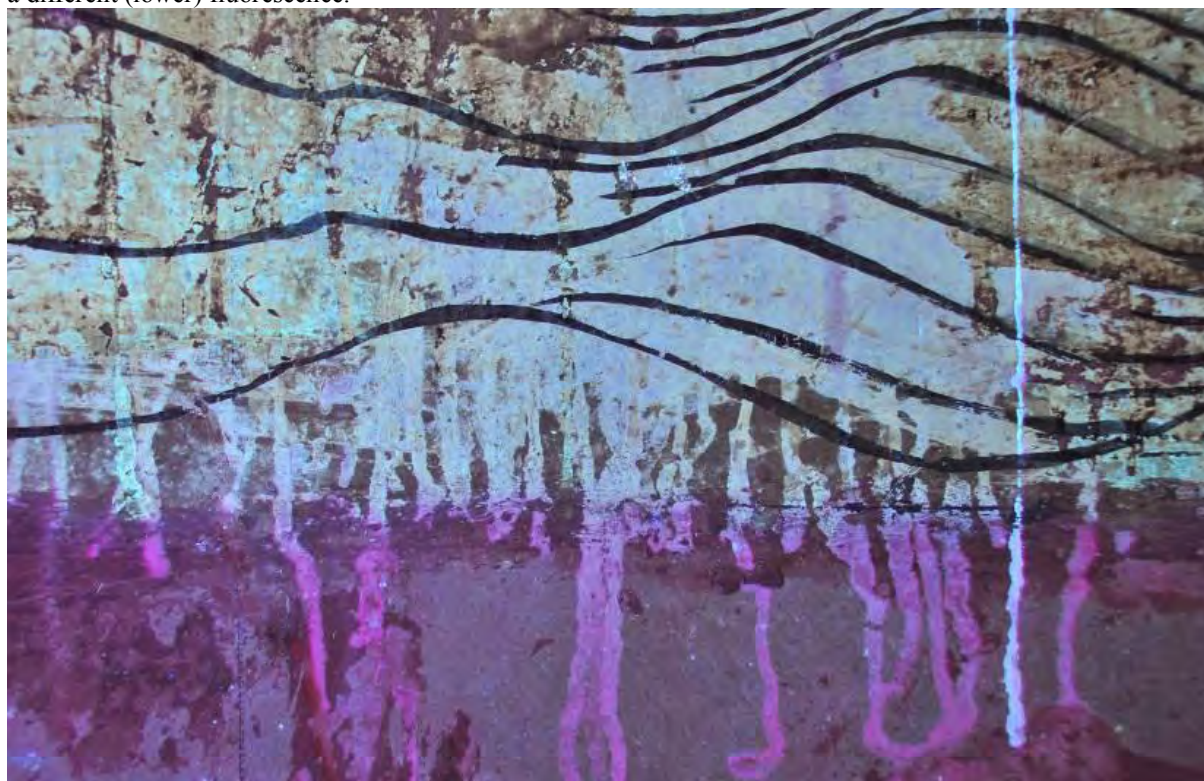
Fig. 284

Tianguan cifu, detail of the segment shown in fig. 283, UV light (without filter): The brown coating appears brown, the brightness depending on the thickness of the application. The part covered over by the pedestal shows a different (lower) fluorescence.

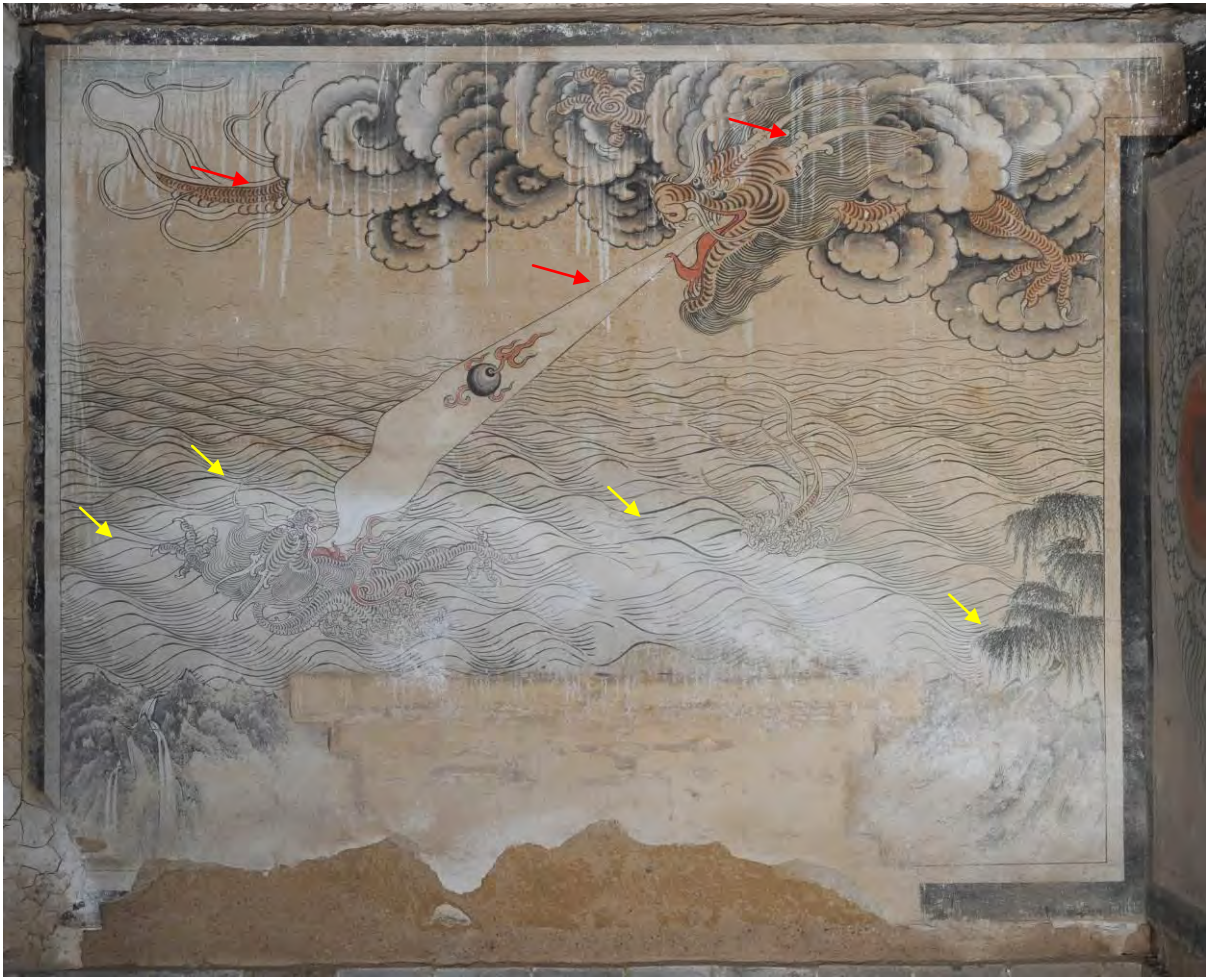
Fig. 285

Long-painting: The sizing and/or protective coating are affected by water, as well as the clouds; the large dragon's breath, horns and tail are unaffected (red arrows). The lower part is damaged by water and salts (yellow arrows indicate border) in a height corresponding to a former coal heap outside the building.

The lower part of the painting shows damages caused by water and/or salts (the contours of the damage correspond to the traces of a coal heap on the outside of the building, fig. 285: yellow arrows). The paint layer appears lighter and damaged. Under UV light, the ground layer is slightly yellowish in the upper, undamaged part, but bluish in the lower damaged area (fig. 287).

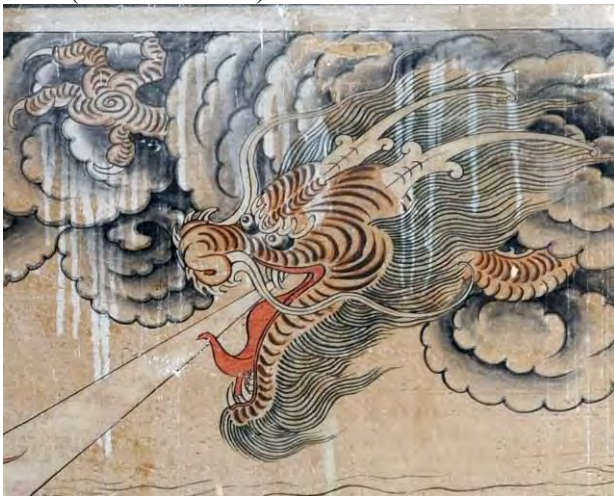
Fig. 286

Long-painting: Detail of the head of the large dragon. The water did not affect the parts painted with opaque white (breath and horns).

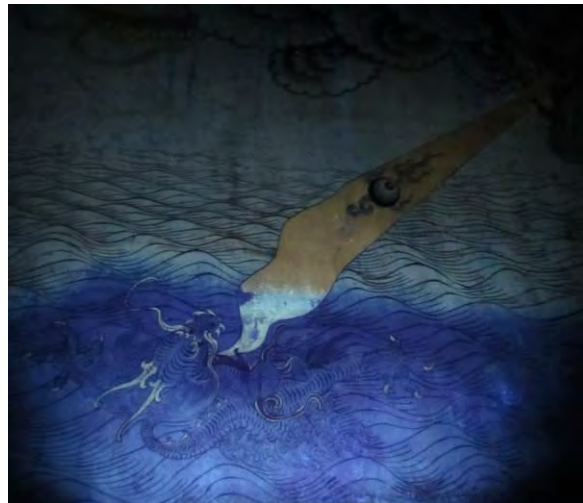
Fig. 287

Long-painting under UV light (without filter): In the damaged part the binding medium is leached out and the fluorescence reduced.

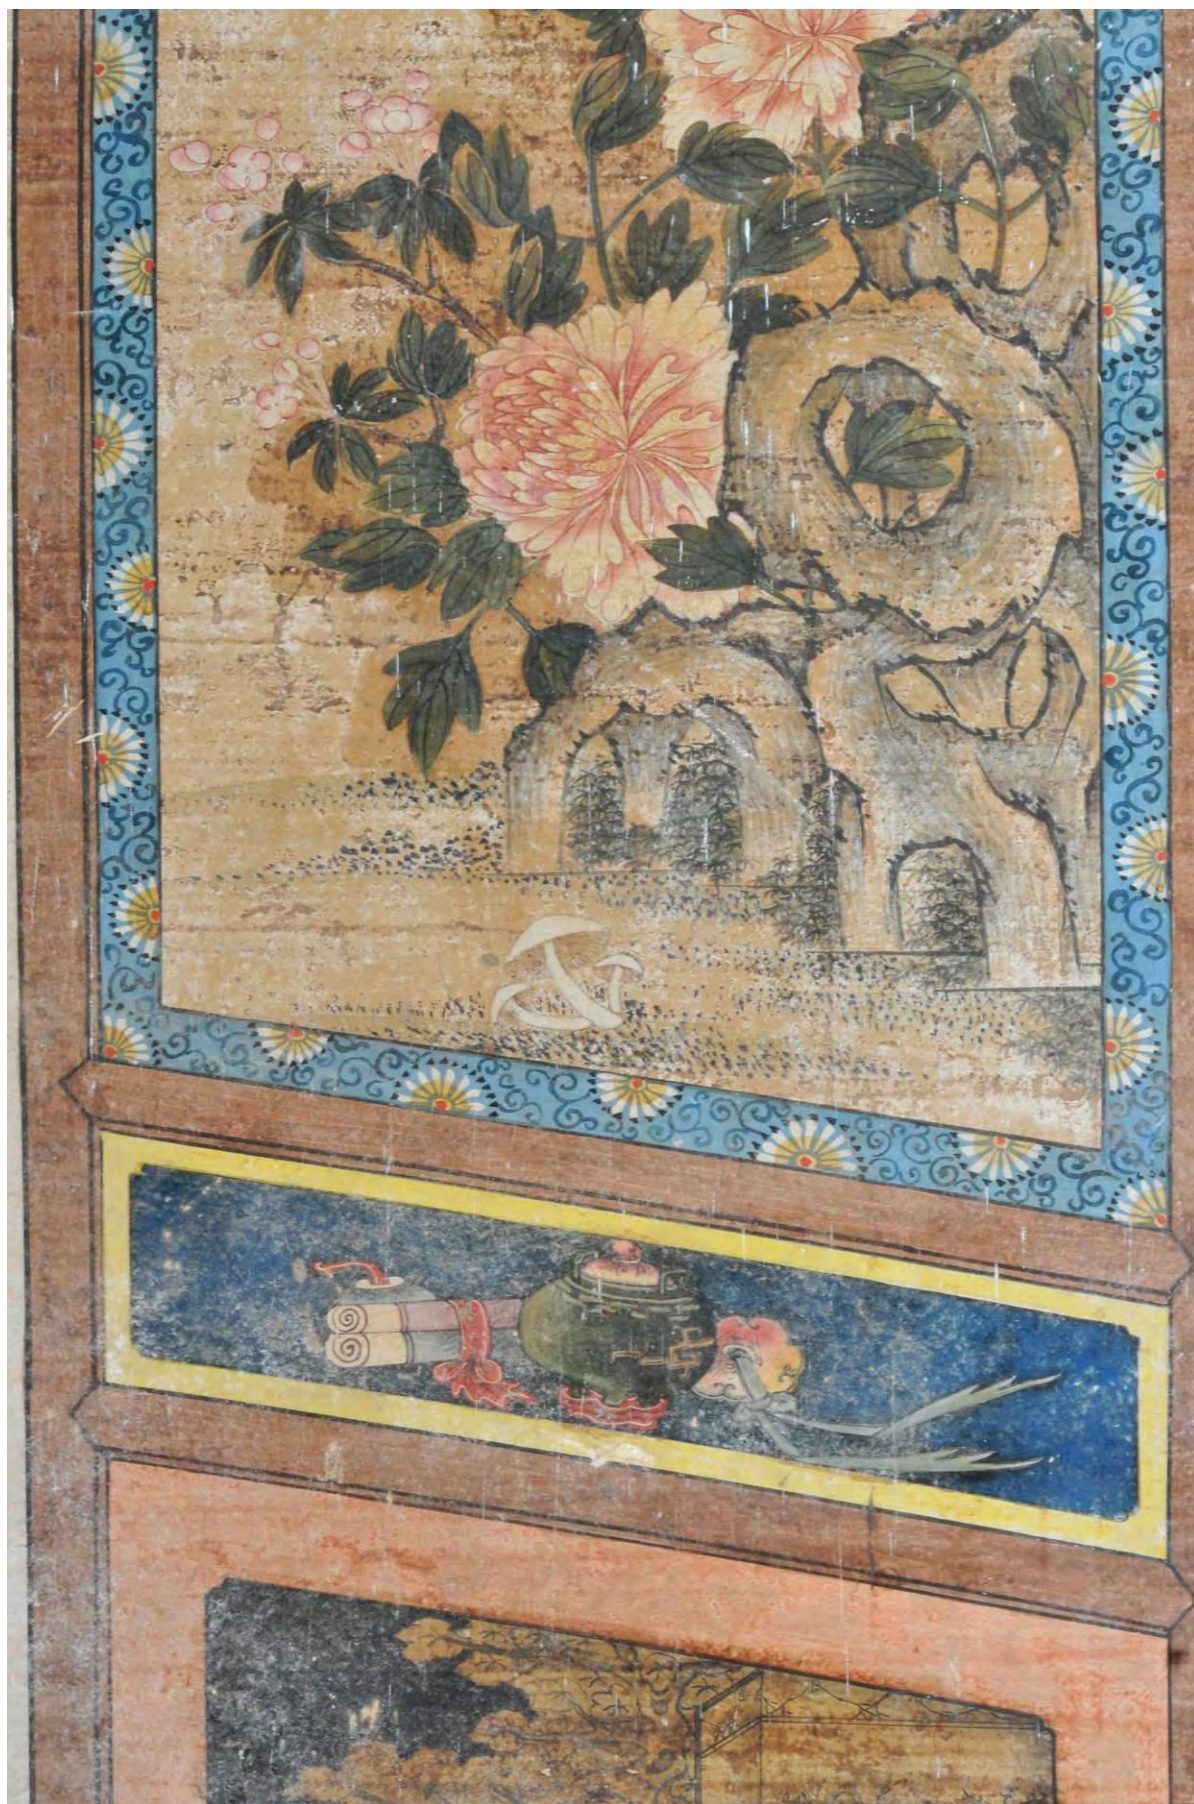
Fig. 289

Pingfeng bei, frame 1: Horizontal structures from application of ground layer visible wherever the paint layers are thin; brownish wash around the peonies in panel 1 *b*.

The *b*-panels show an ornamental pattern (fig. 289, border). The opaque medium blue ground contains a mixture of Prussian blue and lead white.⁹² Blossoms are painted with lead white.⁹³ Black dots were applied to the end of the white petals, and a red dot as centre of the blossom. A yellow glaze covering the blossom is partly brownish today due to discoloration, and often the glazed area is lost, indicating a problem of the painting technique (too high amount of binding medium?). Twines between the blossoms were painted with dark blue.

- (3) The black delineation was repeated in a dark black colour. A binding medium layer was applied as isolation layer, covering also the figures (visible for example in the bare right leg of the old man in panel 2 *b* that was not painted with opaque colours: fig. 291). In the panels 1 *b* and 6 *b*, a layer appearing brownish today was applied around the flowers, giving the impression of a shadow (fig. 289). It is not clear if it contains colourants and if it was applied before or after the isolation layer.

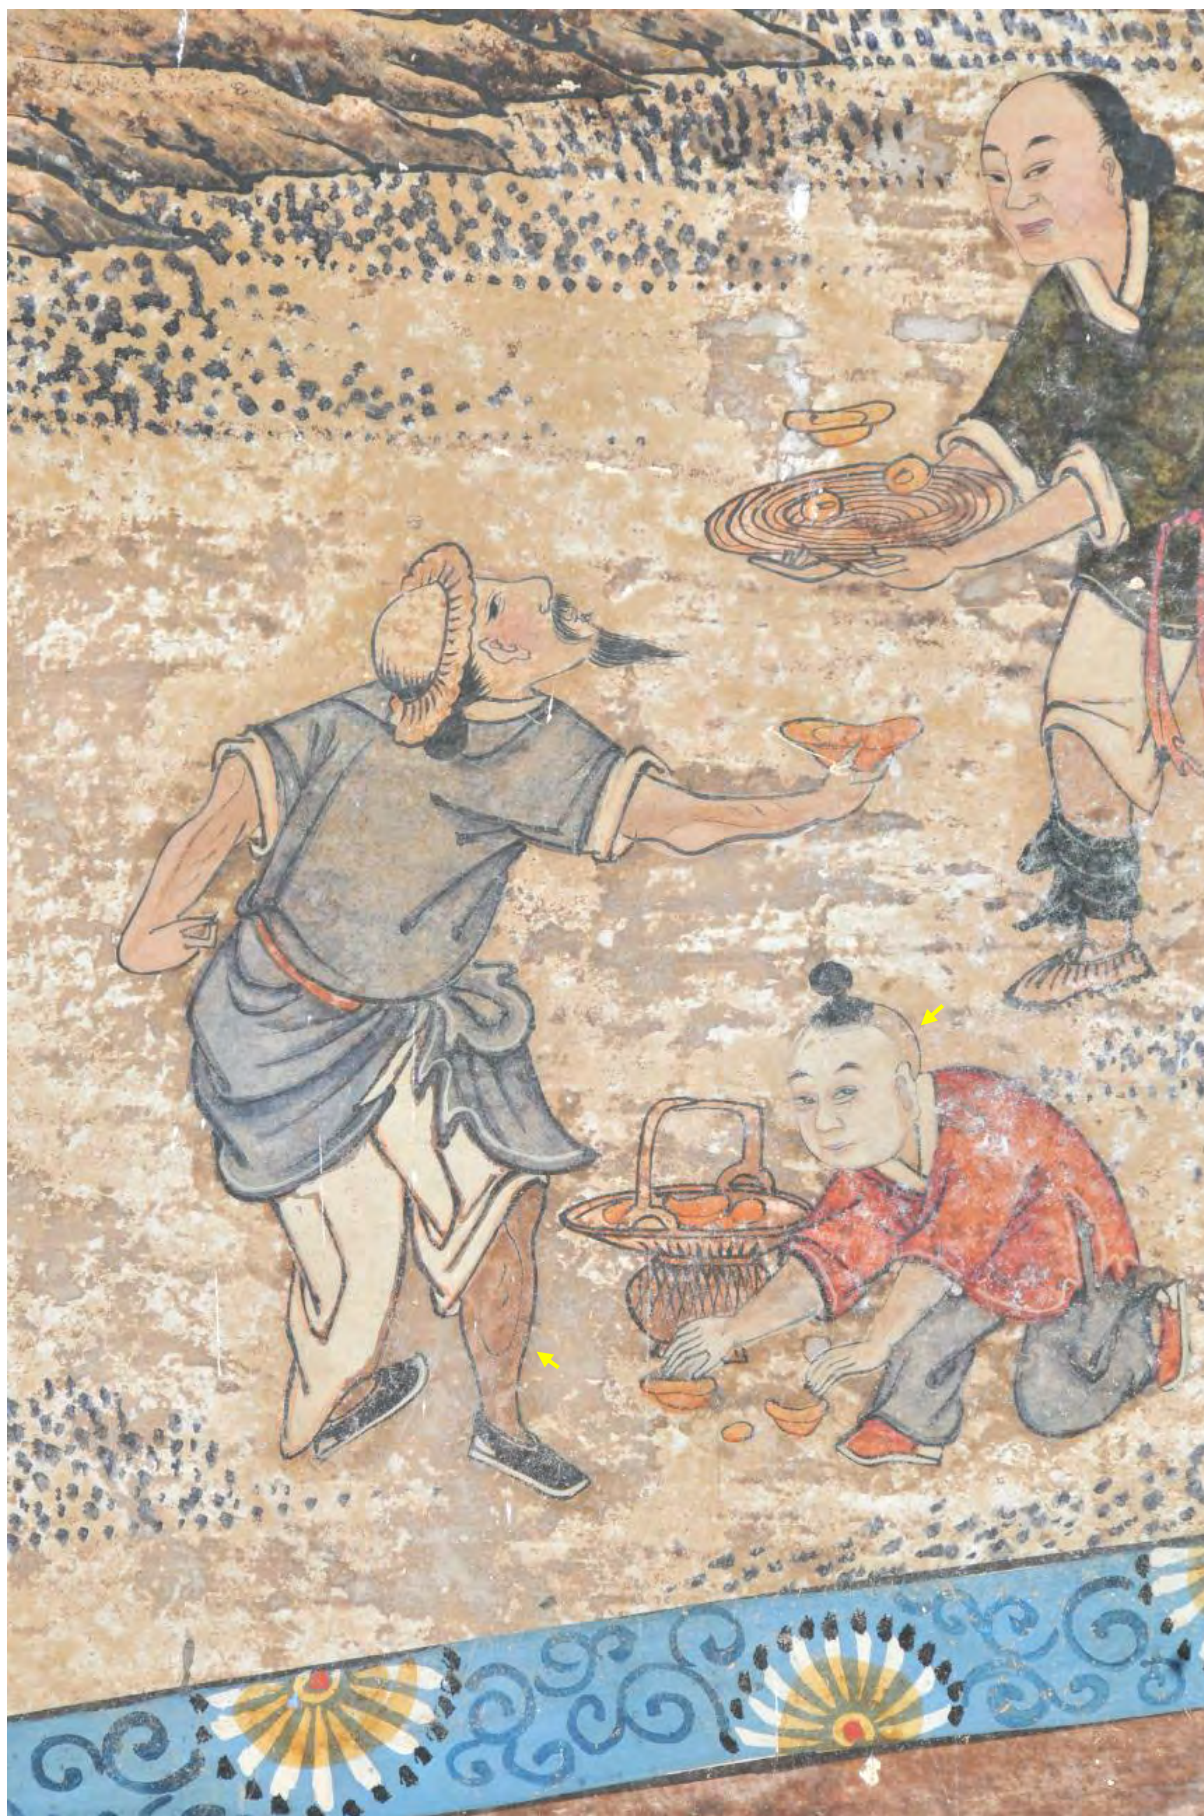
Fig. 291

Pingfeng bei, detail from panel 5 b: In the right leg of the old man and the back of the head of the boy, no opaque paint was applied (yellow arrow).

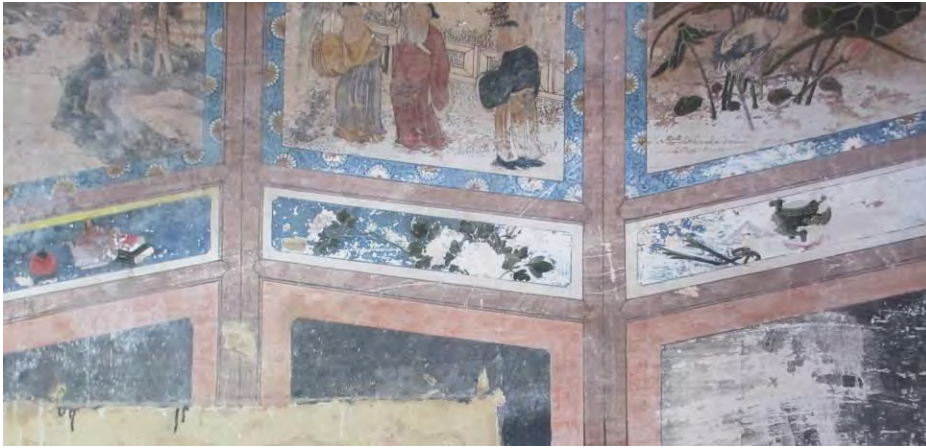
Fig. 292
Pingfeng bei: losses of blue background in the panels 5 and 6 c.

- (4) The background was painted in bright dark blue, containing Prussian blue.⁹⁴ Extensive losses of the blue background in panel 5 *c* and 6 *c* (fig. 292) may be connected to the painting technique or to the presence of salts (see white accumulations visible in fig. 293).

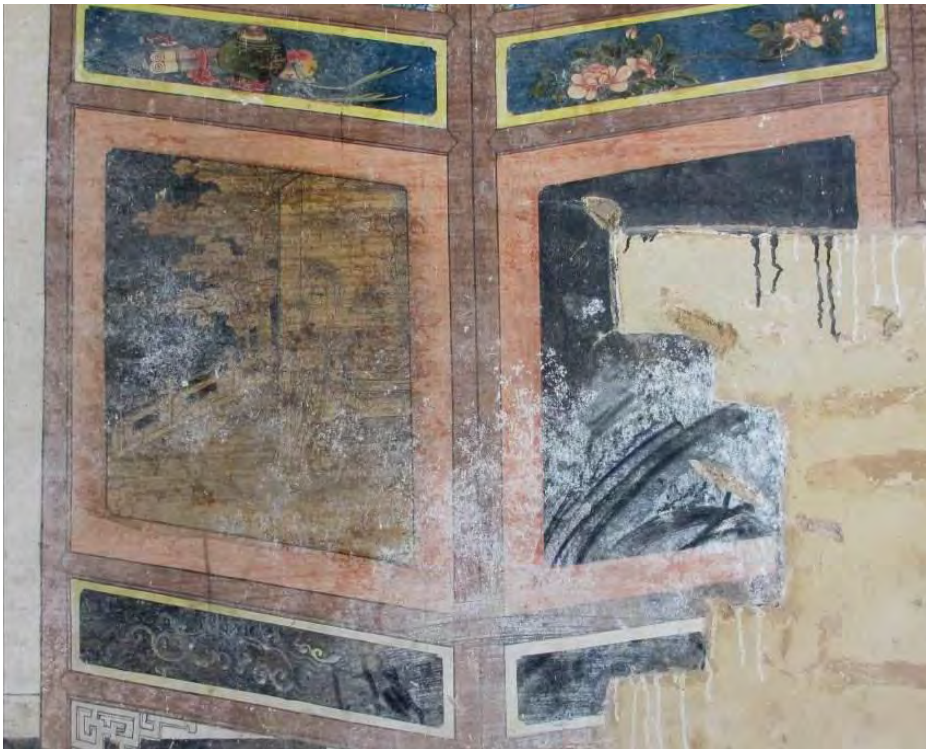
Fig. 293
Pingfeng bei, panels 1 and 2, c to e: The *d*- and the *e*-panels only show a depiction in frames 1 and 6, while frames 2 to 5 are painted black. Panel 1 *d* is covered with a brownish (discoloured) coating. White material on the surface may be salt (contains calcium sulphate).

The *d*-panels differ from other paintings due to a kind of grisaille style against a black background. Only the panels 1 *d* and 6 *d* show depictions because they were fully visible, whereas the *d*-panels of the frames 2 to 5 were mainly positioned behind the lost pedestal and coloured black without any depiction (fig. 293).

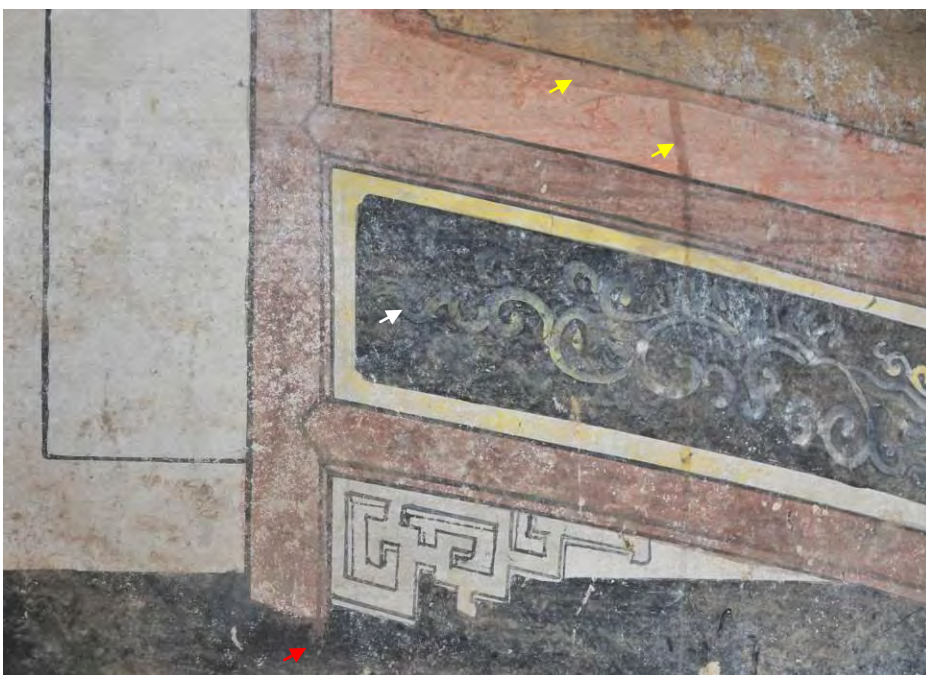
Fig. 294
Pingfeng bei, e-panel and leg of frame 1: The brownish coating from the *d*-panel overlapped the panel frame and ran down (yellow arrow). Partly faded or abraded yellow ornament on *e*-panel (green arrow). The reddish brown of the framework overlaps onto the black framing (red arrow). *Yunleiwen*-ornament next to leg without colouration.

In the panels 1 *d* and 6 *d* only one application of black lines is visible. Smaller areas were coloured with washes that appear grey. The paintings are covered with a brownish coating overlapping onto the red panel frames. Partly it ran or dripped down (fig. 294). Today the coating is so dark and blotchy that the legibility of the scenes is reduced. The layer does not contain pigments.⁹⁸

The *e*-panels were filled in black. A floral ornament was applied with yellow lines. The yellow paint seems to have faded or flaked off in parts where it had been applied thinner (fig. 294).

Next to the legs a *yunleiwen*-ornament is inserted (fig. 294), characterised as open-work by a perspective depiction of the strips. The pattern is similar to the one in the *a*-panels, but at least today the ornament has no colouration.
