Ziyang *Beiwusheng huiguan*

Final report

Part 1: Technique and materials

Research Project 01UG1001
„German-Chinese co-operation in the preservation of Cultural Heritage: Researches for the
conservation of selected monuments in the PR China”

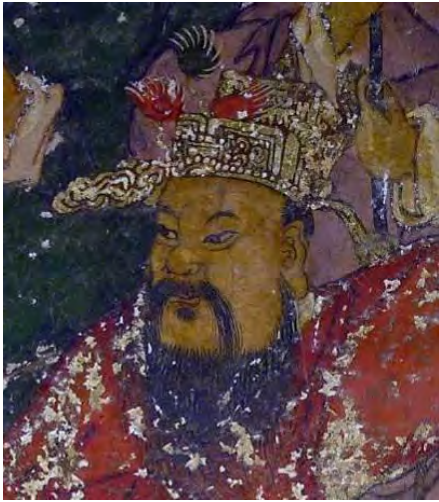
Fig. 303
Sanguo xi, Cao Cao (figure no. 35): caps with leaf gilding

- The use of gold may have been restricted to the most important paintings because of the costs for the material and the application. At the *pinfeng xi*-painting, gilded objects were coloured pink⁹⁹, as the comparison of two caps from the *sanguo xi*-painting and the *pingfeng xi*-painting shows (figs. 303 and 305).

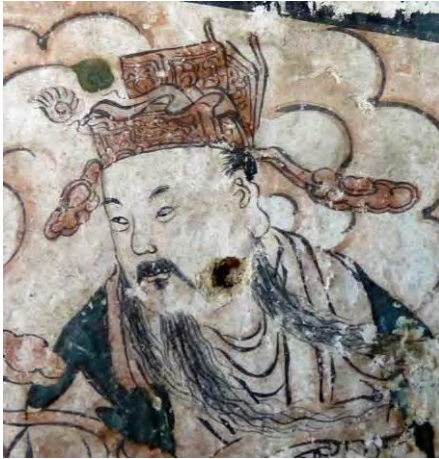
Fig. 305
Pingfeng xi, panel 3 *d*: heavenly official cap like Cao Cao, pink representing gold

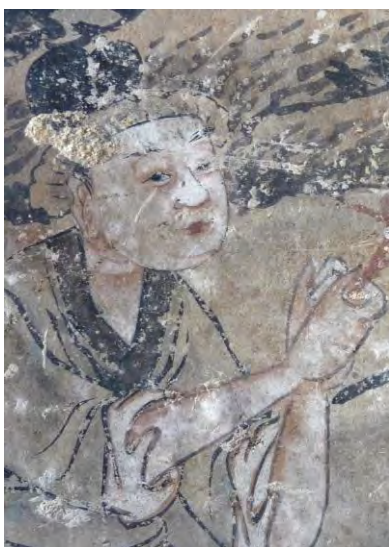
Fig. 320
Pingfeng dong, panel 1 d: young man

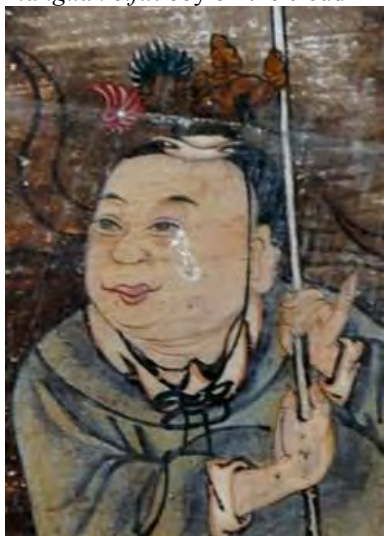
Fig. 323
Pingfeng dong, panel 5 d: man

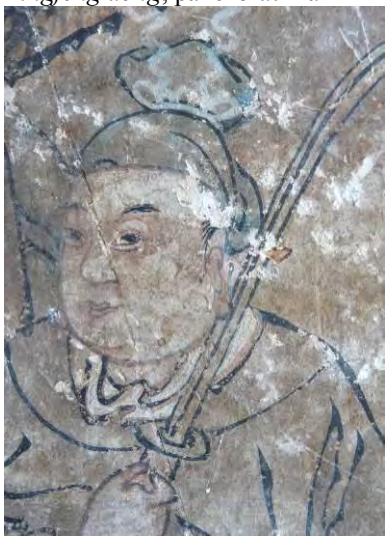
Fig. 324
Pingfeng bei, panel 2 b: boy

The figures in the *b*-panels show again other features with stiff, but more elegant hands and a different kind of facial features. The eyes are rather large; the iris is always set in one corner of the eye and half covered with the upper lid (fig. 324, 321 and 345). The style of the landscape and the flowers, too, is not similar to the other paintings.

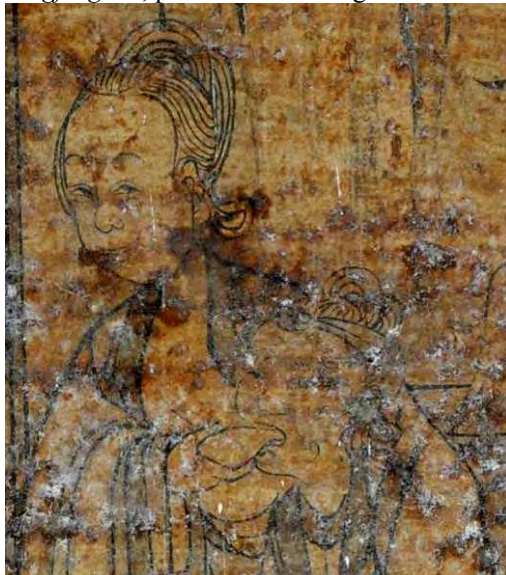
Fig. 333
Pingfeng bei, panel 1 d: 'suckling her mother-in-law'

The two grisaille paintings in the *d*-panels appear unskilled and crude in comparison to other paintings in the halls, but their eyes are depicted as in the figures of the *b*-panels. The difference between the *d*-panels of *pingfeng xi* and *pingfeng bei* can be seen in figures 332 and 333 showing the same scene ('she suckles her mother-in-law'). As the figures in the *d*-panel of *pingfeng bei* are bigger than those of the *pingfeng xi*-painting, they appear even more unelegant.

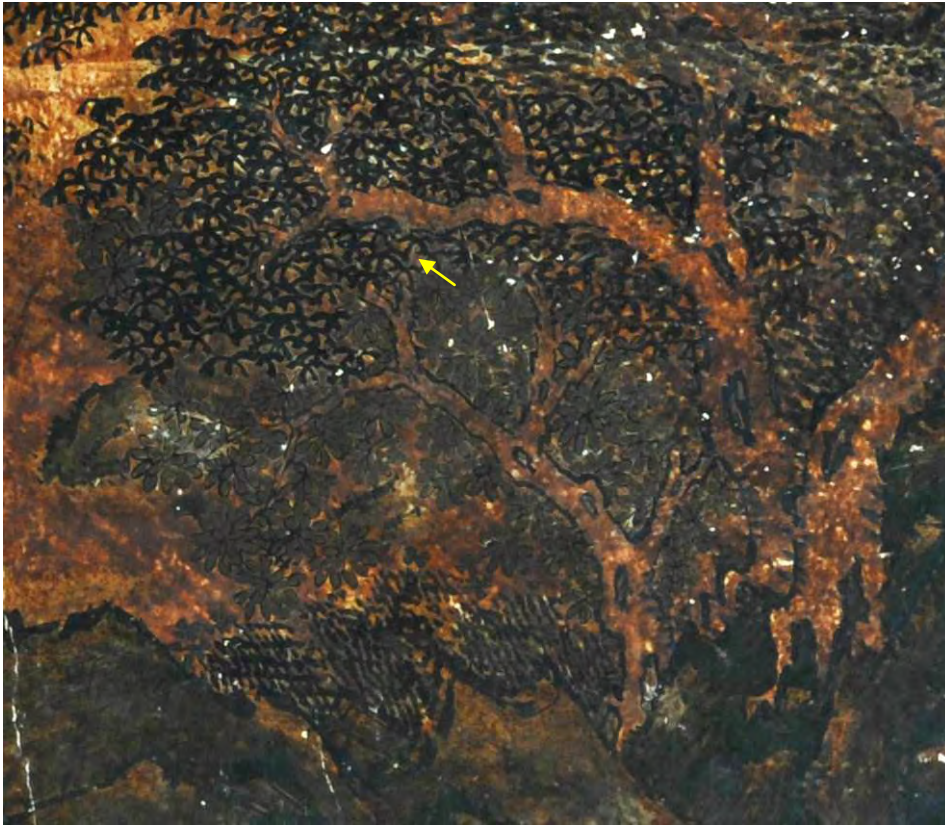
Fig. 334
Sanguo dong, hill
 behind the deer:
 trees with four-lobed
 leaves (arrow)
 appear frequently in
 in *sanguo*-paintings,
 but not in the
 paintings of the
guodian, while the
 other types of plants
 can be found in all
 four paintings

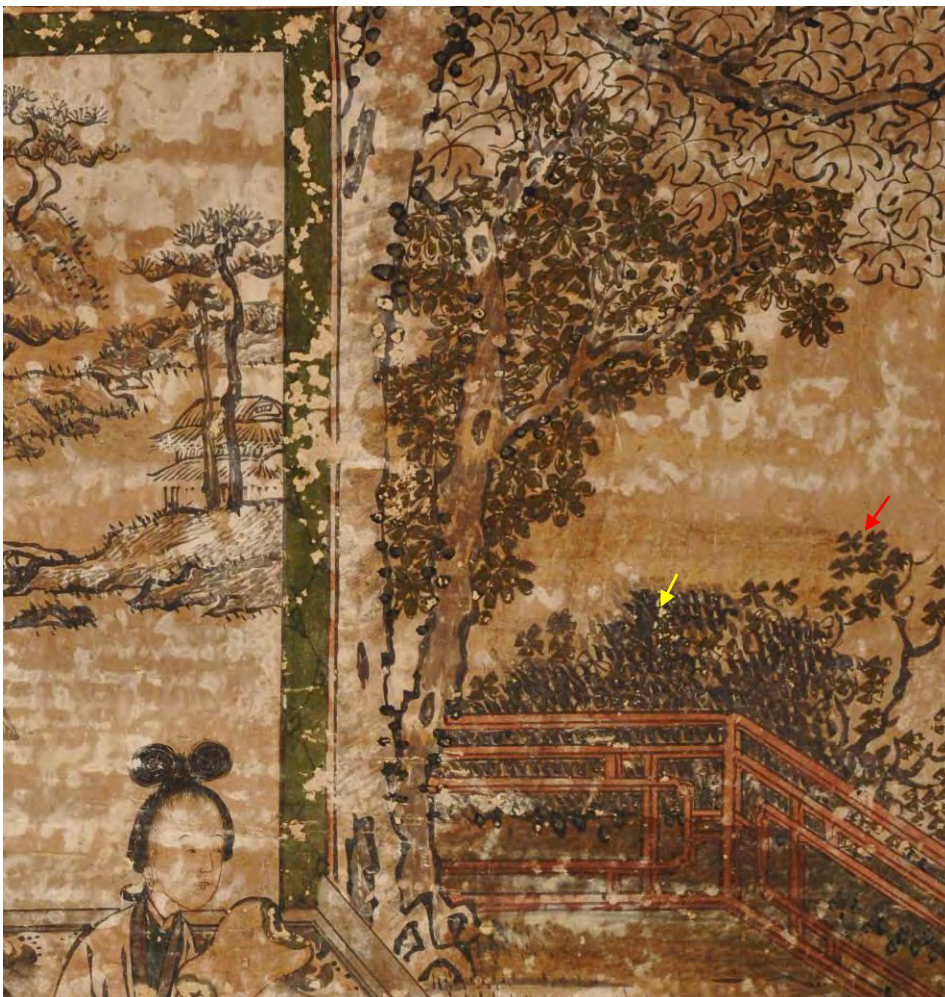
Fig. 335
Pingfeng xi, panel 2
b, trees and shrubs in
 the garden; hills with
 pine trees in the
 painting of the scroll:
 structure of black
 lines in shrubs and
 grass (yellow arrow)
 and plant with
 bushels of four
 leaves (red arrow)

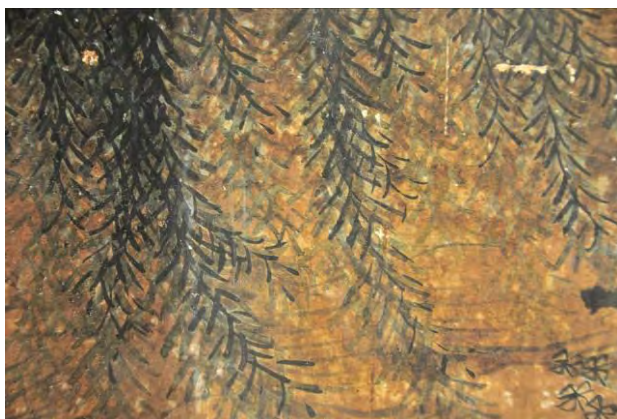
Fig. 336

Sanguo dong: willow twigs with two shades of grey and black, plant with bushel of four leaves or clover (right lower edge)

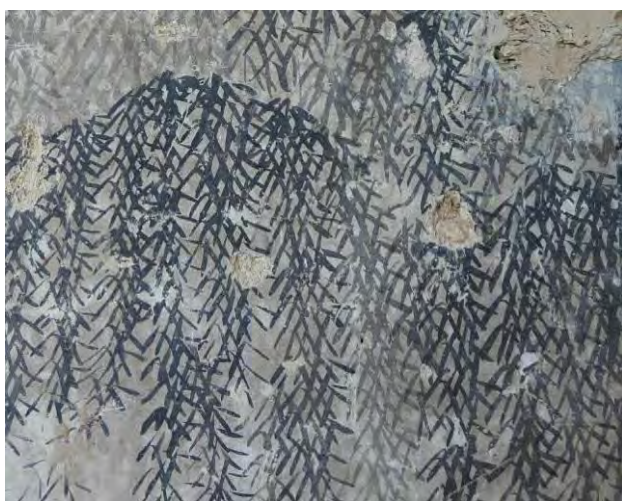
Fig. 338

Pingfeng xi, panel 2 d: willow leaves in four shades of grey

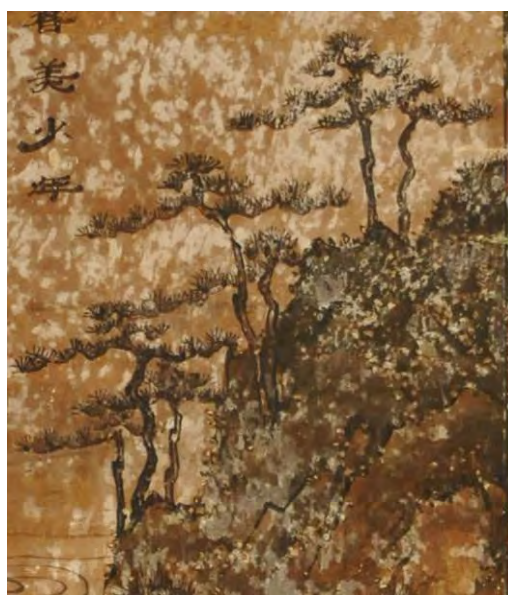
Fig. 337

Pingfeng dong, panel 2 b: pine trees

But there are also differences: The figures are not so slender, the faces fuller. The phalanges of the fingers are thicker and more emphasized. Often the upper eyelids curve downwards above the iris (fig. 296, 303, 311, 312 and 313), but there are also figures with almond-shaped eyes (figs. 316, 341 and 343). The eyeballs are shaded bluish grey towards the corners. In the landscape most of the trees have bushels of four leaves that cannot be found in the paintings of the *guodian* (fig. 334, yellow arrow). The pine trees at the upper edge of the *sanguo dong*-painting are straighter and more uniform than the ones painted in the *guodian* (figs. 337 and 339).

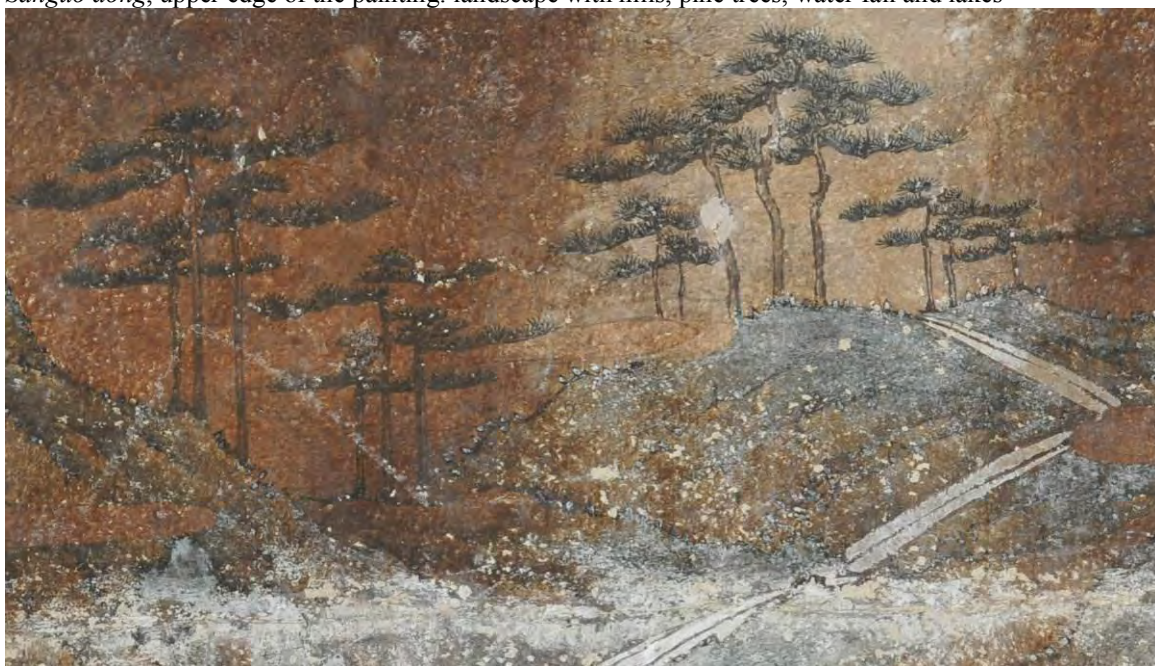
Fig. 339

Sanguo dong, upper edge of the painting: landscape with hills, pine trees, water fall and lakes

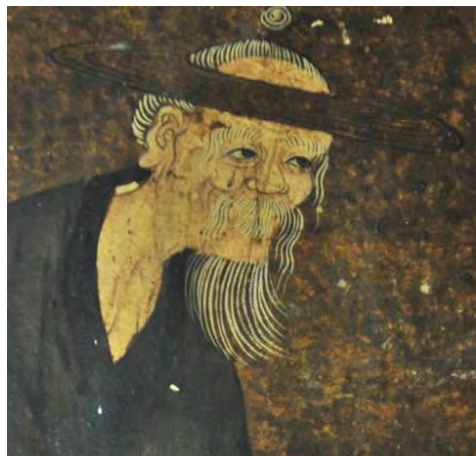
▶ Fig. 341
Sanguo dong, left
edge: boatman
(figure no. 25)

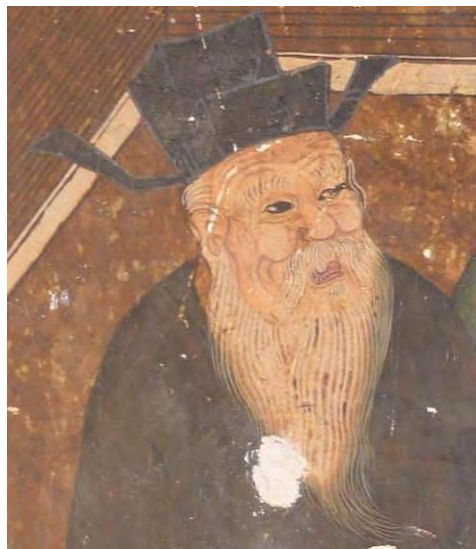
▶ Fig. 343
Sanguo dong: old
man with square
putuo cap (figure
no. 8)

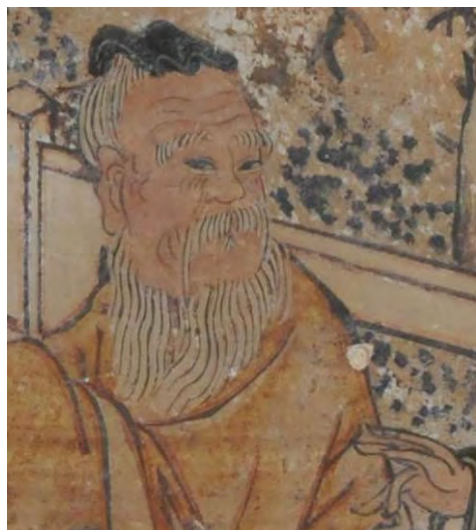
▶ Fig. 345
Pingfeng bei, panel
5 b: old man

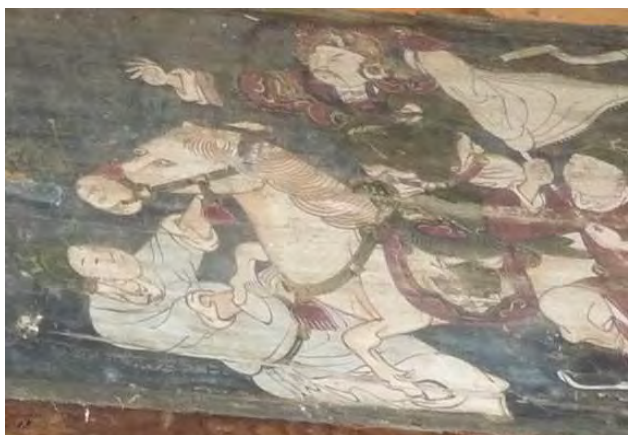
▲ Fig. 350
Guodian, south side, painting on panel: man falling under an advancing horse

A comparable correspondence can be found between the *sanguo*-paintings and the decorations of the lintel of the *guodian*: A man falling under a horse (fig. 350) has the same posture as the man falling under Zhao Yun's horse in the *sanguo xi*-painting (fig. 351), while the horseman resembles other horsemen in the *sanguo*-paintings, for example figure no. 31 (fig. 352). On the lintel, too, pink horses can be found and horses with circlets in their coat. The harnesses are identical as well as the saddles (including the pattern of golden dots at the breastplate of the saddle), the suits of armour, the tunic, the boots and the weapons (fig. 353).

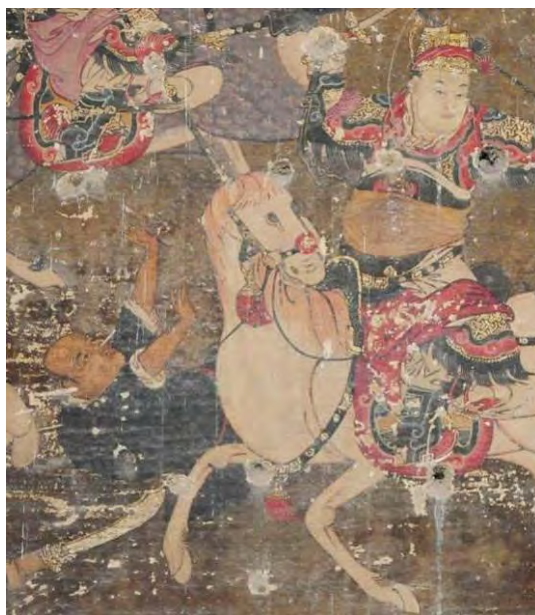
Fig. 351 ►

Sanguo xi: Zhao Yun (figure no. 27), and a man (figure no. 28) falling under his horse

In the lower right part (figures no. 22 to 33), a fierce battle is going on between seven horsemen and two men on foot, one of them (figure no. 28) falling down under the advancing horse of Zhao Yun (figure no. 27) with the infant Liu Shan tucked into his robe (the head of the child is damaged). The nowadays whitish flag-like object above his head (F4) represents the “red light” described in the novel after he had fallen into a pit.

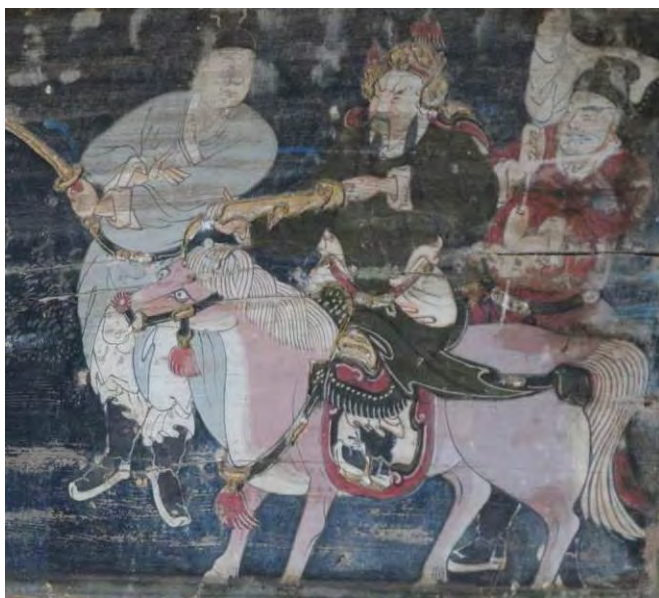
Fig. 353
Guodian, south side, painting on panel: horseman on pink horse with lance (mirror-inverted)

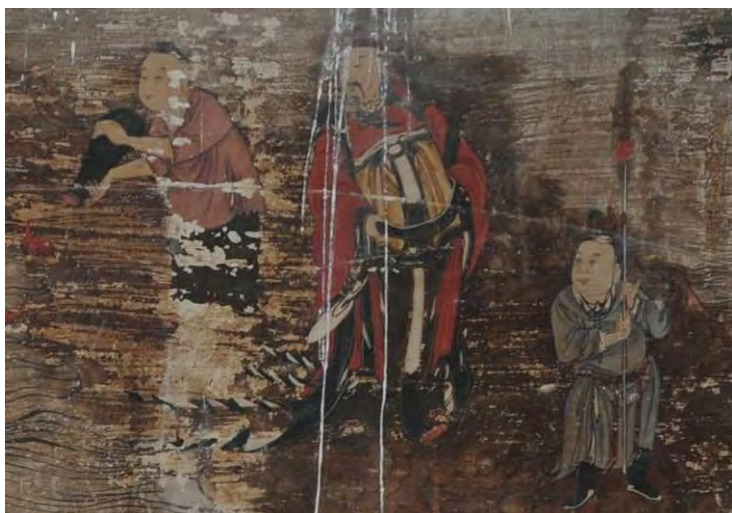
Fig. 354

Tianguan cifu: official and boys on a cloud

There are three paintings showing a heavenly official standing in the clouds, accompanied by one or two boys: the *tianguan cifu*-painting (fig. 354), panel 2 *b* of the *pingfeng bei* (fig. 356) and panel 3 *d* of the *pingfeng xi*-painting (fig. 355). The correspondence between the officials is striking, regardless of the different dimensions (at the *pingfeng xi*, the official is 14 cm high, at the *tianguan cifu* about 60 cm and at the *pingfeng bei* about 35 cm high): the posture of the body and the movement of the drapery are very similar. At the *pingfeng bei*- and the *tianguan cifu*-painting even the colours of the clothes are identical, and both officials carry the *ruyi* under the left arm, while in the *pingfeng xi*-painting the colours are different (and less rich), and the official is holding the *ruyi* with his right hand. Each of the officials is accompanied by a boy who pours bats (as symbols of luck) downwards to the earth. These boys, however, are not similar.

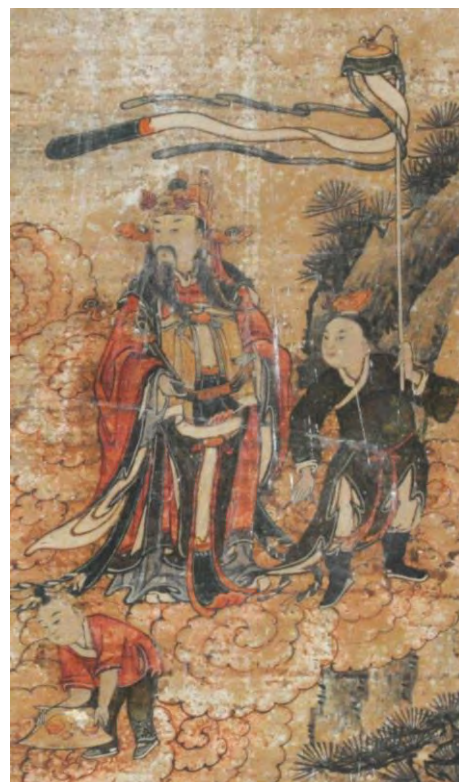
Fig. 356

Pingfeng bei, panel 2 *b*, official with two boys [Zhao Zhou 2012]

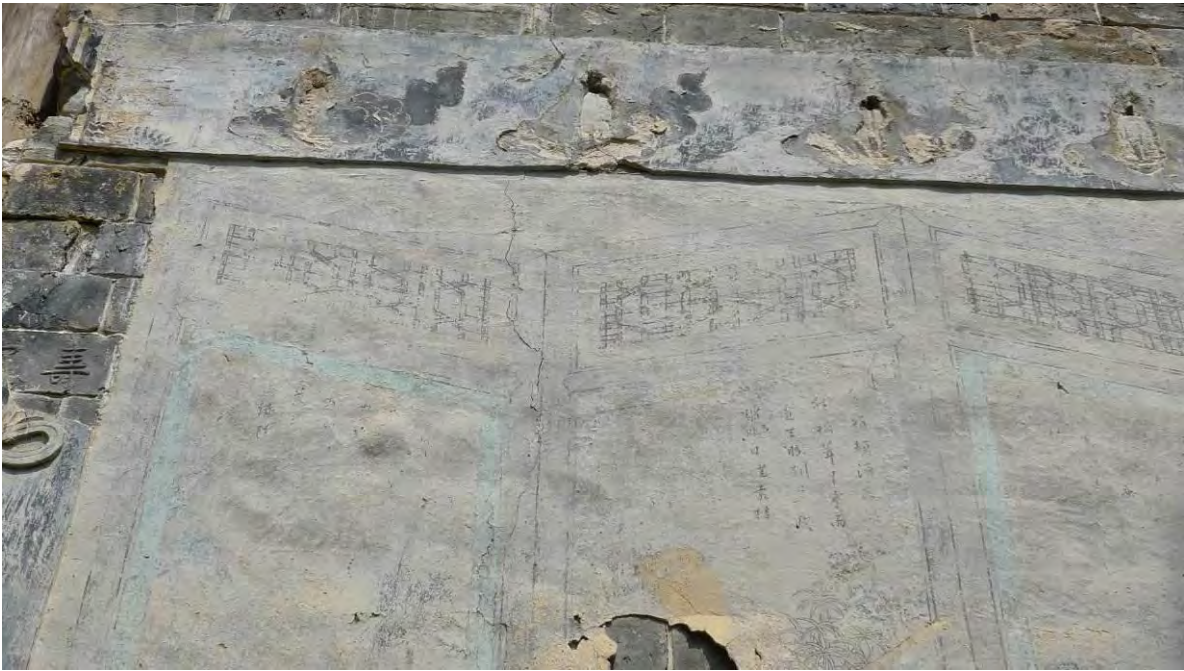
Fig. 357

Jiangxi *huiguan*, front room, east wall, upper part: stucco frame with traces of paintings (persons on clouds?) and stucco ornaments (left side); a-panels with three interlaced octagons; b-panels with star borders with green (and red) ground and figurative scenes

In the front and the rear rooms, decorations are only discernible at the gable walls (east and west walls). If the eaves' walls, too, had murals, they disappeared without trace. The murals on the gable wall are surrounded by a frame made of stucco, in the front room they are additionally decorated with masks and cloud scrolls formed out of the stucco at the upper corner (fig. 357). The stucco lintel above the paintings in the front room was also painted with figurative scenes (fig. 358). In the rear room the stucco frame is flat, undecorated and painted black.

The narrow *a*-panels show a lattice of interlaced octagons, with three octagons per panel at the east wall (fig. 357) and six octagons at the west wall (fig. 358). The *pingfeng xi*- and *pingfeng dong*-walls have four octagons (fig. 359). The large *b*-panels show figurative scenes set in landscapes and/or architecture. There are inscriptions with painted seals above the scenes like at the *pingfeng xi* and *pingfeng dong*-paintings. The narrow *c*-panels probably show small figures in landscapes (fig. 370). The *d*-panels contain smaller figurative scenes. In the *e*-panels still lifes are discernible, containing censers, chime stone pendants and other objects (fig. 364 and 365). The arrangements are thus comparable to the still lifes in the *c*-panels of the *pingfeng xi* and *pingfeng dong*-paintings.

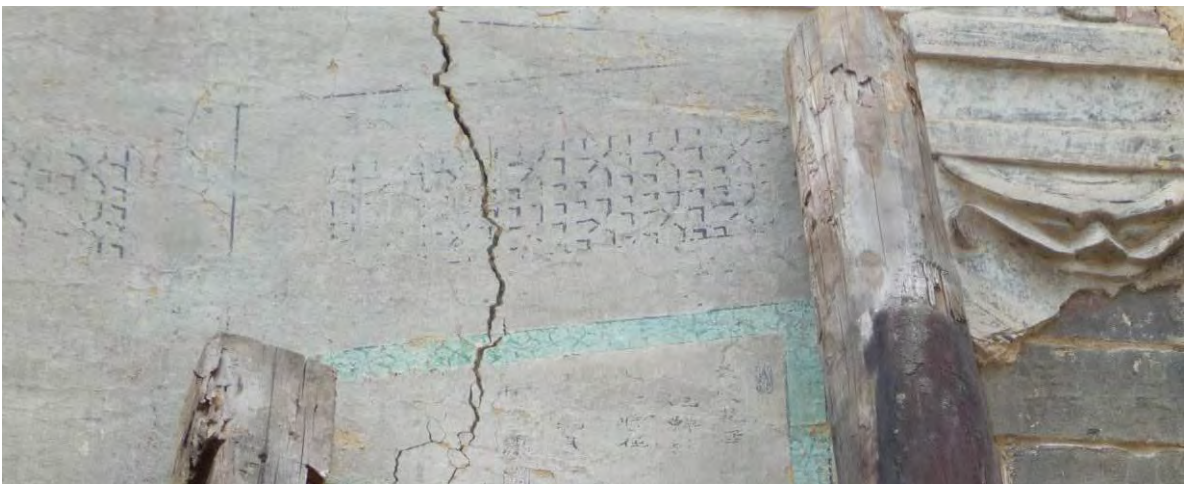
Fig. 358

Jiangxi *huiguan*, front room, west wall, upper part: stucco mask next to folding screen; lattice with six interlaced octagons in the a-panels; star pattern with green ground discernible at the panel frame of the b-panel

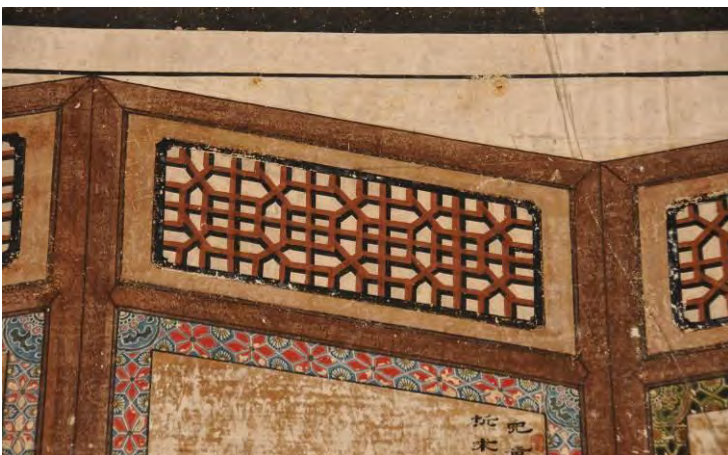
Fig. 359

Beiwusheng *huiguan*, *pingfeng xi*, panel 5 a: lattice with four interlaced octagons

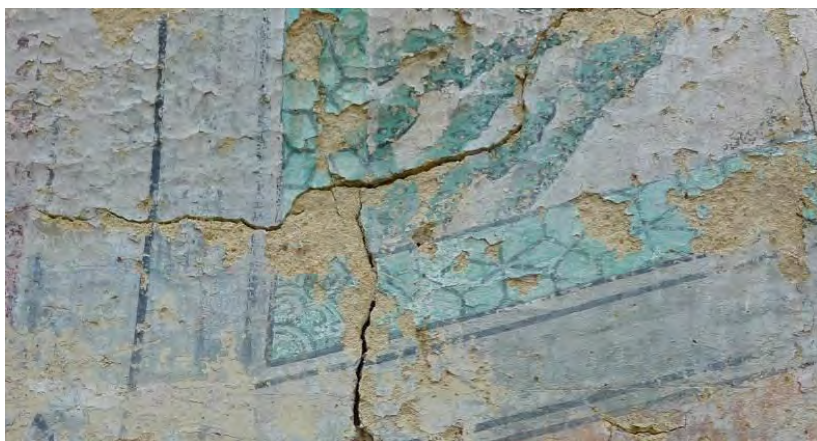
Fig. 360
Jiangxi *huiguan*, front room, west wall: star pattern on green ground. The filled-in paint layers of the star segments and the cloud scroll in the corner are faintly visible as well as traces of the blossoms between the stars.

The panel frames were coloured orange red. The *b*-panels had an ornamental decoration in two alternating colours: Against green and red grounds, the same star pattern was painted as at the *pingfeng xi*-painting. Against the green ground, the corner ornament shows a cloud whirl like the one at the *pingfeng xi*-painting (figs. 360 and 361), against the red ground the corner ornaments are blossoms like those at the *pingfeng dong*-painting (figs. 362 and 363).

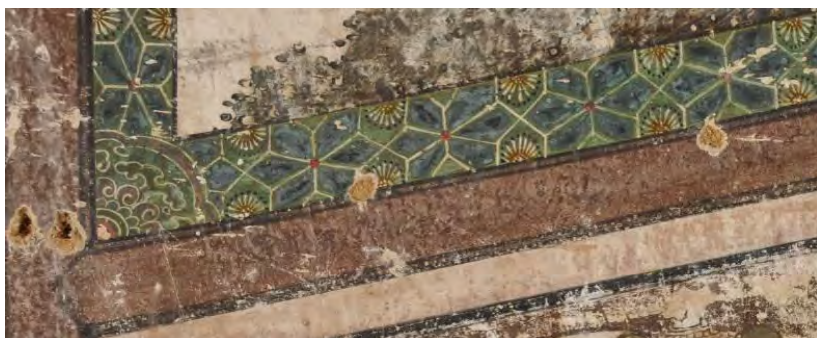
Fig. 361
Beiwusheng huiguan, *pingfeng xi*, panel 8 *b*: star pattern and cloud scrolls as corner ornament

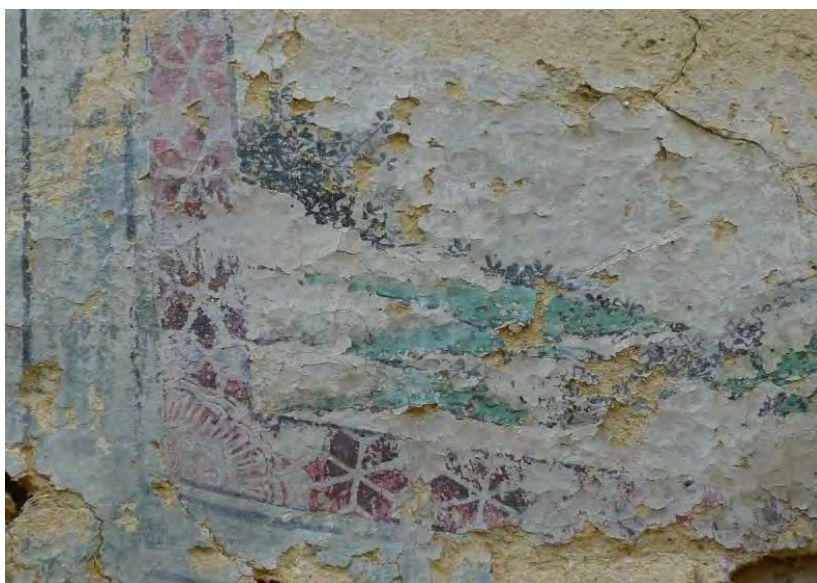
Fig. 362
Jiangxi *huiguan*, front room, west wall: Star border on red ground. The corner ornament is a larger quarter blossom.

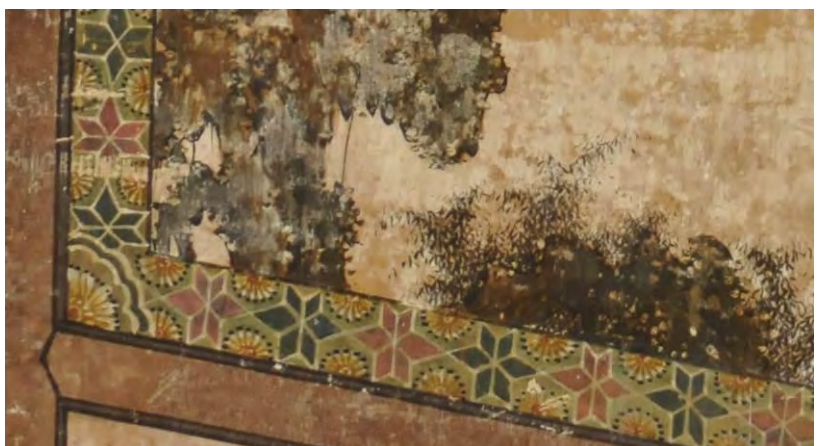
Fig. 363
Beiwusheng huiguan, *pingfeng dong*, panel 3 *b*: star pattern and quarter blossom as corner ornament

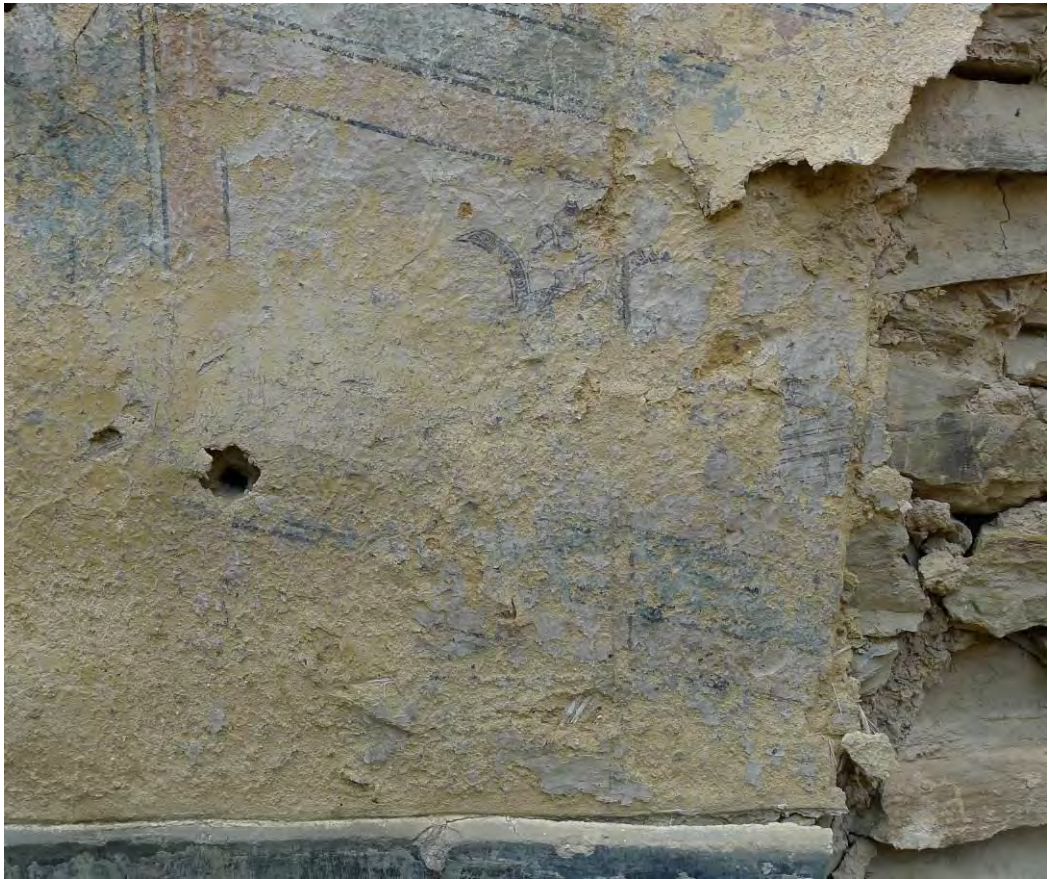
Fig. 364
Jiangxi *huiguan*, front room, west wall, *e*-panel with still life (censer)

Fig. 365
Jiangxi *huiguan*, front room, east wall, *e*-panel with still life (censer, chime stone, rock or root)

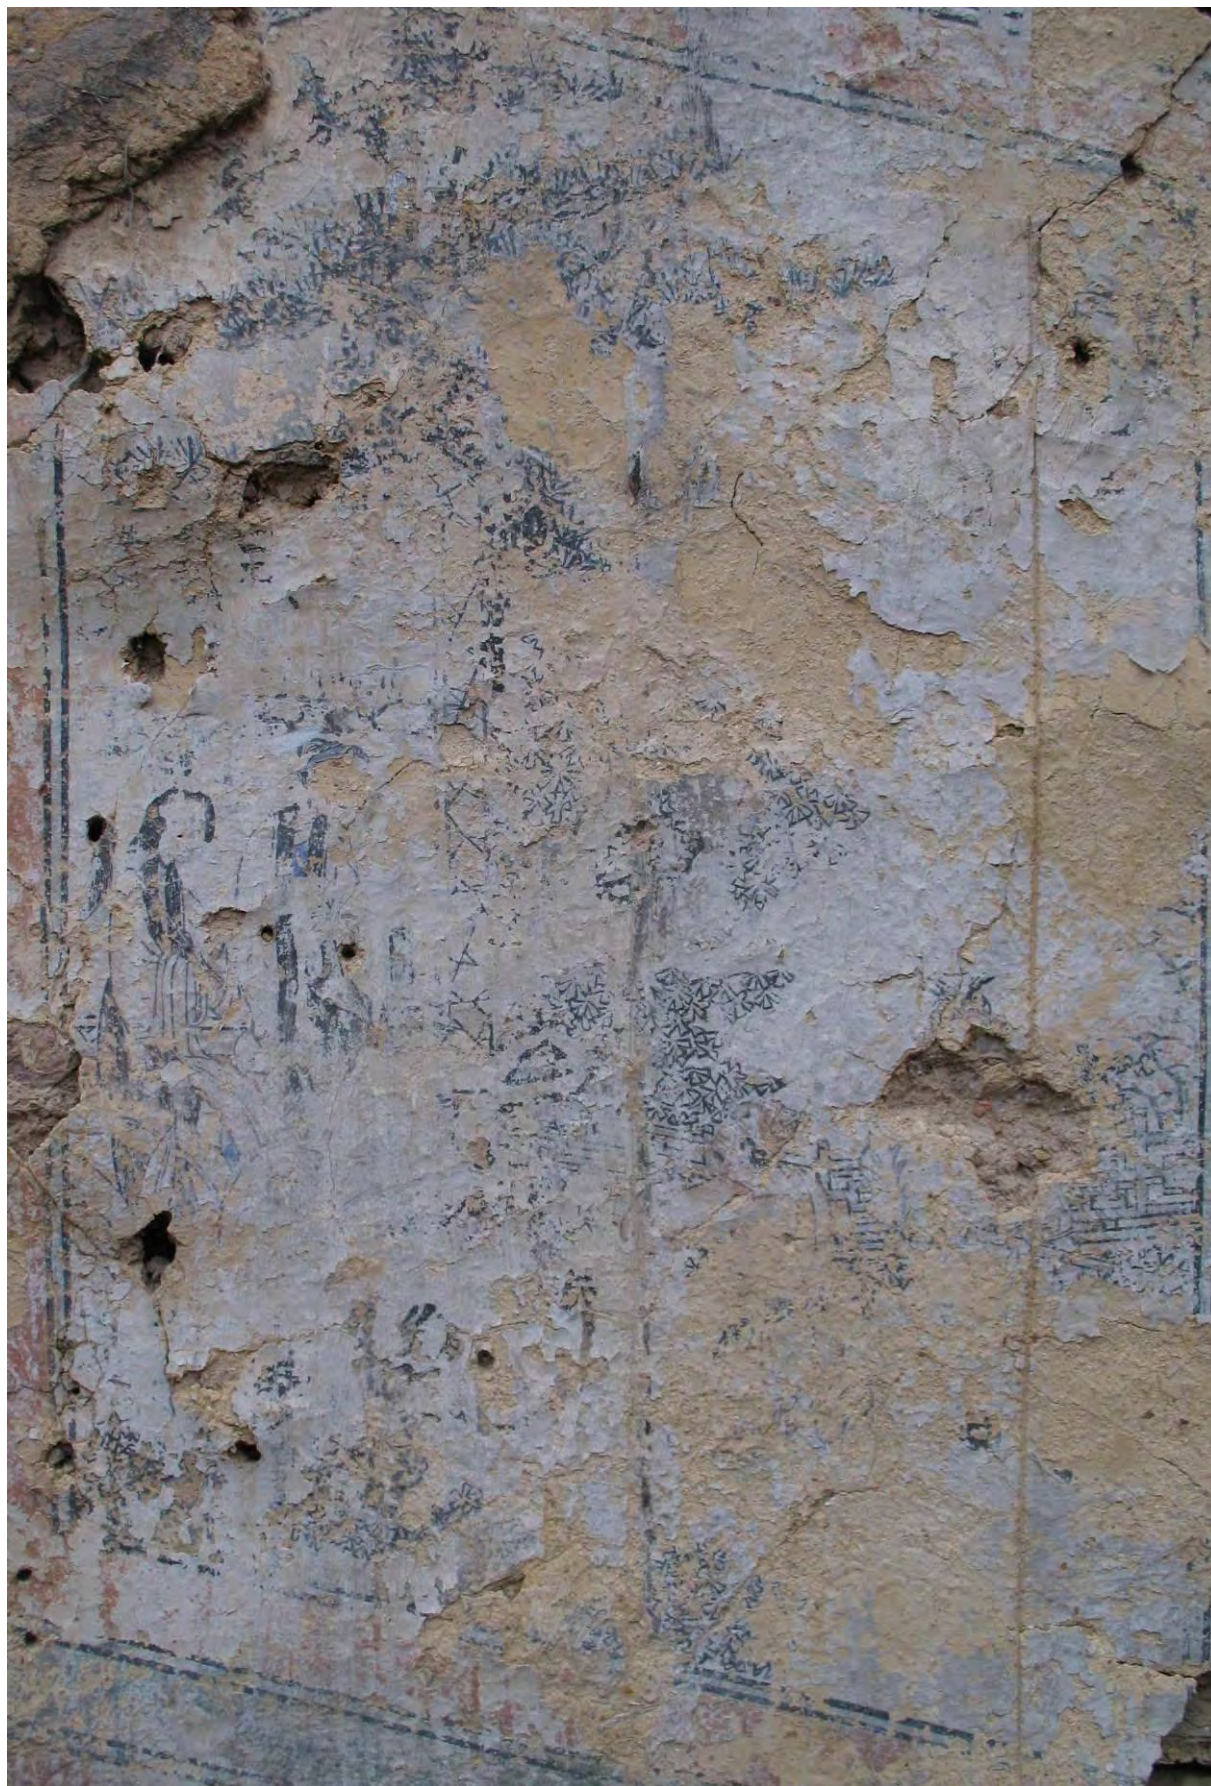
Fig. 366
Jiangxi huiguan, front room, west wall, panel 5 *d*, in April 2011

The *b*- and *d*-panels showed figurative scenes. One better preserved scene at the west wall in panel 5 *d* shows the same scene as panel 7 *d* of the *pingfeng xi* in the *beiwusheng huiguan* (figs. 366-369): An old lady is sitting next to a young lady who is holding a stick with a tassel hanging down from the end. Behind them there is a painting with a marbled border. Next to the lady, on the right part of the painting, there is a view into a landscape or garden. Two men are depicted in front of the ladies, one standing, the other one kneeling.

Although the painting in the Jiangxi *huiguan* is severely damaged, the strong resemblance of the two paintings is still recognisable: The two women are seated in the same way. The young lady wears a robe with grey borders that in both paintings may be pink. The undergarment has a different colour (in the *pingfeng xi*-painting green). She is holding the stick with the right hand, leaning it over her elbow (in the Jiangxi *huiguan* her hand and the tassel on the stick can be recognised). Her left hand is raised to her chest. The old lady has the same headdress and hairstyle on both pictures. The hairband and the undergarment in both paintings are blue, while the robe has a grey border.

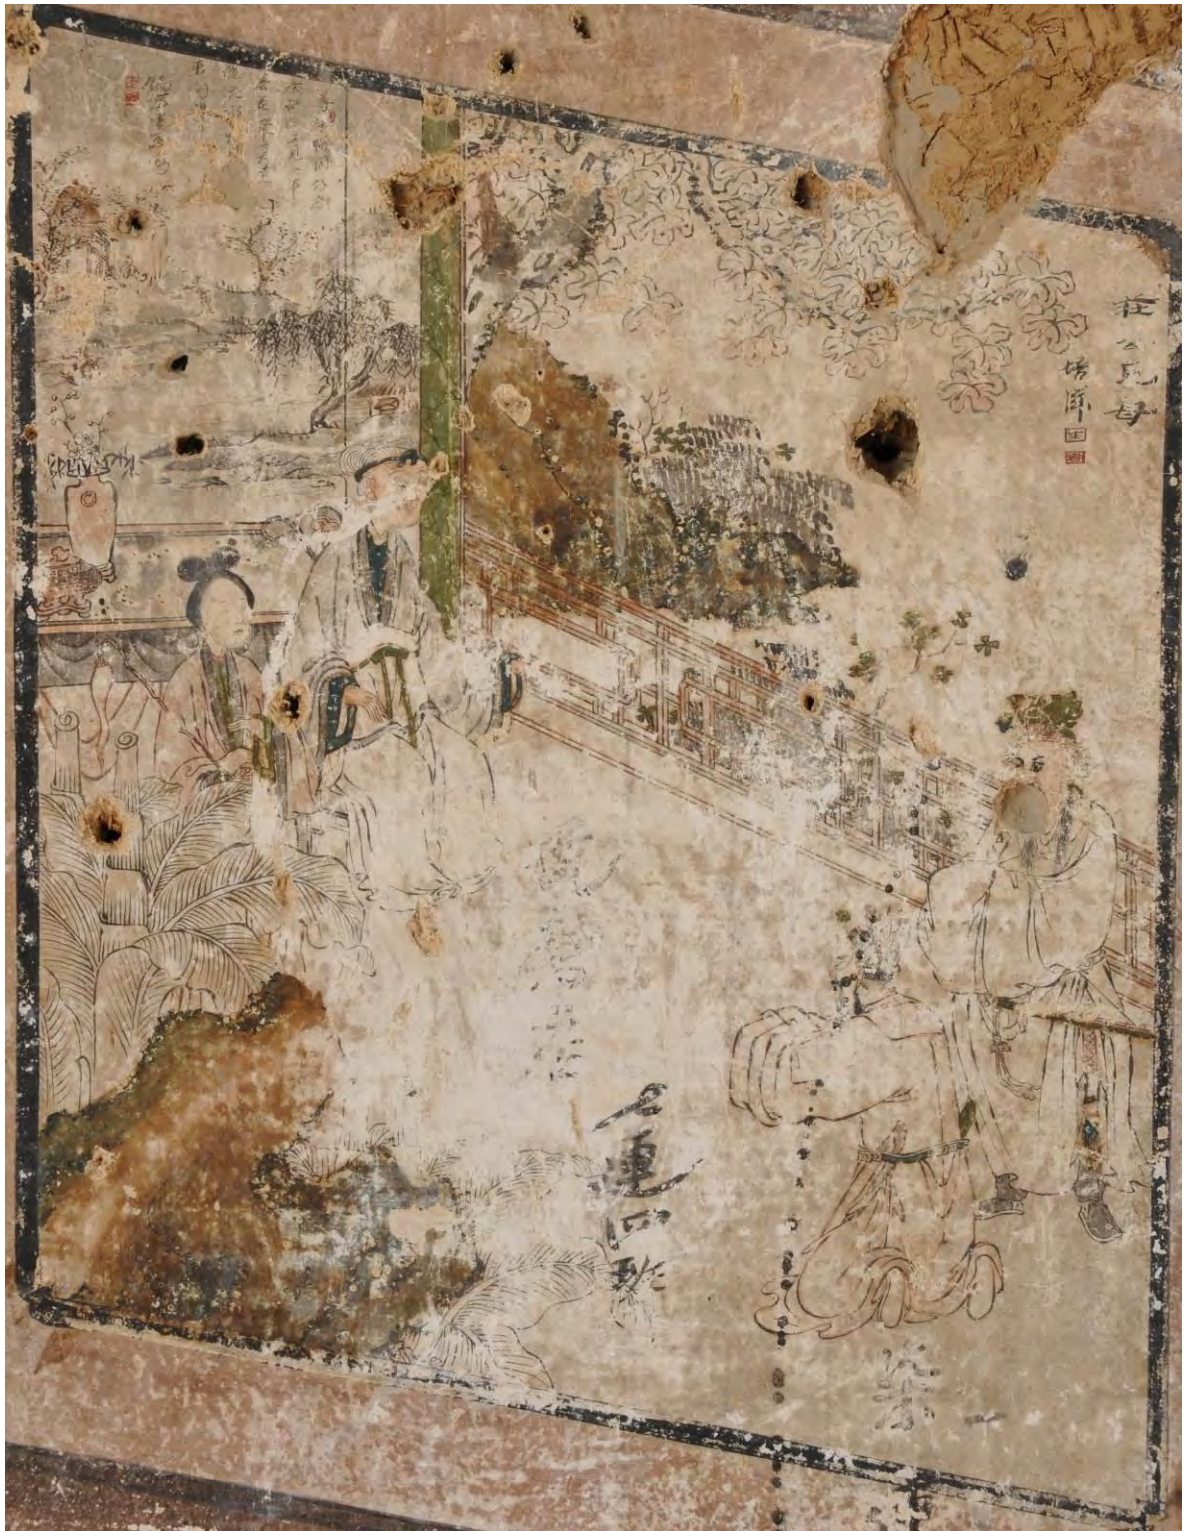
Fig. 367
Beiwusheng huiguan, pingfeng xi, panel 7 d, August 2012

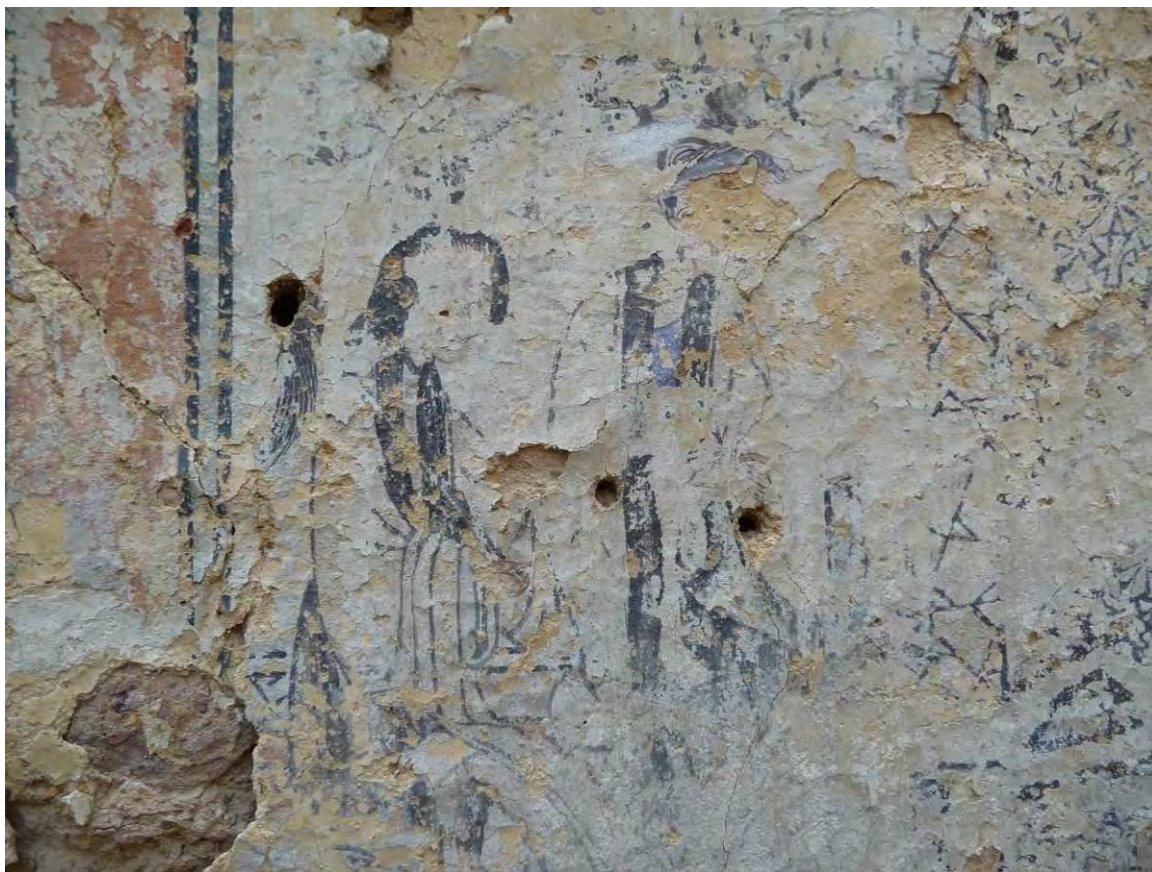
▲ Fig. 368
Jiangxi *huiguan*, front room, west wall, panel 5 d
(Aug. 2012)

The conformance of the two depictions including the design of details and the choice of the colours is so high that it cannot be coincidental. There either must have been master drawings or published depictions serving as templates for both paintings, or the same painters were active in both *huiguan*. The brush strokes of the black drawing in the Jiangxi *huiguan* looks different from the calligraphic style with varying broadness that is characteristic of the paintings in the *b*- and *d*-panels of the *pingfeng xi*-painting: The paintings were probably not carried out by the same painter. The choice of the border patterns, however, being exactly like those in the *pingfeng xi*-painting, with a variation of the corner ornament realised in the *pingfeng dong*-painting, is a very strong link. Maybe the same teams of painters were active in both *huiguan*. This would also mean that at least the paintings in the Jiangxi *huiguan* are not much older than those in the *beiwusheng huiguan*.

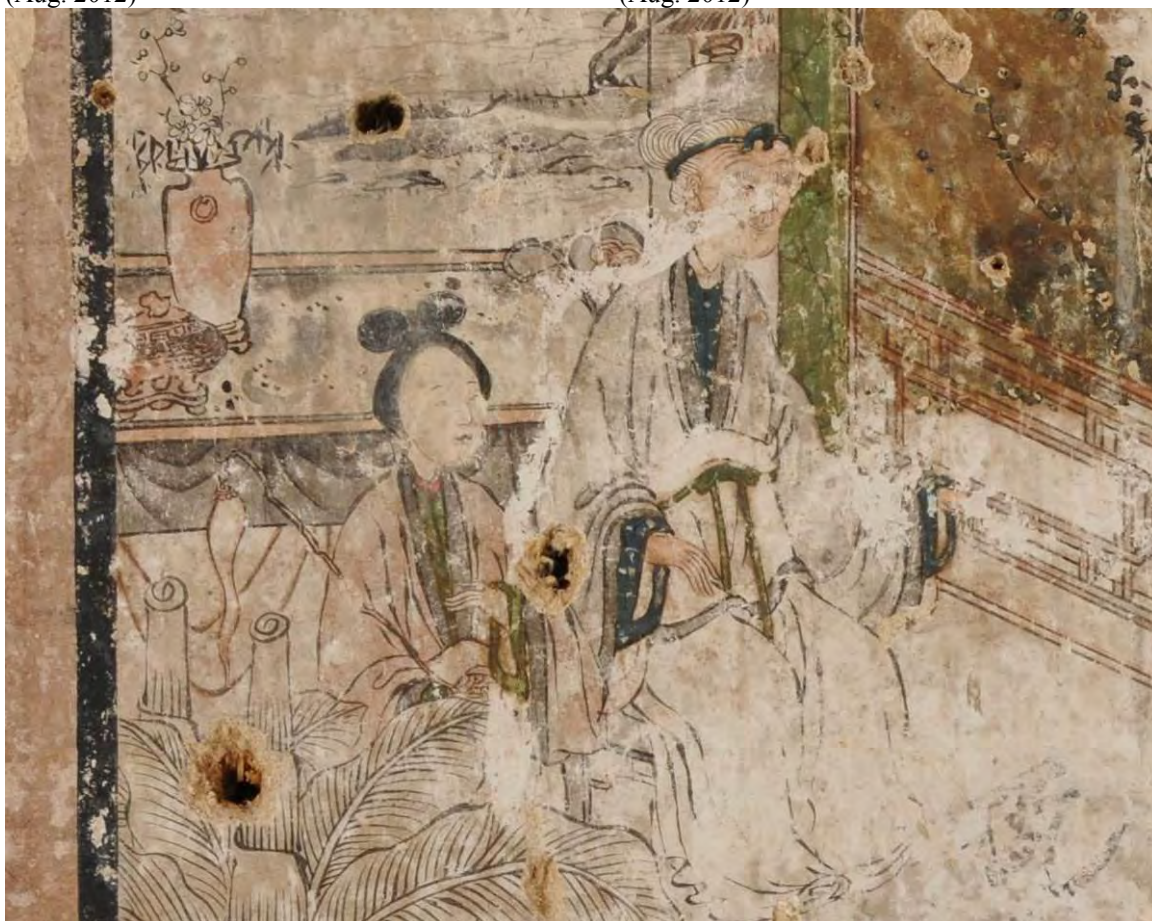
▼ Fig. 369
Beiwusheng *huiguan*, *pingfeng xi*, panel 7 d
(Aug. 2012)

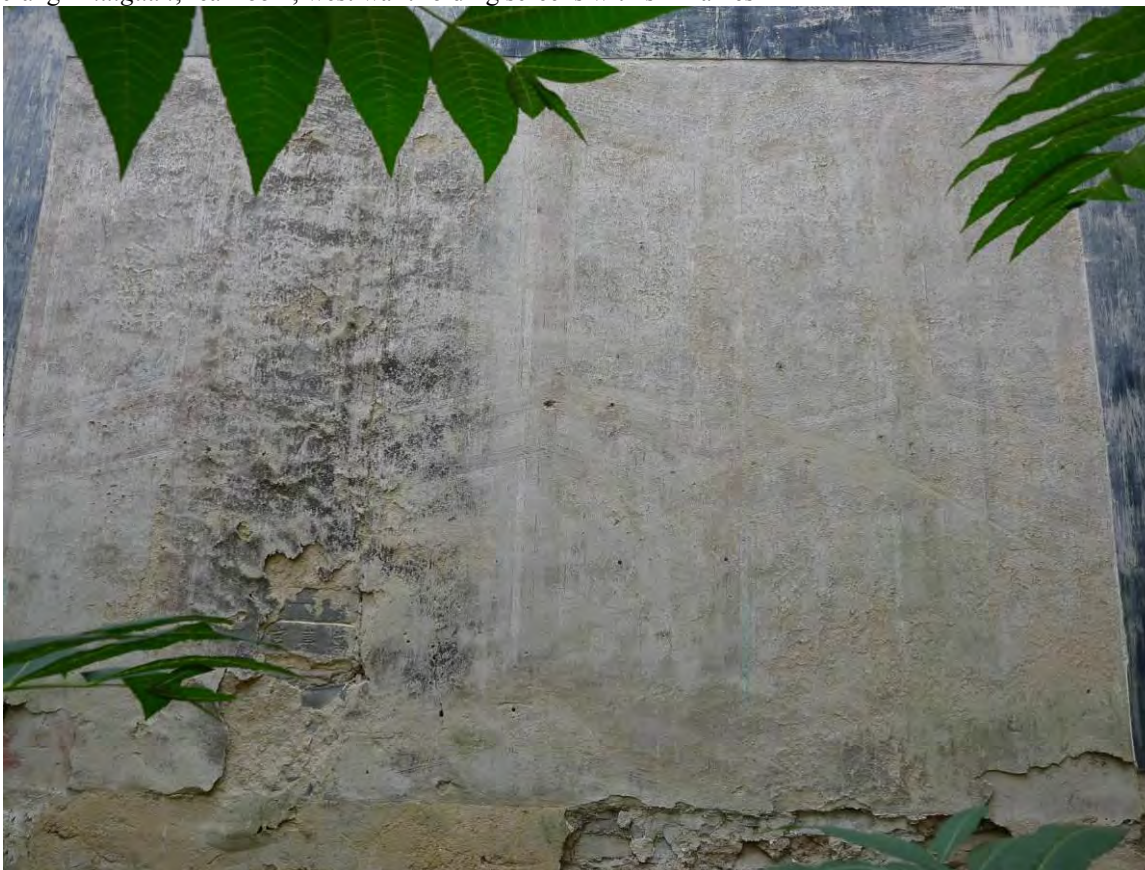
Fig. 371
Jiangxi *huiguan*, rear room, west wall: folding screens with six frames

The preserved painting on the west wall shows a folding screen with six frames (fig. 371). The design is slightly different from those in the front room and the *beiwusheng huiguan*. The *a*-, *c*- and *e*-panels are rather narrow and of about the same height. The *b*-panels are the biggest paintings. The *d*-panels are higher than in the *beiwusheng huiguan*.
