Ziyang *Beiwusheng huiguan*

Final report

Part 1: Technique and materials

Research Project 01UG1001
„German-Chinese co-operation in the preservation of Cultural Heritage: Researches for the
conservation of selected monuments in the PR China”

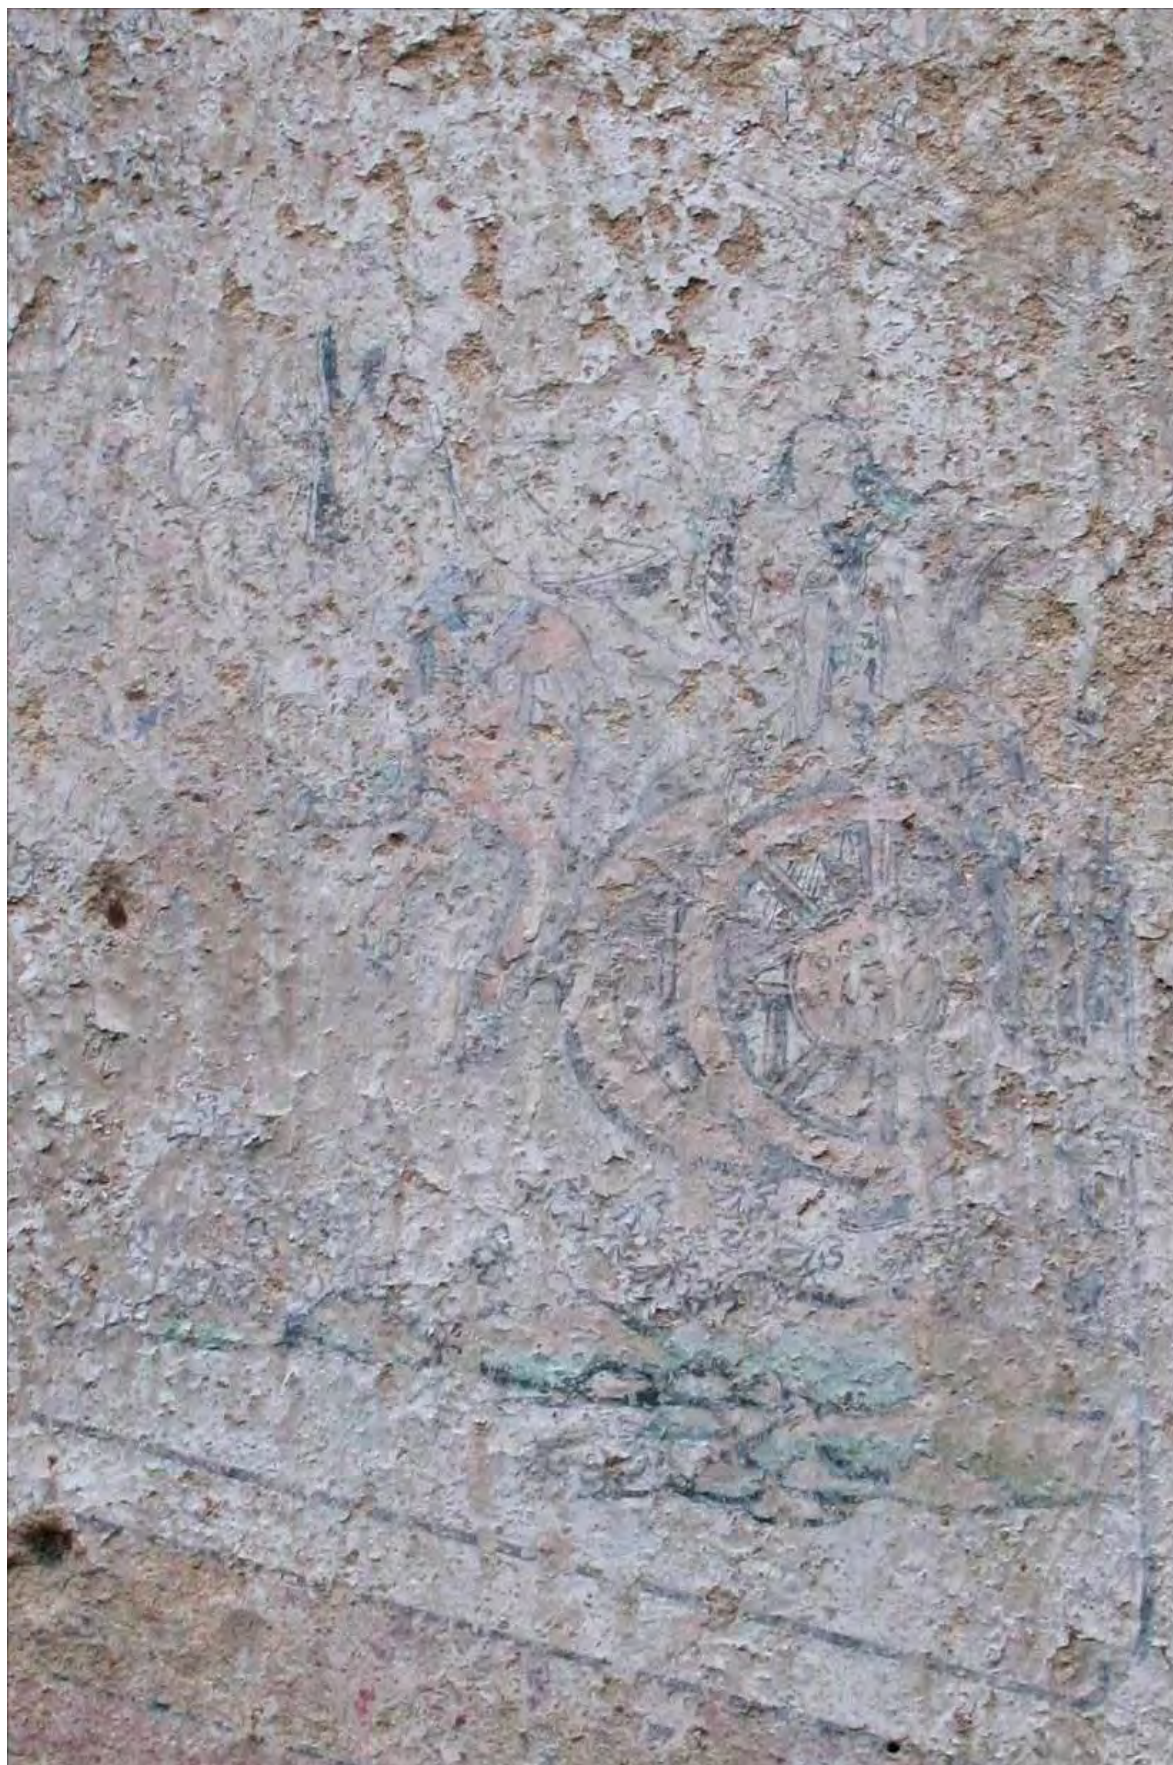
Fig. 372

Jiangxi *huiguan*, rear room, west wall, panel 4 *b*: Rider on an orange horse pulling a rickshaw or sedan chariot in which a lady is sitting. In the background on the right side, a wooden balustrade is discernible.

B- and *d*-panels have a coloured panel frame in which a filling frame is inserted. The corners of the filling frame are curved like the filling frames at the *pingfeng xi*- and *pingfeng dong*-paintings (fig. 372, lower right edge). The sides of the filling frame are also shown, indicating a trimming that protrudes from the panel frame.

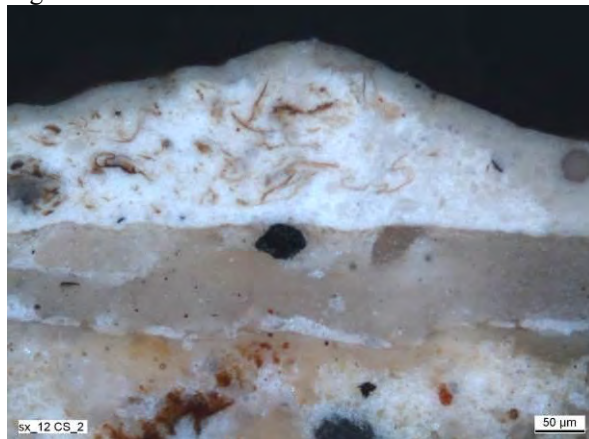
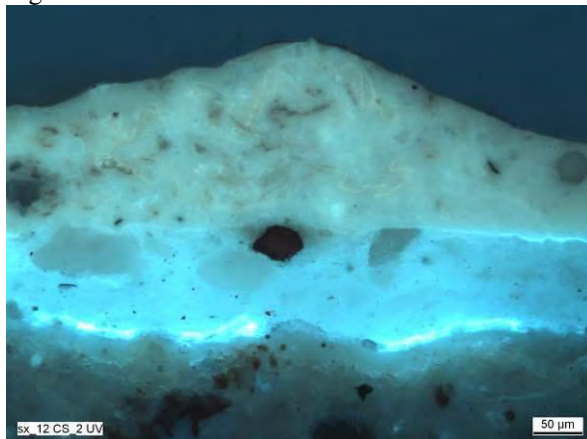
Fig. 379: *sx* 12 CS 2 VIS

Fig. 380: *sx* 12 CS 2 UV

It was discussed if a red dyestuff for tinting the “red light” reddish may have been used as a glaze, but no evidence could be found analytically. The streaks of brownish material visible in the cross section (fig. 379) may indicate an incomplete homogenisation of the paint, but also point to the admixture of a medium containing an organic colourant.

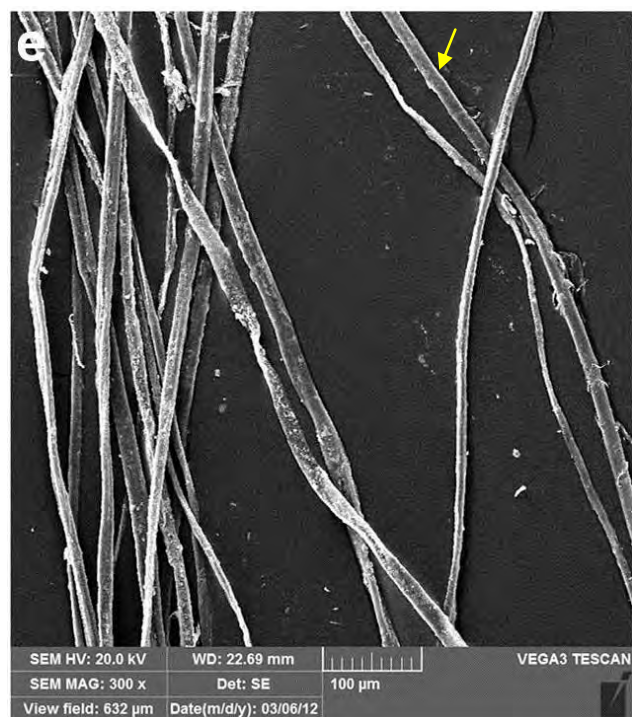
◀ Fig. 383: HU et al. 2013 b, fig. 4e: Cotton fibers; there may be one bast fibre as well (arrow)

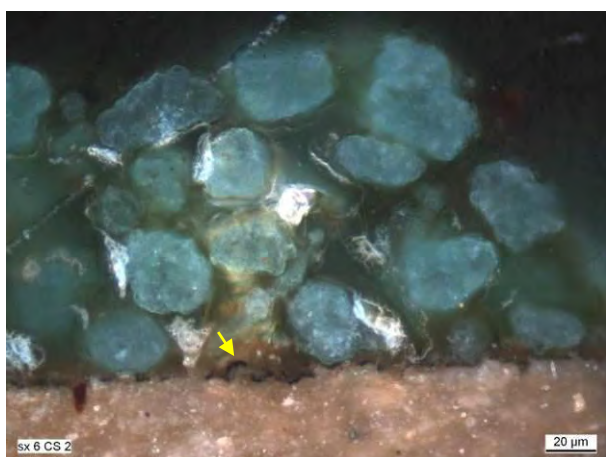
Fig. 388: *sx 6* CS 2, element mapping for Ca and S: high contents of calcium sulphate corresponding to thin grey layer and some particles in the ground layer

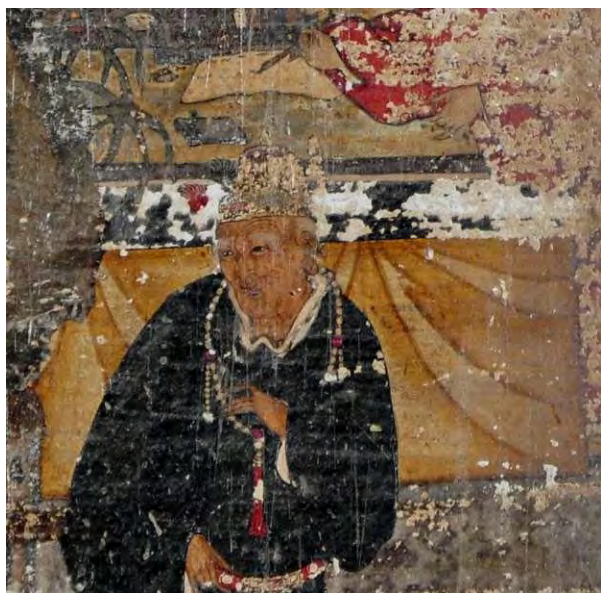
Fig. 389: *Sanguo xi*-wall, small pavilion, ochre table cloth

Lead white was also used as underpainting for translucent glazes, for example in the bright ochre yellow table cloth (4-8 µm thick, *sanguo xi*, figs. 389-394), in the purplish pink robe of a servant (5 µm thick, *sanguo dong*, fig. 399) and in pink horse coats (sample *sx* 14).

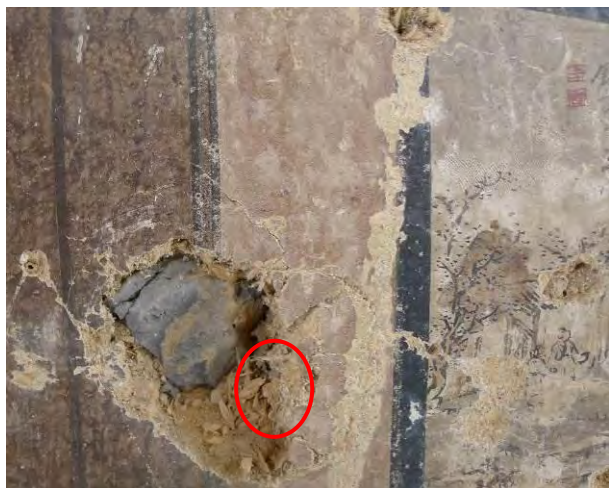
Fig. 395: sampling area of *pfx* 8 and visual impression of pinkish panel frame (panel 7 *d*)

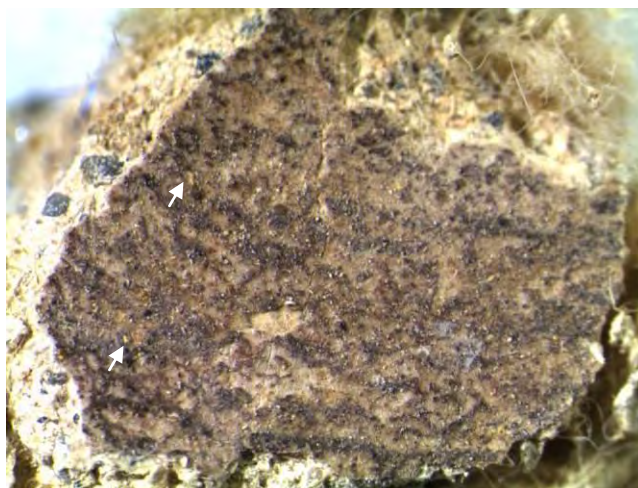
Fig. 396: Sample *pfx* 8 (1.0 x 1.6 cm), accumulations of pigments in the paint, discernible yellow clusters (arrow)

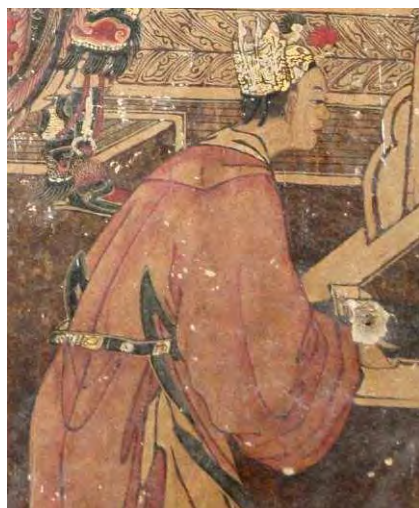
Fig. 399
Sanguo dong, servant with purplish pink robe (figure no. 1): sample *sd* 3 was taken from the right sleeve

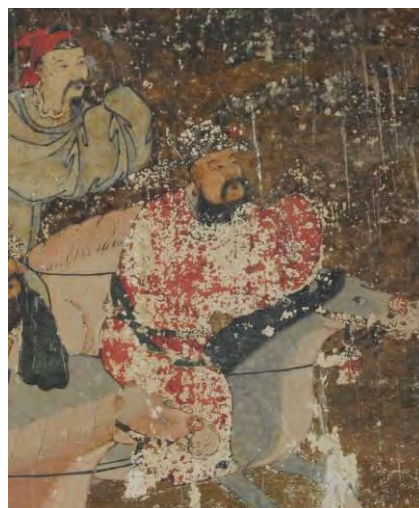
Fig. 401
Sanguo xi, Cao Cao (figure no. 48): distinctive damage of red paint layer in the robe, while the cap of the soldier is well-preserved

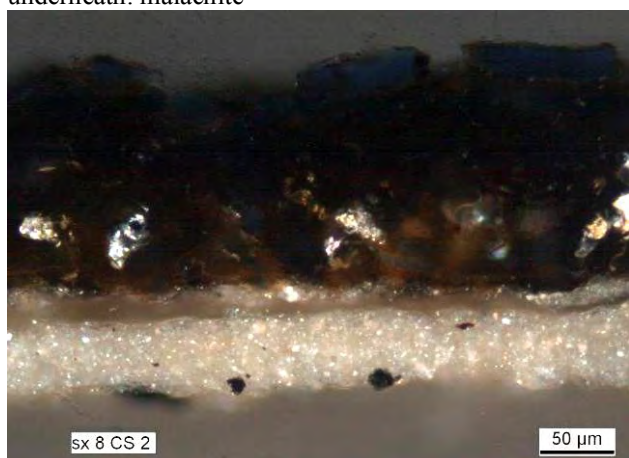
Fig. 406: *sx 8 CS 2*, smalt particles in brown medium

The binding medium appears dark brown and is either discoloured or may have contained a dyestuff. It shows a strong orange UV fluorescence, very different from other samples (fig. 406 and 408).

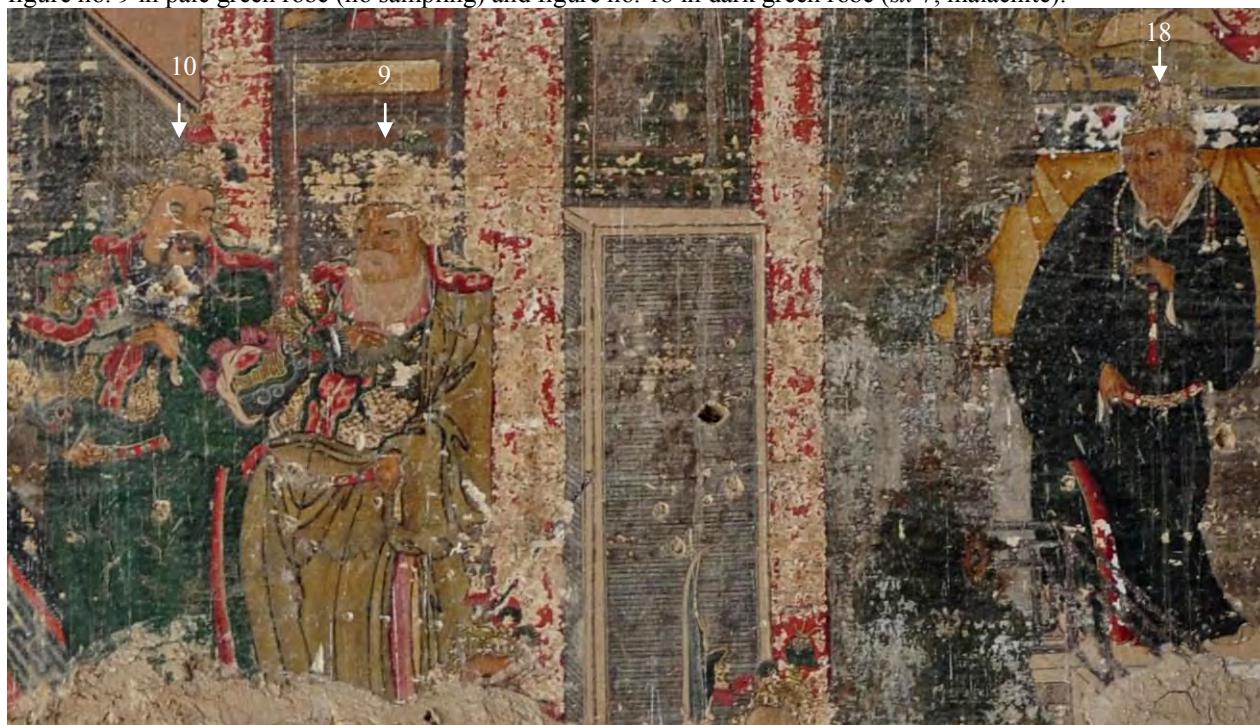
Fig. 412: *Sanguo xi-wall*, three men in green robes: Figure no. 10 in bright green robe (*sx 6*, copper chloride), figure no. 9 in pale green robe (no sampling) and figure no. 18 in dark green robe (*sx 7*, malachite).

Malachite was identified in the green robe of a man (figure no. 18, fig. 412, right side) in the *sanguo xi*-painting (sample *sx* 7). The sample contains only very few particles of azurite, showing that pure qualities of malachite were available, and some lead white. In the cross section the paint layer looks homogeneously green. Underneath there is a thin layer rich in binding medium that is more brownish and darker than binding medium layers visible in other samples. It may be a coloured wash or a brownish layer (fig. 413: b). XRF showed that the paint layer also contains lead and arsenic. Lead partly comes from lead white (small particles containing only lead), but there also are angular green particles containing Cu, As and Pb (fig. 411). It is not clear what kind of minerals they are. They may be to be a green by-product of the malachite.

The lighter green robe of another man in the *sanguo xi*-painting (figure no. 12, fig. 412, left side) is painted with an unusual pigment: Compared to the robe painted with malachite, the colour is bright green. The paint layer is thick and consists of rather coarse spherical particles which can be recognised using a microscope already at low magnification.

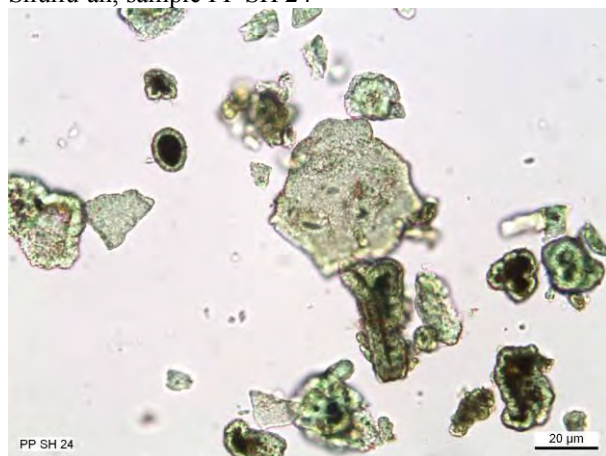
Fig. 418: atacamite from a green paint layer in the Shuilu'an, sample PP SH 24, crossed polars

dark or red core and a bright white up to bluish birefringence. The particles with dimensions mostly up to 20 μm often show a dark or red core and a bright white up to bluish birefringence (fig. 417 and 418).

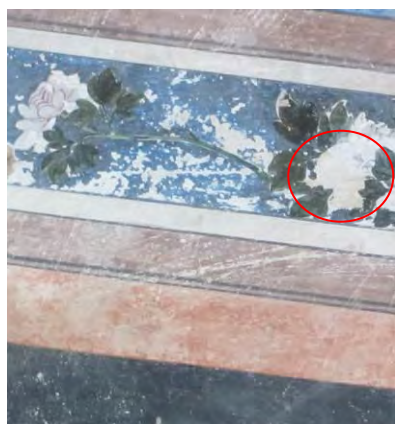
Fig. 420: *pingfeng bei*, panel 5 c, light pink peonies on blue ground; sampling area of *pfb* 3

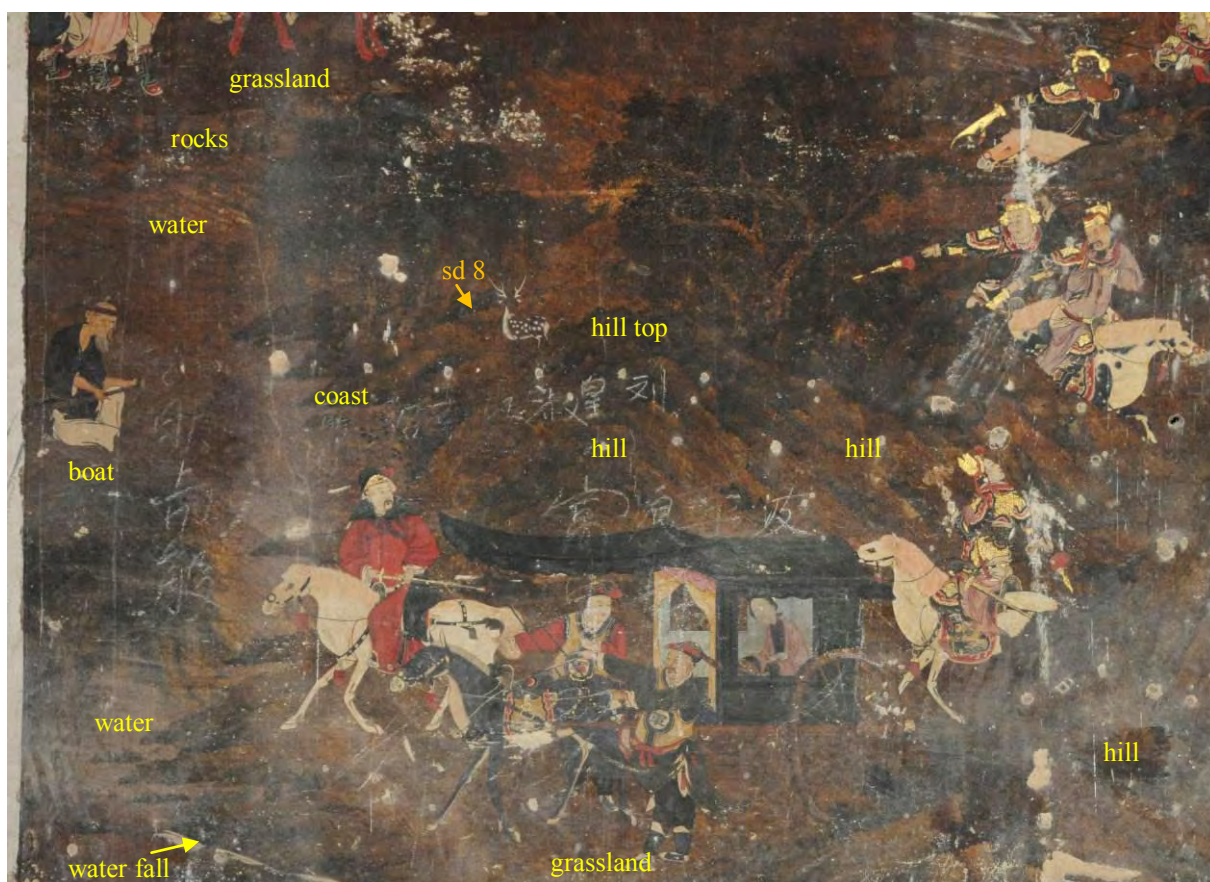
Fig. 430: *Sanguo dong*-painting, different parts of the landscape. Hill tops and coast: malachite; grassland and the slopes of hills: Prussian blue, malachite or botallackite and black (greenish hues?), partly also cinnabar and red lake (brown hues?)

The landscape in the *sanguo*-paintings looks brown today. Though different shades are still recognisable as darker or lighter brown, the intended colours are not discernible anymore (fig. 430). The strongly discoloured binding medium layer applied over the whole paintings on top of the washes does not contain pigments, but only brown medium (sample *sx* 10). It probably is the main reason for the brown appearance of the background.

The tops of the hills which nowadays look dark, the coast lines and some highlights in the landscape had originally been green, the paint layers containing malachite. In sample *sd* 8, taken from a dark appearing “hill top” next to the deer (fig. 430 and 431), the sequence of layers can be distinguished: The first delineation was drawn in black, followed by a first wash that contains green particles (probably malachite). The outline was drawn again in black before a thicker green layer containing malachite was applied (fig. 434 and 435). The malachite layer is covered and encased in a brown binding medium layer. The brown medium that stained the upper half of the ground layer brown (fig. 433) probably is the isolation layer applied on top of the washes (i.e. the material present in sample *sx* 10).

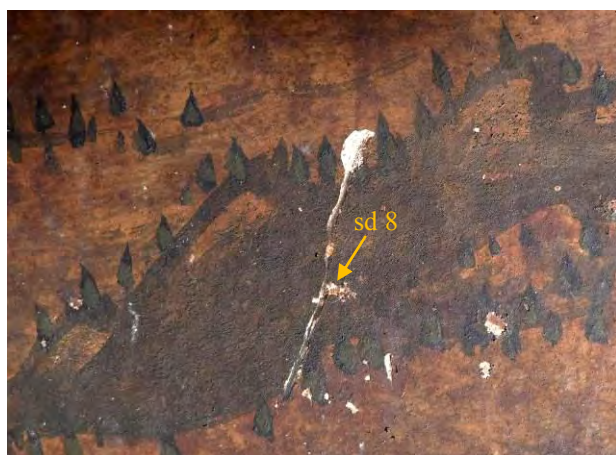
Fig. 431: Sample *sd 8*, sampling area (see fig. 430)

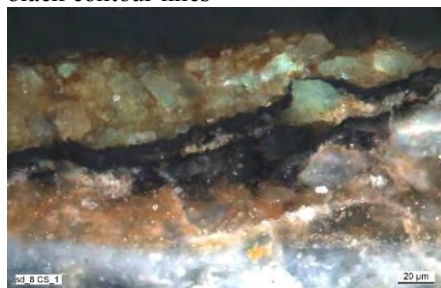
Fig. 434: *sd 8* CS 1, thin section, VIS

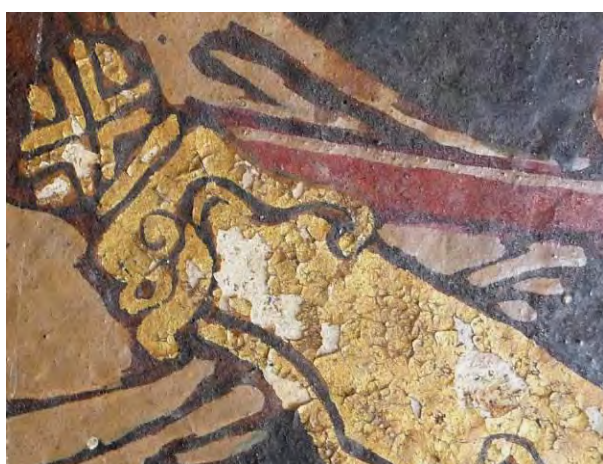
Fig. 436

Sanguo dong-wall: detail of gilded lance head (height of picture corresponds to 2.5 cm)

Two samples were taken from gilded weapons painted at the *sanguo dong*-wall (samples *sd* 2 and *sd* 4). It can be assumed that even for the tiny gilded decorations leaf gold was used. Creases and rips in the gold leaf can be recognised (fig. 436). Underneath the gold a reddish transparent layer (14–27 μm thick) is visible that can be interpreted as the mordant to apply the gold. In UV light, the mordant has a strong yellowish fluorescence (visible in the cross section, fig. 439). The layer does not contain pigments. There is a thin (about 3 μm thick) red layer underneath containing fine red pigments (fig. 438 and 439).

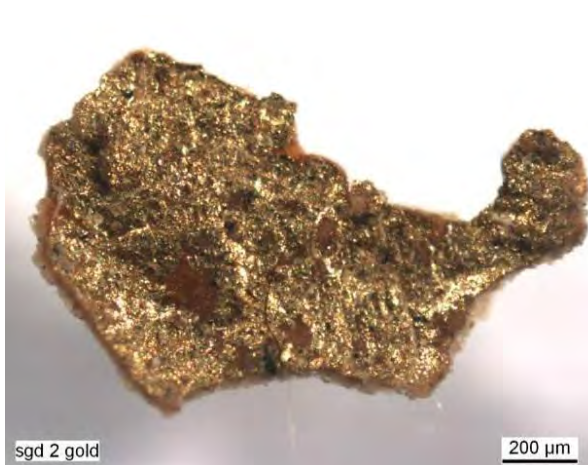
Fig. 437

Sample *sd* 2: gold leaf on reddish transparent mordant.

According to the analyses carried out in China on sample *sd* 2, the mordant was found to contain C and Pb which was interpreted as a colouration by red lead. The thin red layer underneath contains Hg and S, thus the red pigment can be identified as cinnabar. The gold leaf was analysed to contain 89.3 w% Au, 8.5 w% Ag and 2.2 w% Cu.¹⁵⁵

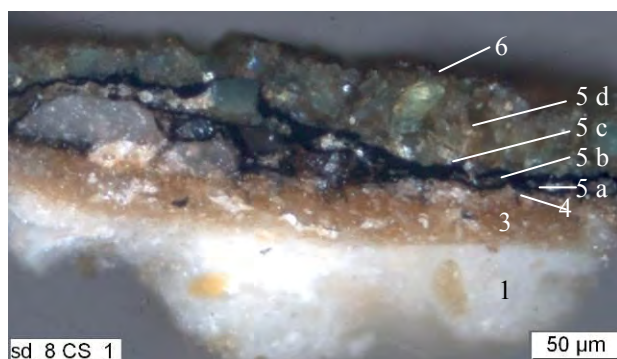
Fig. 450: *sd 8 CS 1*, green hill top (see fig. 431)
6 brown glaze / coating
5 d opaque paint layer
5 c black contour line
5 b green wash
5 a black delineation
4 less stained surface (isolation layer?)
3 white ground layer, stained brown
2 sizing
1 fine coat *xi ni*

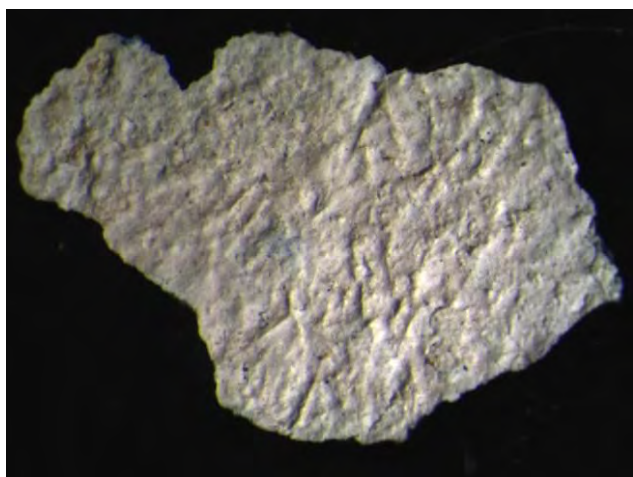
Fig. 460: Flake of sample *pfx* 15, reverse
Brush marks and imprints of the surface of the *xi ni* are discernible. Length of picture corresponds to 4.5 mm.

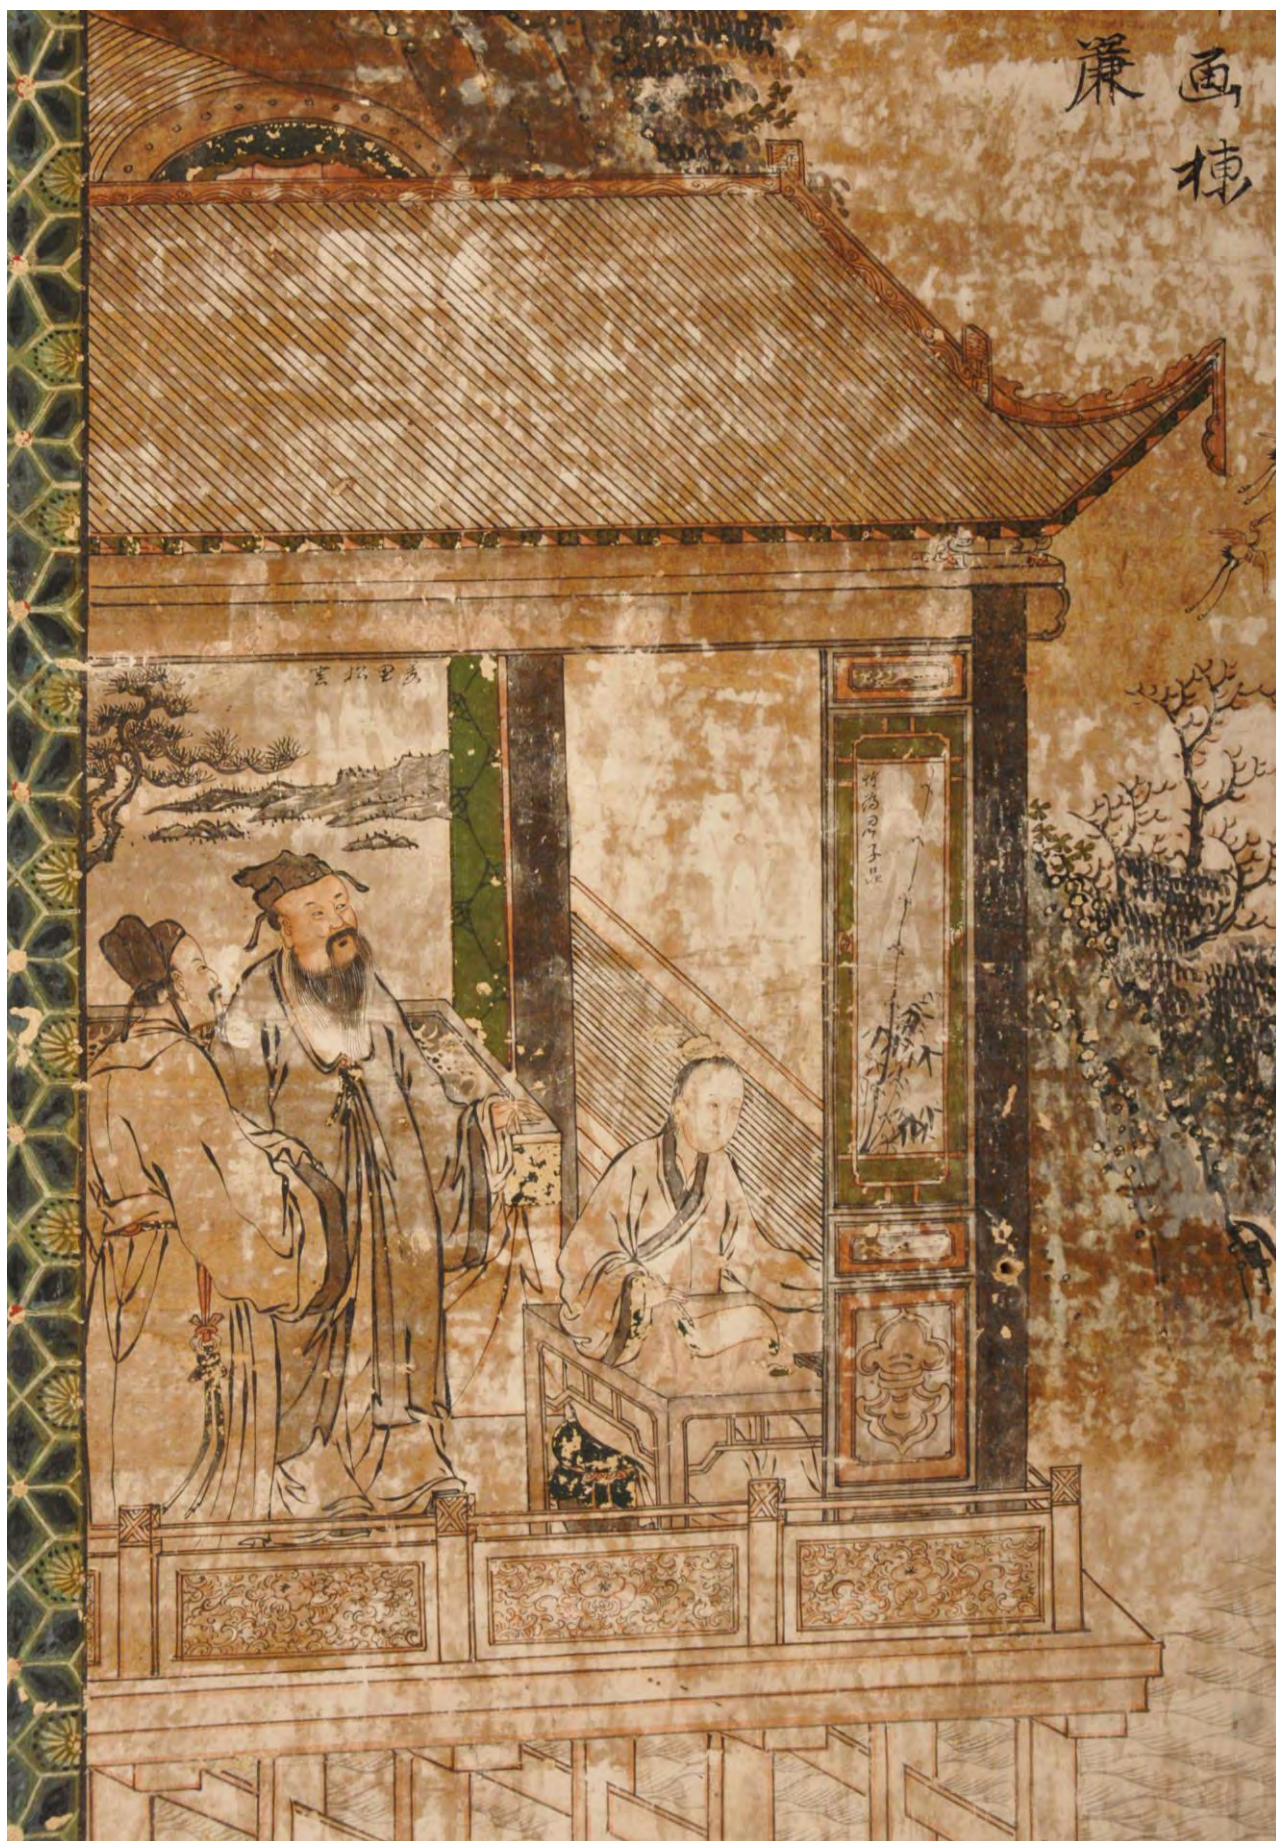
Fig. 462

Pingfeng xi, panel 3 d: Prince Tang's Palace
