# **The Yuanjue Grottos in Anyue**

**Annual Report 2007–2009**

**BMBF Project 01 GWS 079**

近千年,在长期自然营力作用的影响下,四川安岳石刻岩体产生了严重的环境地质病害。构造裂隙、卸荷裂隙及层面裂隙交错切割,将石窟区的岩体切割成巨块状,形成危岩体,威胁游客和文物的安全,需要及时采取科学保护措施进行治理。因此,查明圆觉洞石刻环境地质病害的现状和成因,是四川安岳圆觉洞石刻区文物保护的首要任务。

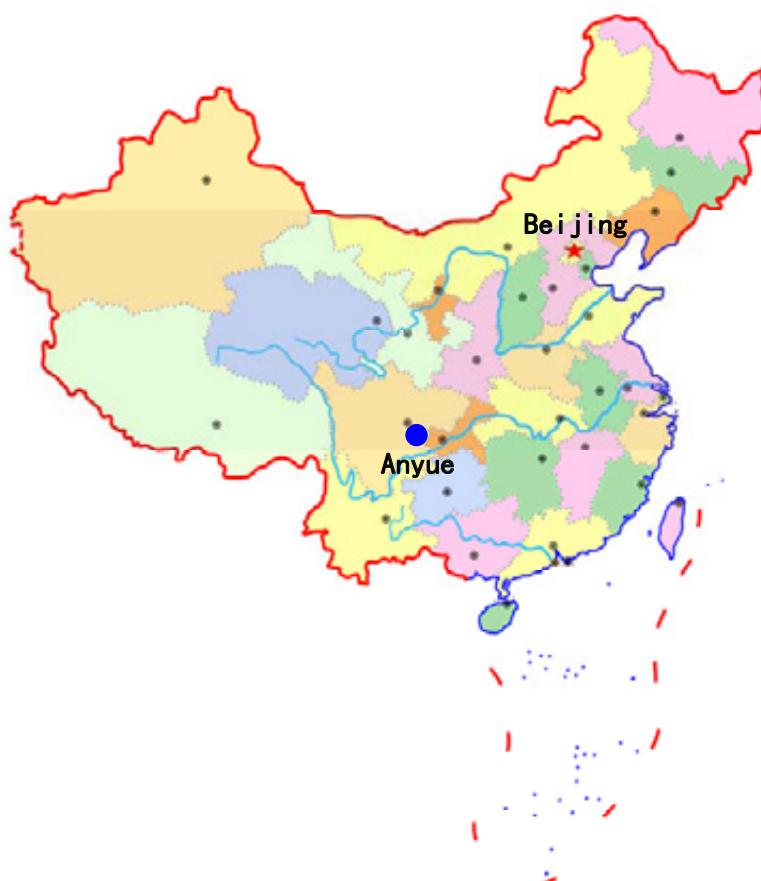
图 1-1 安岳圆觉洞石刻地理位置  
Fig. 1-1 Geographical Position of Yuanjuedong Cave

圆觉洞石刻区位于安岳县城南 1km 的云居山上（图 1）。石刻均分布于云居山顶南北两侧的砂岩陡崖之上，长 186m，现存摩崖造像 103 壑窟，造像 1933 躯，碑刻题记 25 处，唐代浮雕

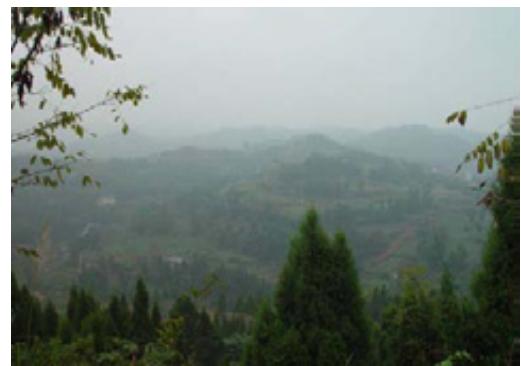
图 2-1 保护区沟谷发育

Fig.2-1 Incised Gully of Yuanjuedong

圆觉洞石刻区位于安岳县城南1km的云居山上，石刻区的地形为“坪状”丘陵，区内制高点海拔高度为404.9m。台坪状残丘呈串珠状分布于石刻区周围，形成圆觉洞石刻区的地表分水岭。由遂宁组泥岩构成丘体，水平状砂岩构成丘顶。东北及西南大沟为深切沟谷（图 2-1），相对高差84.2m，沟头由巨厚层状砂岩形成5~15m高的陡崖。丘陵斜坡由砂、泥岩叠置而成，向四周逐渐变缓，岩层产状近水平。砂岩在地形上形成陡崖或陡坡，泥岩组成缓坡。山顶处以砂岩为主，地形坡度陡，约60°~80°。山体下部以泥岩为主，坡度变缓，山脚处坡度为20°~30°（图 2-2）。圆觉洞石刻造像分布在山顶的弧形砂岩崖壁上，崖壁长约210m。

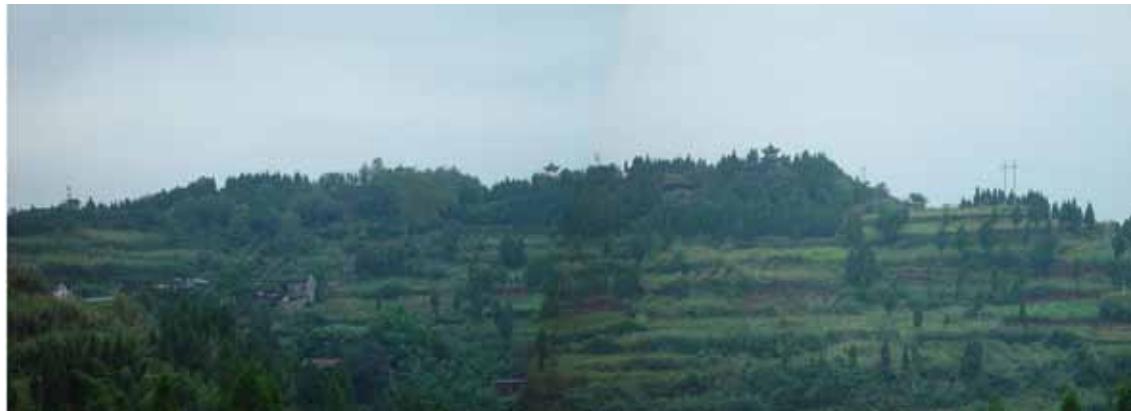
图 2-2 圆觉洞石刻区地形

Fig2-2 Topography of Yuanjuedong

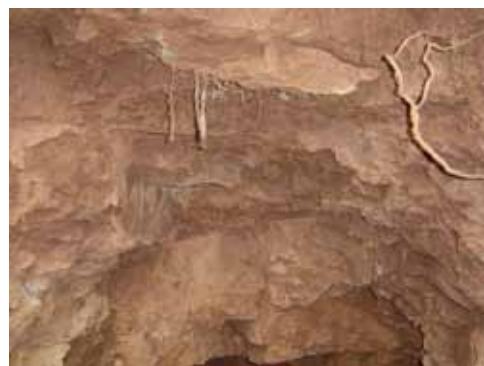
图 2-3 遂宁组第一段泥岩

Fig.2-3 Mudstone of Jurassic Period ( $J_{3sn-1}$ )

**第一段( $J_{3sn-1}$ )：**该段岩性为紫红色泥岩(图2-3)，厚层状，夹褐黄色～褐色薄层状粉砂岩，在泥岩中发育青灰色弱胶结粉砂岩。主要分布于研究区地势低洼的山沟范围内，表面大部分为第四系覆盖。

**First Stratum ( $J_{3sn-1}$ )：** Mauve thick-bedded mudstone (Fig.2-3), interbedded thin layers of siltstone with brown yellow to maroon color, and caesious weakly-cemented siltstone is developed in the mudstone. Which is mainly distributed in the low-lying gully of the research area, and the surface is covered by the deposit of Quaternary System.

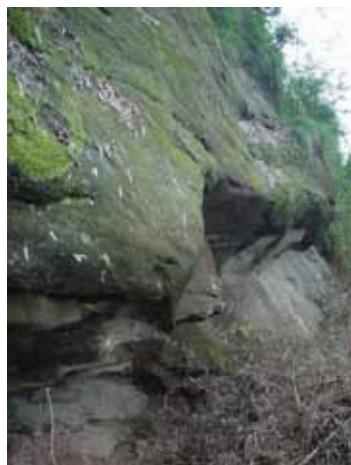
图 2-4 遂宁组第二段砂岩

**Fig.2-4 Sandstone of Jurassic Period ( $J_{3sn-2}$ )****Fig.2-5 Sandstone interbedded mudstone**

**第二段( $J_{3sn-2}$ )：**青灰色钙质胶结粉细砂岩，风化后岩石表面为褐红色(图2-4)。该岩层主要出露在石刻区的东南部。岩性为巨厚层～块状，完整性好，并形成坡度为60度左右的陡崖。该岩层在石刻区的西北角渐变为砂岩夹泥岩(图2-5)，或砂泥岩互层，泥岩以褐红色为主，其中发育灰白色粉砂质条带。

**Second Stratum ( $J_{3sn-2}$ )：** Calcareous cemented siltstone, whose surface is of maroon color after weathering (Fig.2-4). This rock stratum is emerged in the southeast of the Yuanjuedong. between huge thick layer to massive stone with comparatively integration and a steep dip angle of 60°. This rock stratum change into sandstone interbedded with mudstone when it extends to the northwest part of Yuanjuedong (Fig. 2-5), and the mudstone color is mainly maroon, while off-white siltstone stripes are developed.

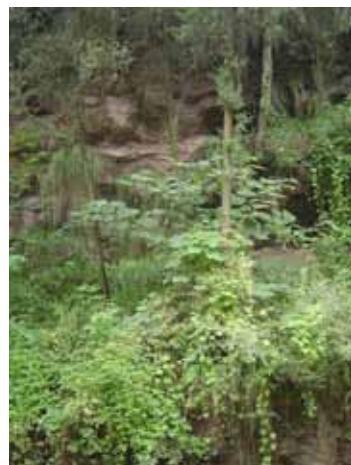
图 2-5 砂岩夹泥岩

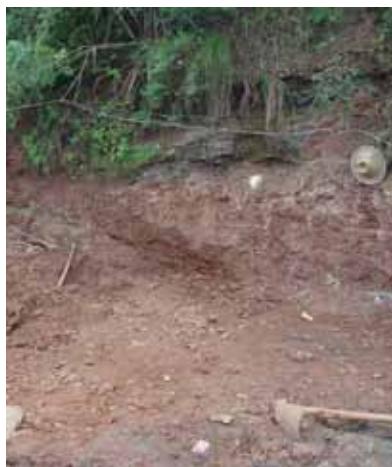
图 2-6 泥岩夹粉砂质泥岩（天然陡坎）

**Fig.2-6 Mudstone interbedded silty mudstone (natural steep ridge)**

**第三段( $J_{3sn-3}$ )：**该段岩性为紫红色～褐红色泥岩夹褐黄色粉砂质泥岩，厚层状，中见灰白色粉砂质条带，开挖后容易形成干缩裂缝，导致岩体表面破碎。该岩层在地形上形成小型陡坎(图2-6)。该层主要被第四系残积土、耕植土所覆盖，天然露头主要为粉砂质泥岩。

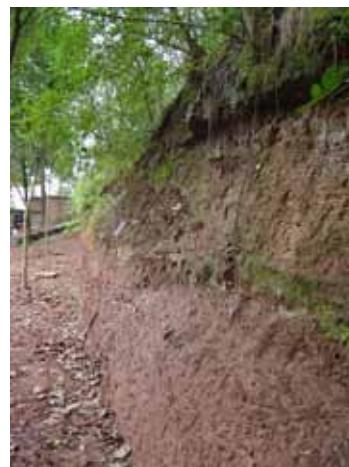
图 2-7 第三段泥岩与第四段砂岩接触界线

**Fig. 2-7 Delimitation boundary between sandstone of Third Stratum and mudstone of the Fourth Stratum**

第四段( $J_{3sn-4}$ )：主要为厚层~巨厚层、灰黄色~褐红色粉细砂岩，钙质胶结为主，沿层理发育较多定向排列的云母片。该岩层上下部位水平层理发育，而中部发育交错层理。该砂岩层与下覆泥岩分界明显(图2-7)。沿接触面见地下水渗出。该段岩体主要分布于山顶部，形成陡崖。圆觉洞

Fourth Stratum (( $J_{3sn-4}$ )): Calcite cementation siltstone with sallow to maroon color in general to extraordinary thick layer, and quiet some directional arrayed sheet mica is developed according to the stratification of this section. The horizontal bedding developed well in the upper and lower part of this stratum, while the middle part is cross-bedding. This sandstone layer has clear delimitation boundary with the lower mudstone layer (Fig. 2-7), and ground water seepage can be observed along the contact surface. This

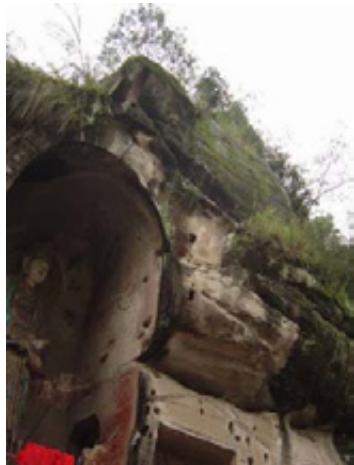
**图 2-8 第四段厚层~巨厚层砂岩  
Fig. 2-8 Thick sandstone of Jurassic  
Period ( $J_{3\text{sn-4}}$ )**

石刻区的龛窟造像主要分布在该段砂岩陡崖上(图 2-8),是本次工作的重点研究区域。

stratum rock is mainly distributed in the top of the mountain, which forms the steep cliff. Most of the statues and grottoes of Yuanjuedong are located in sandstone cliff of this stratum (Fig. 2-8), which is the key research region of this project.

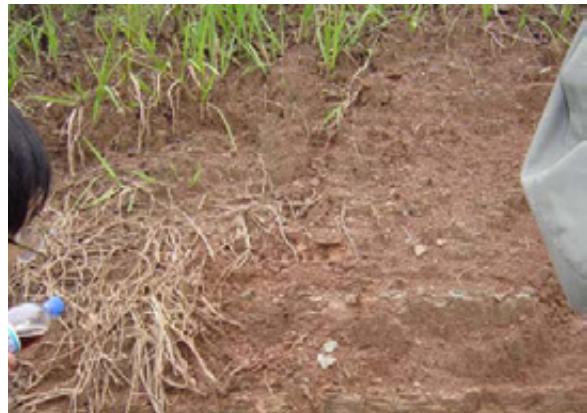
**图 2-9 泥岩风化形成残积土  
Fig. 2-9 Residual soil formed by mudstone  
weathering**

The sandstone in the research region is relatively integrated, which easily generate steep cliff, thus provide good foundation for grotto excavation. Mudstone clay is rich in mineral substances, which subject to disintegration under the alternation of the dry and humid circumstances, so its resistance capacity to weathering is low.

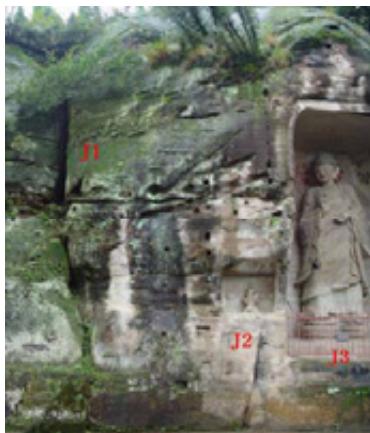
图 2-11 裂隙  $J_1$ 、 $J_2$ 、 $J_3$   
Fig.2-11 Joint  $J_1$ ,  $J_2$ ,  $J_3$

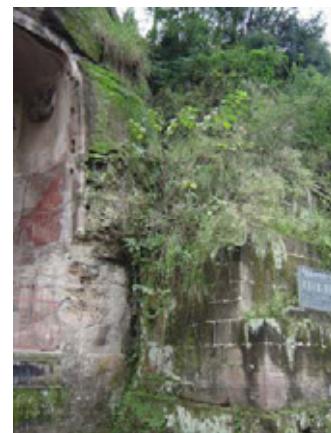
图 2-12 园觉洞旁裂隙  $J_4$   
Fig.2-12 Joint  $J_4$  beside Nich 9

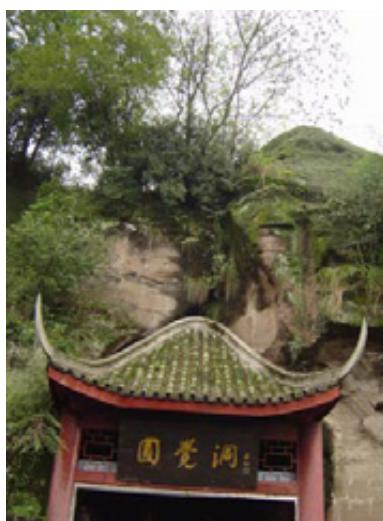
图 2-13 园觉洞顶部裂隙  $J_5$   
Fig.2-13 Joints of  $J_5$  at the top of Yuanjuedong Cave

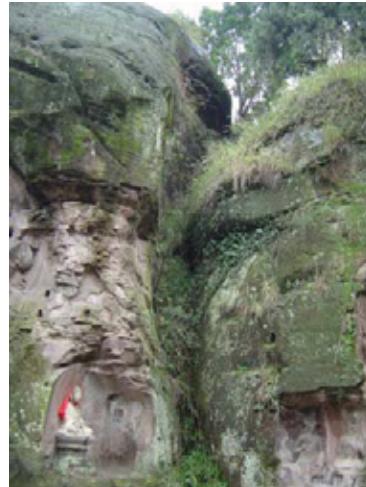
图 2-14 5 号龛旁裂隙  $J_6$   
Fig.2-14 Joints of  $J_6$  near the niche of No.6

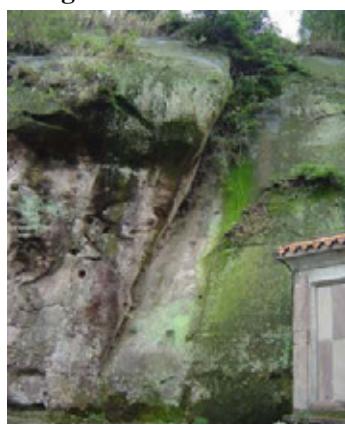
图 2-15 裂隙  $J_7$   
Fig.2-15 Joint  $J_7$

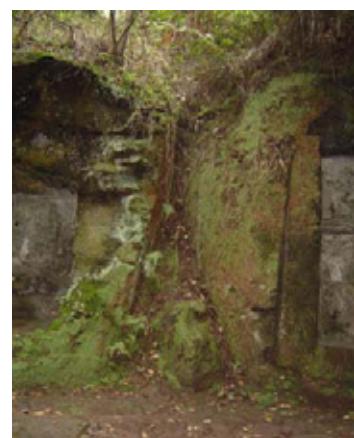
图 2-16 裂隙  $J_{10}$   
Fig.2-16 Joint  $J_{10}$

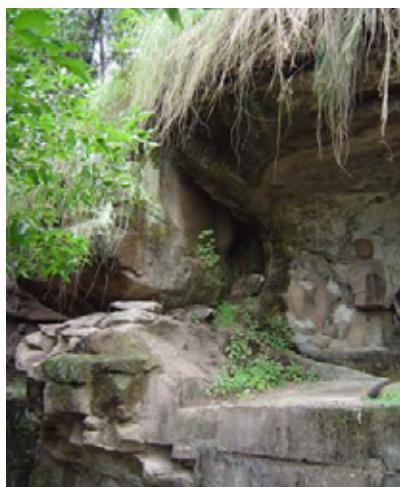
图 2-17 裂隙 J<sub>12</sub> 导致石窟破損  
Fig.2-17 Grotto Damage Resulted from J<sub>12</sub>

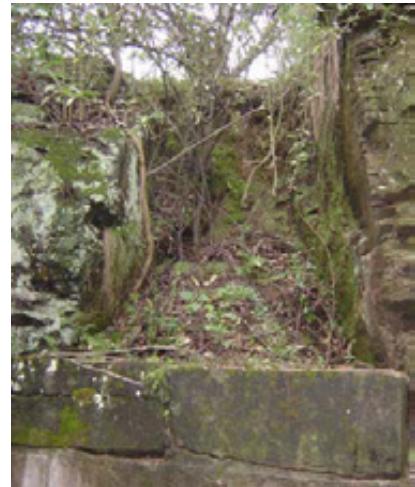
图 2-18 裂隙 J<sub>14</sub> 松散层堆积  
Fig.2-18 J<sub>14</sub> in Loose Deposit

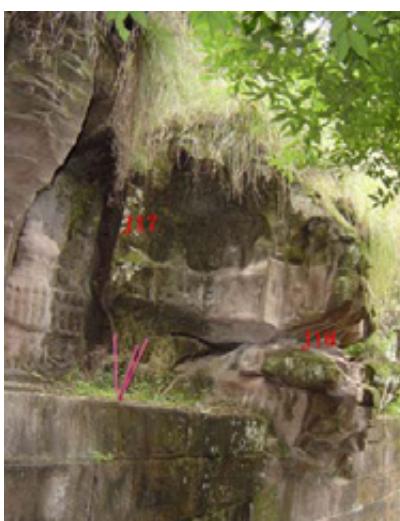
图 2-19 卸荷裂隙 J<sub>17</sub> 和 J<sub>18</sub>  
Fig. 2-19 Relief Joint J<sub>17</sub> and J<sub>18</sub>

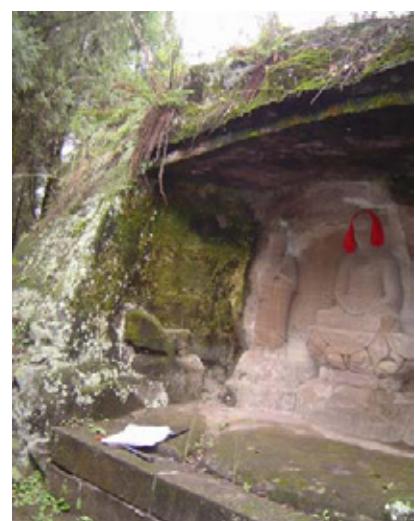
图 2-20 卸荷裂隙 J<sub>18</sub> 在 67 号龛边缘  
2-20 Relief Joint J<sub>18</sub> beside Niche No. 67

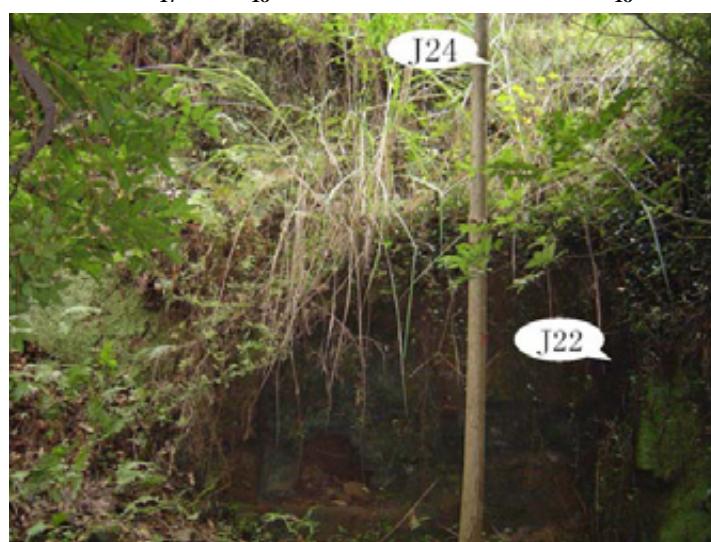
图 2-21 裂隙 J<sub>22</sub> 于 J<sub>24</sub> 切割形成危岩体  
Fig. 2-21 Unstable Rock Cut by J<sub>22</sub> and J<sub>24</sub> Joint

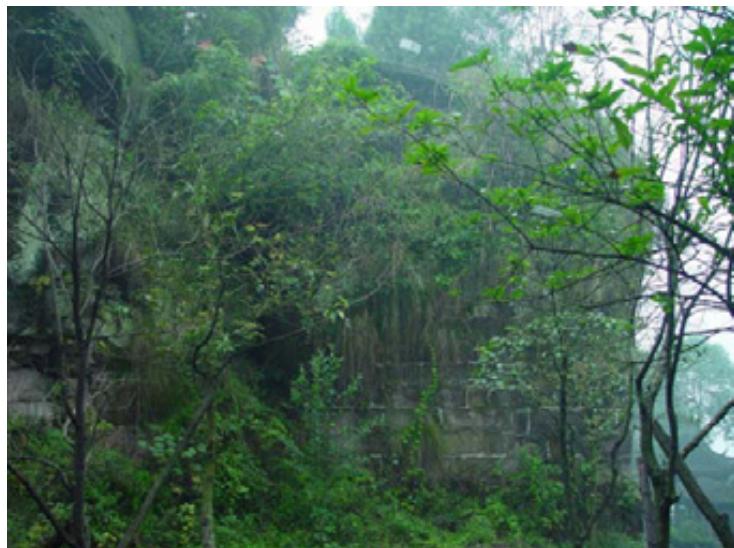
图 2-22 14 号龛后发育的卸荷裂隙  $J_{31}$

Fig. 2-22 Relief Joint  $J_{31}$  in the Back of Niche No.14

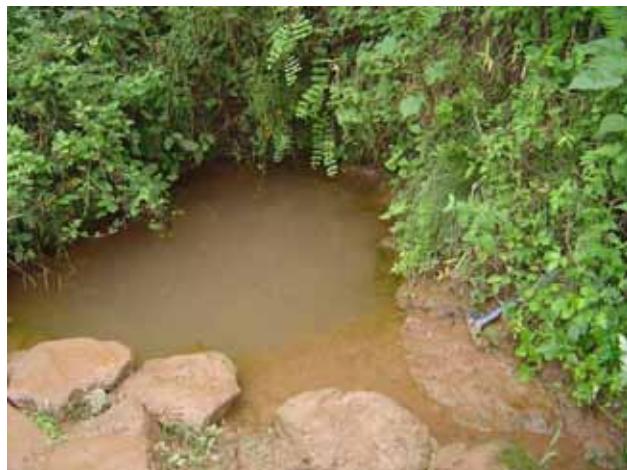
部砂岩裂隙中储存的地下水被下部相对隔水的泥岩阻隔，导致沿砂岩和泥岩交界面溢出成泉。

Because of the obstruction of the waterproof mudstone, the ground water stored in the sandstone fissures always overflowed as spring in the interface of sandstone and mudstone.

图 2-23 保护区西南角小路旁泉眼

**Fig. 2-23 Spring beside the Road of Southwest Yuanjuedong**

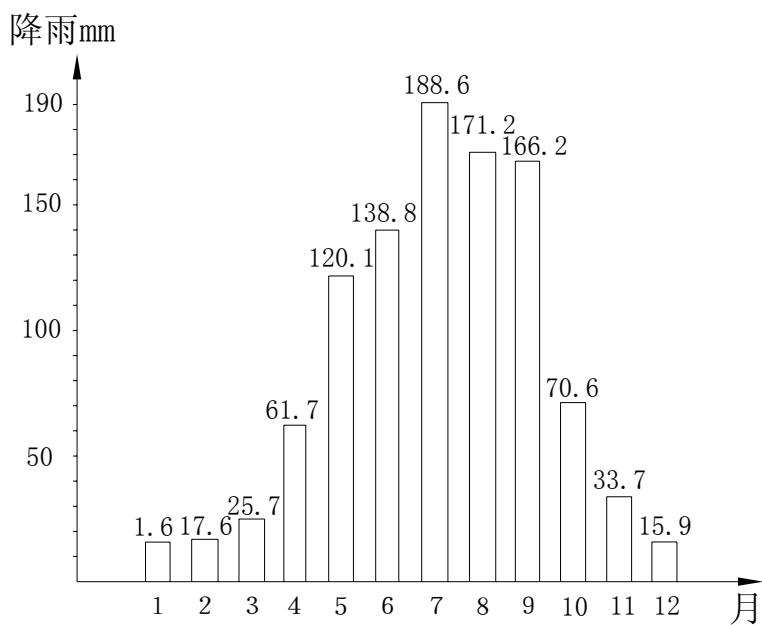
图 2-25 安岳县历年各月雨量比较

Fig. 2-25 Monthly Rainfall in the Past Years

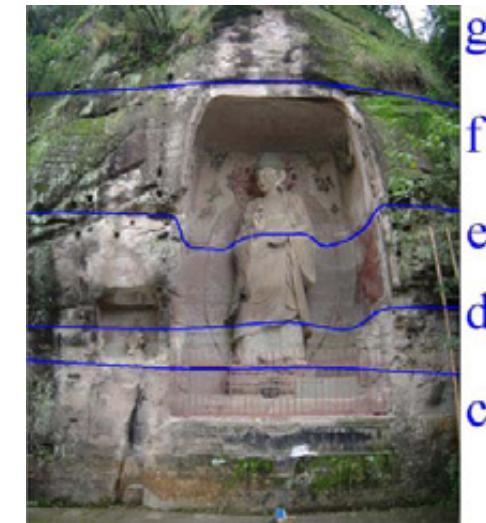
10 号窟

According to color, structure etc., the rock can be divided into 7 layers with a respective name of a, b, c, d, e, f, g. Group 10 covers layers from c to g. Group 5, which is near to Group 10 to be chosen to describe the rock layers integrally, covers from a to c.

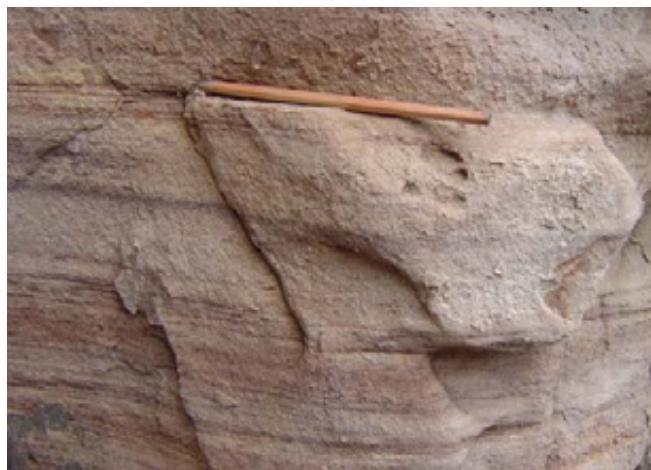
图 3-2 4 号龛 b 层水平层理发育

Fig. 3-2 Horizontal bedding in Group 4

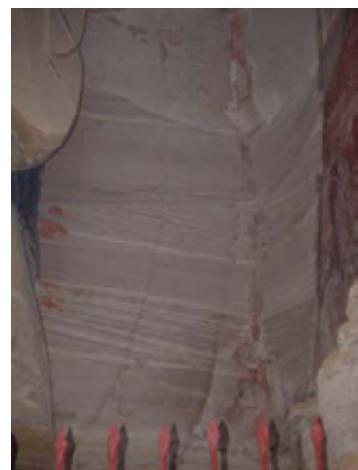
图 3-3 10 号龛 e 层中交错层理

Fig.3-3 Cross bedding in Group 10

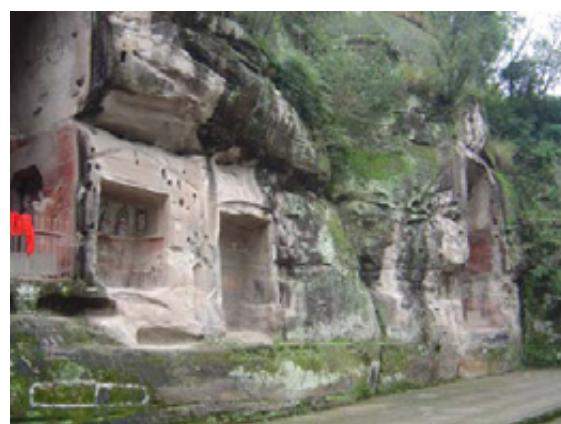
There are several bedding fissures developed in the rock, where seepage and weathering took place, leading to the weathering flute, especially between layer e and layer f.

图 3-4 岩壁层面形成凹槽

Fig.3-4 Weathering flute in the rock wall

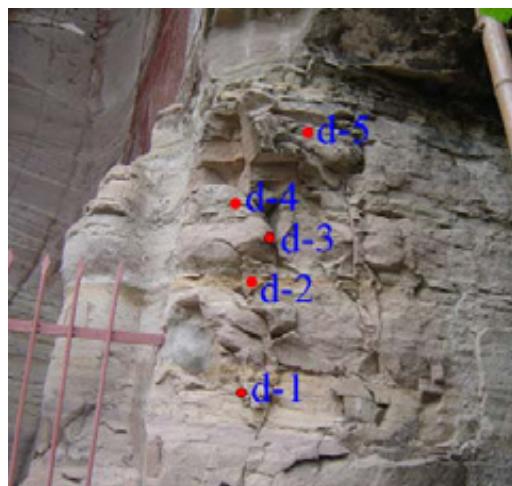
In order to investigate and analyze the reasons influencing the weathering of sculpture, rock samples from b to f stratum are tested, and quite some samples are taken from d stratum (Figure 3-5).

图 3-5 d 层取样点

Fig.3-5 Sampling spots for layer d

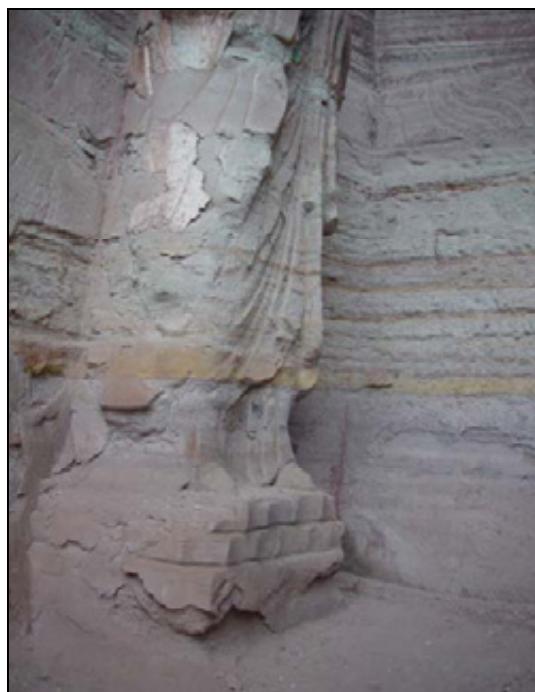
**图 4-1 10 号窟主佛右侧佛像风化病害现状**

**Fig.4-1 Weathering Condition of the Buddha on the Right Side of Sakyamuni figure in Group No.10**

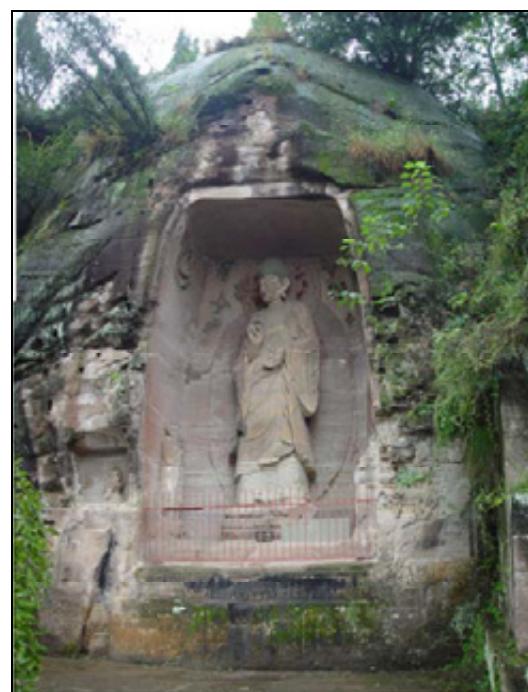
This grotto is badly preserved as a whole. The upper part of the Buddha figure is lost, an ellipse falling piece lies in the top stratification, and a fissure of 5 mm wide developed in the right wall. The weathering of this grotto is very serious, blister of the apical plate can be observed, and 1 to 5 mm thick

**图 4-2 10 号窟保存现状**

**Fig.4-2 Group No. 10**

crumbling occurred on the wall. The two rock walls along the grotto are covered by moss.

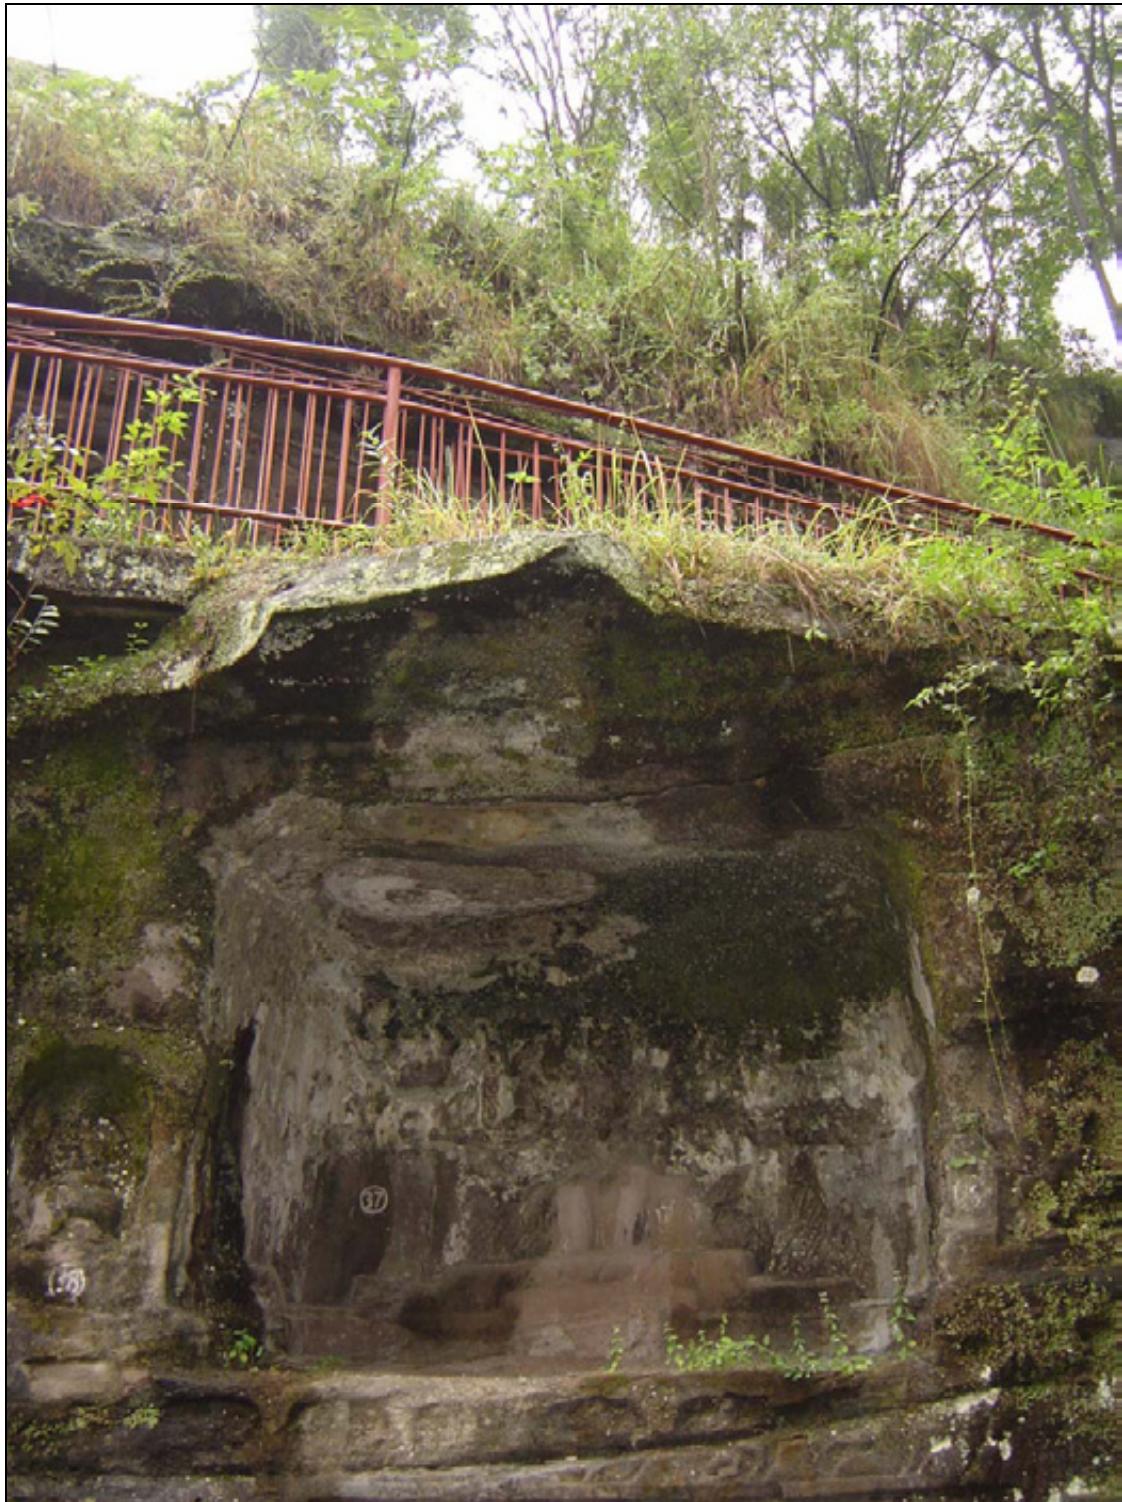
图 4-3 37 号龛保存现状

Fig.4-3 Group No. 37

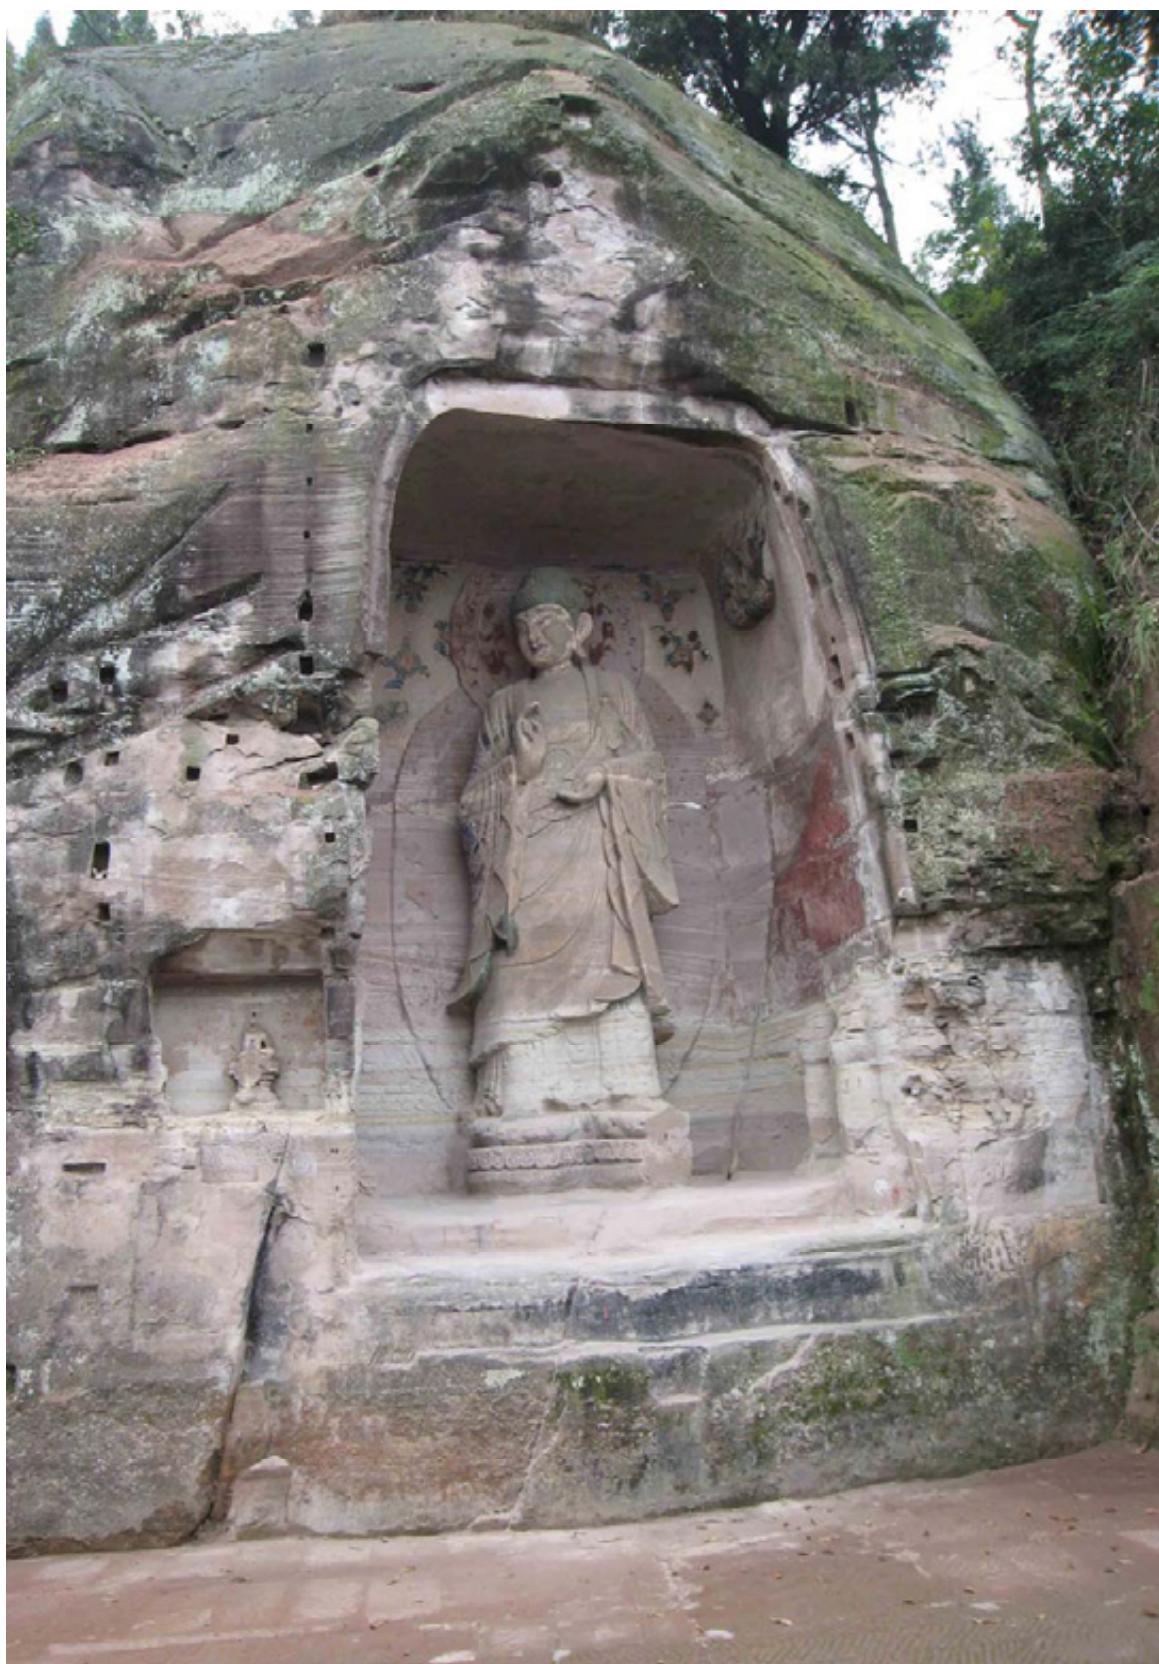
图 4-4 圆觉洞 10 号龛——释迦牟尼龛(2007.11)  
Fig. Group 10-Sakyamuni(Photodd in Nov. 2007)

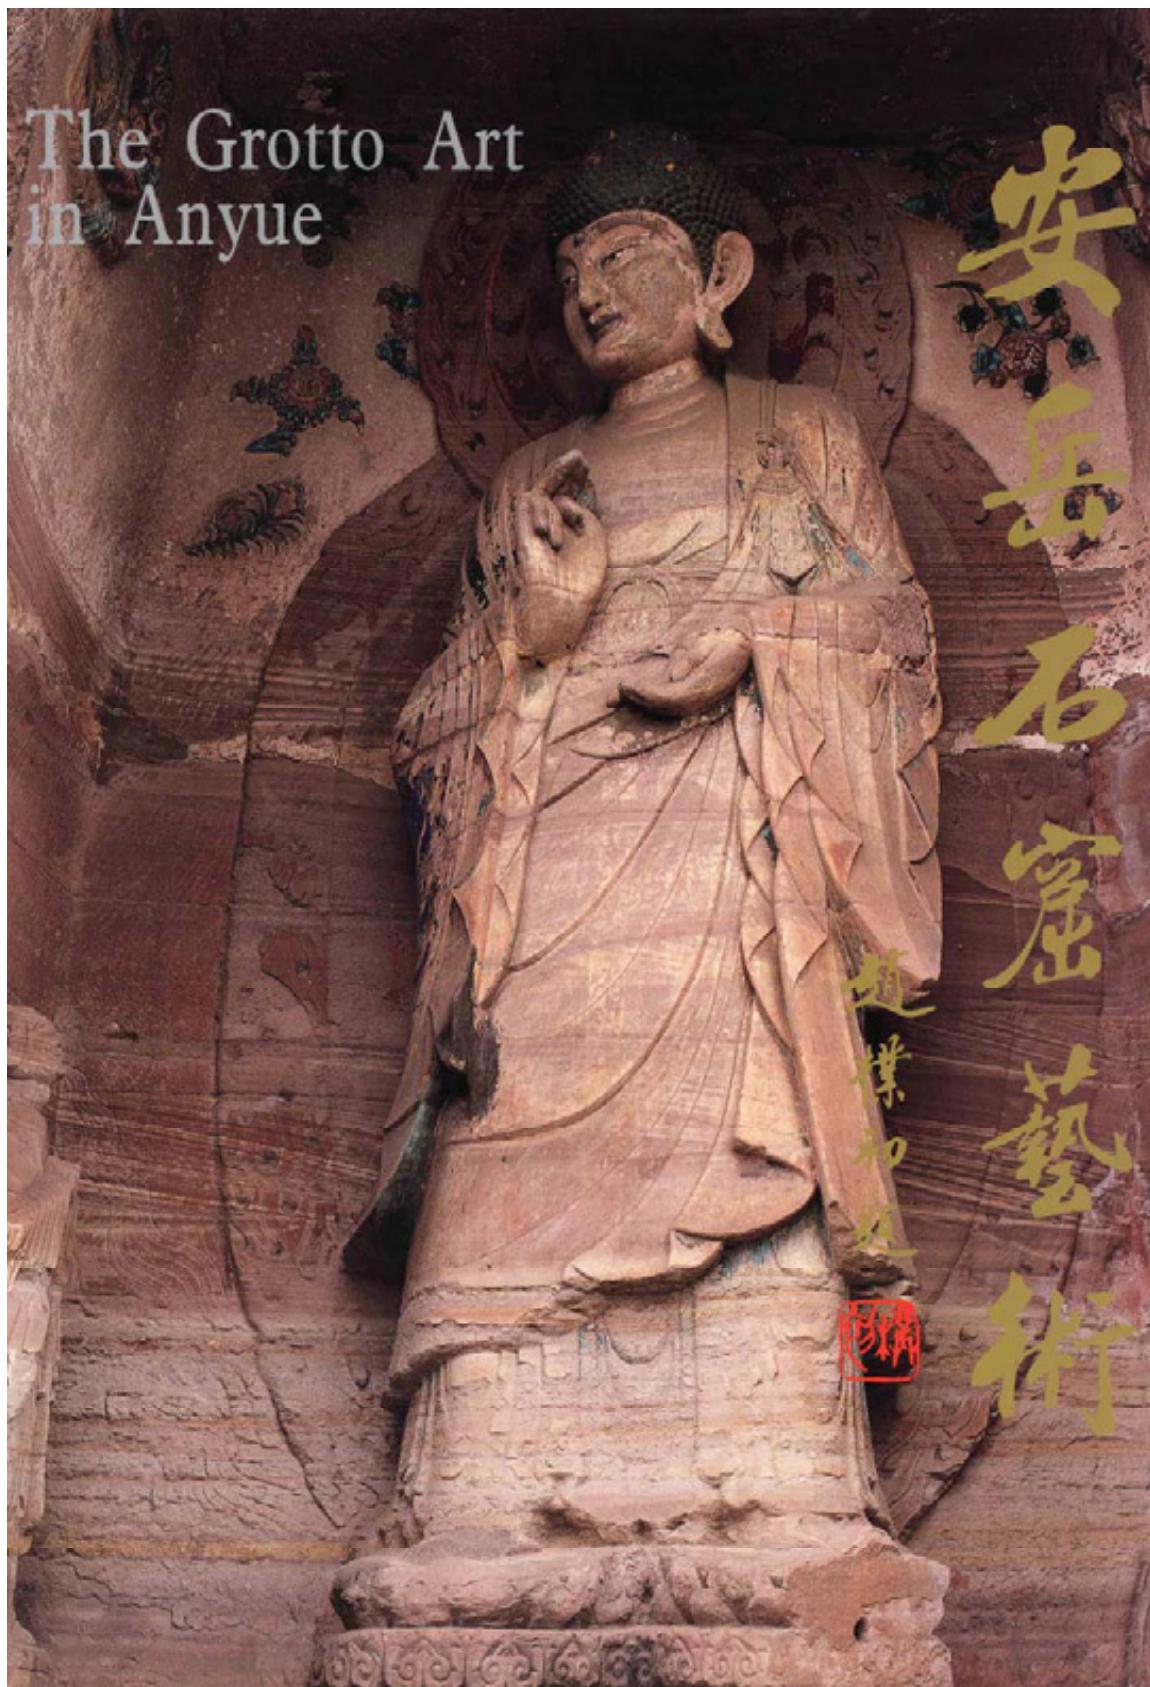
图 4-5 圆觉洞 10 号龛——释迦牟尼龛(自《安岳石窟艺术》1997.04 出版)

Fig.4-5 Group 10-Sakyamuni from *The Grotto Art in Anyue*, Published in April, 1997

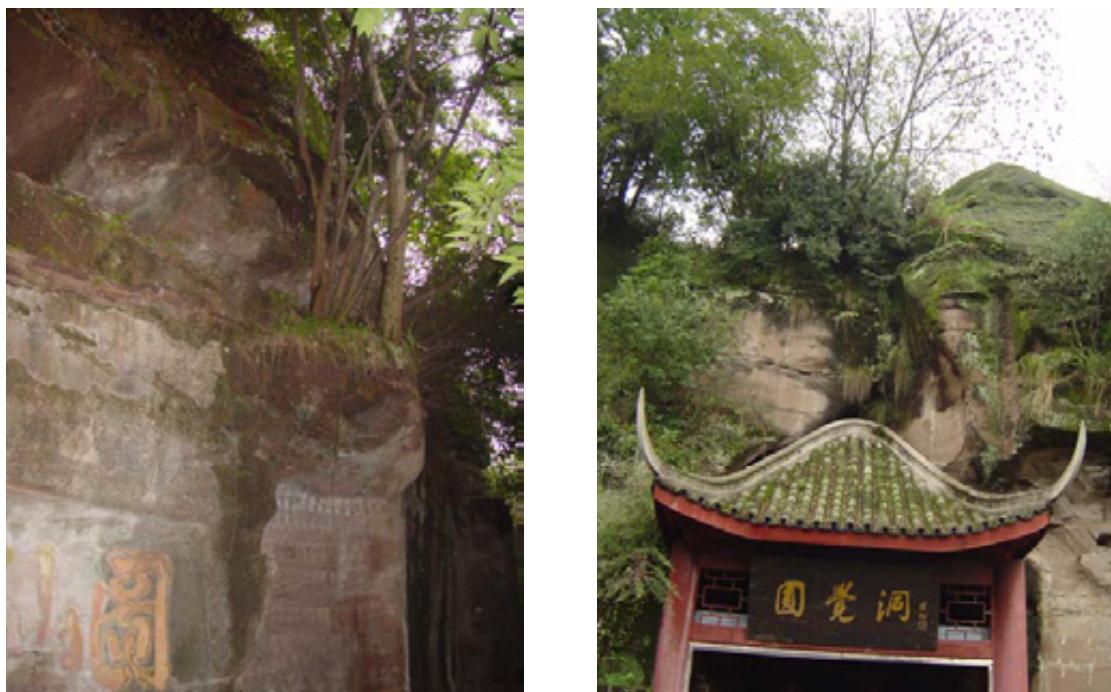
Anyue County lies in middle subtropical monsoon area with humid climate and plenty of rainfall. Lots of widely-opened structural fissures are distributed on the cliff wall of Yuanjuedong, which is filled in by the earth of Quaternary System, thus provide good living environment for the weed and tree. Large numbers of moss, weed and tree are grew on the cliff wall of SCA, these plants, especially their flourishing root system have great influence on the stone carvings. Firstly, the plants prolong the residence time of moisture on rock surface, and then extend the time of permeation to the grottoes, which will increase the acting time of water and rock. Secondly, during the plant growth, the rotting and deterioration of its root system will generate acid materials, which can accelerate the corrosion and dissolution of the rock. Thirdly, the plant root will extend continuously along the rock crack, which will expand the crack and lead to the break down and falling of the rocks. The trees growing in the fissure, weathering flute and weak interlayer have even greater influence on the cliff rock, and the flourishing root system will break down the rock, decrease its intensity and then increase the velocity of rock instability (Figure 5-1).

图 5-1 裂隙中根系发育产生生物风化病害

Fig.5-1 Biological Weathering Disease Resulted from Plant Root Growth

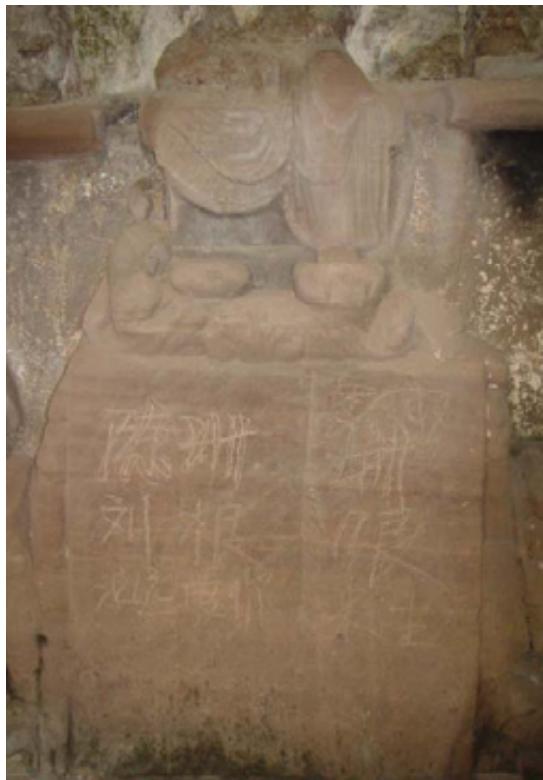
**图 5-2 人为刻画形成文物损害**  
**Fig.5-2 Damage Caused by Human Activity**

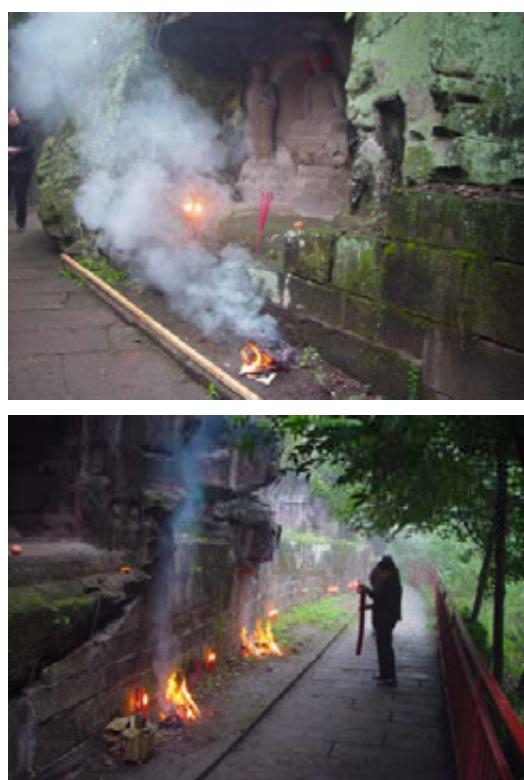
**图 5-3 祭祀烧香对文物的烟熏**  
**Fig.5-3 Smoking Disease Caused by Sacrifice and Perfume Burning**

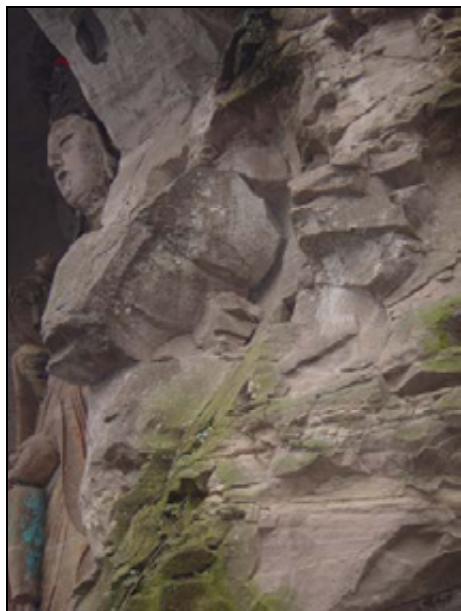
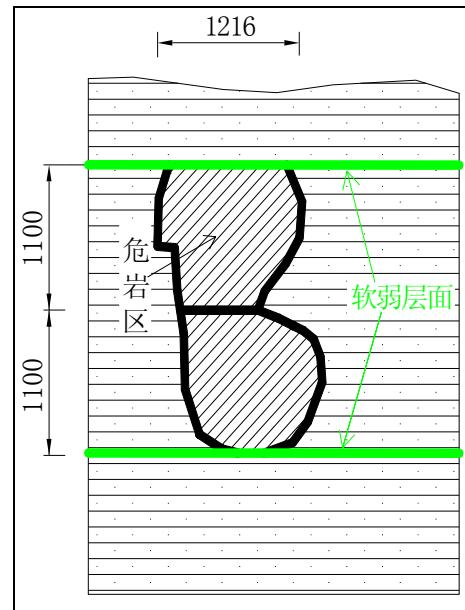
1号危岩体正面图  
Front View of No. 1 Unsafe Rock

No. 1 unsafe rock lies on the left wall of No. 7 Jingping Kwan-yin Niche, which is 2.2 m high, 1.22 m wide, 0.9 m thick and 2.9 m above the ground surface. Both on the bottom and top of the unsafe rock No. 1, a weak intercalation is developed. Because of the intersect of the relief joint with 65° dip angle and the weak intercalation, the upper part of the unsafe rock is separated from the mountain body, and only the 0.8 m lower part supports the load of the whole unsafe rock, which can be seen from Fig 6-1. The possible destroy mode of this unsafe rock under the influence of gravity and circumstances is downward shear sliding destroy along the fissure surface.

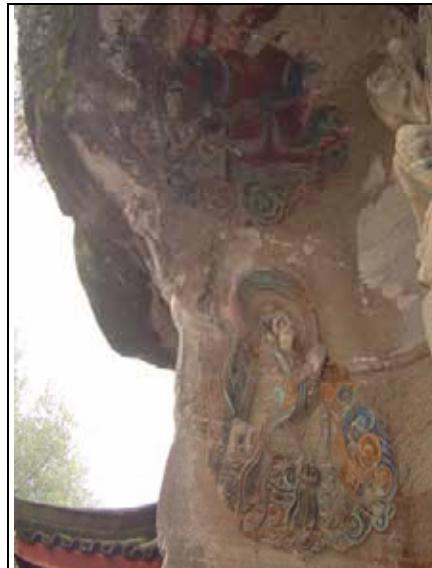
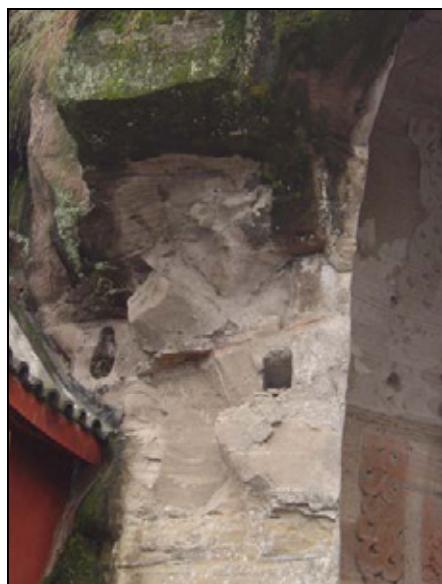
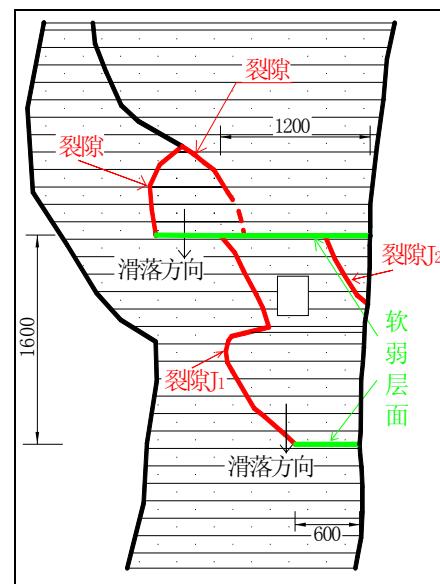
2号危岩体正面图  
Front View of No. 2 Unsafe Rock

Longitudinal Profile of No. 2 Unsafe Rock

Anchoring measures are recommended for the reinforcement of No.2 unsafe rock.

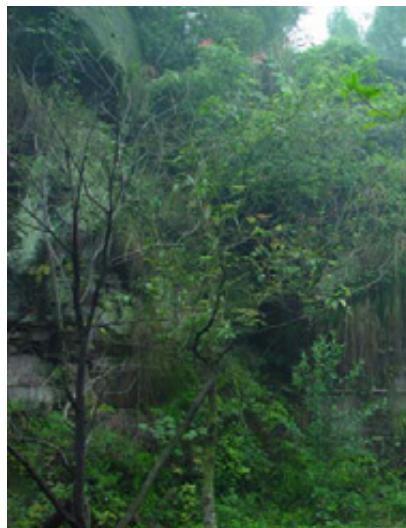
(a) 3号危岩体右侧裂隙

(a) Fissure on the Right Side of No. 3

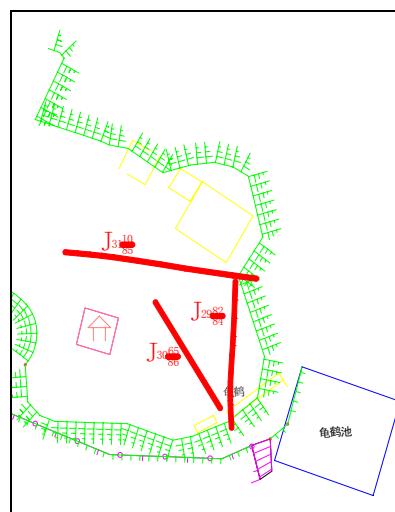
(b) 3号危岩体平面图

(b) Plane View of No. 3 Unsafe Rock

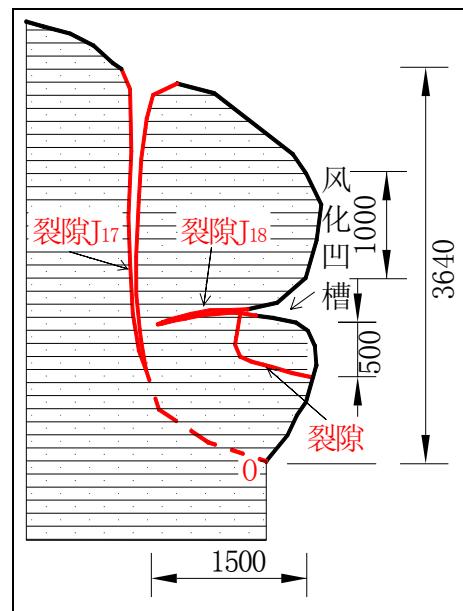
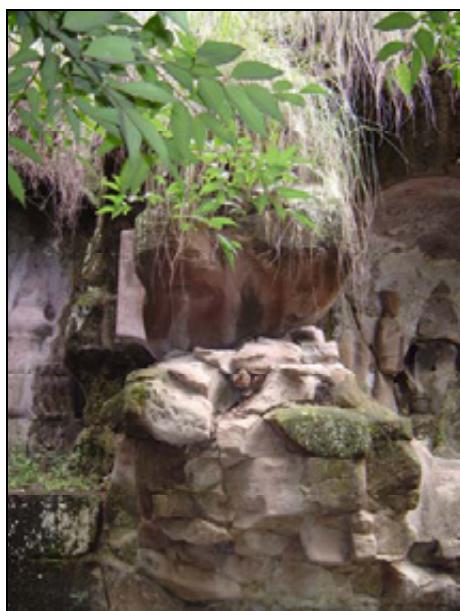
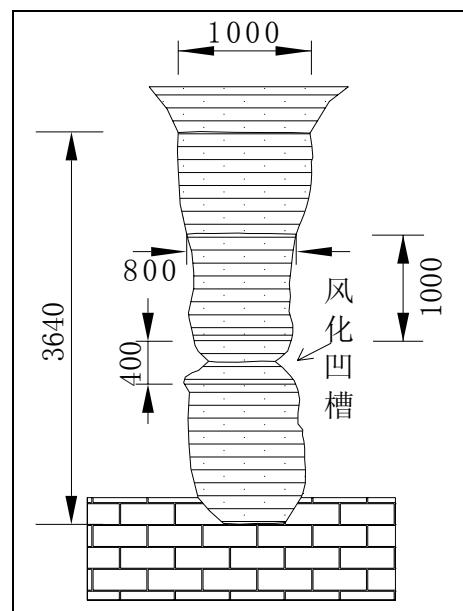
4号危岩体正面  
Front Face of No. 4 Unsafe Rock

4号危岩体侧面  
Lateral Surface of No. 4 Unsafe Rock

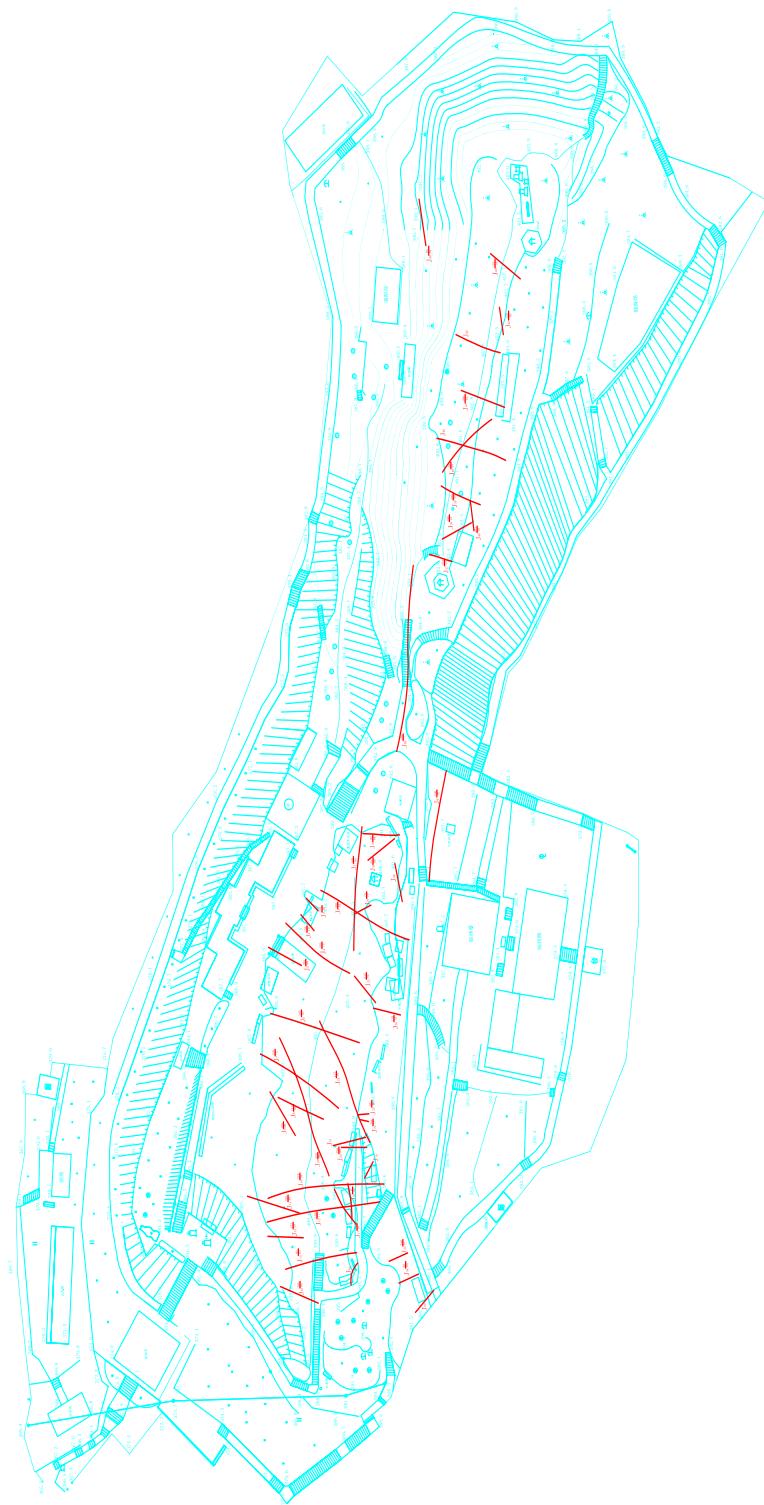
## Fissure Distribution Map

# 圆觉洞石刻保护区裂隙分布图

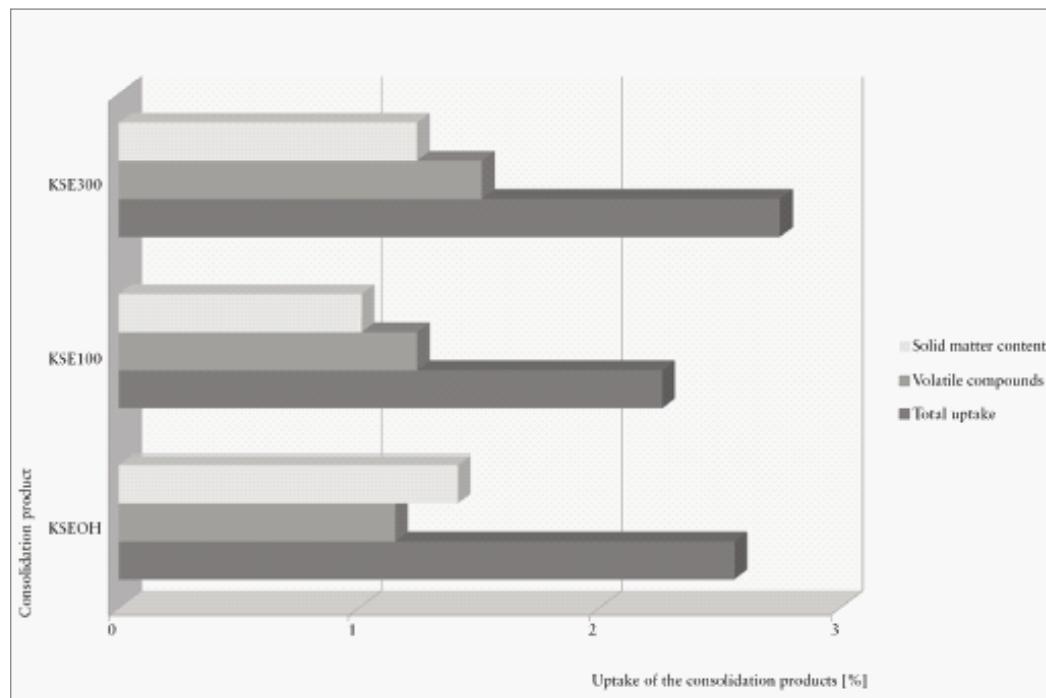
**Fig. 2:** Differing absorption of the consolidation products by the stone slices

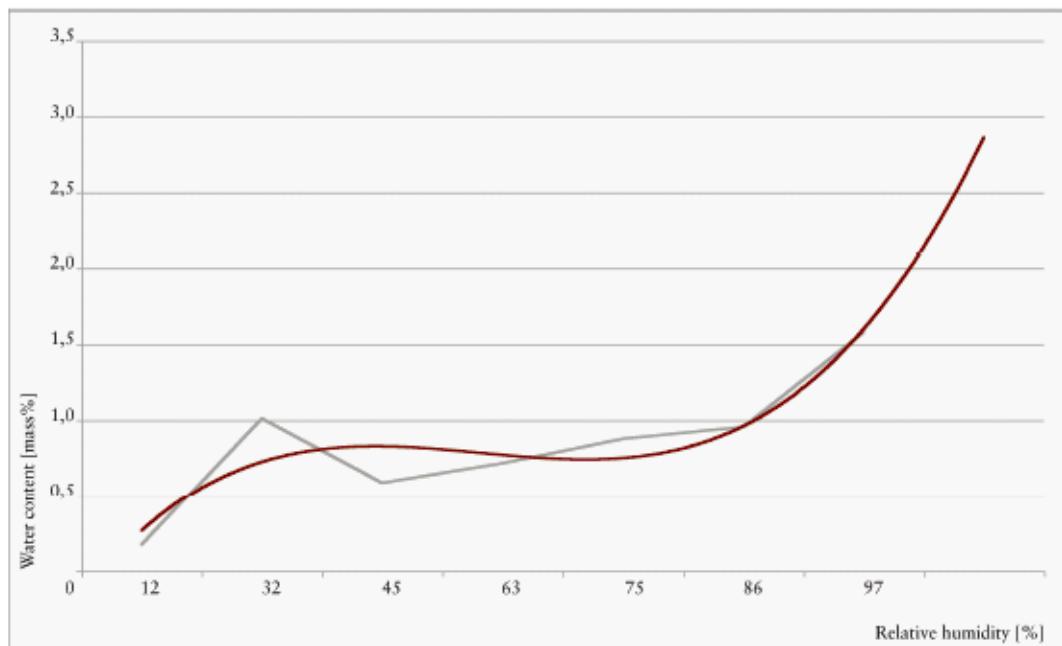
Fig. 4: Course of the isothermal line of sorption (red curve) determined using the measured values (gray curve)
