# **The Yuanjue Grottos in Anyue**

**Annual Report 2007–2009**

**BMBF Project 01 GWS 079**

近千年,在长期自然营力作用的影响下,四川安岳石刻岩体产生了严重的环境地质病害。构造裂隙、卸荷裂隙及层面裂隙交错切割,将石窟区的岩体切割成巨块状,形成危岩体,威胁游客和文物的安全,需要及时采取科学保护措施进行治理。因此,查明圆觉洞石刻环境地质病害的现状和成因,是四川安岳圆觉洞石刻区文物保护的首要任务。

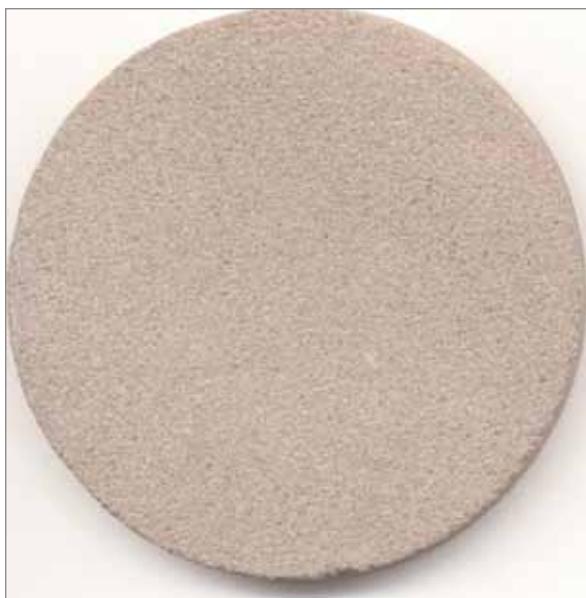
**Fig. 10:** Slice of the Anyue Sandstone

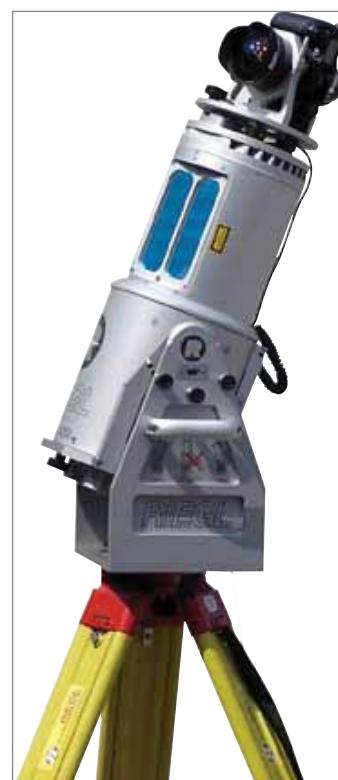
**Abb. 1:**  
3-D-Laserscanner  
LMS-Z 420i der  
Fa. Riegl

- Erfassung der Texturinformation mittels digitaler Spiegelreflexkamera Nikon D 100
- 3-D-Laserscanning der Gesamtgeometrien und der Detailinformationen mit Riegl LMS-Z420 i
- Vermessung der erreichbaren Bereiche mittels Streifenprojektionssystem QT-Sculptor PT-M 1280 in maximal möglicher Auflösung

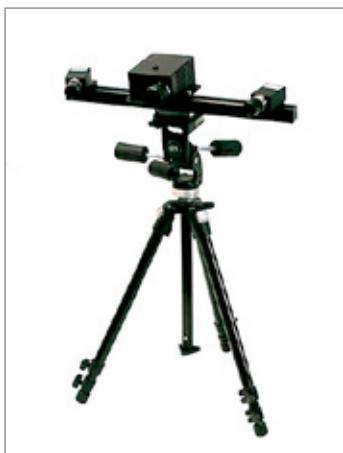
Zur Erfassung der komplexen Detailgeometrie und Verzierungen kam das Streifenprojektionssystem PT-M 1280 in Verbindung mit der Software QT-Sculptor zum Einsatz. Der Arbeitsbereich des Systems liegt zwischen 0,5–4 m, seine Genauigkeit bei max. 0,1 mm. Das Gerät arbeitet dabei standardmäßig mit Hochgeschwindigkeitskameras mit einer Auflösung von 1024 x 768 Pixel.

**Abb. 2:** Das Messsystem QT-Sculptor PT-M 1280

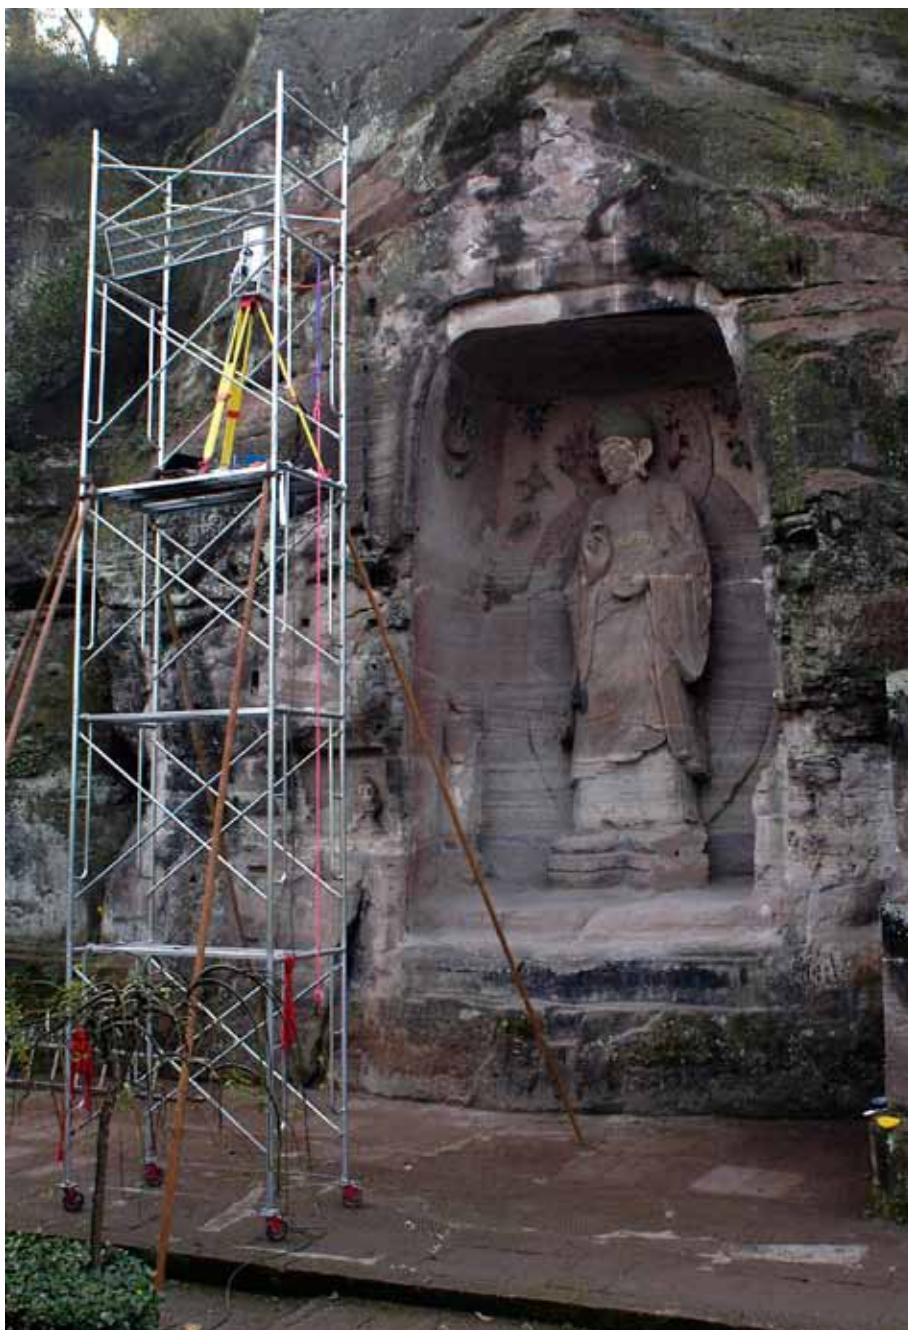
**Abb. 3:** Vermessung der Grotte Nr. 10 mit dem Riegl-Laserscanner auf dem fahrbaren Gerüst mit Stützkonstruktion

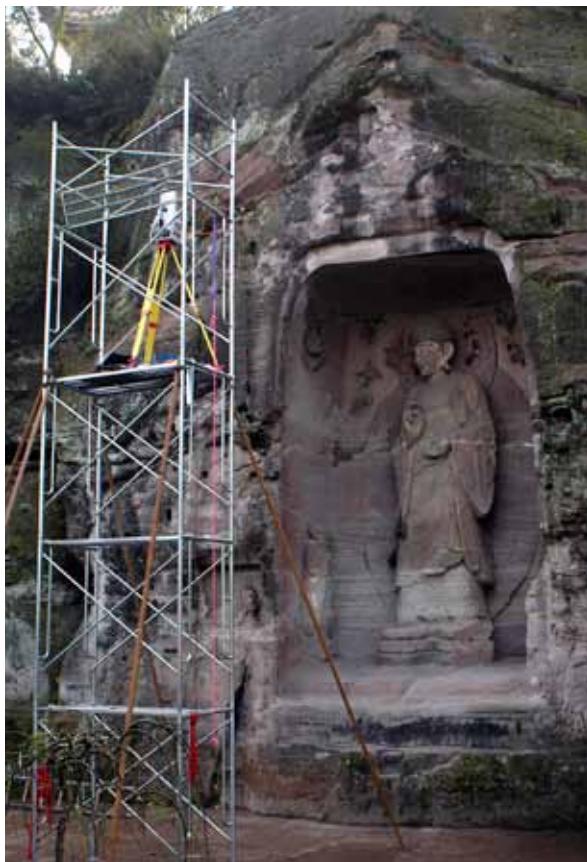
**Abb. 4:** Vermessung der Grotte Nr. 10 mit dem Riegl-Laserscanner

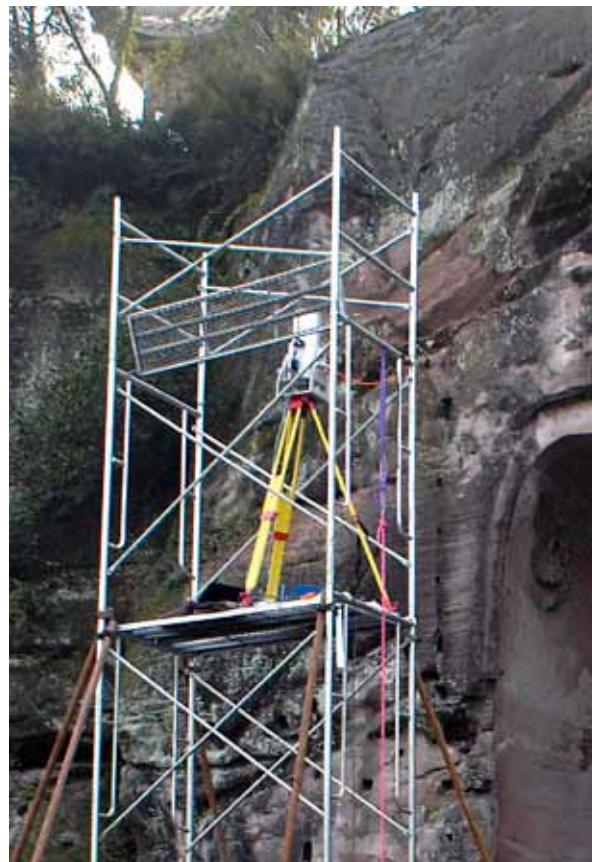
**Abb. 5:** Messungen innerhalb der Grotte Nr. 10 mit dem Riegl-Laserscanner

Aufgrund der Höhe und der Tiefe der Grotte war bereits im Vorfeld abzusehen, dass bestimmte Bereiche nicht zu erfassen sein würden. Dies betraf vor allem die Haube des Buddhas sowie verdeckte Bereiche am Kopf und den Schultern. Außerdem war am aufsteigenden Wandabschluss wegen zu steiler Zielungen und in den Bereichen hinter den seitlich angeordneten Figuren wegen zu geringem Aufnahmeabstand mit Aufnahmelücken zu rechnen.

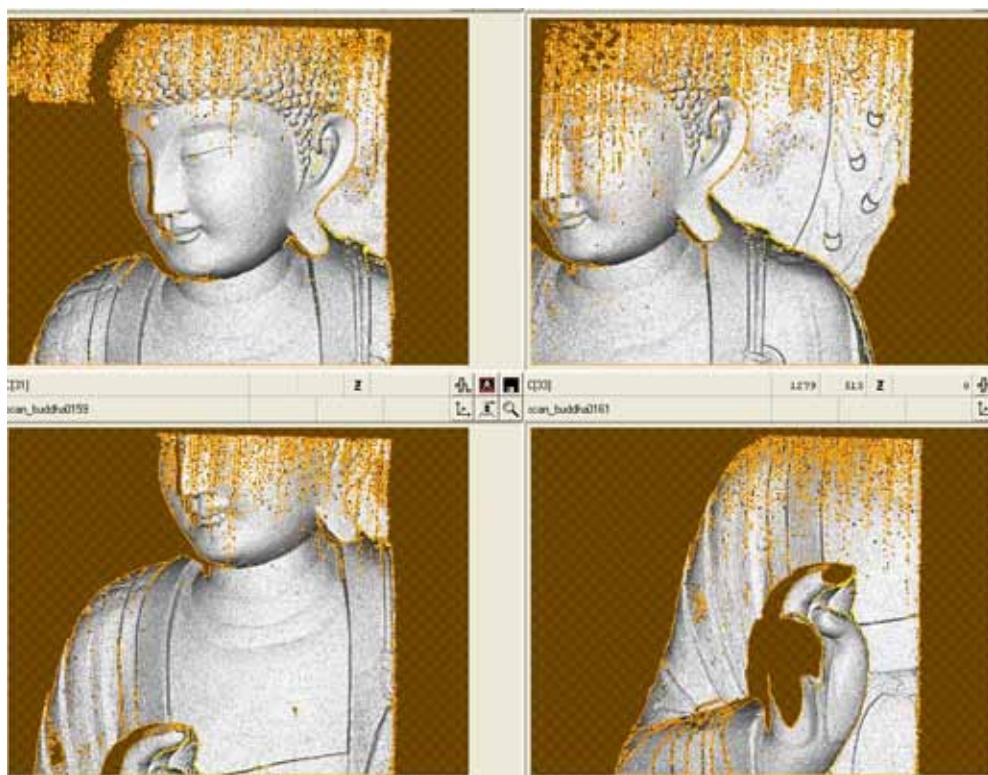
**Abb. 7:** Tiefenbild einer Scanposition (2-D)

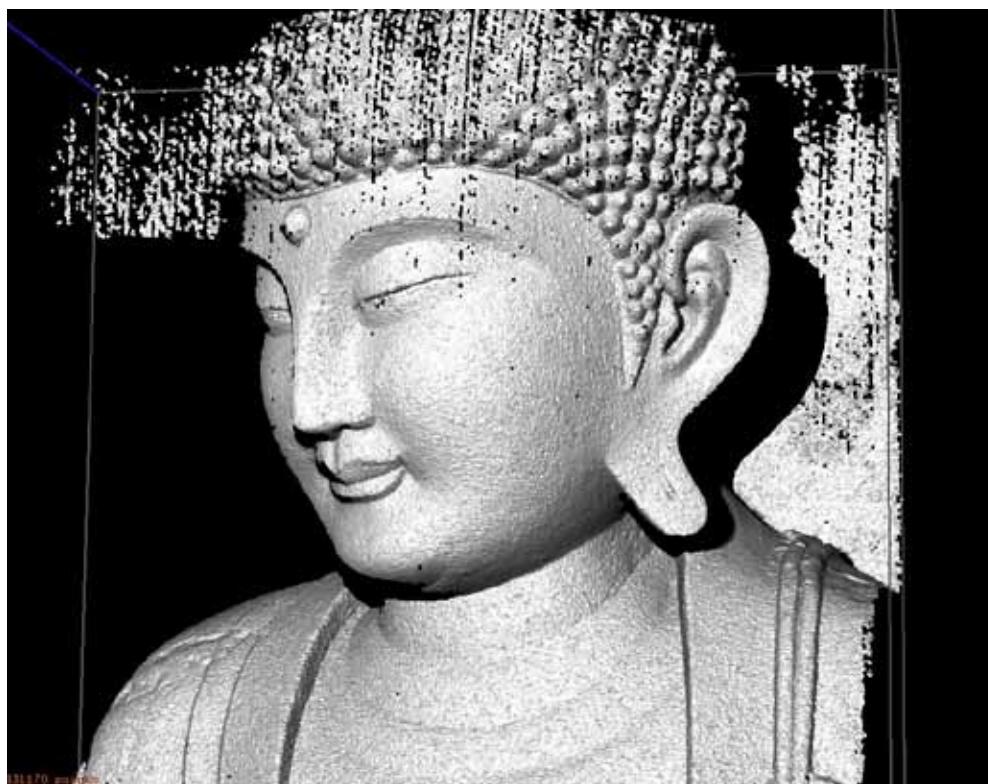
**Abb. 8:** Ansicht der beim Scannen entstandenen Punktwolke, Aufnahme mit QT-Sculptor

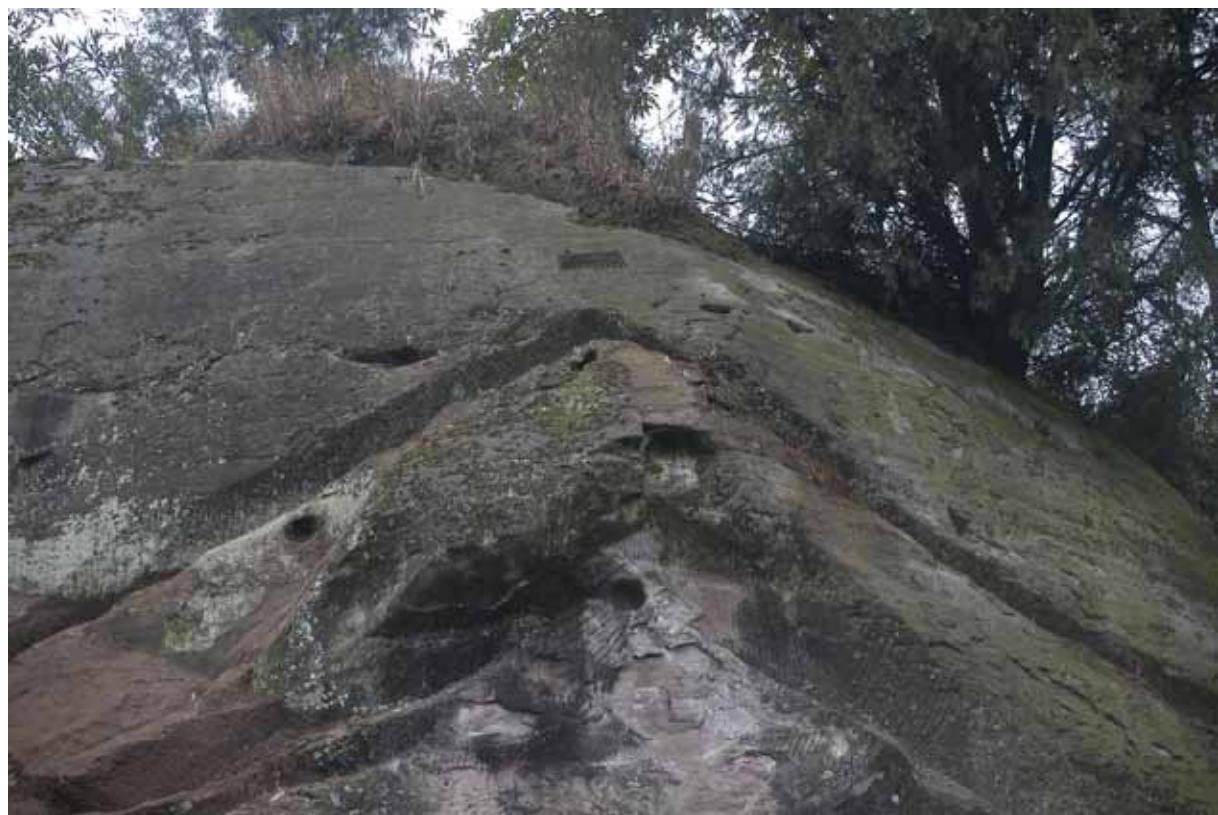
**Abb. 10:** Beispiel für ein Texturbild ohne Blitzlicht

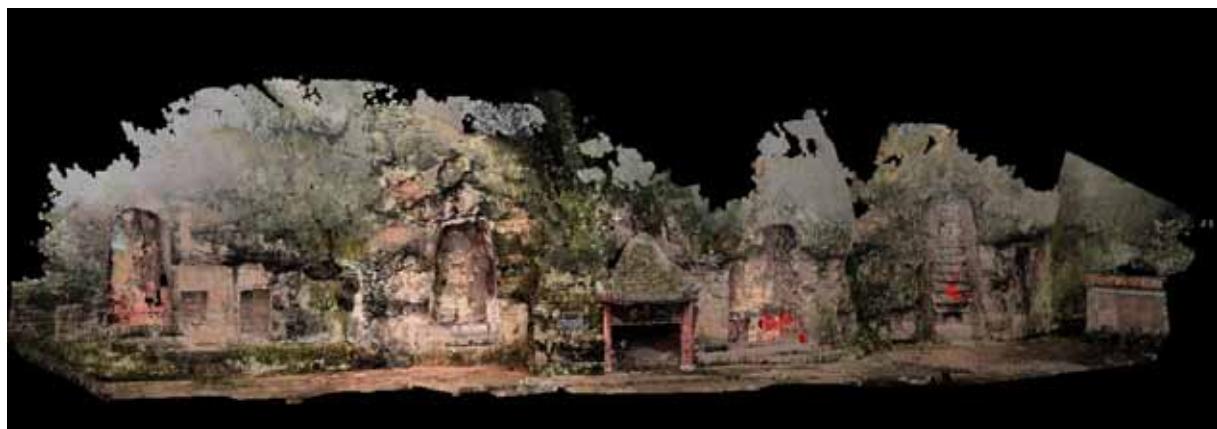
**Abb. 13:** Kolorierte Gesamtpunktwolke aller Standpunkte des Laserscanners

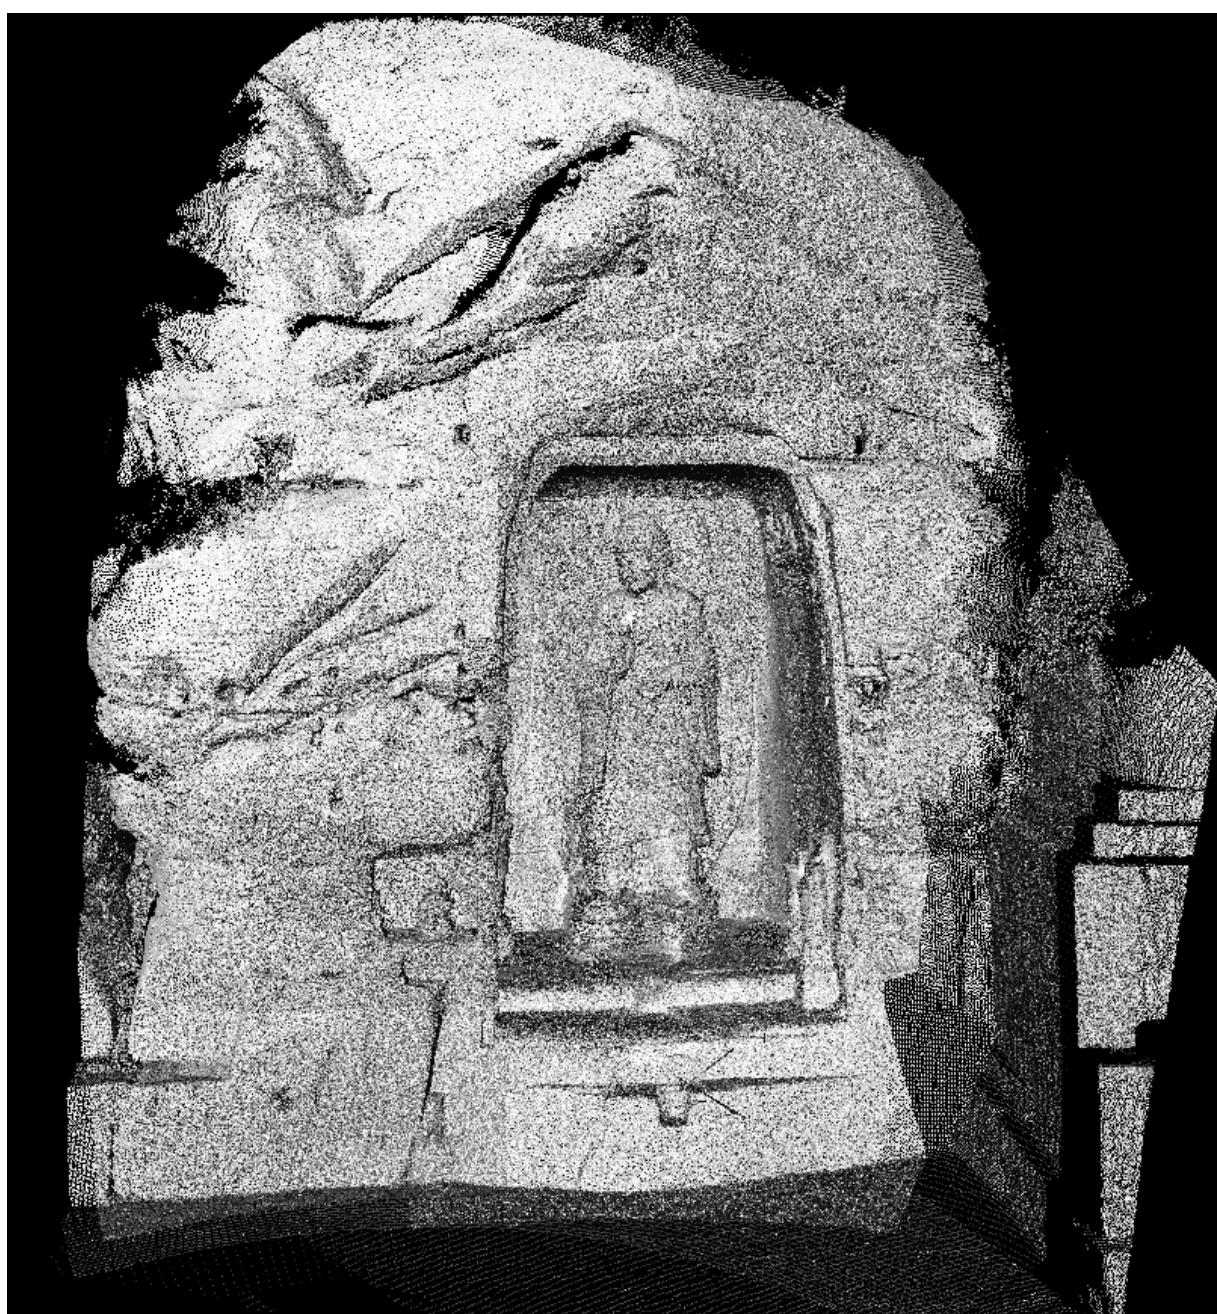
**Abb. 14:** Gesamtpunktwolke: Kombination der Laserscanner- und Streifenlicht-Aufnahmen mit QT-Sculptor an Grotte Nr. 10

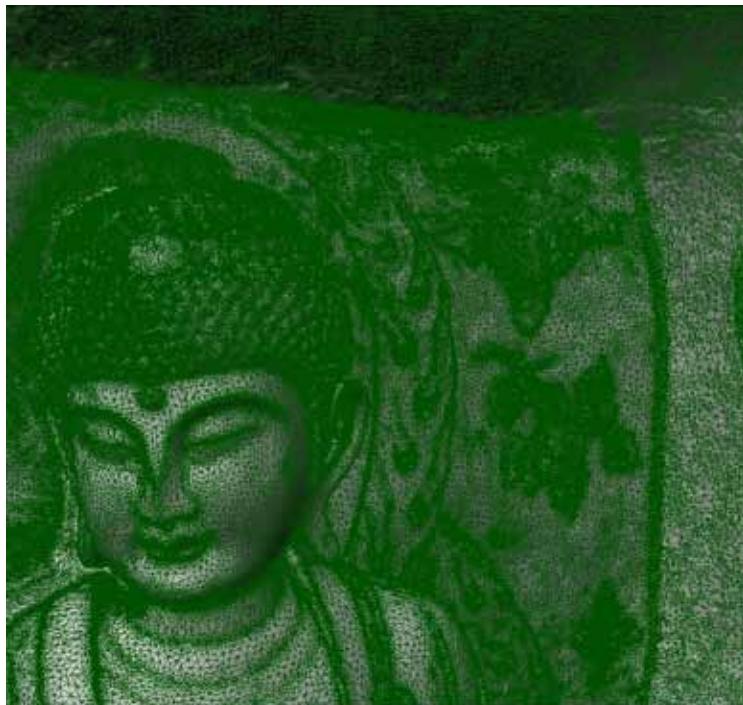
**Abb. 16:** Dreiecksvermaschung aus Laserscanner- und Streifenlichtdaten im Detail (schattierte Ansicht oben und Gitternetz unten)

Einige Bereiche am Kopf des Buddha, hinter der rechten Hand und im Schulterbereich sowie die rechte Seite des Mönches an der linken Grottenwand, konnten nicht erfasst werden. Hier entstanden im 3-D-Modell Fehlvermaschungen, die im Nachhinein manuell beseitigt werden mussten. Das Modell wurde an diesen Stellen vereinfacht geschlossen, um Löcher zu vermeiden. In diesen Bereichen muss mit Abweichungen vom Originalzustand gerechnet werden.

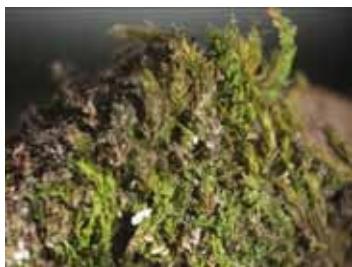
Sample 1a, b:

This sample is a piece of red sandstone on which a moss with small, nonvascular leaves have grown. On the outermost layer of stone, the moss has built up a 1<sup>+</sup>-millimetre thick layer of humus. In the mean time, it has dried out and is easily removed from the stone. On the layer of humus, there appears to be an optically light, damaged biogenic area that goes approximately one to two millimetres into the stone. In the layer of humus, the thick, brown rhizoids of the moss and the fine hypomyces mycelium creates a covering that extends into the biogenic layer. As the moss' rhizoids thin out over the intact stone area of the sample (up to 1,5 cm) and are able to penetrate the stone, the fine, transparent fungal hyphae can be found throughout the entire sample. In the sample, there is the typical musty to earthy smell of mold, which is a by-product of metabolic processes. A complex mixture of volatile organic compounds belonging to the material classes of the alcohols, ketones, terpenes, and aromatic compounds are responsible for this.

In the corresponding thin section (< 20 µm), the inspection of a cross-section of up to 7 mm located over the stone matrix confirms the penetration of moss rhizoids through the test sample. Decomposing biogenic material collects in its many pores and appears to be a diffused brown mass. The intact moss rhizoids appear to be fibrous, structured plant pieces.

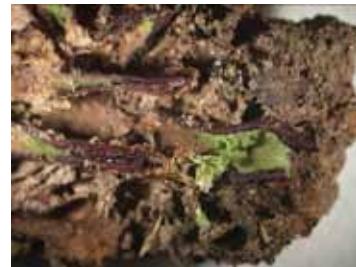
Sample 2a, b:

Just as in Sample 1, there is a piece of red sandstone, on which a piece of moss with wide, non-vascular leaves has grown. In this sample, a 1<sup>+</sup>-millimetre thick layer of humus has built up under the layer of moss. The thicker this layer is, the more easily it can be removed. In this sample, the layer of humus has dried out.

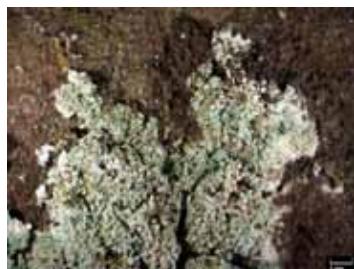
Sample 3a, b:

The red sandstone, as in Samples 1 and 2, is covered with a white-green lichen. Under this layer of lichen is a moss growth that has already been largely displaced from the lichen. The Bryopsida can only sporadically be identified.

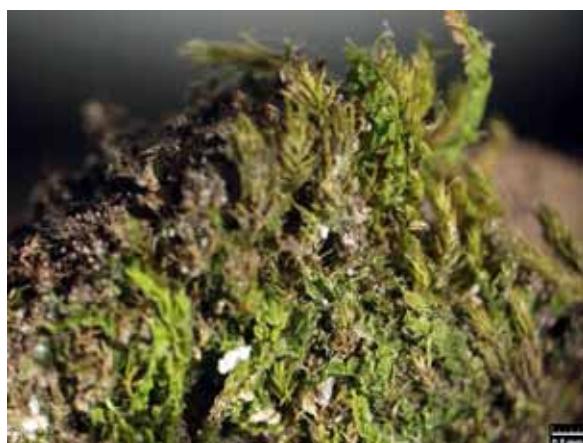
**Image 1:** Overview of Sample 1: Sandstone with vigorous moss growth (LM, approx. 16x).

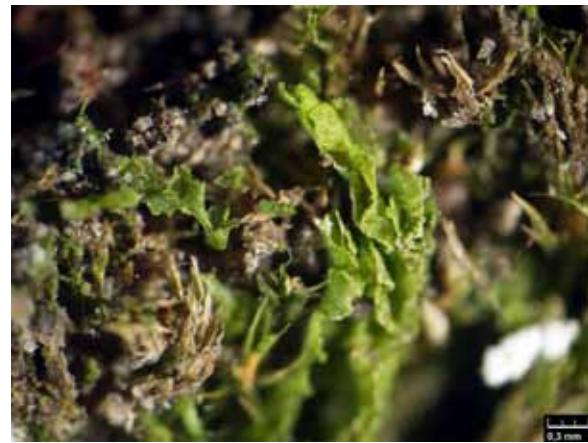
**Image 2:** Detail of Sample 1: The small, non-vascular Bryopsida appears to be *Gyroweisia* sp. (LM, ca. 40x)

- In addition, the fact that the *Gyroweisia sp.* moss found in Sample 1 has not yet been seen in China. In this instance, it is possible that it is a type that has not yet been discovered! If circumstances allow, this biodiversity-enriching new moss should be left in place.

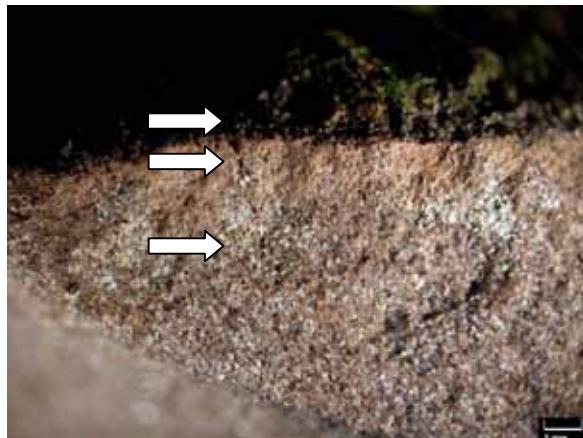
**Image 3:** Overview of the Sample: In this photo, the different layers of humus and the original layer of sandstone are visible (LM, approx. 11x)

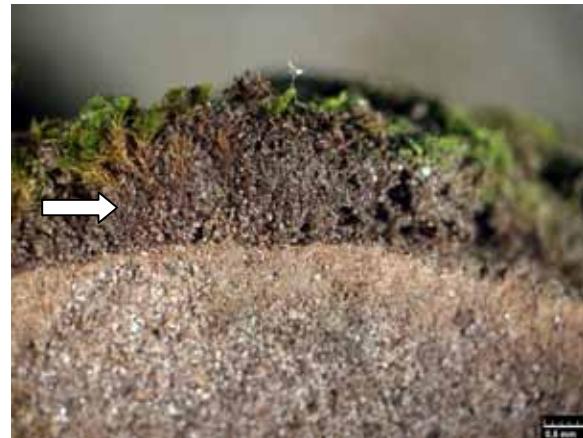
**Image 4:** Detail: Under the moss, a layer of humus about 1 mm thick has built up and is easily removed from the outer layer of the stone (LM, approx. 20x)

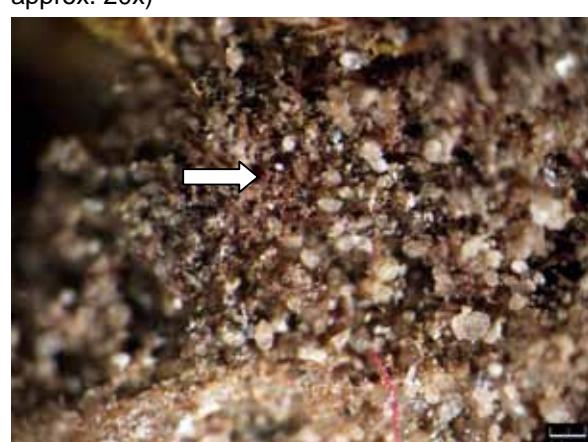
**Image 6:** Detail: Moss rhizoids (red brown) have completely grown through the layer of humus (LM, approx. 50 x)

- As a rule, mosses and lichens are typically more protective of than damaging to the stone. The sandstone that is present here has over a loose, very porous structure, through which moss rhizoids easily grow. Their growth can also help to consolidate and strengthen the sandstone structure.

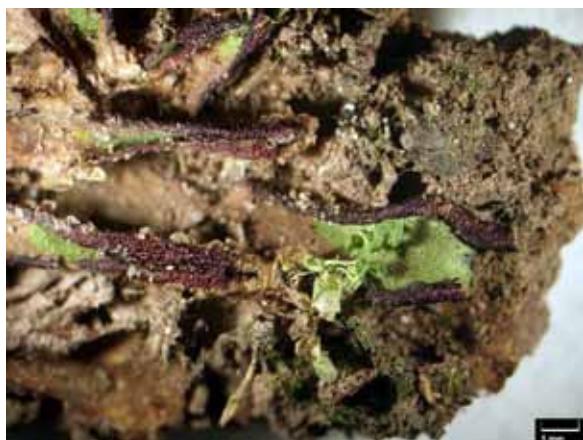
**Image 1:** Overview of Sample 2: Sandstone with moss, whose green wide thalli are curling up because of dry local conditions (LM, approx. 11x)

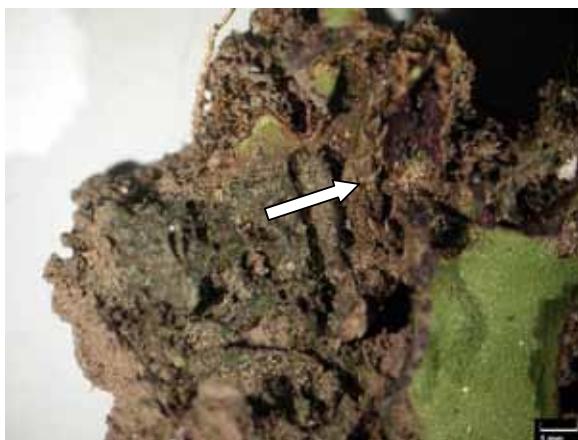
**Image 2:** Overview of Sample 2: In some spots, there are traces of a previously existing moss colony. Here is the dead stem with small pieces of a Bryopsida (LM, approx. 11x)

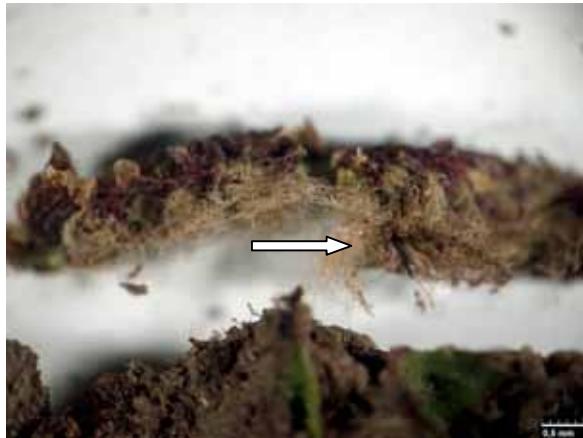
**Image 3:** In the cross section The light Marchantiophyta rhizoids, which are one-celled and more delicate than the dark brown rhizoids of the previously existing moss colony (LM, approx. 20x)

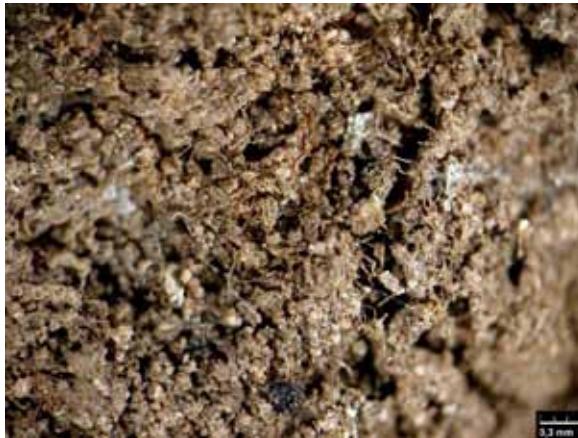
**Image 4:** Overview of the outer layer of stone after removal of the moss growth, with the light rhizoids of the Marchantiophyta and the dark brown rhizoids of the Bryopsida (LM, approx. 40x)

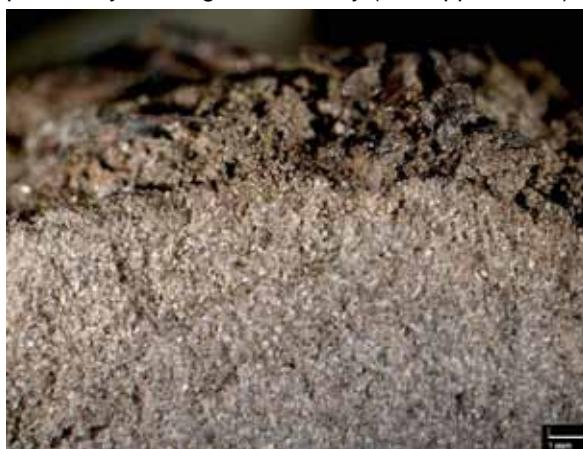
**Image 5:** Cross section of Sample 2: In this probe, it is remarkable that there is a barely noticeable or missing biogenic layer (LM, approx. 11x)

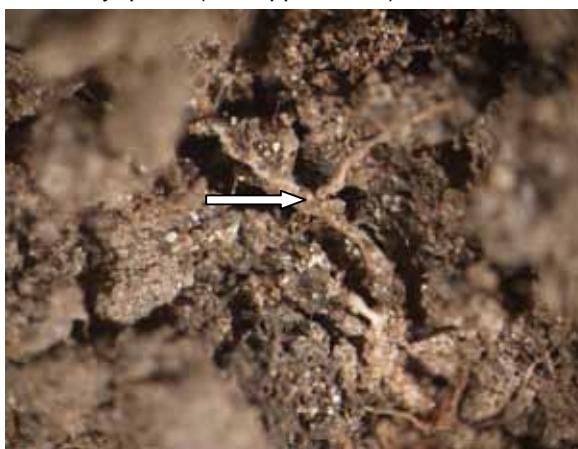
**Image 6:** Cross Section of Sample 2: In the layer of humus, pieces of higher-order plants can be found, just as in layers where germination can occur (LM, approx. 32x)

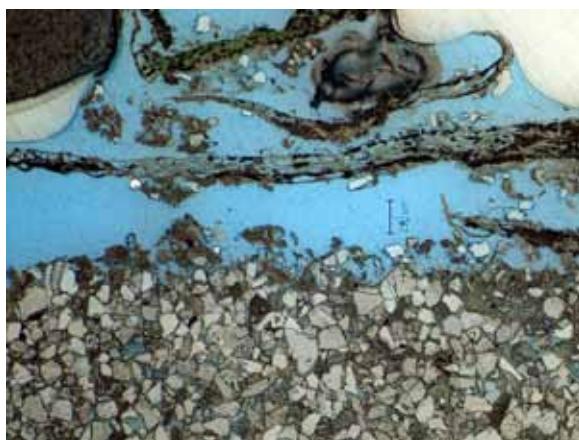
**Image 7:** Thin Section/Cross Section: The wide Marchantiophyta thallus has become separated from the stone (LM, approx. 50x)

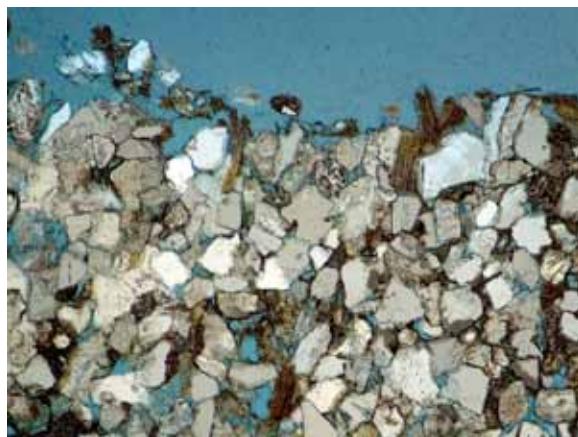
**Image 10:** Thin Section/Cross Section: Here in detail, the structure of the rhizoids and the amorphous material of dead biomasses, with its own microbial colony and stored metabolic processes, can be distinguished from each other (LM/POL, approx. 100x)

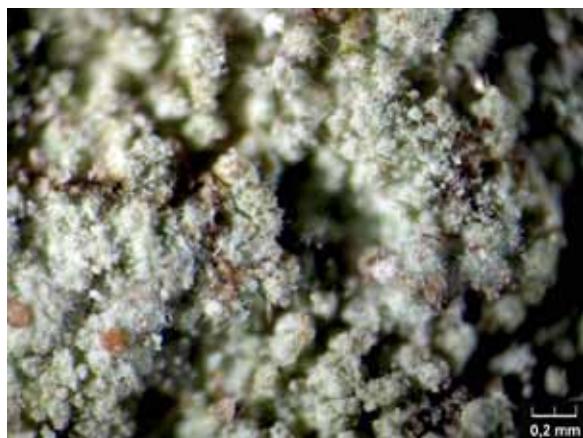
**Image 03:** Detail: The lichen *Lepraria* spec. has a relatively simple construction. Cotton-like particles break down the thallus into fine particles (LM, ca. 64x)

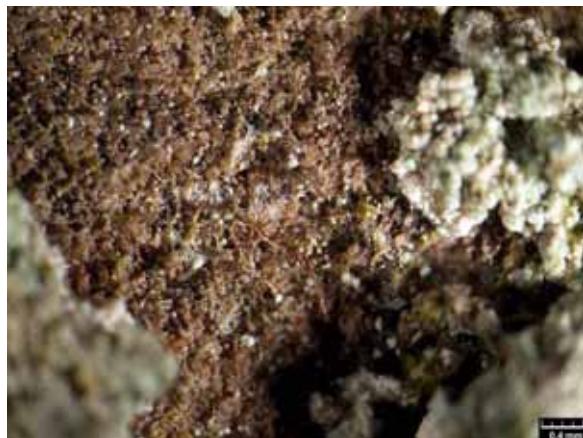
**Image 05:** Overview of Sample 3: On the outermost layer of the stone, rhizoids from a previous moss growth are visible (LM, approx. 32x)

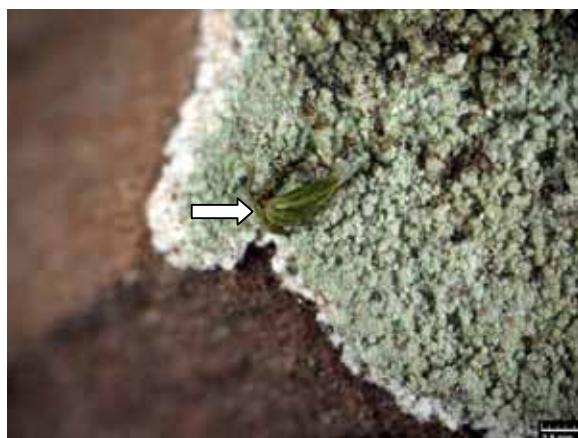
**Image 02:** Detail: *Lepraria* spec. can establish itself on a bryopsida. The lichen growth has almost completely pushed back the moss. In addition, the green, algae-rich area is present in the outer area of the lichen thallus (LM, approx. 20x)

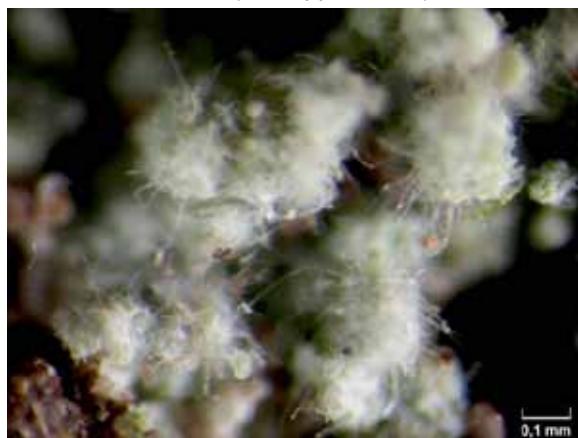
**Image 04:** Detail: Green algae is imbedded into the small pieces which make up the white fungus mycelium (LM, approx. 144x)

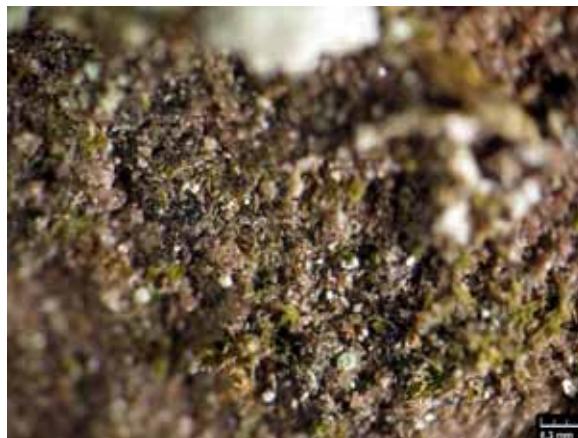
**Image 06:** Overview of Sample 3: There are also moss protonemata next to the rhizoids (LM, approx. 40x)

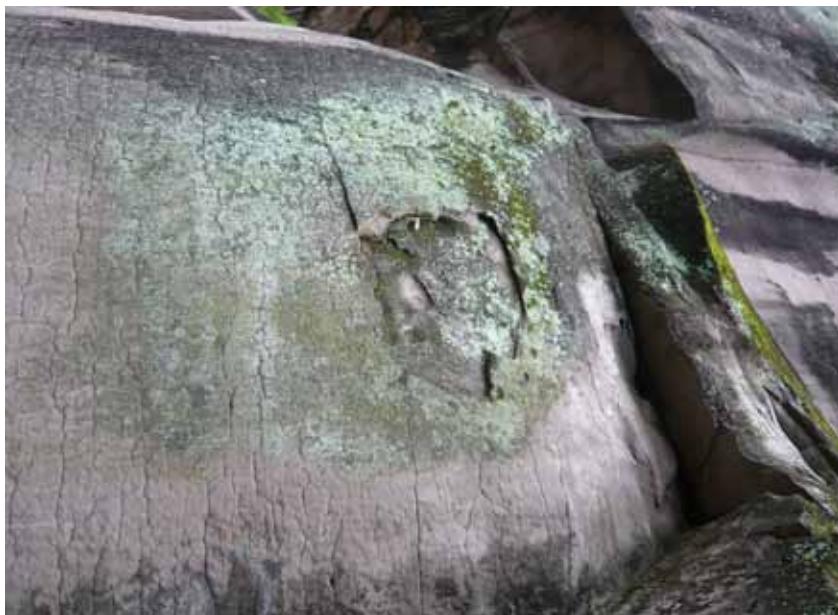
Moss and ferns, which are covering the grottoes in part flat, are able to store humidity. This leads to a permanent raise of the stone moisture onto and within the covered area, with the long term consequence of a considerable structural damage of the stone.

**Fig. 4:** Scaling as a reason of permanent moisture penetration

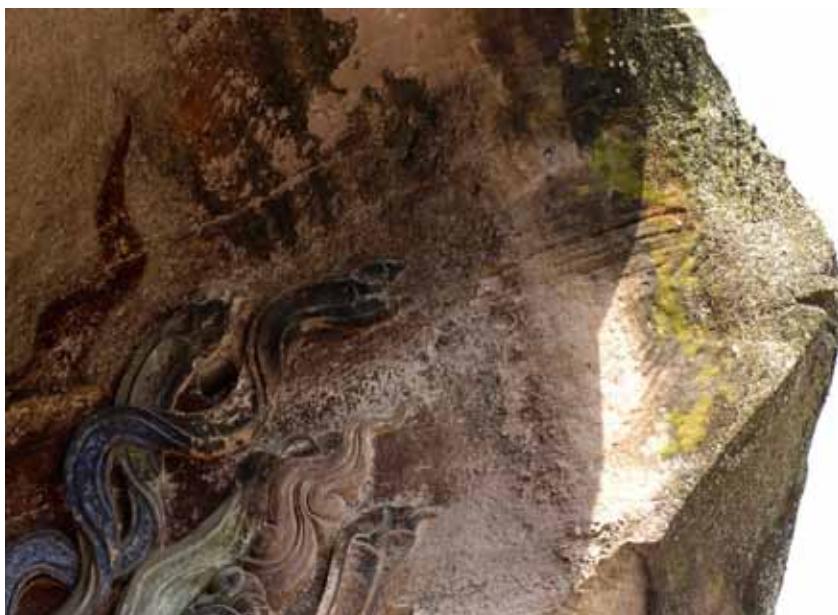
**Fig. 5:** Example of discoloured surface areas as a reason of biological colonisation, grotto no. 10, upper left hand side corner

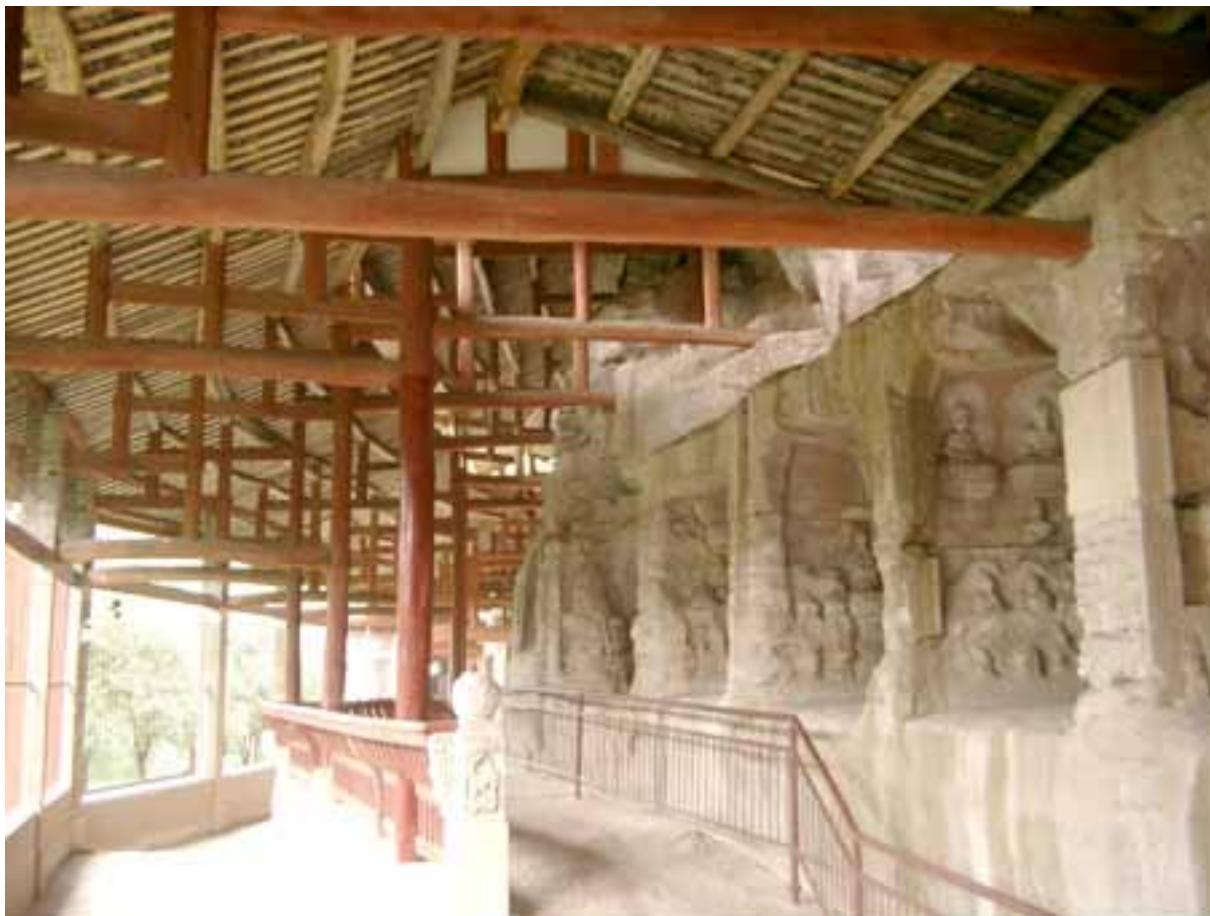
**Fig. 2:** Protective structure at Beishan in Dazu County

The modern protective buildings are built in the sites with numerous small and medium-sized niches, such as in Beishan (Fig. 2) and Shizhuanshan in Dazu, and Xiyan in Zizhong, etc., protecting the

statues in niches from further weathering. They are also built in the style of the traditional local architecture and appear stylistically consistent with the rock carvings.<sup>12</sup>

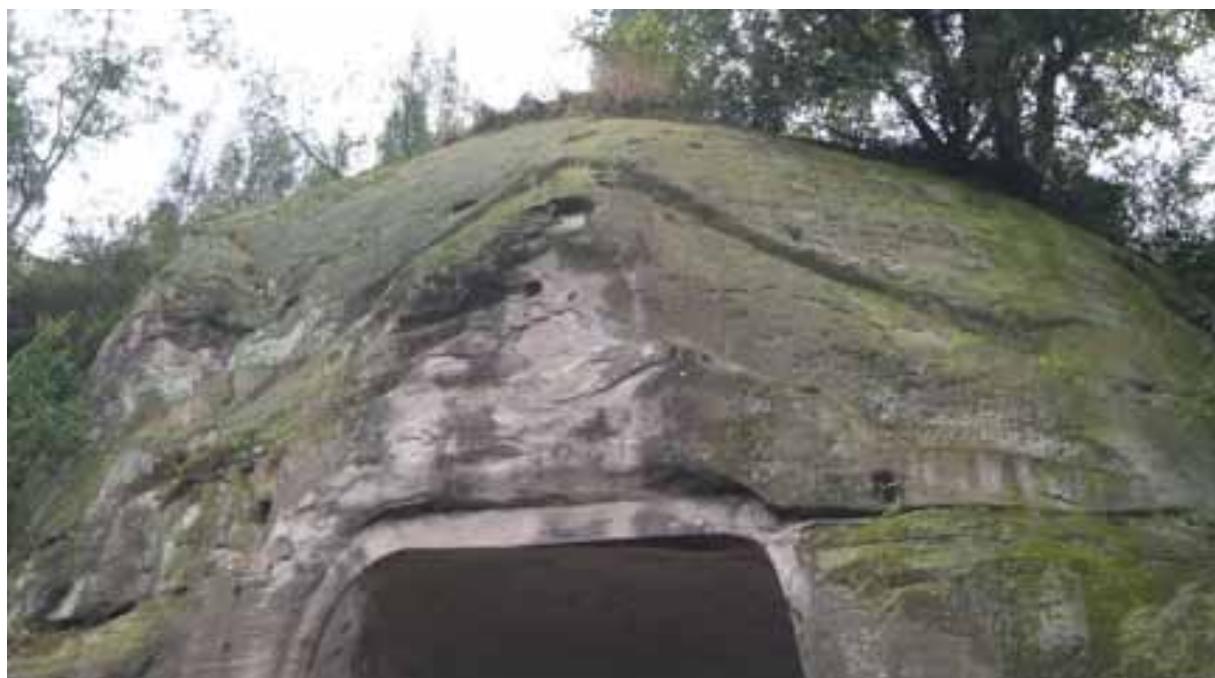
**Fig. 3:** Two grooves above no. 10 at Yuanjuedong

The profile of the pavilion is the same as a half of a double-roof pavilion of approx. 12 metres height with two raised roof corners, while the rear roofs are to be built against the rock wall using the older grooves. From the top of the roof to the top of lower roof is about 4.3 metres and from the lower roof to the platform about 7.7 metres.

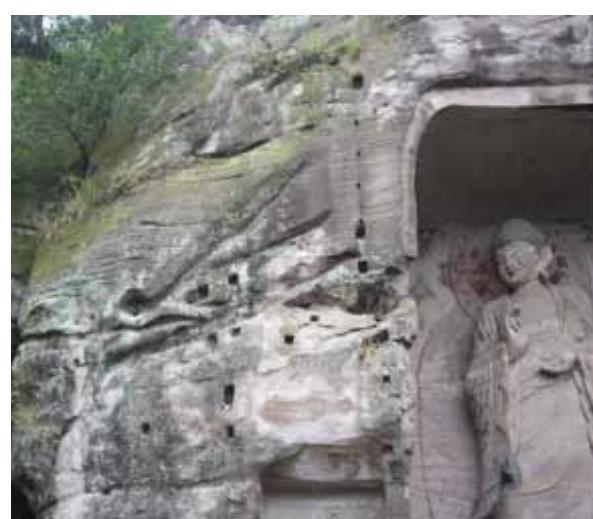
Halfway up the niche on both sides there are also many traces and grooves, of which those on the left side of the niche are heavily weathered and have mostly fallen off. On the right side at the same height, several grooves are found corresponding to the traces above the niche, for the grooves of a particular period are generally parallel to each other (Fig. 4). Like the traces above the niche, the higher and older traces here are from the earliest frontal building, while the lower ones belong to

**Fig. 4:** Traces and holes on the right side of niche no.10

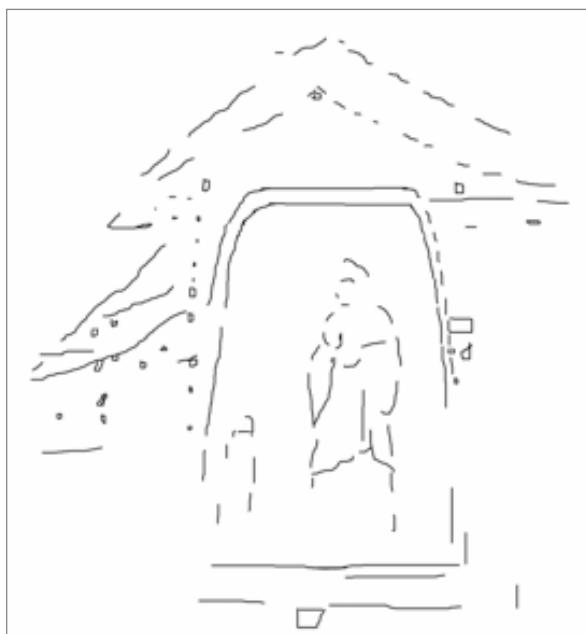
**Fig. 5:** Traces of frontal buildings outside niche no. 10

the wall outside and inside the niche that obviously were left by the beams of the structures.

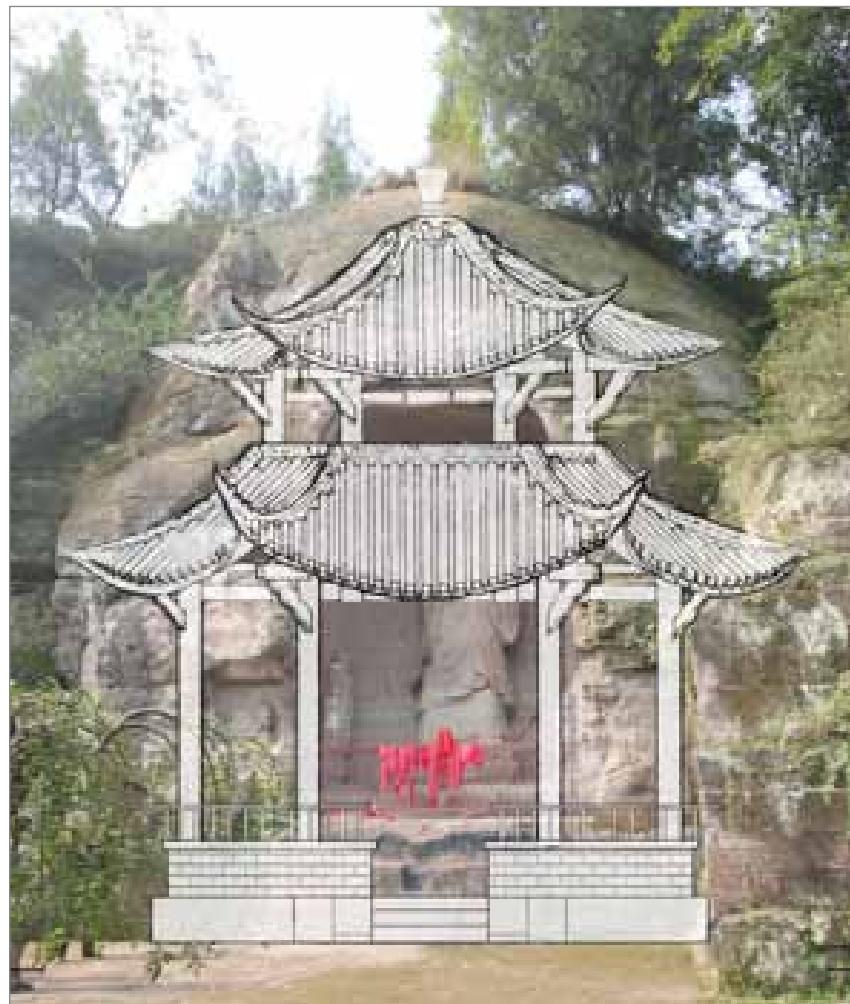
**Fig. 9:** Elevation of the planned pavilion in front of niche no. 10

Seen from the elevation (Fig. 9), the upper roof is built on the higher groove with two raised roof corners and grey roofing tiles. The roof is carried by the wood columns and beams connected by crossing brackets. No walls will be built between the columns for the sake of lighting and ventilation.

The lower roof will be built in a similar way and the weight of the upper part should be carried by the four columns of the lower part through diagonal beams. The platform is about 60 cm high from the present ground with three steps leading the visitors into the pavilion. A brick or stone wall with seats and a balustrade above the platform could be built and left in its original colour in consistence with the grey roofs and red columns.

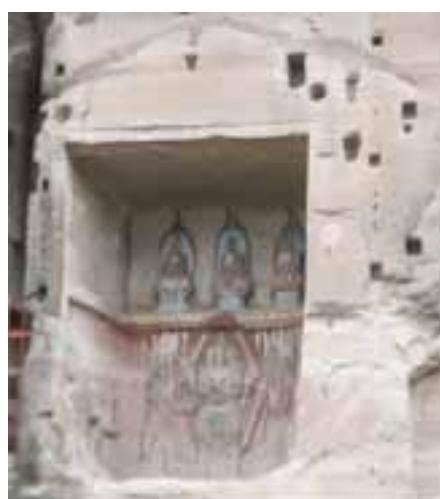
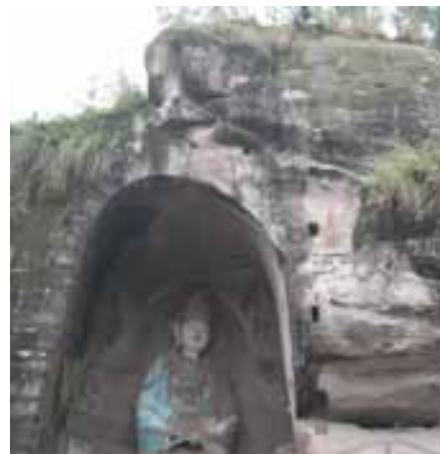
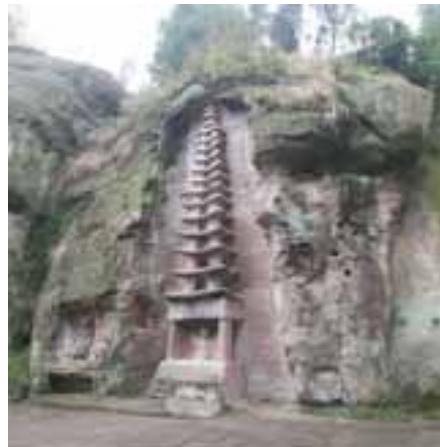
**Fig. 10 a–d:** Traces of frontal buildings outside the niches at Yuanjuedong

In Yuanjuedong, the examination of other niches and grottoes shows that the former frontal wooden building for the niche no. 10 was by no means a single case; rather, there are traces of historical wooden constructions outside almost all the niches and grottoes on the north side. They are niche no. 14, the Guanyin with Lotus-bud; niche no. 12, the King of Vidya; grotto no. 8 of Complete Enlightenment; niche no. 7 of Kundika Guanyin, and niche no. 4 of 13-storied Pagoda (Fig. 10 a–d) etc.
