DAAD Summer School

"Dialogue on Cultural Heritage in Times of Crisis"

FROM THEORY TO PRACTICE: HOW TO SAVE OUR HISTORICAL HERITAGE IN DANGER -COMPARATIVE CASE STUDIES.

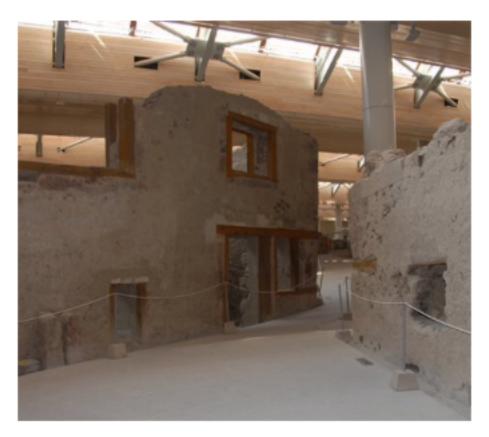
Figure 1. A building from the settlement of Akrotiri.

The main building material is stone, wood, and clay for example hewn stone was used extensively around the openings (fig.1). Now it is generally accepted that they used timber as for example for the construction of walls. Also, with clay they manufactured mortars and mudbricks. The buildings were composed of the entrance, the hall with the central pillar, the Minoan (tripartite) hall and the storage room. On the ground floor there were workshops for domestic tasks or shops (They found tools includings stone grinding mills, crucible and cooking pots). The first floor was the main part of the house. There, residents welcomed guests and also it may have served as bedrooms. Also, the first floor of many houses was decorated with frescoes

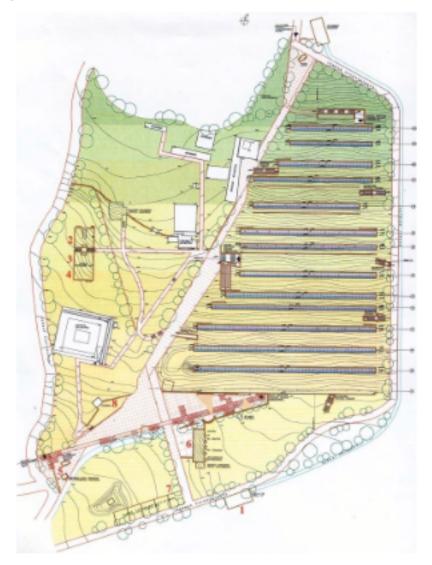
Figure 2. The new protective shelter.

The architect N. Fintikakis proposed a project of a bioclimatic shelter which respects the environment (fig.2). When the excavation begun and they excavate for the foundation of the pillars for the new shelter, took the opportunity to find out the entire history of the site and the pre-eruption relief of the area. The new roof was covered with a layer of soil, with that, there is thermal comfort inside, the light enhances the monuments, the rainwater is stored and it is in complete harmony with the surrounding landscape. The new walkway is around of the perimeter of the excavated area and is accessible also to people in wheelchairs. Last but not least, the new storage facilities of restored wall-paintings, combining safe-keeping and easy access for study and maintenance. Archaeologist are currently working on the conservation and restoration of findings as well as the 3D simulation of the buildings with their frescoes (Doumas, Ch. 1997; 33-39) (Doumas, Ch. 2008; 7-24) (Doumas, Ch. 2013; 113-117).

• The architect N. Fintikakis and the project of a bioclimatic shelter.

• The pillars for the new shelter and the opportunity for discovery the entire history of the site.

• The ceiling cover with a layer of earth gives several advantages to the environment and the archaeological site.

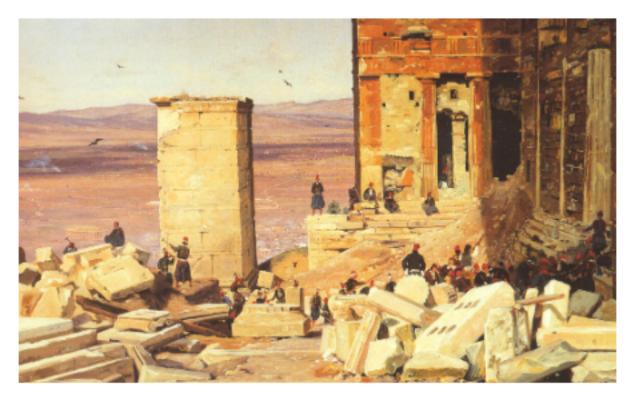
Figure 3. The Dominate of the empiricism and the prevalence only the ancient materials.

Later, between 1842 and 1845 Pittakis was responsible for the restoration of the Parthenon together with Rizos Ragavis. They restored 4 columns of cella and they placed similar parts in random locations. Also, they made use of unsuitable materials and spolia. In 1872 Panagis Kalkou was responsible for the second restoration of the Parthenon. In this period they restored a part of the cella, maintained the Western frieze and the architraves. Again they placed similar parts in random locations and they made use of unsuitable materials. Above all it worth to mention that it was a work without documentation and publication.

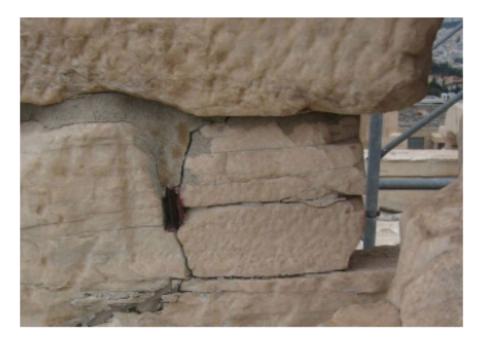
Figure 4. The use of cement mortar.

conservation projects without supervision by others. The extensively use of iron clamps to link architectural parts was disastrous. The expansion of the iron in the oxidation caused cracks in the architectural parts. Also, he used cement mortar and ignored the importance of the Pentelic marble (fig.4)(Korres, M. 1994;319-323) (Tufano-Mallouchou, F. 2007; 36-40) (http://www.ysma.gr) (http://www.theacropolismuseum.gr).

- Balanos did not follow the new practices and he used wrong practices .
- He began in 1894 a conservation projects without supervision by others.
- The use of iron clamps and the expansion of the iron.
- The use of cement mortar.

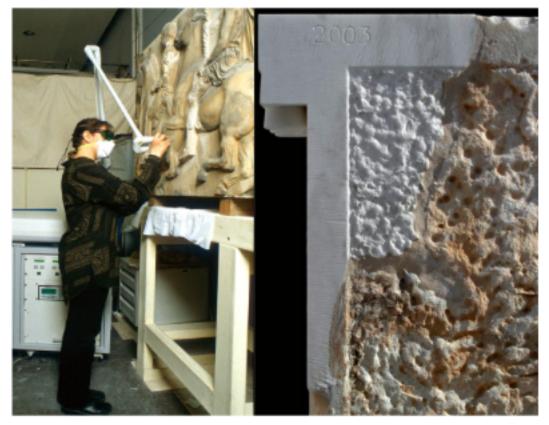
Figure 5. The cleaning of the sculptures(left) and the structural restoration (right).

The basic principles of restoration and conservation are the follow, firstly there should be a possibility of restoring the monument to the condition it was before the operation. Secondly, the intervention to the parts which have already been restored has to be limited and thirdly the maintenance of the building should not interfere to its appearance. Moreover, the sections of the monuments that are problematic are dismantled. In addition the scattered architectural parts are placed in their original position. Also, the structural restoration includes the filling of microcracks - gaps and the stone surface conservation includes their cleaning (fig.5). Finally, the scattered architectural parts are restored and integrated using titanium rods (http://www.ysma.gr) (Korres, M. 1994; 326-330)

• The work of the stone surface conservation includes their cleaning.

• Scattered architectural parts restored and integrated using titanium rods.

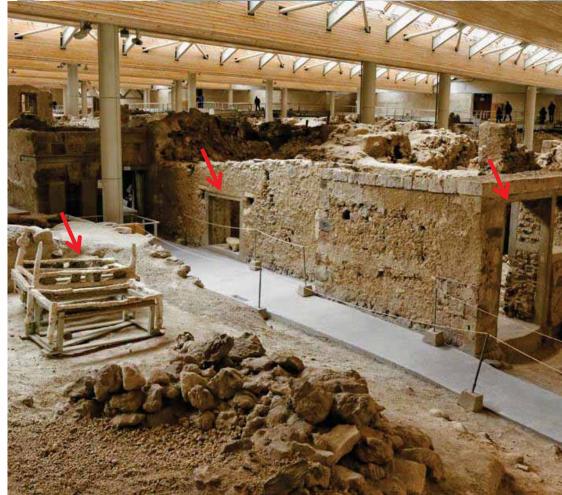
• In the ~16th century was buried under the pumice and volcanic ash.

- This destruction helped to preserve many the up floors for many buildings.
- Organic materials furniture and timber framework - and their imprints.

The city of Akrotiri was buried in the 16th century under thick deposits of pumice and volcanic ash. The way in which the town was destroyed helped to preserve many buildings up to the first and sometimes even the second floor. In many cases traces of organic materials like pieces of furniture, timber framework, baskets, remained buried under the volcanic ash. All these objects under special conditions and techniques can be rescued. However, it does not exist any evidence of human remains or hoards that probably due to the fact that the residents understood the weird phenomena before the eruption of the volcano and they left from the settlement (Doumas, Ch. 1997; 31-33), (Marinatos, N. 2014; 10-17, 176-177).

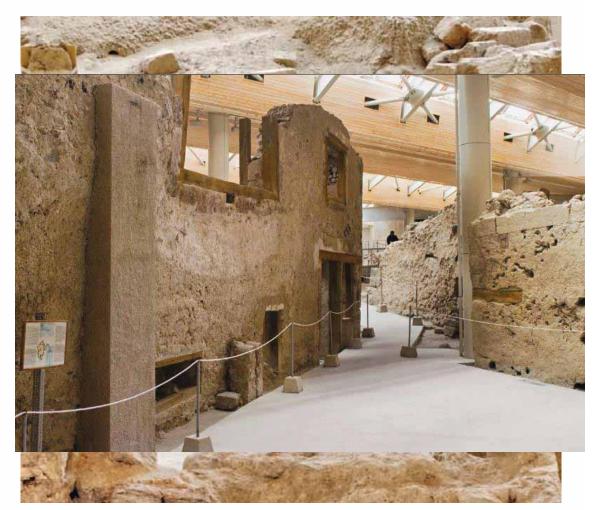
• Marinatos and the method of the underground tunnels.

• The attempt to place wood on the remains of the ancient wood.

• The struts from concrete for the protection of the walls.

• The use of concrete for restoration of the organic imprints .

• The wrong use -> The rectilinear and horizontal windows.

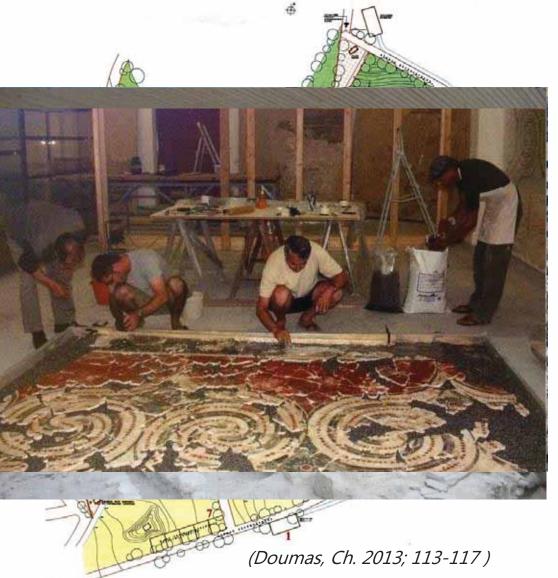
The new protective shelter.

• The walkway is accessible also to people in wheelchairs.

• The new storage facilities and laboratories.

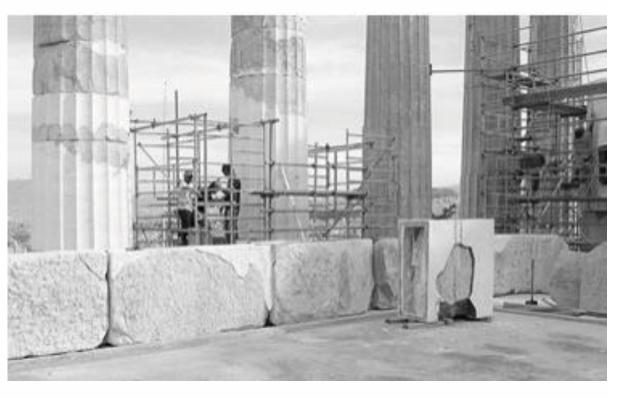
- They restored the monument in the condition it was before the operation.

- The intervention limited to the parts which have already restored.
