The Murals of the beiwusheng huiguan in Ziyang

Final report

Part 2: Condition, Conservation and Restoration

Research Project 01UG1001
„German-Chinese co-operation in the preservation of Cultural Heritage: Researches for the
conservation of selected monuments in the PR China“

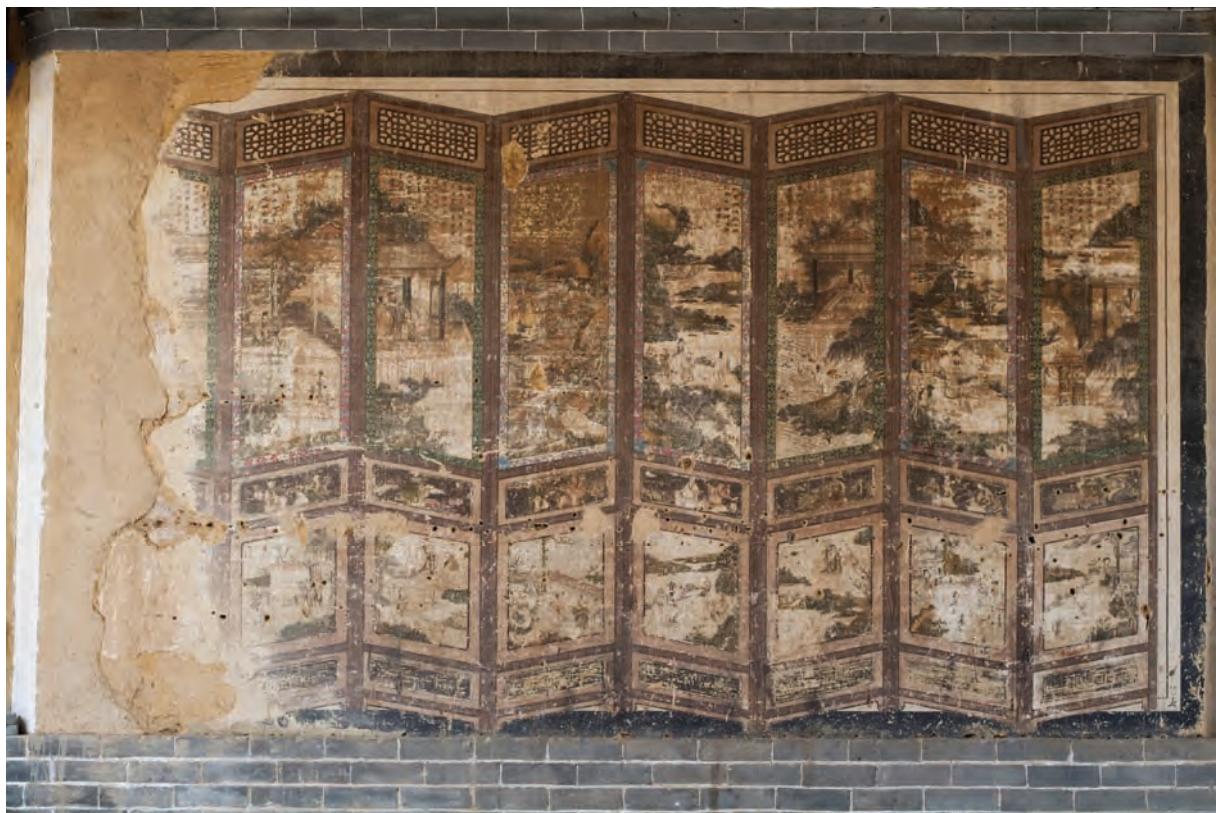
Fig. 1

Photo taken in 2011, before cooperation work started on-site [Photo by Research Institute for Conservation of Cultural Heritage of Shaanxi Province].

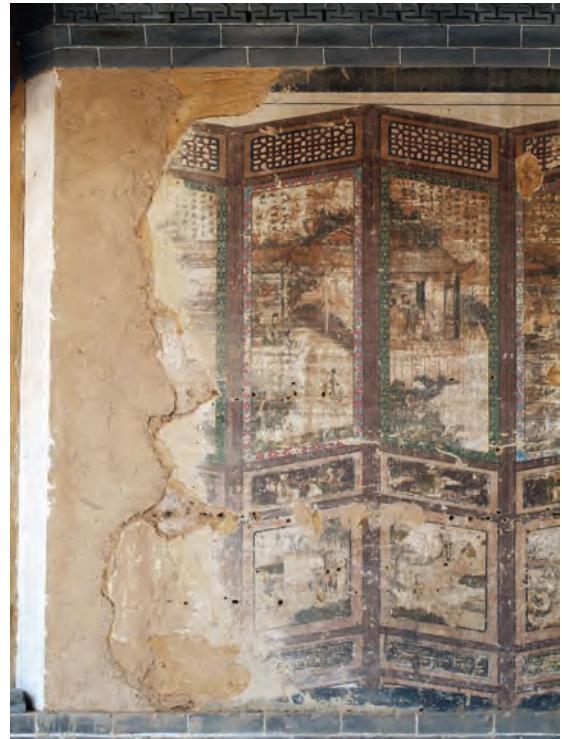
Fig. 4

After repairing the roof in 2008 the loss of plasters on the left was filled up to 2nd undercoat level. In adjoining areas, the priming layer has been washed off from the fine coat.

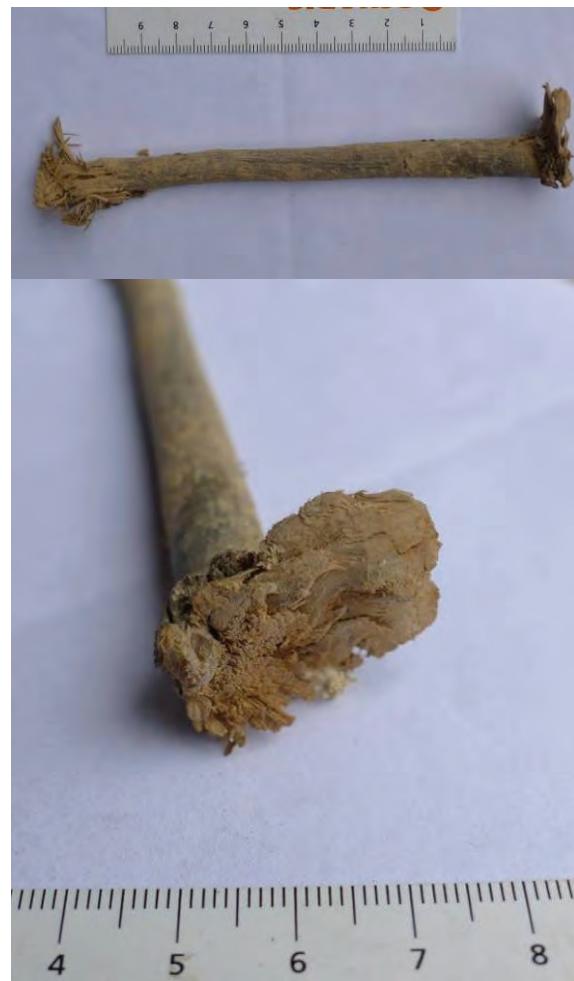
Fig. 10
Pingfeng xi, panel 2 d, wooden stick in one of the holes.

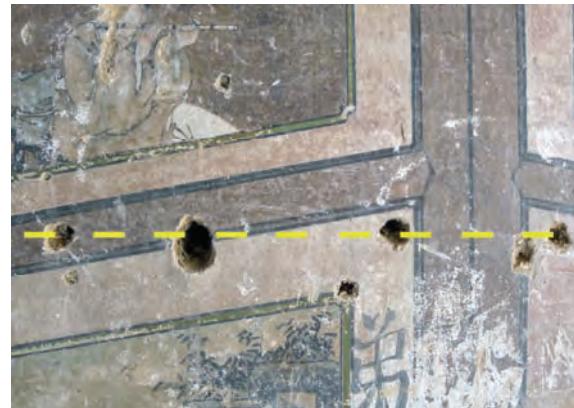
In the lower third of the *pingfeng xi*-, *pingfeng dong* and the *sanguo*-murals, man-made holes in varying sizes can be found. The diameters range from around 1–15 cm with depths up to 30 cm. Some of the holes are aligned (fig.5, 13). This gives evidence of constructions which were added later, but had already been removed, when the wooden panelling was built-in. However, there are also holes which do not follow a regular order. The smallest of these were probably caused by nails. At *pingfeng xi* (panel 2d), a small piece of wood was put into a hole and could have served as a dowel (fig.10, 12). This could be an original, constructional part, which was e.g. used for the scaffolding. In other holes, shards of tile had been inserted, for which an explanation regarding their function is missing (fig. 11).

Fig. 13
Pingfeng xi, between panel c and d holes are arranged on a horizontal line.

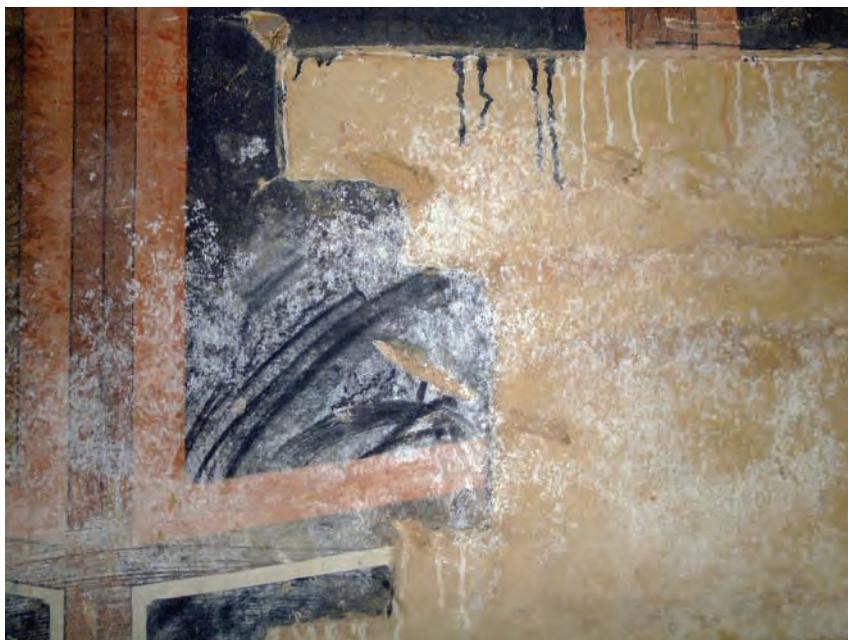
Fig. 16

The reason for this white efflorescence is a heap of coal which had still been stored on the outside of this wall when the roof was repaired in 2008 (fig. 16). The coal stock gathered the rain falling from the roof and directed the water towards the buildings' wall. The wall became wet and was also kept moist for some time by the coal. With the desiccation of the wall, water-soluble salts were transported towards the evaporation level on the painting's surface and the outer brickwork façade, where crystallization led to white efflorescence. The source of the salts could not be determined. One possibility is that they were already contained in the building materials; another is that they were dissolved in contaminated soil and were transported upwards through the brickwork wall. In raking light the surface of the mural *long* has a kind of rippled surface, altered by the former moist wall that caused swelling and shrinking resulting in this deformation (fig. 23). During the work stays the floor in the north-eastern area of *zheng dian* and also the eastern area of *guo dian* were often wet after heavy rain falls, but the pedestal zone did not seem to get moist anymore.

Photo taken during the roof renewal in 2008, showing a coal stock outside *zhengdian*'s north wall [Photo provided by Mr. Jiangbo].

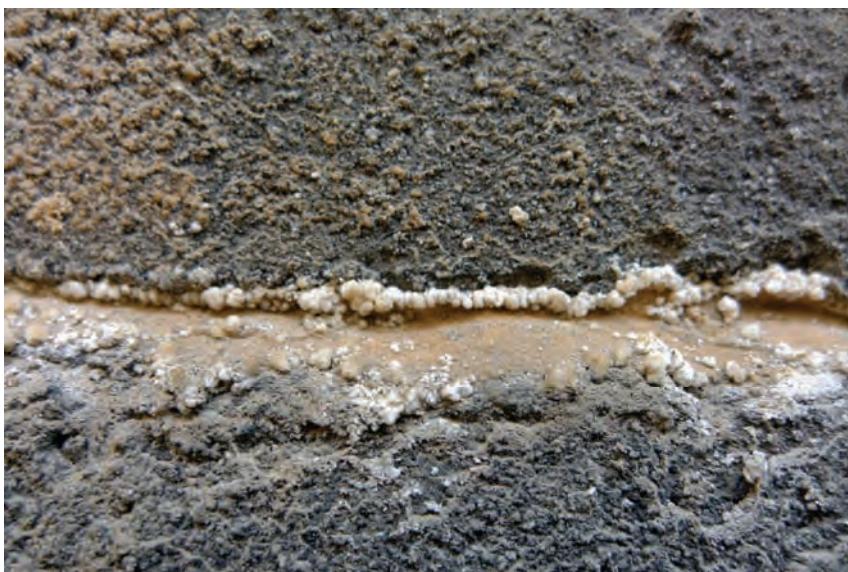
Fig. 17
Close-up of the bottom left part of *pingfeng bei*, white efflorescence on the painted and unpainted surface.

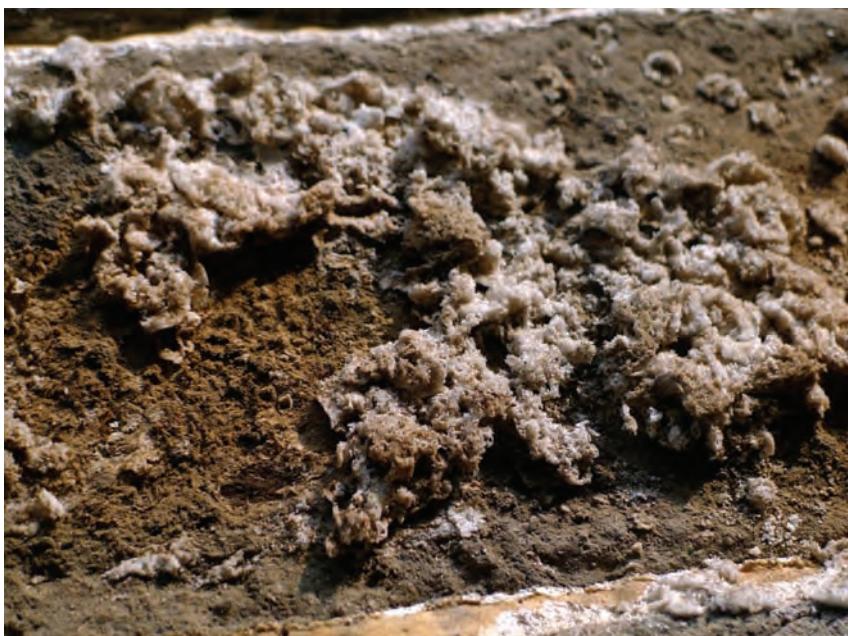
More extensive plaster losses are recorded on the north wall of the *zhengdian*. Above the brickwork pedestal zone in the lower area of the murals *pingfeng bei* and *long* losses of fine coat and partially also 2nd undercoat occurred. Above the losses of the two murals, a whitish, crescent-shaped area with white efflorescence (fig. 14, 17) can be seen. In this whitish area, interfaces between plaster layers and also between first undercoat and brickwork support have partly lost contact, which resulted in large voids between different plaster layers. The plasters of the undercoats have a decreased structural cohesiveness, but the fine coat is still quite stable. At a closer look, white crystallized accumulations are visible in the plaster layers of the undercoats as well as on the interfaces between the undercoat layers and the fine coat (fig. 22). Components such as stones and straws are incrusted with white material (fig. 20). In a repair plaster between the murals *pingfeng bei* and *long*, losses in the shape of craters and white crystallized accumulations are present in the centre of the loss. It seems as if crystallisation burst the surface away (fig. 21). These damages and efflorescence correspond to the outside façade of this wall (fig. 15). The joints have white crystallised crusts and a few bricks have efflorescence on the surface. In one or two cases the surface of the bricks was damaged or even lost due to crystallisations, in most cases the joints are much more affected than bricks (fig. 18, 19).

Fig. 18
North façade with white efflorescence along the joints.

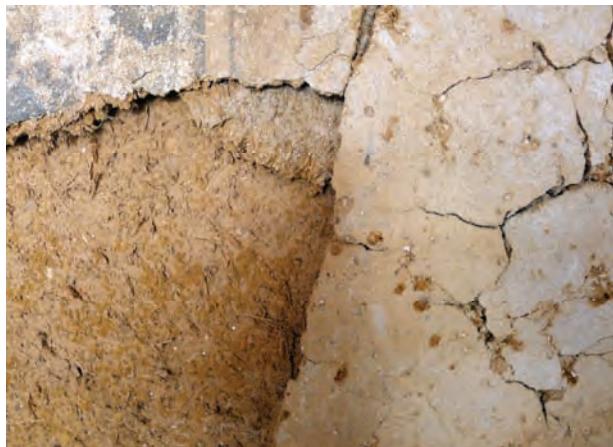
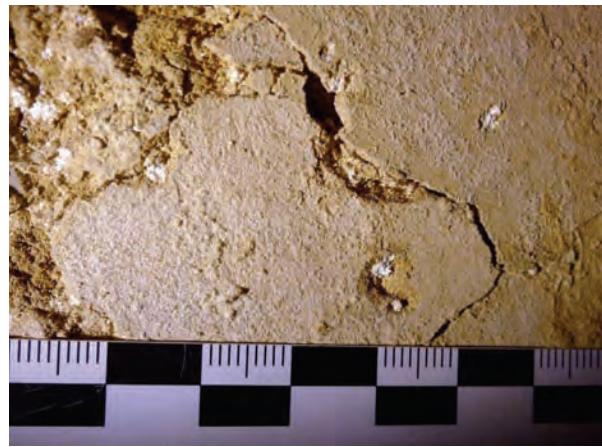
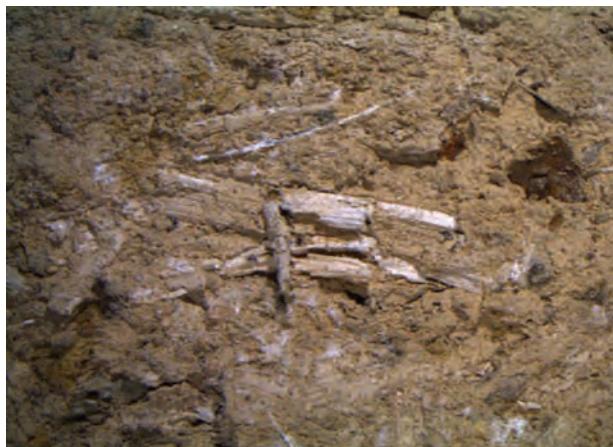
Fig. 19
North façade: crumbly surface of a brick, which is affected by salts.

Fig. 20 Detail of lower long wall. The straw is incrusted with white material.

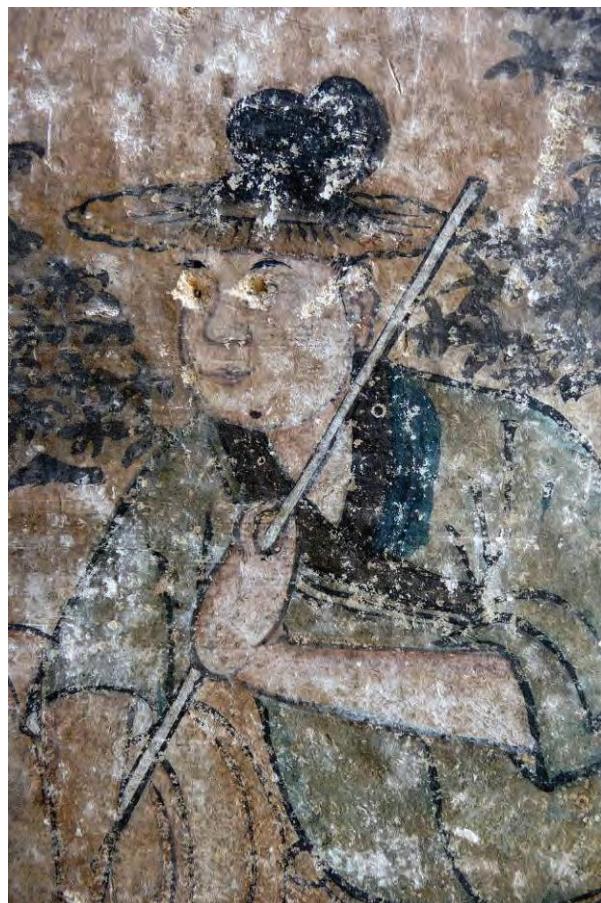
Fig. 24

Detail of a man in *pingfeng dong* panel 4 d. Holes are pricked into the face and eyes are circled with ink or paint.

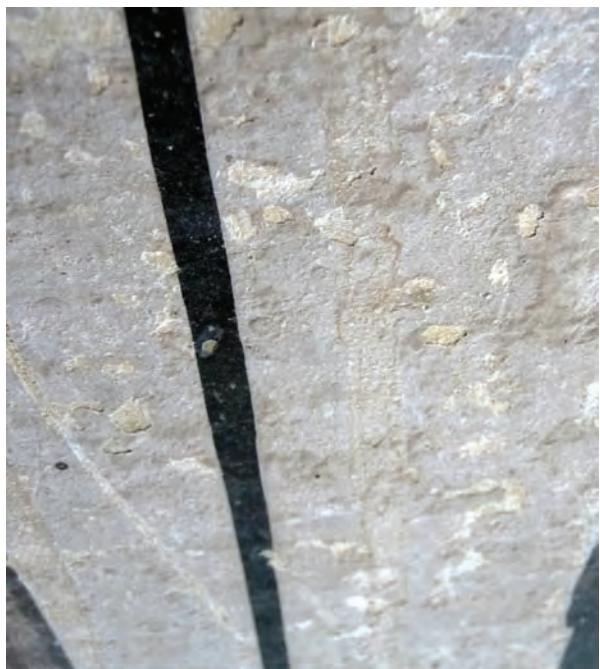
Fig. 29

Detail of *pingfeng dong* panel 3b, graffiti with chalk.

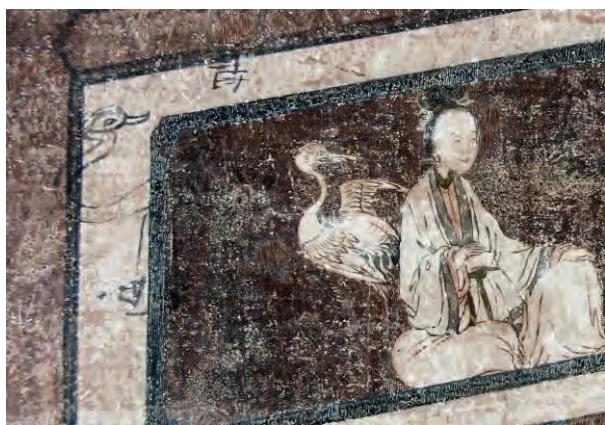
Fig. 30

Pingfeng xi, next to panel 8a/b: The light grey to white background colour next to the folding screen is at the same time the priming layer for other paints. In parts blisters and detachments from the fine coat can be seen, which resulted in losses.

The light grey to white background colour next to the folding screen is also in other places of the mural as the priming layer for the other painting colours. Between the framework and the black framing this white to light grey layer has partly blistered and detached from the fine coat, which resulted in losses (fig. 30).

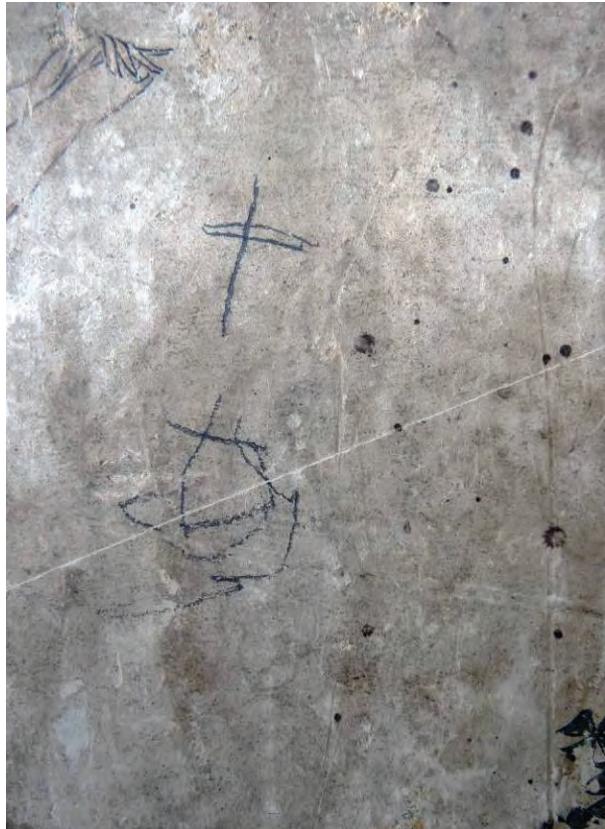
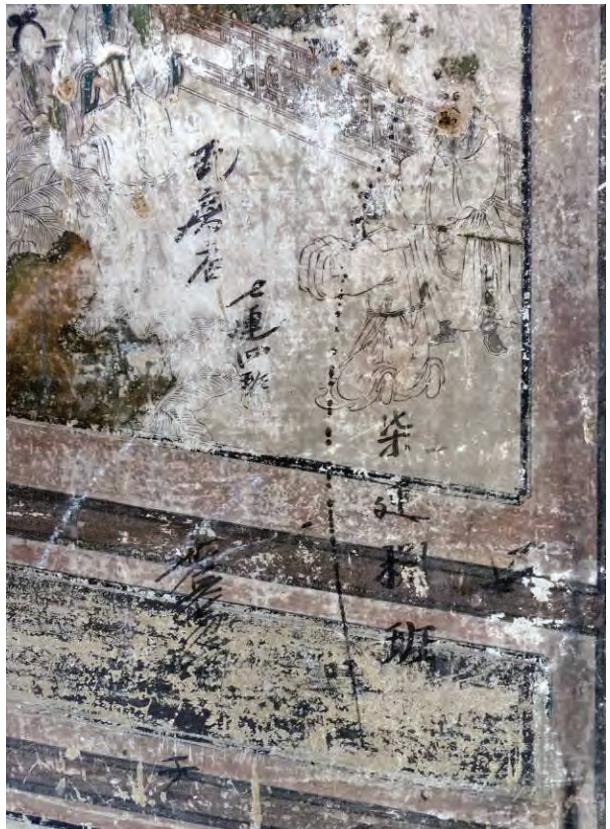
Detail of *pingfeng xi* panel 2c, a graffiti repeating the crane from the original painting

Detail of *pingfeng xi* panel 5 d, pencil graffiti.

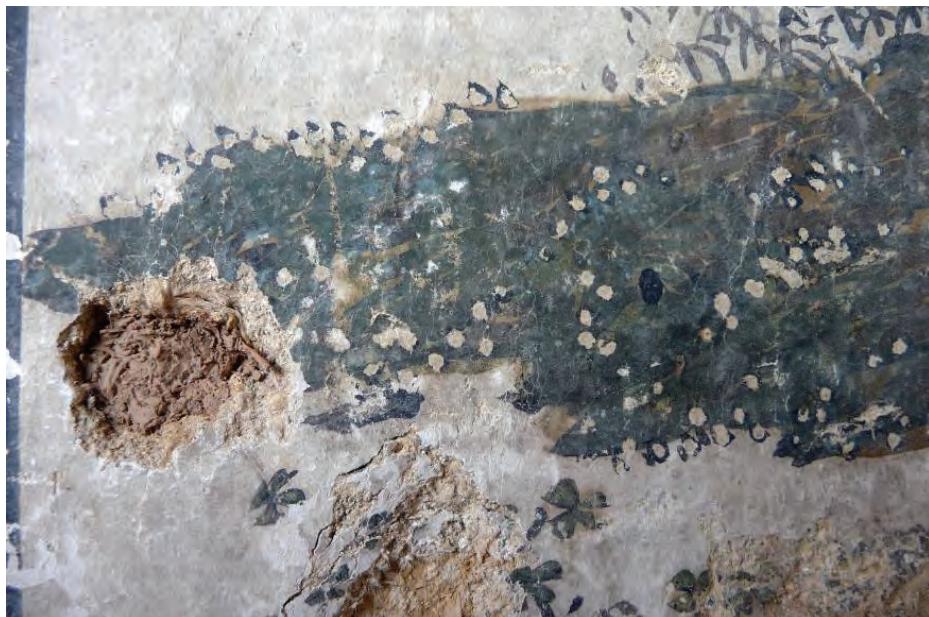
Fig. 34
Pingfeng xi, panel a, the black filling frame paint has a whitish blurred surface and some losses.

One of the black paints on *pingfeng xi* which has been used for the black filling frames of the panels a and d shows a distinctive deterioration, compared to the black fill that has been applied on top of the contour lining. The black fill paint does not have good adhesion to the carrier, so that fragments got lost. The surface of this paint has altered and turned whitish in some other parts. Compared to the other black paint used on *pingfeng xi* it seems more sensitive to water and gets blurred by it (fig. 34)

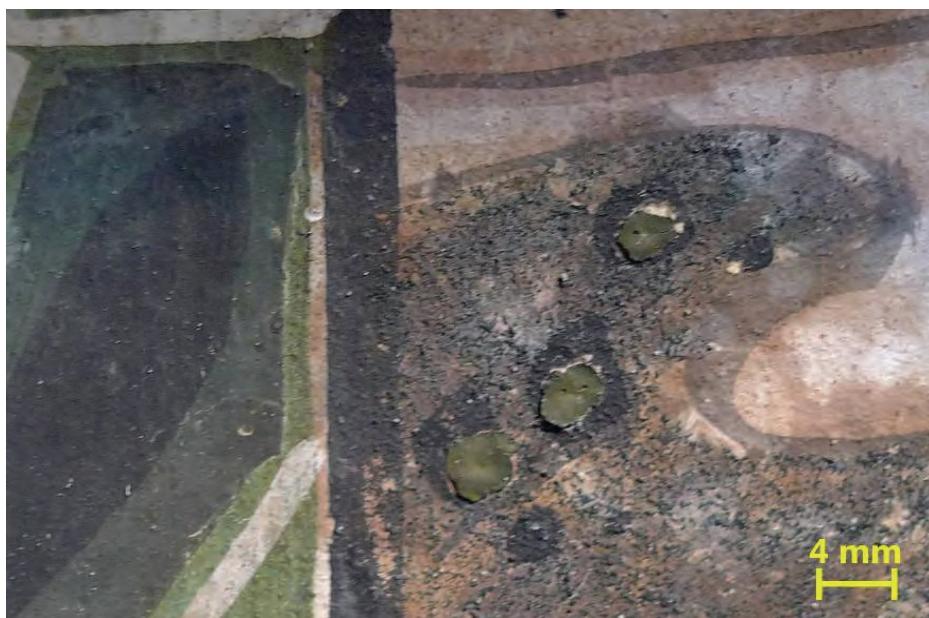
Many of the green dots, found in large numbers all over the murals are detached, fragmented or completely lost (fig. 35, 36). The green paint is rather stiff and has a good cohesion. Its thermal or hygric properties must be different from the layer beneath, so that starting from the edges of the dots the green paint peels off the carrier substance and finally falls off. Sometimes a little green paint remains in the centre of the dot.

Fig. 35
Pingfeng xi, the green dots are almost entirely lost; a light fine coat-coloured dot pattern has remained.

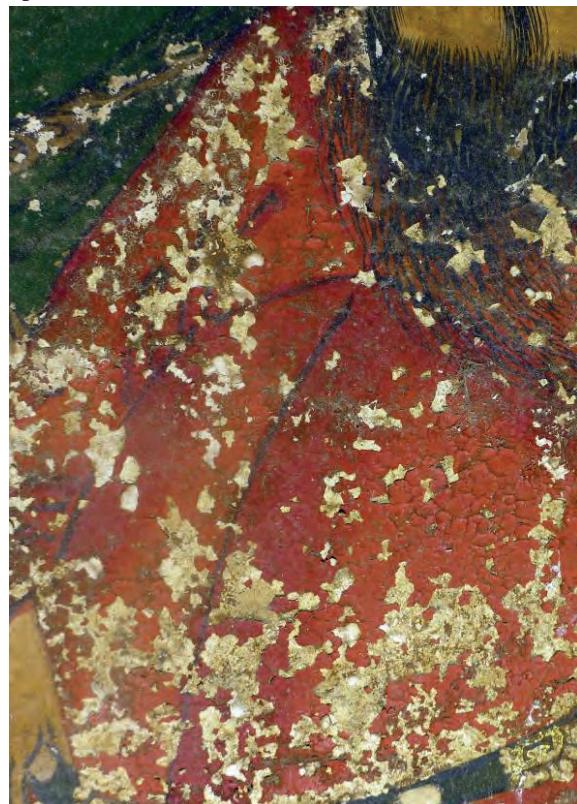
Fig. 40

Sanguo xi close-up, the red paint has cracked to small fragments; edges of fragments started coiling up.

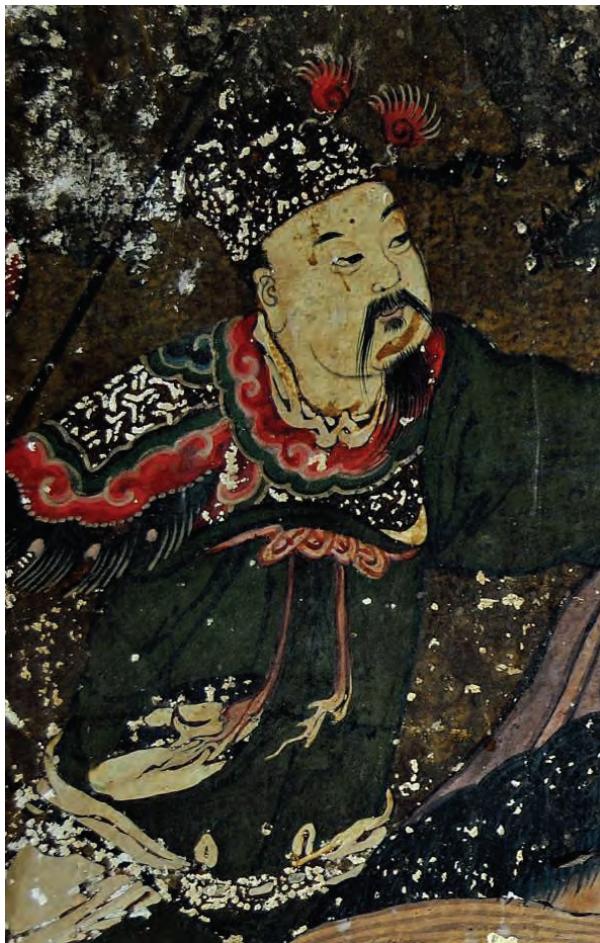
Fig. 41

Applications of gold on the murals *sanguo xi* and *sanguo dong* are often lost. At places, where gold was applied on fine ornaments it is lost today with the surrounding paint layers still intact (fig. 41). This damage is linked to the painting technique. The properties of the mordant are the problem, so that the gold layer together with mordant cracks and finally separates from the priming layer.

Sanguo xi close up of a rider: Gold applications such as ornaments on the hat, the chest, the shoulder armour and on the belt got lost.

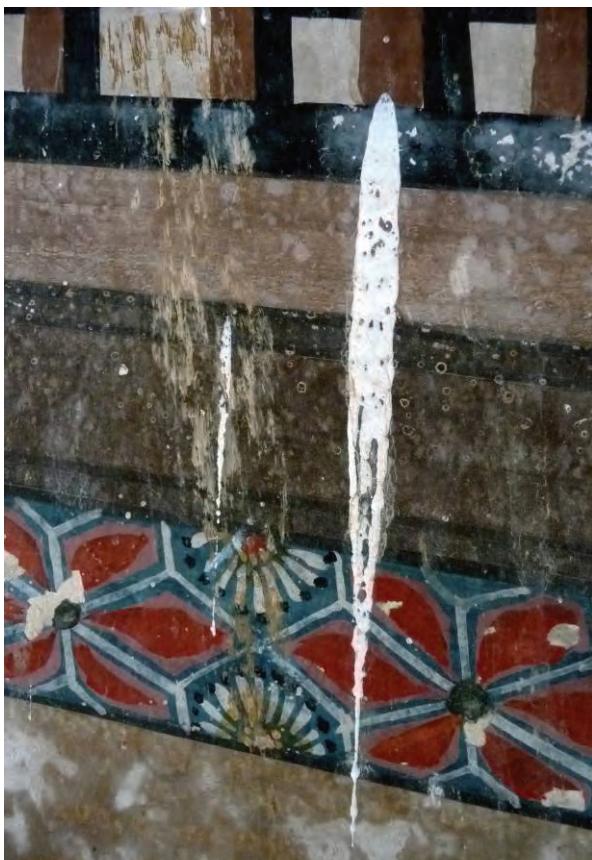
Fig. 45
Pingfeng x, panel 7 a/b, a splatter of white paint.

On *pingfeng xi* different stains and soiling was found. The surface was covered with a layer of fine-grained heavy dust. Some excrement from birds or bats sticking to the surface could also be found. In the lower area were several stains from a thick but rather soft whitish material, which could have been wax. Apart from splatters from the graffiti paint mentioned above also splatters from other paints, probably deriving from more recent repainting of the hall's architecture can be seen. (fig. 45, 46).

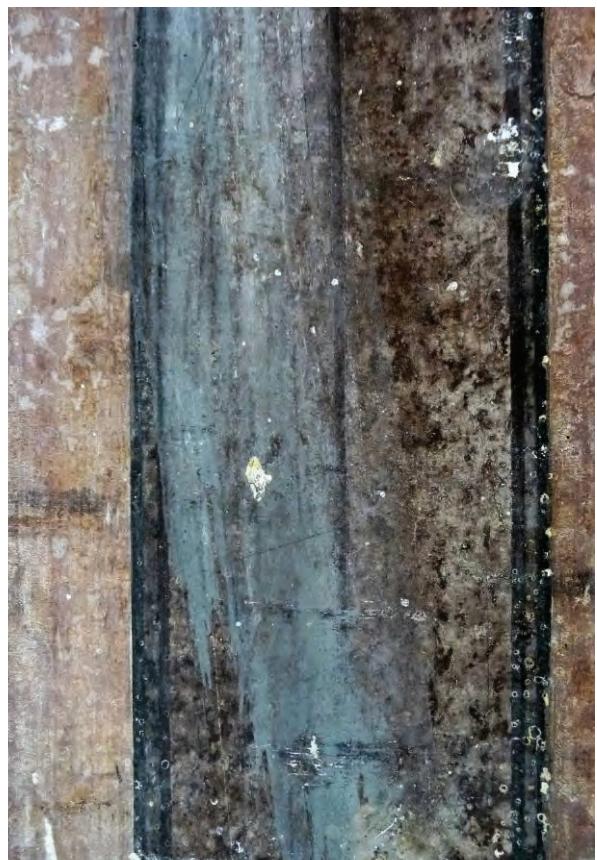
Fig. 46
Pingfeng x, panel 7 a/b, splatters of grey paint from the renewal of the cornice on top of the mural.

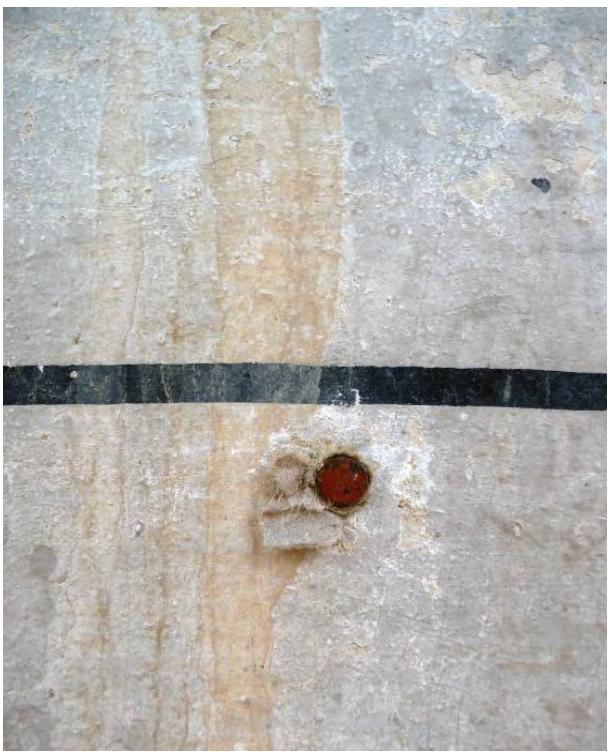
Fig. 50
Pingfeng xi, above panel 7a, fibrous material like paper under a nail head. Washed up dust or clay in line where water was running down.

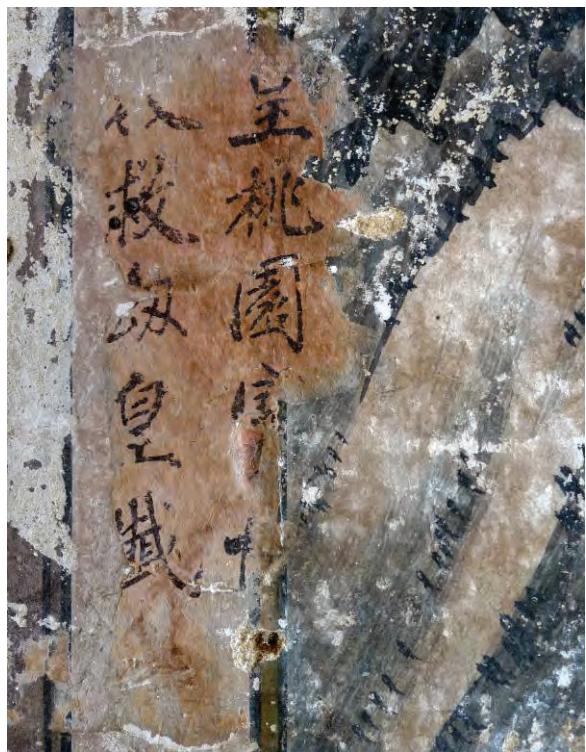
Fig. 52
Pingfeng dong, panel 5 d brownish paper with letterings glued onto the painting's surface.

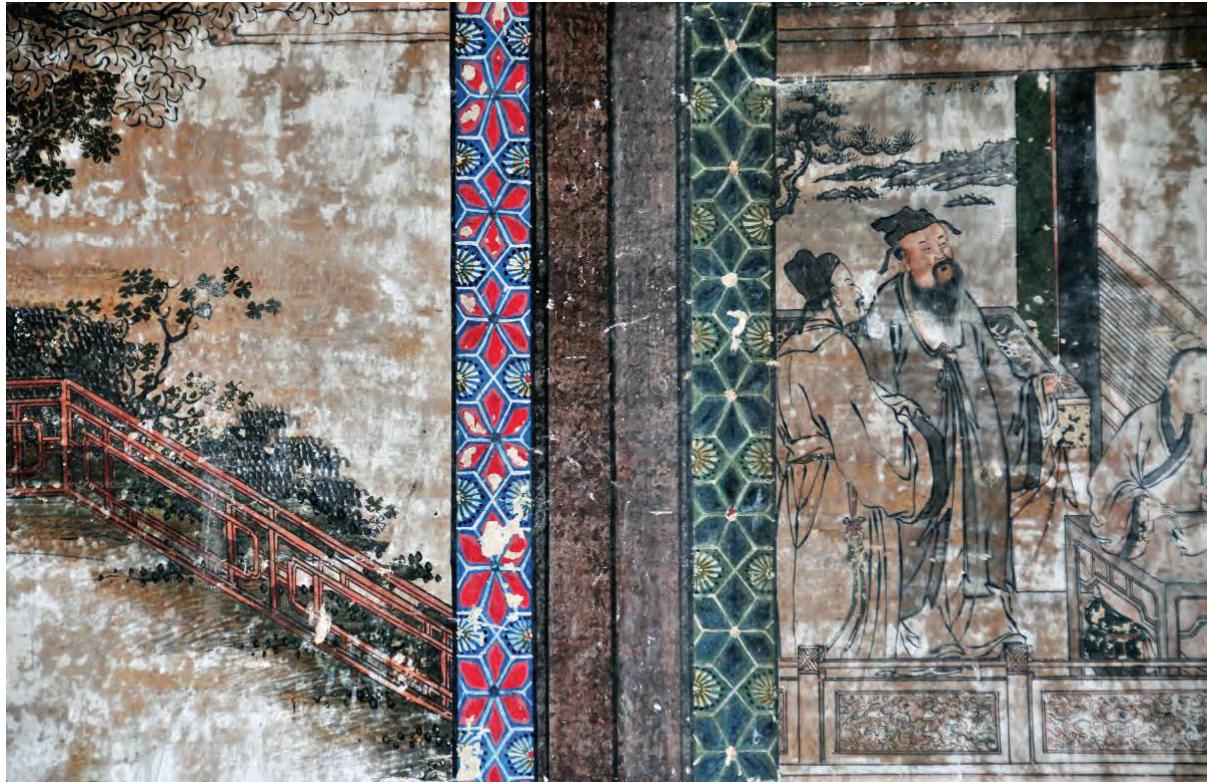
▼ Fig. 56

pingfeng xi panel 2 b to 3 b, in the right half of the photo the painting is still covered with a thin layer of dust, the left half it is already cleaned with the dry-cleaning sponge named “Akapad@ soft”.

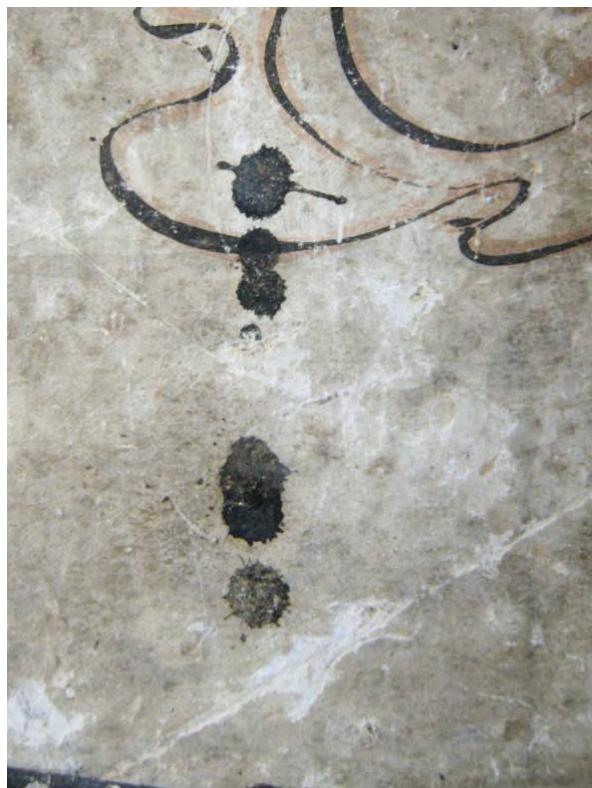
Fig. 58

pingfeng xi panel 7d, splatters of ink from a graffiti.

The Chinese colleagues wanted the numerous Graffiti to be removed or become illegible. Graffiti made from chalk was easily removed with the dry cleaning sponges. Graffiti made of other material could not be removed, although different approaches were tried. Cleaning with erasers led to damage of paint and priming layer. An eraser pen (Faber-Castell/Perfektion 7057) was tested and considered unsuitable. It was possible to reduce some of the graffiti paint with it, but at the same time the soft priming layer underneath was compressed and its surface gloss changed. The graffiti made with ink seem to have been carried out with different paints. Some were not affected by water at all, but some could be reduced a little with moist cotton swabs (fig. 58, 59). The paint also permeated layers of the painting and of priming layer, however, so the graffiti could not be taken off without damaging those. Since there was no possibility to clean or take off the Graffiti without damaging the mural, retouching was chosen as a way to conceal them and match these areas with the surrounding. Paint stains and soot, which has permeated into the painting layers, could also not be removed, but stains from waxy material could be removed with hexane. Paper sticking on the surface was lightly wetted and could then be taken off with the help of a wooden tool and the horn spatula.

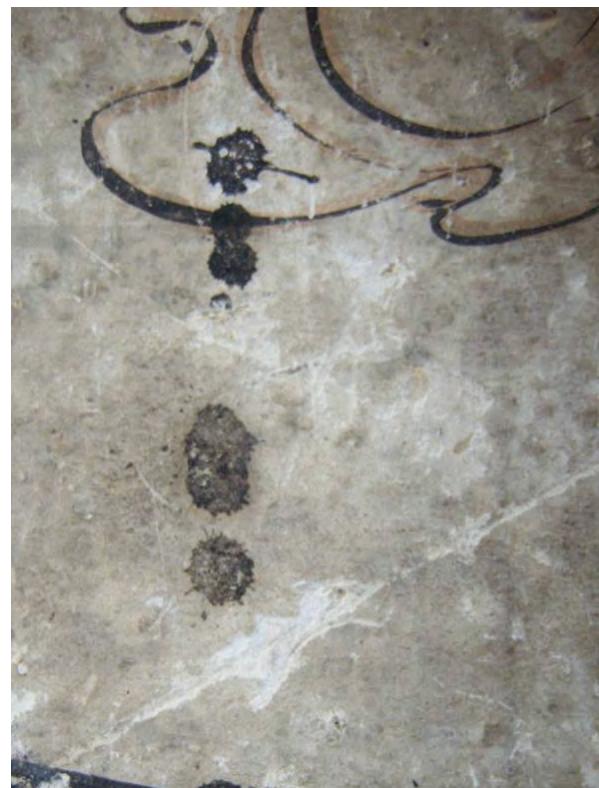
Fig. 59

pingfeng xi panel 7d, the two splatters of ink on the bottom were reduced with a damp cotton swab.

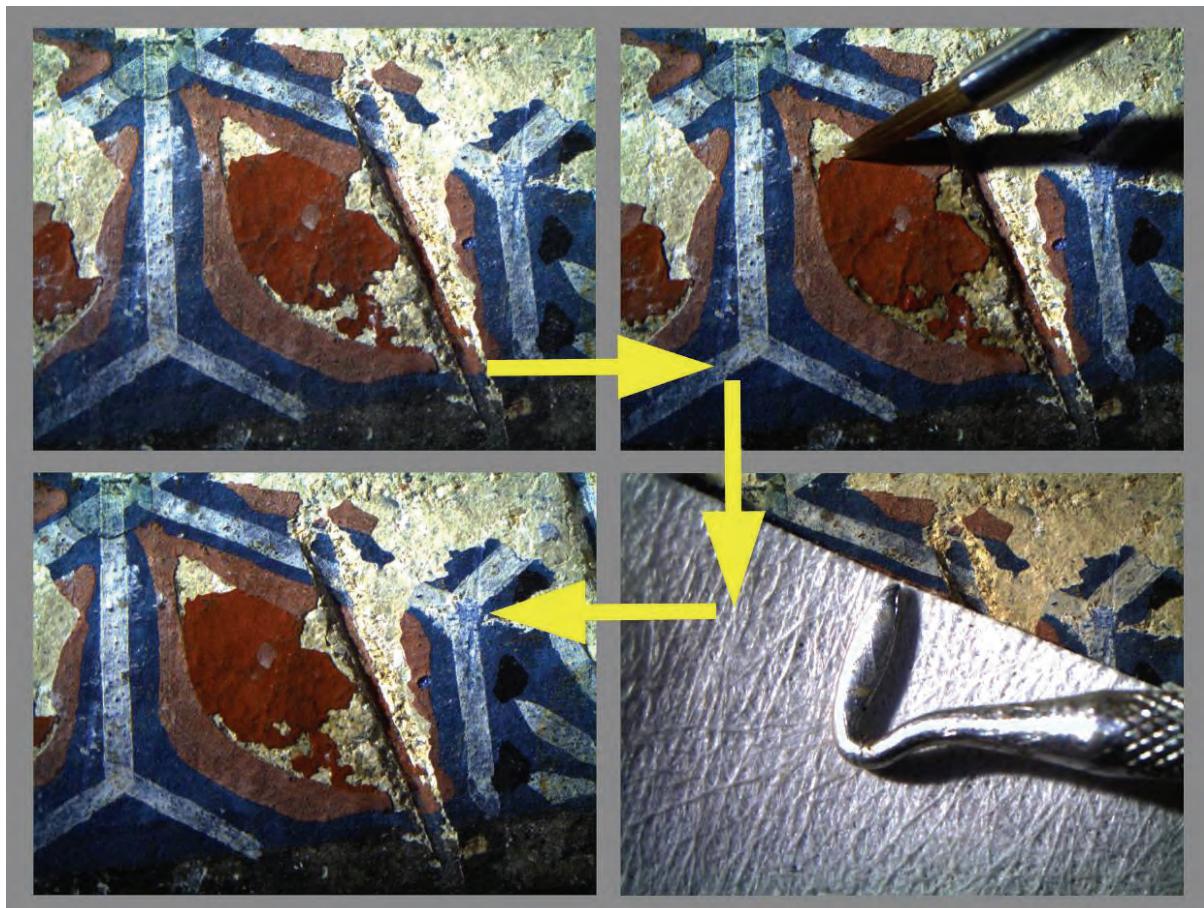
Fig. 62
 Consolidation of paint layer: Application of consolidant (sturgeon glue, Funori) with a brush and reattaching delaminated layers with the help of a heated spatula and through an Evolon® mat.

Especially the flower borders and green dots which can be found all over the painting and the dark brown backgrounds of the c- and e-panels needed consolidation. Flakes of paint detached due to tensions within the layer and adjoining parts were prone to falling off as well. The consolidation and reattaching to the support was done with sturgeon glue, modified with Fu Nori. The concentration used was 3 % - containing two parts sturgeon glue and one part Fu Nori.² The sturgeon glue has good properties, such as good adhesive strength, elasticity and low viscosity for good penetration behaviour. The modification with Fu nori makes the consolidant dry matte and increases its viscosity, so that the consolidant does not permeate the priming layer too fast. The consolidant was applied warm with a small brush. In a second step, the flakes were pressed down with a heated spatula where heat was needed. A piece of Evolon® mat was used in between the spatula and the paint layer surface (fig. 62). Where no heat was needed, for example for the consolidation of c- and e-panels, colourshapers with silicone tip stamps made from Melinex foil cushioned with cotton were used.

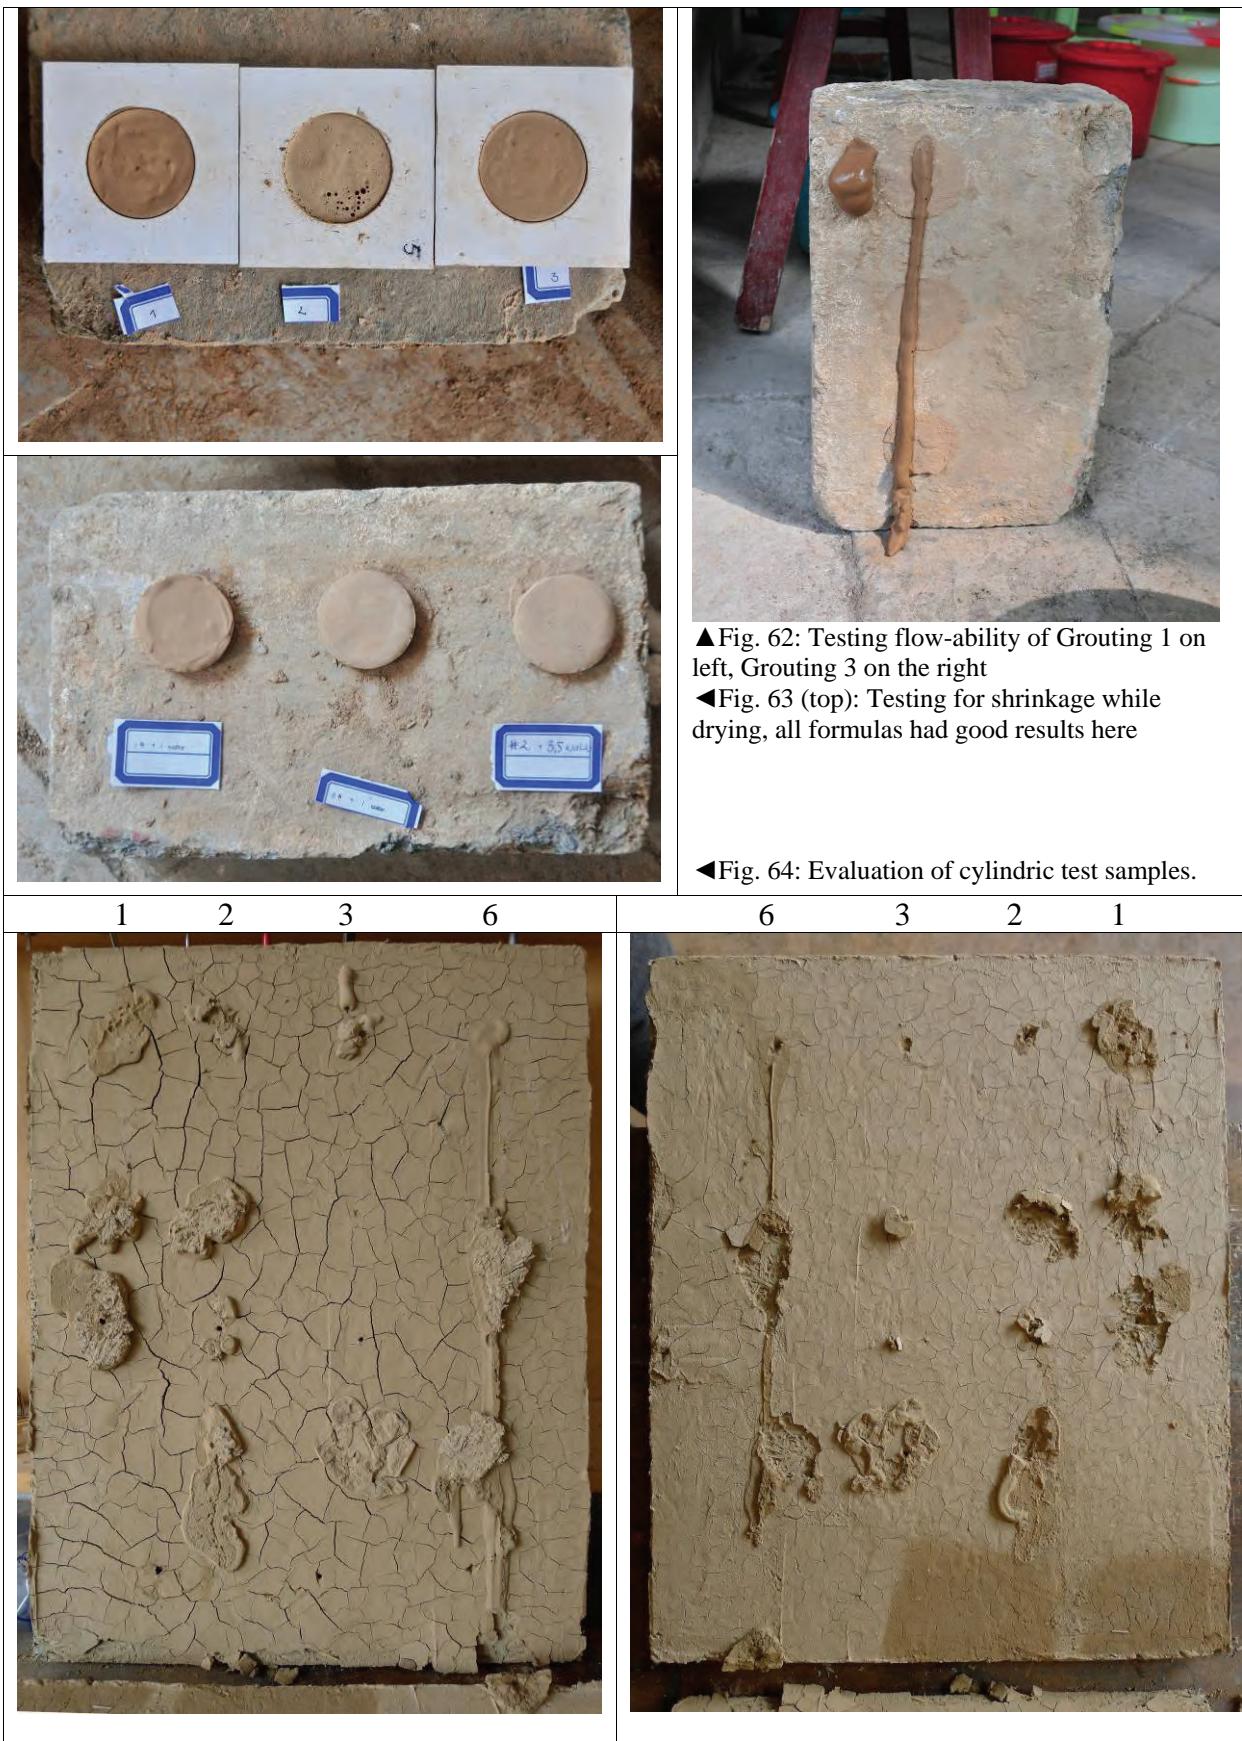
<i>Evaluation</i>	<i>Grouting1</i>	<i>Grouting2</i>	<i>Grouting3</i>	<i>Grouting 6</i>
<i>Usage</i>	<i>Good injectability, spreads well</i>	<i>Too high viscosity, not fluidly injectable through cannulae, too much pressure needed to press through the 4 mm cannula, because of poor fluidity the pressure within the void model increases, the two boards started a cracking sound/ noise</i>	<i>Good injectability, but less than Grouting 1, somehow blocked within the hole in the board</i>	<i>Highly fluid, flows down the void</i>
<i>Evaluation of break</i>	<i>as a stamp within the void, 1 x break of cohesion, 2 x ripped off plaster from the board</i>	<i>As a stamp within the void, breaks within the grouting mortar, cohesion break</i>	<i>Two breaking phenomena: cohesion break in the plaster and mixed cohesion/adhesion break without damage of plaster</i>	<i>Where grouting got stowed and by this it bridged the gap, there is a cohesion break in the plaster</i>

Fig. 65: Void model opened after one week of drying, grouting recipes 1, 2, 3 and 6 labelled on top.

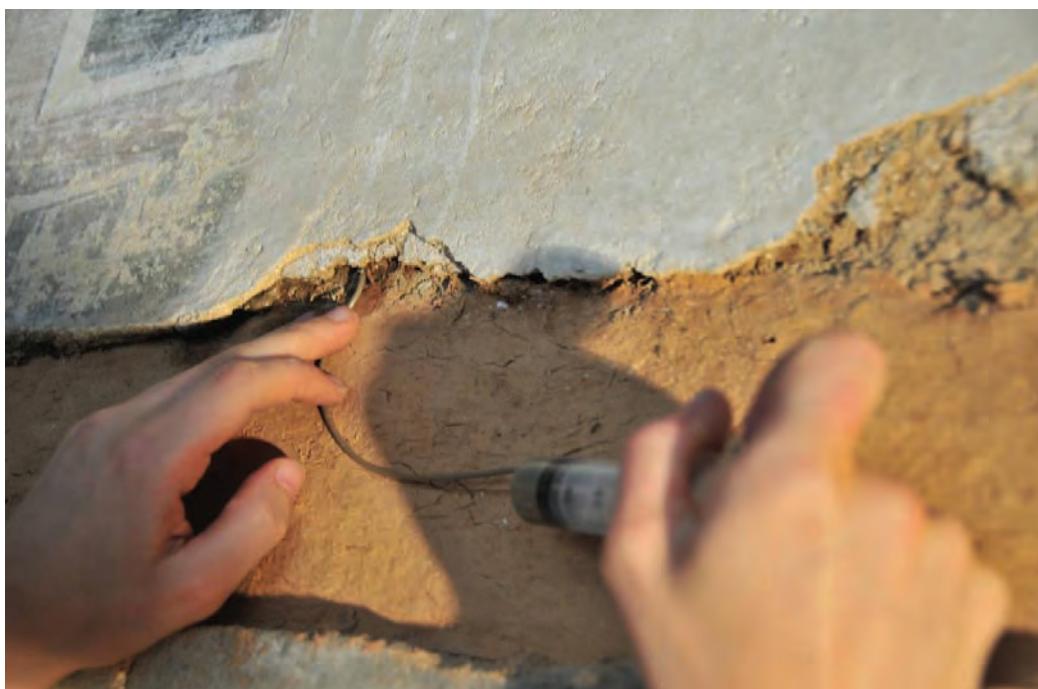
Fig. 66
Injecting
grouting
through a
small tube.

For wetting the voids it was first a mixture of water and alcohol (2:1) injected. Next grouting was injected, either with a syringe and small tube or a cannula (fig. 66, 68). During injection the surface of the plaster was held in position, so that it wouldn't bulge. After injection stamps were pressed on the surface to let the grouting dry in the voids under pressure. The stamps were wood sticks or sometimes an empty plastic bottle, which were cushioned with a piece of polyethylene foam enveloped into a piece of Evolon®-textile.⁵ This was necessary otherwise the grouting would detach from the voids inner surface. This was an observation made during work. After at least one day of drying, the stamps could be removed. Where voids had big openings they were stuffed with filler material designed for filling the losses in the coarse coat (fig. 71, 72) first before grouting was injected after drying of the plaster.

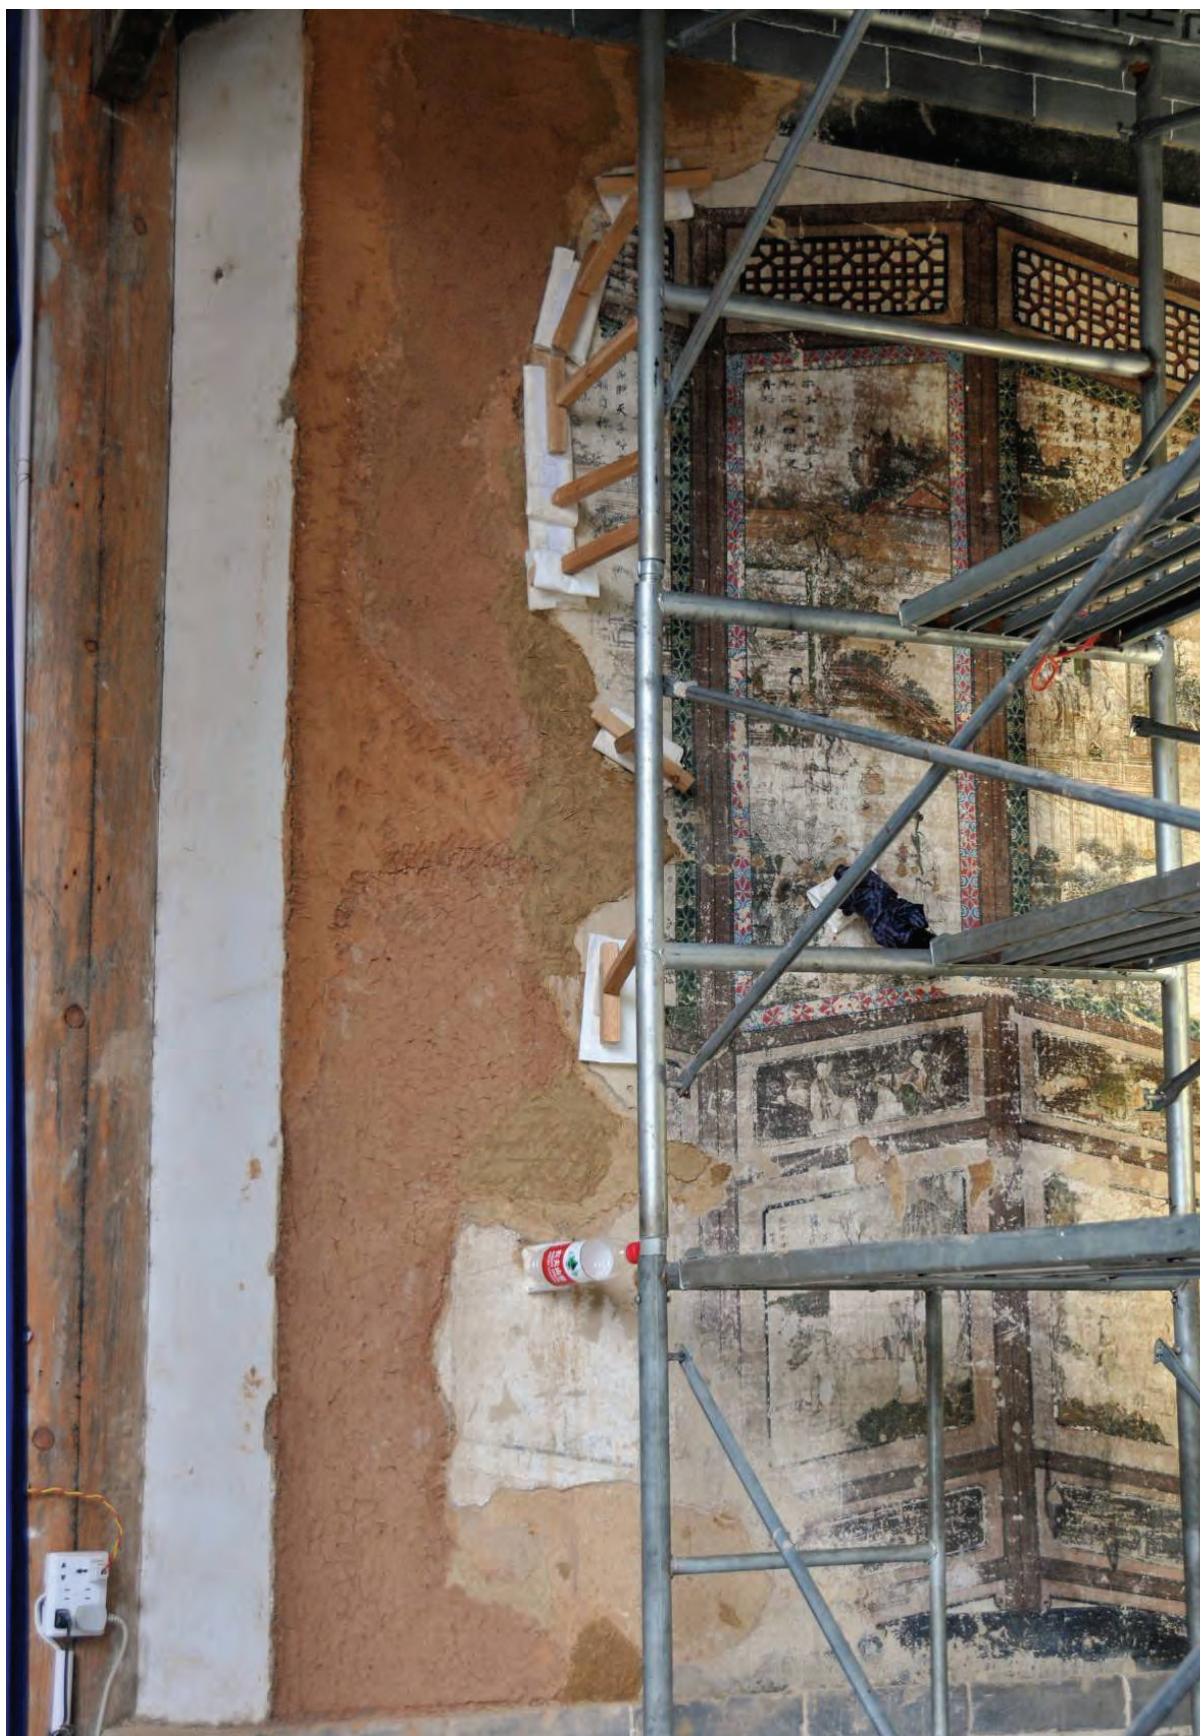
Fig. 67

The detached edges of the big loss were grouted and pressed during drying with stamps-

Along the edges of the big loss on the left of *pingfeng xi* the fine coat was detached from the coarse coat layers almost across the whole height of the wall. The detached parts were grouted and pressed into position during drying with a stamp, which was made from a piece of expanded polystyrene foam, enveloped into a piece of Evolon® mat pressed towards the wall by a wooden stick or sometimes also simply by an empty plastic bottle (fig. 67). In the area of the loss attempts had been made earlier to fill it up to the 2nd coarse coat level. Two different mortars were used for these repairs, both of a more reddish tint than the original plaster. Still in some places some more coarse coat mortar was needed to fill up to the 2nd coarse coat level entirely. The mixture used, is the same that had been designed to fill holes within the painting up to the coarse coat level, containing local earth (loam), straw and sand. The surface of the fillings was roughened up with a criss-cross pattern into the fresh mortar so that the fine coat would interlock with it (fig. 79, 80).
