The Murals of the beiwusheng huiguan in Ziyang

Final report

Part 2: Condition, Conservation and Restoration

Research Project 01UG1001
„German-Chinese co-operation in the preservation of Cultural Heritage: Researches for the
conservation of selected monuments in the PR China“

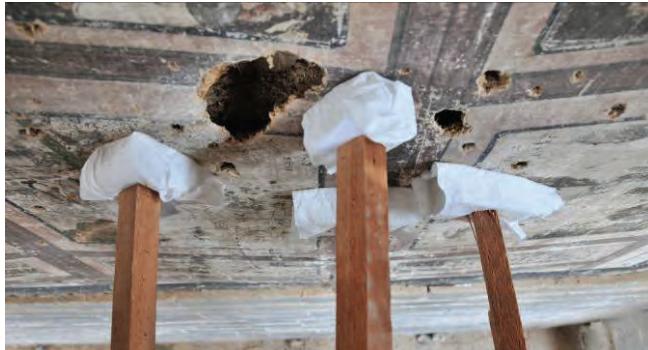
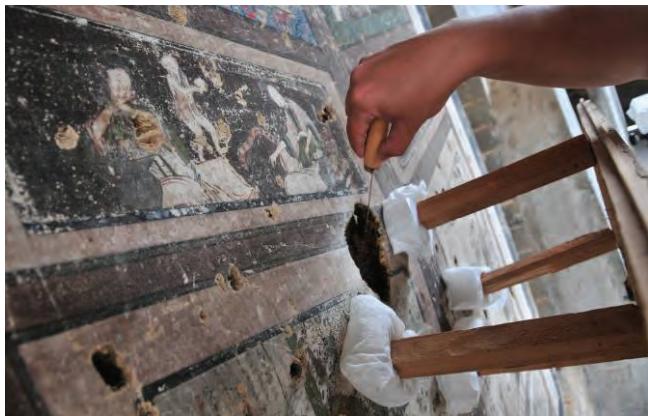
▲ Fig. 71, 72

Stamps hold the detached fine coat in position, while deep holes and reachable caverns get filled with coarse coat filler.

For wetting the voids it was first a mixture of water and alcohol (2:1) injected. Next grouting was injected, either with a syringe and small tube or a cannula (fig. 66, 68). During injection the surface of the plaster was held in position, so that it wouldn't bulge. After injection stamps were pressed on the surface to let the grouting dry in the voids under pressure. The stamps were wood sticks or sometimes an empty plastic bottle, which were cushioned with a piece of polyethylene foam enveloped into a piece of Evolon®-textile.⁵ This was necessary otherwise the grouting would detach from the voids inner surface. This was an observation made during work. After at least one day of drying, the stamps could be removed. Where voids had big openings they were stuffed with filler material designed for filling the losses in the coarse coat (fig. 71, 72) first before grouting was injected after drying of the plaster.

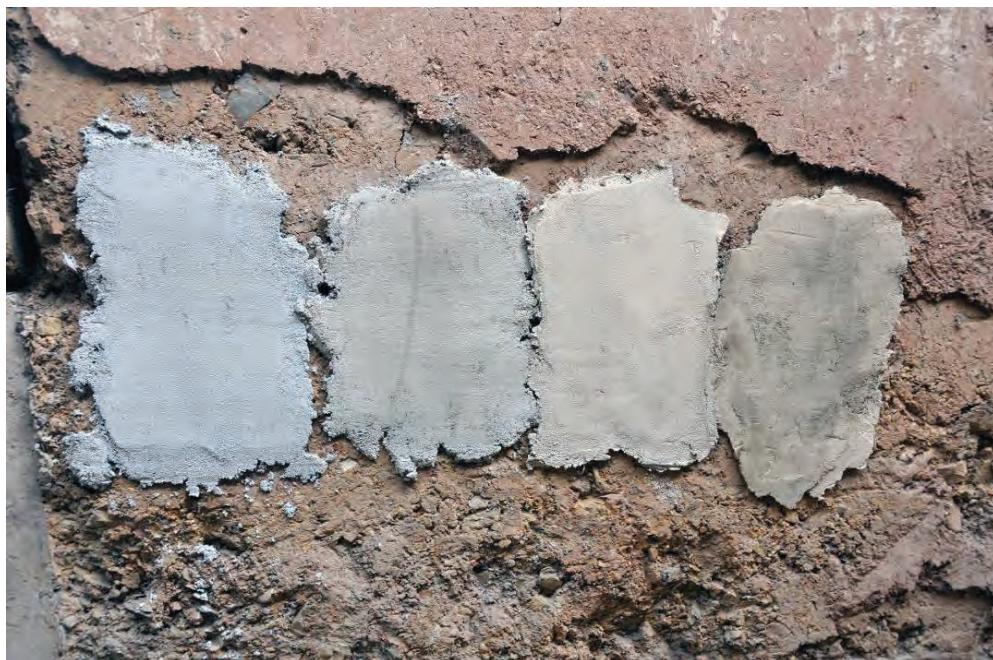
Fig. 81
Tests with different kind of sands, to achieve the right colour for the big fine coat fill. The 2nd from left is the mixture with completely washed river sand and judged to fit best. This test wall is a later building in the *beiusheng huiguan* in which the toilet is situated.

For the fine coat plaster we made a new mixture different from the fine filler, containing ore lime. Visual examination and also analysis showed, that the sand contained in the original fine coat as flat, rounded slate particles. This is just what the sand from the river right below the *beiwusheng huiguan* looks like. So we gathered the sand from the riverbank there. This sand made the plaster first unpleasantly grey, but when we washed out the fine greyish fractions of the sand it got better and together with yellow sand, yellow loam and lime a nice light yellowish colour resembling the original fine coat plaster was able to be made. (fig. 81).

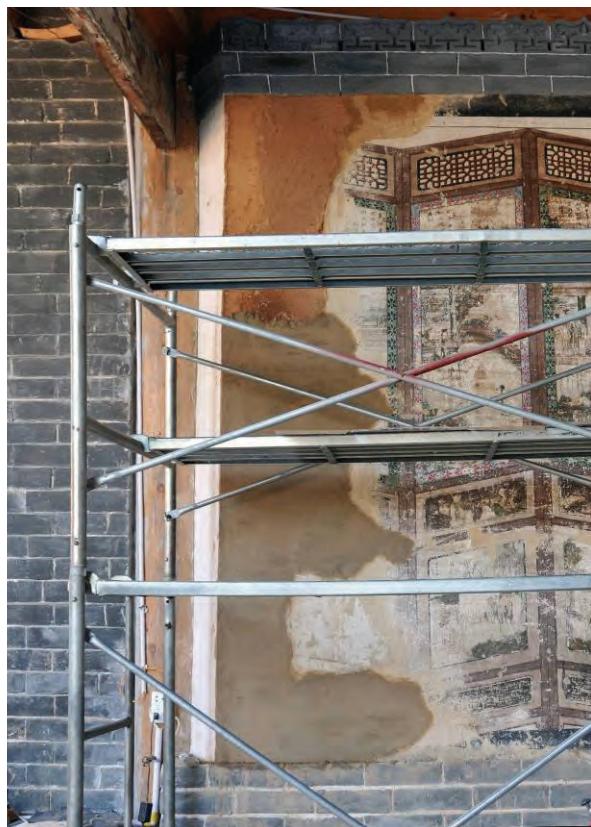
Fig. 82
The application of the fresh fine coat mortar carried out by a team of two. One filling the area and the second doing the crossing to the historic surface with a small spatula to avoid soiling.

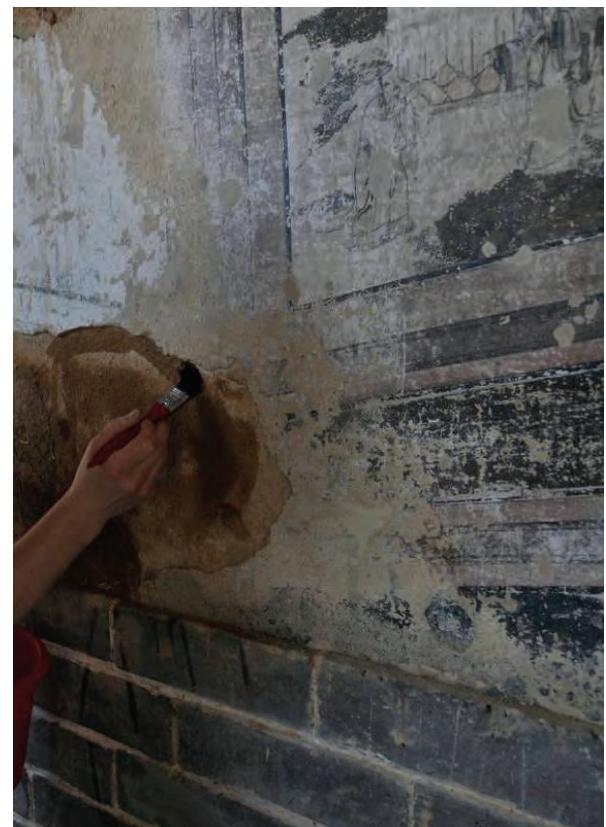
Fig. 83
The coarse coat surface was carefully wetted, before the fine coat plaster was applied. The paint layer of adjoining areas was not to get wet.

The proportion of loam, lime and sand was chosen according to analysis results. We mixed in a similar amount to what our analysis showed, that the fine coat contains. This was around 50-50 -65 % quartz, around 10 – 30 % calcite and around 7-14 % clay minerals and others.⁷ We sieved the riverbed sand to a maximum size of 3 mm and then washed it, to get out the fine greyish fraction. Then we took 5,5 parts grey river sand, 1 part yellow sand, 2,5 parts slaked lime and 1 part yellow loam (<75 µm). Finally 2 VP of finely pulled cotton fibres were added and thoroughly mixed. No extra water was added as the washed river sand already contained enough water. The plaster was good to spread and work and after drying only little cracks appeared. The plaster thickness applied varies from around 4 mm up to approximately 1 cm. The application of the fine coat plaster was made with a trowel and carried out from bottom to top (fig. 82, 84). Along the edge of the original plaster a second person filled the crossing with a small spatula, to avoid soiling the historic surface. Bit by bit the coarse coat surface was carefully wetted before the plaster was applied, to not let the fresh plaster dry too fast and to improve the bond between coarse coat and fine coat (fig. 83)

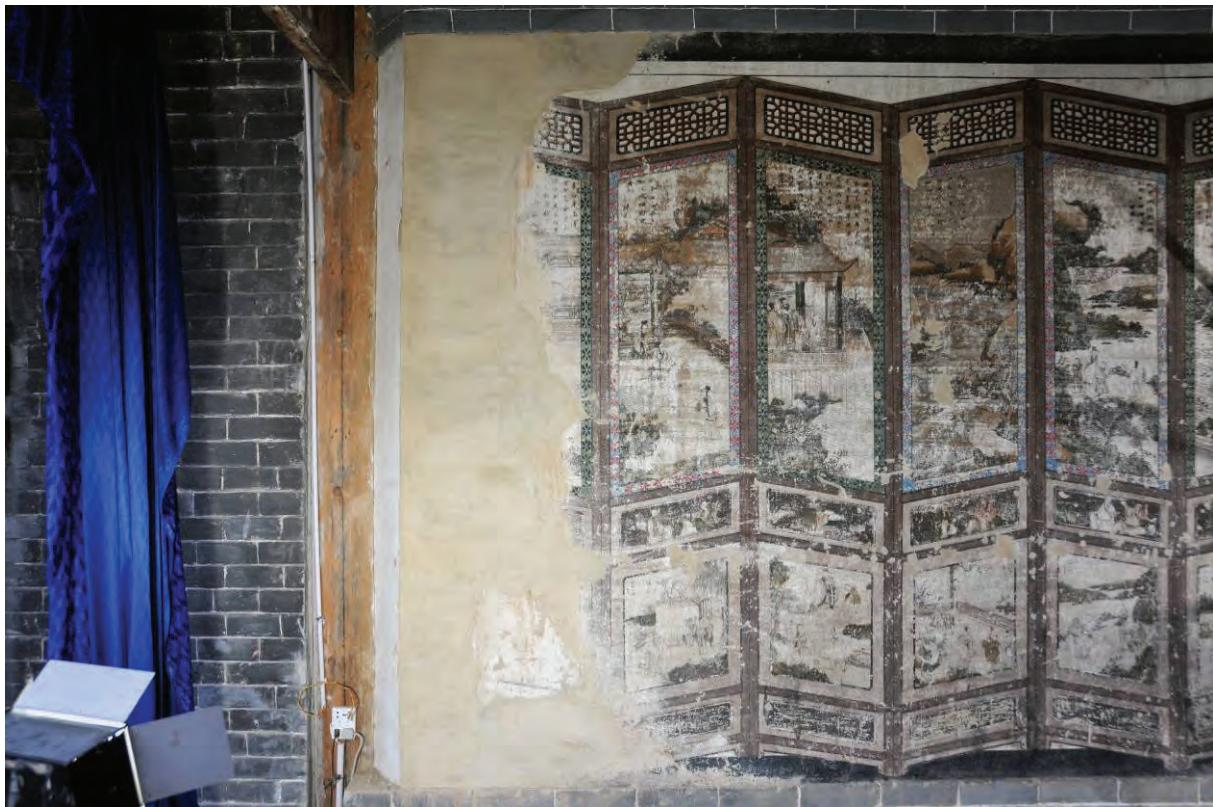
Fig. 84
Pingfeng xi, after drying of the applied fine coat in May 2012.

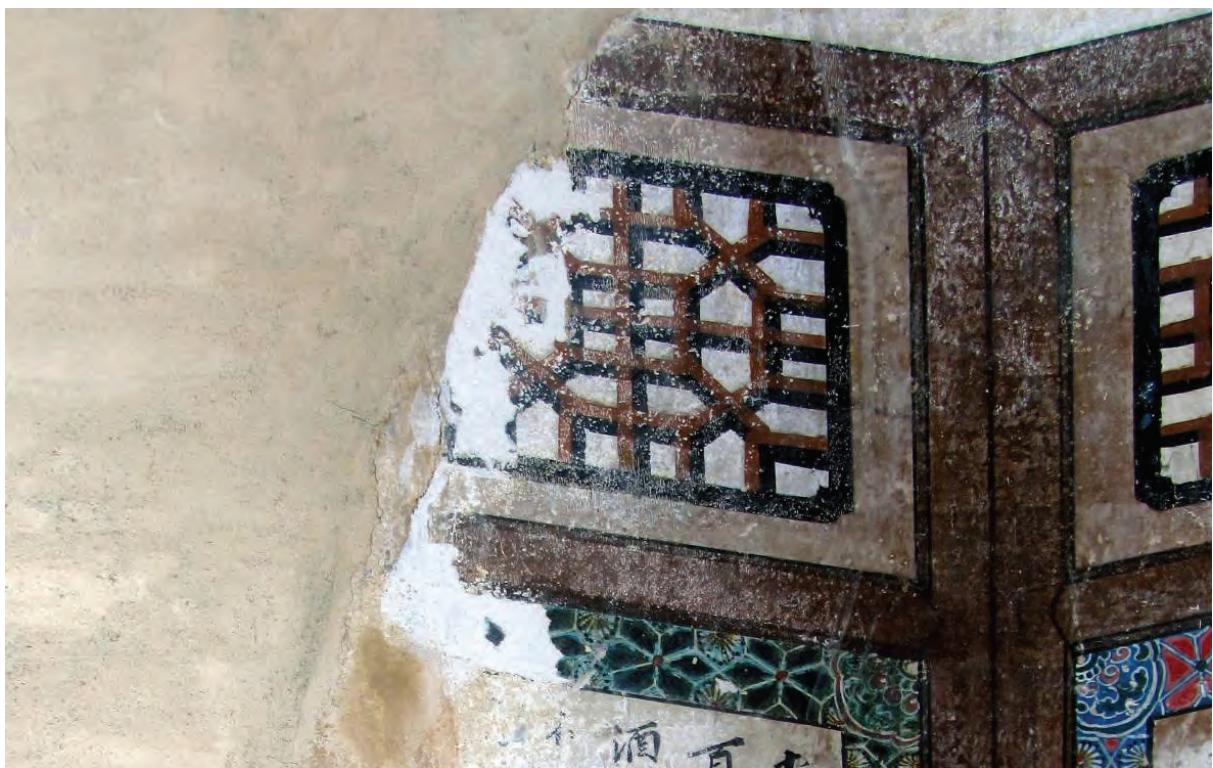
Fig. 85
Pingfeng xi, detail of panel 1 a. White priming material applied to the remains of original fine coat.

The priming material is made *up of a 7 % rabbit hide glue solution (+ 5% slaked lime)* as a binder and of kaolin and yellow loam (9,6 : 0,4 VP) as fillers and also colouring components. 10 Parts of the glue solution were mixed with 8 parts of loam. The mixture was left to soak for one day and then some more water was added until the watery diluted condition as needed for a multi-layered application was reached.

The areas prepared with priming material were treated with a size of a 4 % rabbit skin glue to reduce absorbency and make retouching possible.

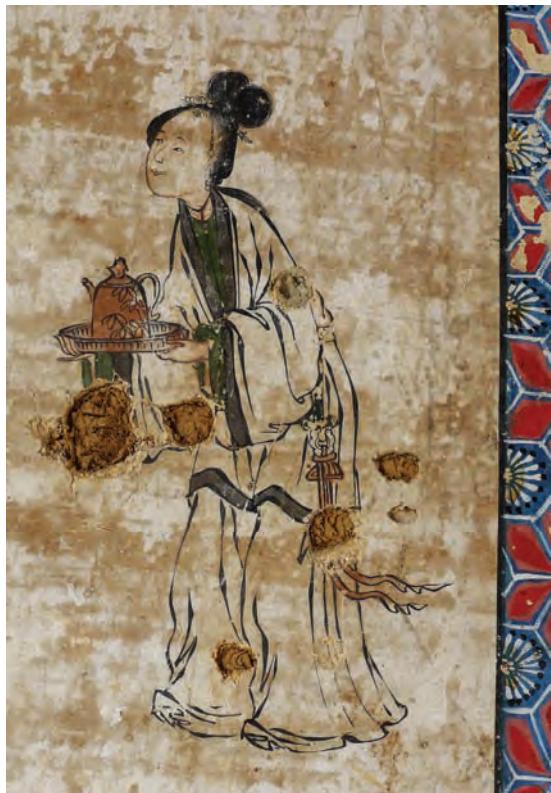
◀Fig. 86, Fig. 87 (below left)
Pingfeng xi, detail of a woman in panel 2b, before and after cleaning, consolidation and filling. The colour of the fine filler blends in with the surrounding colour and does not need to be retouched.

Before applying the fine coat filler, a slurry was applied to the loss, which made the filler better attach. Very small cracks, losses or open edges from dented surface were filled only with the slurry. The slurry was made from the fine coat filler mixture without fibres. The colour of the fine coat filler and hereby also the colour of the slurry, was adjusted in tests with different amounts of yellow and grey loam. The colour of the fine filler should fit as good as possible into the surface colour of the painted panels' background. By this, smaller fillings can already be reintegrated and wouldn't need retouching (fig. 77, 78).

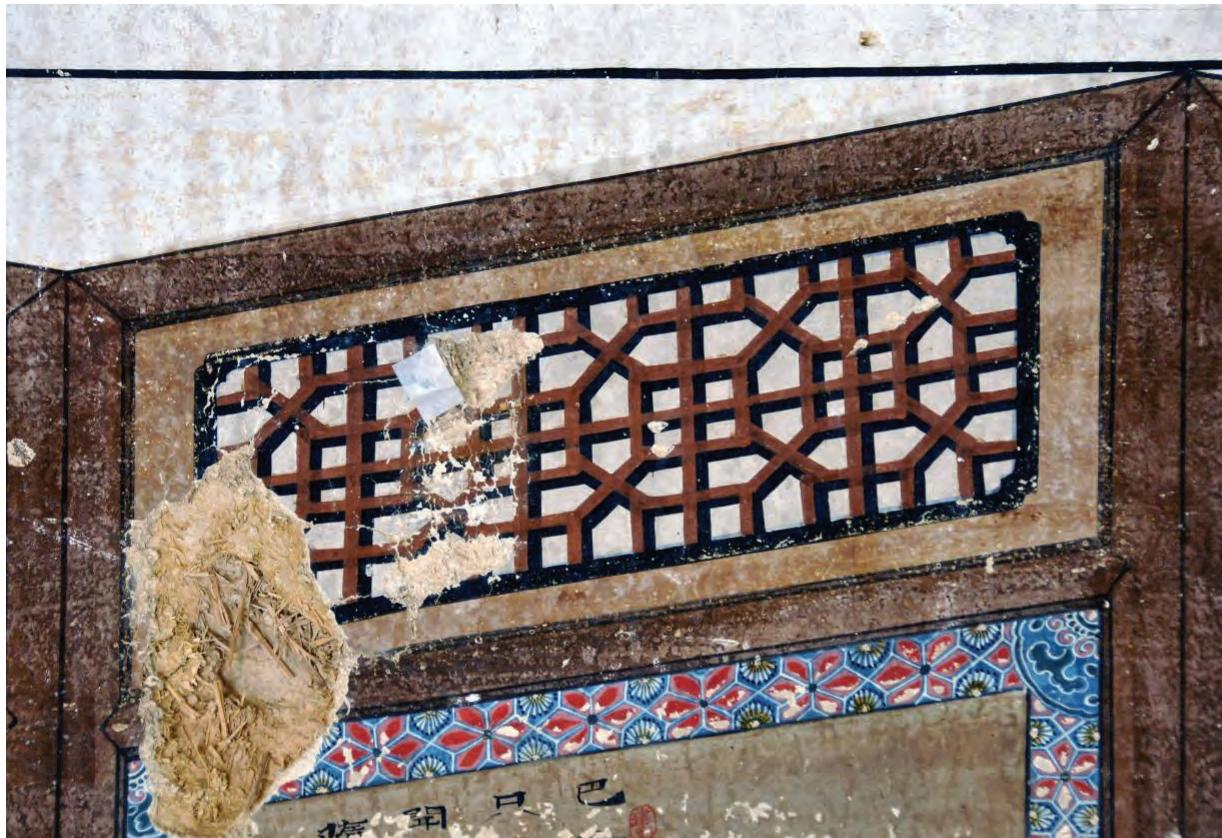
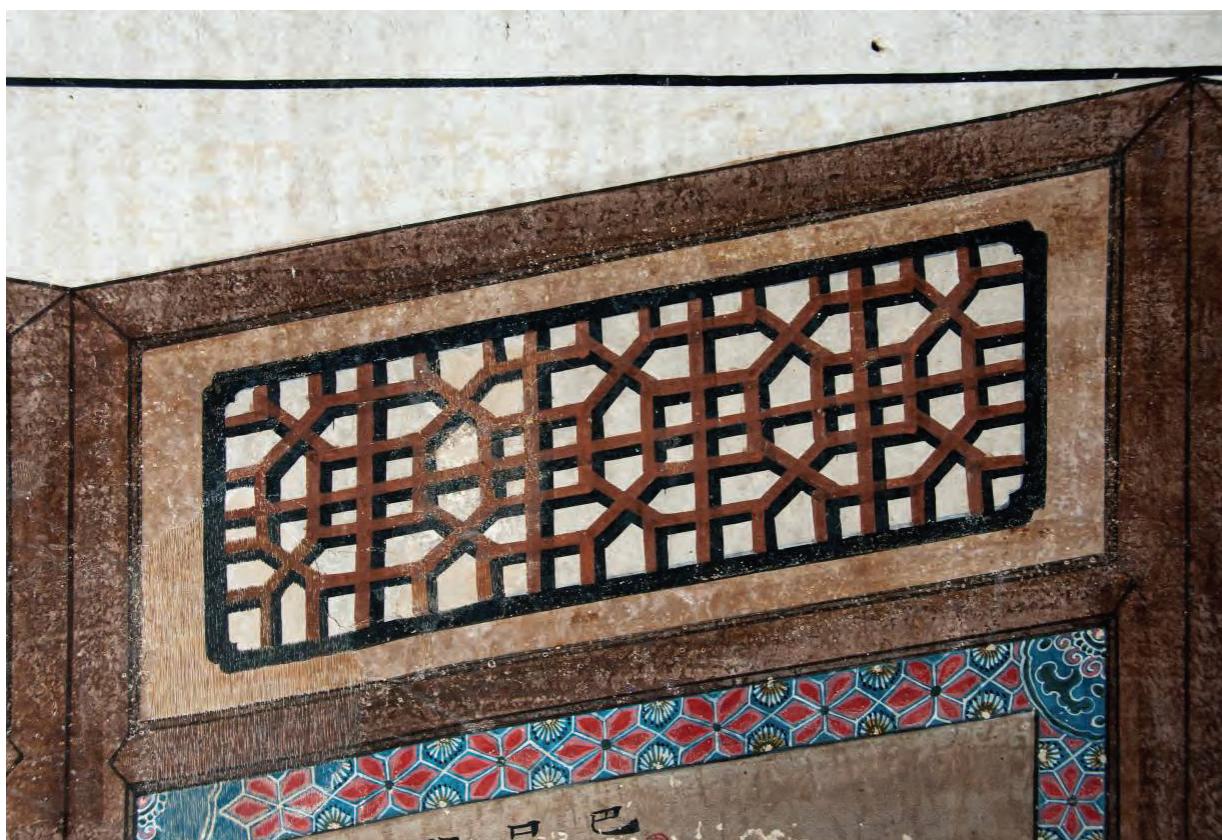
Fig. 90, Fig. 91 ▼

Pingfeng xi, panel 4 a, before and after restoration. Retouching reconstructed shape and colour of the framework, lattice-work and the repetitive pattern of the flower-and-star-border.

Where it was possible to determine the original shape and colour, retouching was conducted to reconstruct it. The mural *pingfeng xi*, which depicts a folding screen, has a lot of architecture-like forms or shapes, which have a distinctive geometry. Losses within these clear shapes of two lines or areas of same colour can therefore be reconstructed. These areas are the black outer framing, the folding screens framework, but also objects that have a clear and distinct shape, for example vessels. Losses within repetitive patterns, like the black and red lattice-work in the top part and the blue and green flower or star borders could also be reconstructed by retouching (fig.90, 91).

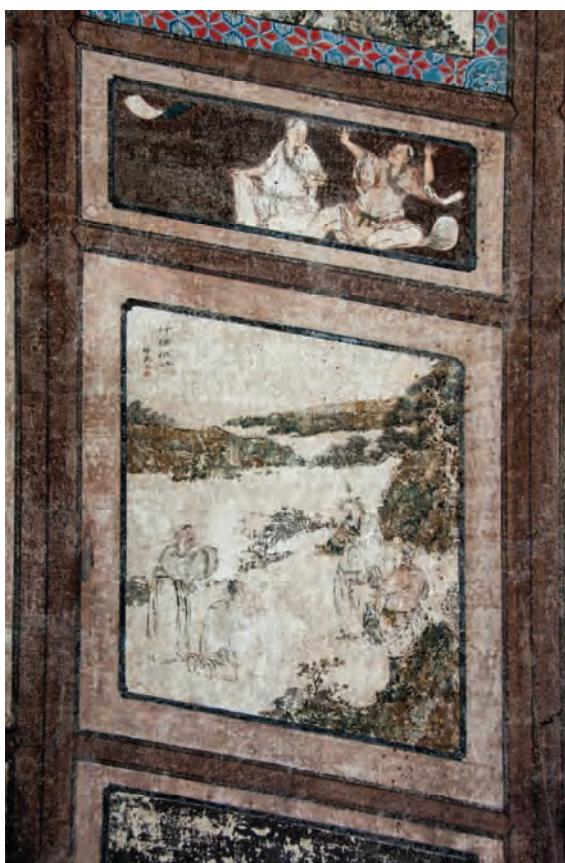
◀Fig. 95
pingfeng xi, panel 5d after restoration. The tratteggio retouching, which were visible at a close range are invisible from a distance, see also the photo before.

The technique of retouching chosen was „Tratteggio“. By this, losses were reintegrated with small vertical lines of 3–5 mm long. Using two to three layers of different colours, the losses are not recognisable as damaged anymore seen from a distance (fig. 95). The colour and shape match the surrounding painting, only at close range the structure of lines is perceptible and makes the retouching distinguishable from the old painting (fig. 96, 97). One exception was made for the retouching of the slim black panel filling frames. It turned out to be more suitable to use lines parallel to the frames' outlines. First we tried doing also consistently vertical lines, but the retouching orthogonally to the frame resulted in an uneven contour and only being able to paint one line across the width of the frame created a too well-ordered pattern.

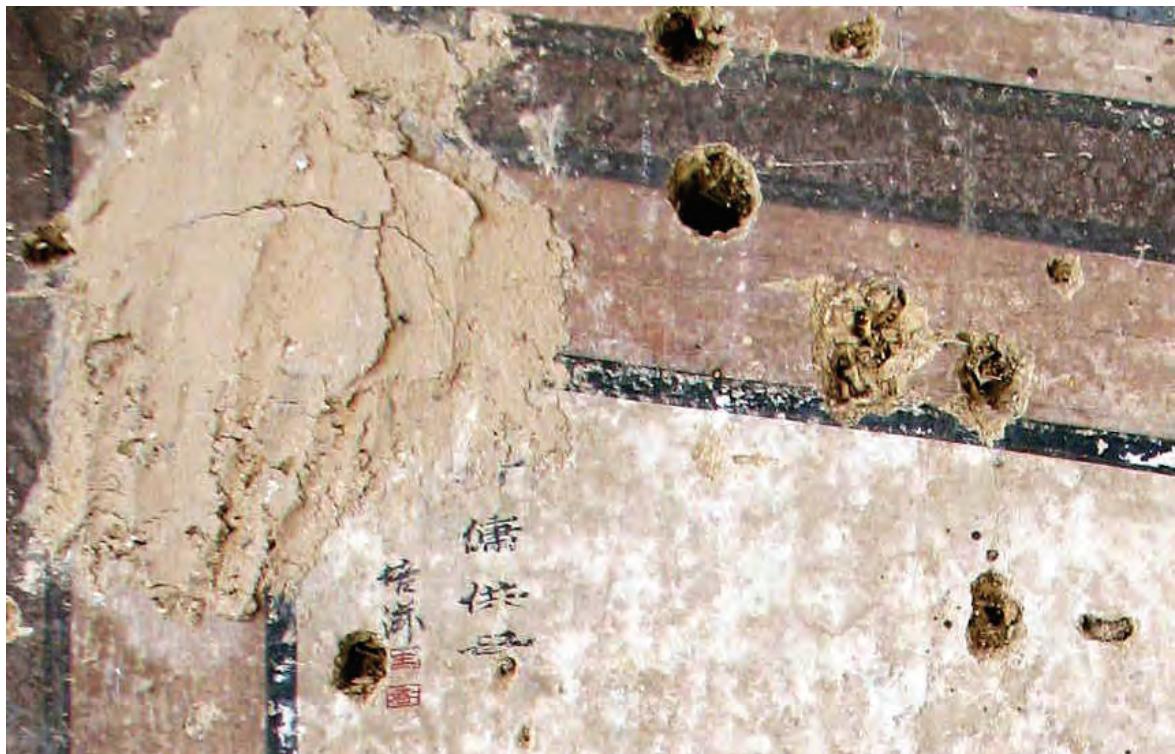
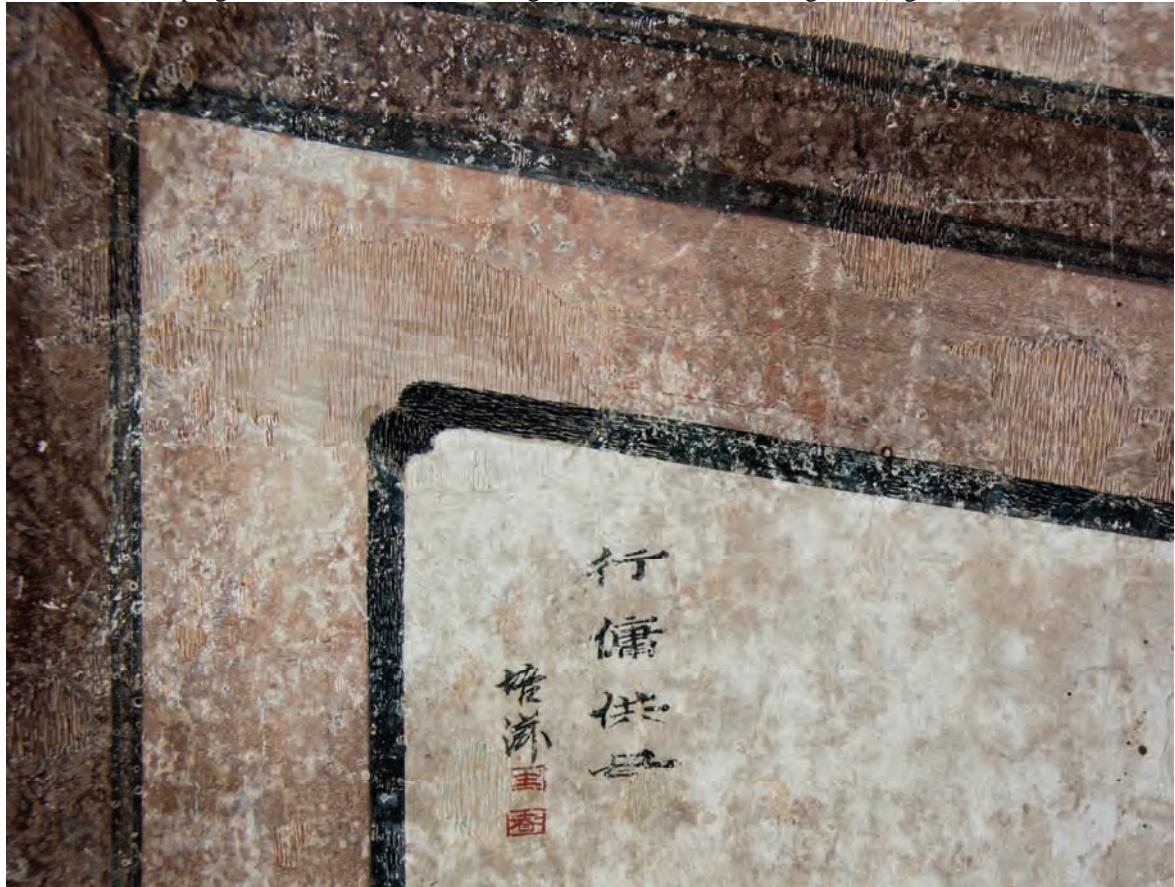
Fig. 96, 97

pingfeng xi, detail of panel 5d before restoration and after restoration. From a close range the mainly vertical lines of the tratteggio retouching is easy distinguishable from the original painting. Only the slim black panel filling frame (here the inner frame) was retouched using lines following the direction of the frame, i.e. also horizontal or sloping lines. From a distance fillings and losses are well integrated (fig. 95)

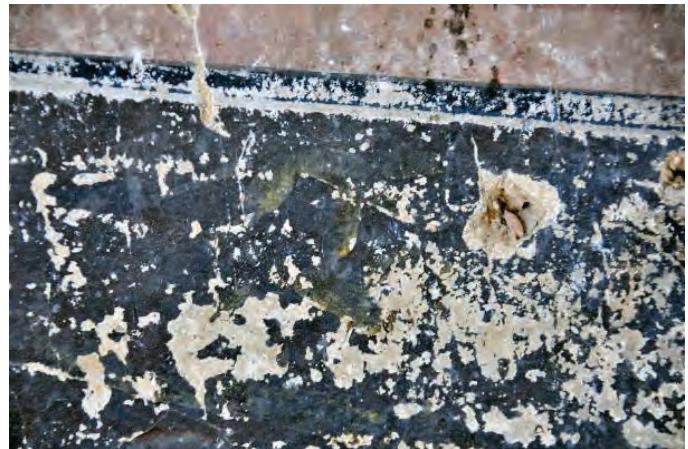
Fig. 98

At the bottom of the mural *pingfeng xi*, the e-panels are severely damaged. There are only little remains of paint that give evidence of the design, which could be seen here before. The remains found belong to a bright yellow rounded ornament which was painted on top of the dark brown background (fig.98). Mostly the yellow pigment is lost and only the remaining whitish binder allows tracing the ornament. This trace looks like the yellow ornament, which is still present on the folding screen in the main hall (*zheng dian*), declared as *pingfeng bei* (fig. 99). At *pingfeng xi* the dark brown background of the e-panels looks like the colour of the background of the c-panels. The only difference is, that in the c-panels the space for the figure was left blank when the dark brown background colour was applied. In the e-panels the brown background colour was applied to the whole area and afterwards the yellow ornament was painted on top of it. At a closer look to the dark brown background colour of the *pingfeng xi*'s e-panels there is a 2nd ornament (in chinese named *yun leiwen*) of an angular shape visible. This ornament is black and hardly visible within the dark brown background. It is located beneath the yellow ornament and in UV-Light the black ornament has a yellowish fluorescence (fig. 100, 101). This ornament is also present and well preserved in the e-panels of *pingfeng dong* (fig. 102). In some e-panels, especially in 8 e the flaking off paint layer occurred in the same place where the *yun leiwen* ornament was present (fig. 103). Because of this damage the *yun leiwen* ornament is well recognizable. The *yun leiwen* ornament was most likely already covered with the yellow ornament during the making of the murals. Either the *yun leiwen* ornament has turned black or the ornament could be overpainted as a change of the concept at an early stage. It is unlikely that it is a later addition because the background colour looks the same as in the c-panels. The yellow ornament is also present on *pingfeng bei* and there it is no later change, but the original and only design. These are the facts and now the question of how to deal with these badly damaged areas. After having integrated all bigger sized losses with retouching, either reconstructing colour and shape or in a neutral colour when it was impossible to reconstruct the drawing.

Pingfeng xi, panel 5 e, traces of the yellow ornament on a dark brown background colour.

However, not enough material has remained to reconstruct this yellow ornament with retouching. Reconstructing the older, but better visible *yun leiwen* ornament would be wrong. The only possibility would be to integrate the losses into the brown background. The idea was, that the contrast of the dark brown paint layer remains get reduced and by this means the remains of the yellow ornament or the whitish traces of his ornament would become better visible. We were aware, that the situation created by integrating only into the background colour without an ornament would also create a synthetic condition on the e-panels. Not showing a bright ornament but integrating the losses into the background colour was still regarded to be the suitable way to treat these areas. Otherwise these areas would be the only places that looked fragmentary on this wall and also more fragmentary compared to the other murals' condition. So we started retouching these areas in a slightly lighter tone than the true background colour (fig. 104, 105). After a while we had a new discussion on the already mentioned synthetic, dark areas that we created with the missing necessary bright ornament giving the right contrast. It it was unsatisfactory to the team and conjointly decided to stop and leave these areas without reintegration. Only the slim black panel filling frames should still get reconstructed by retouching. The retouching, which had already been carried out

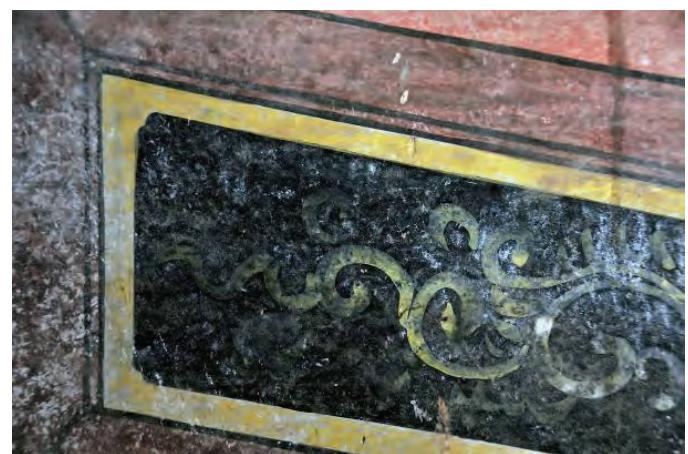
Fig. 99

Pingfeng bei, panel 1 e, the yellow ornament on a black background colour is much better preserved here.

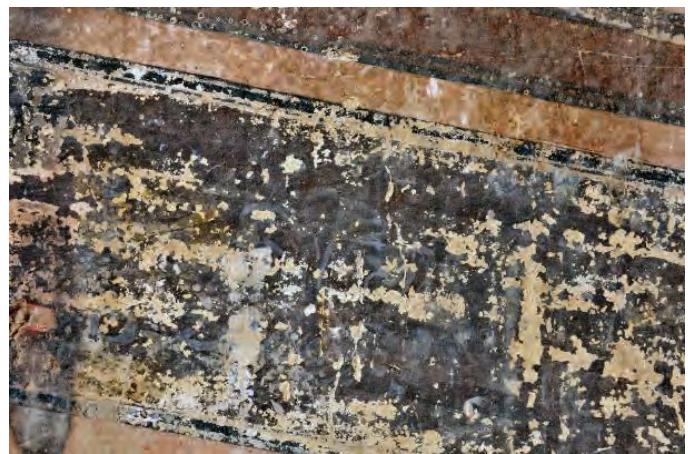
Fig. 100

Pingfeng xi, panel 3 e, white fragments of yellow ornament on dark brown, the geometric ornament is black in the dark brown layer.

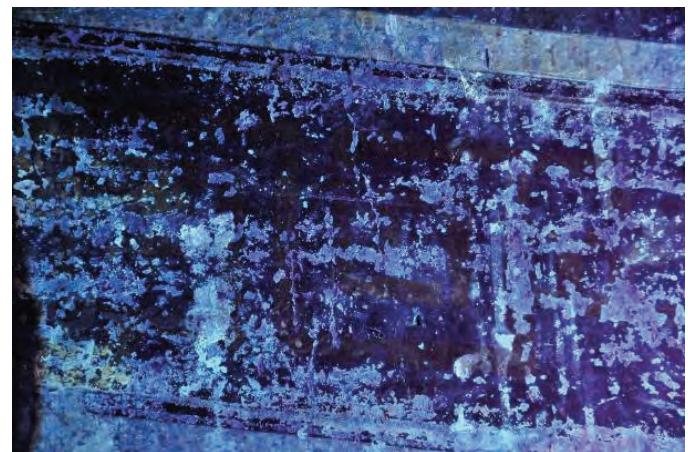
Fig. 101

Pingfeng xi, panel 3 e under UV light the geometric black ornament gets a yellowish fluorescence.

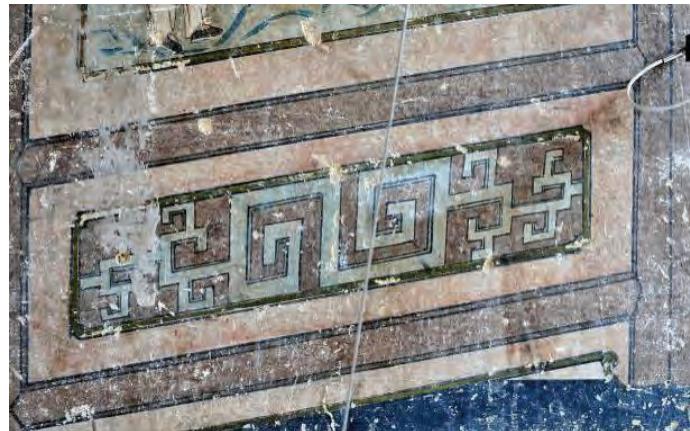
Fig. 102

Pingfeng dong, panel 6 e: *yunleiwen* ornament in pale blue with brown background

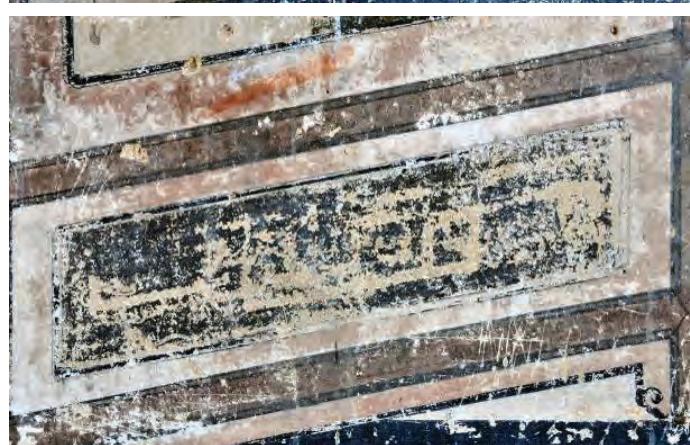
Fig. 103

Pingfeng xi, panel 8 e, losses follow the geometric ornament

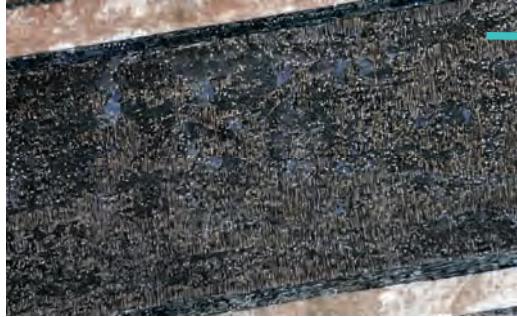
Fig. 104

Pingfeng xi, panel 8 e, losses integrated into the background colour with *tratteggio*.

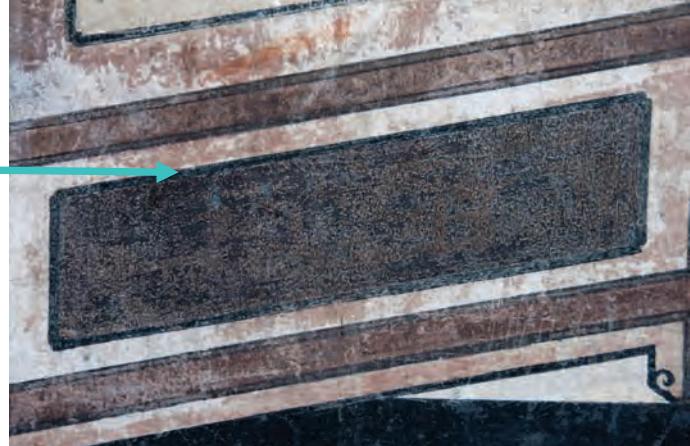
▲Fig. 105

Pingfeng xi, panel 8 e, detail of the retouched area with remains of whitish binder from the yellow ornament.

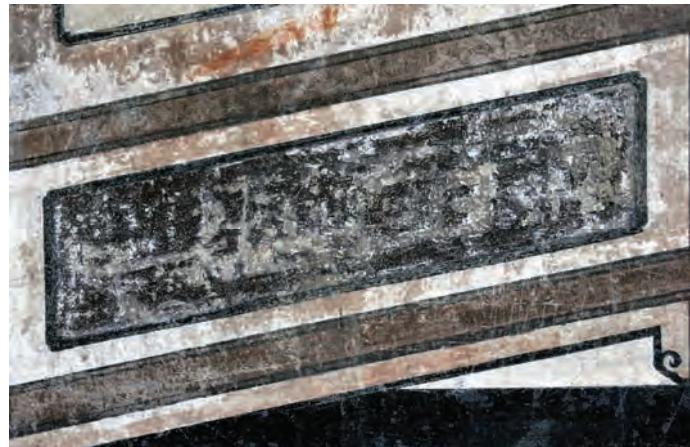
Fig. 106

Pingfeng xi, panel 8 e, after reducing the retouching with a cotton swab and water.

should get reduced by cleaning (fig. 106). The losses of paint layer in the other e-panels should stay without retouching. Only fillings within the damaged e-panels get integrated into the damaged layer by retouching. This might be deviating from the concept of reintegration, but there was no satisfactory solution for treating these areas, so they stayed fragmentary (fig. 109, 110).

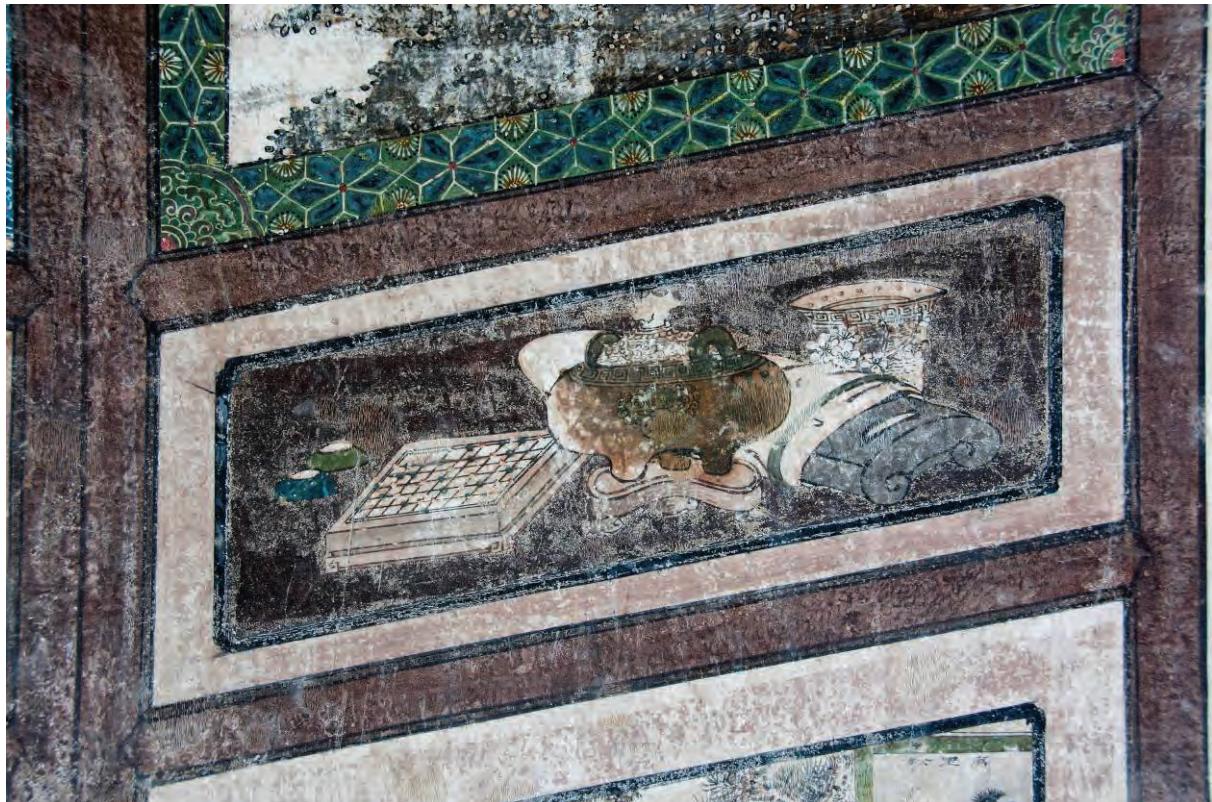
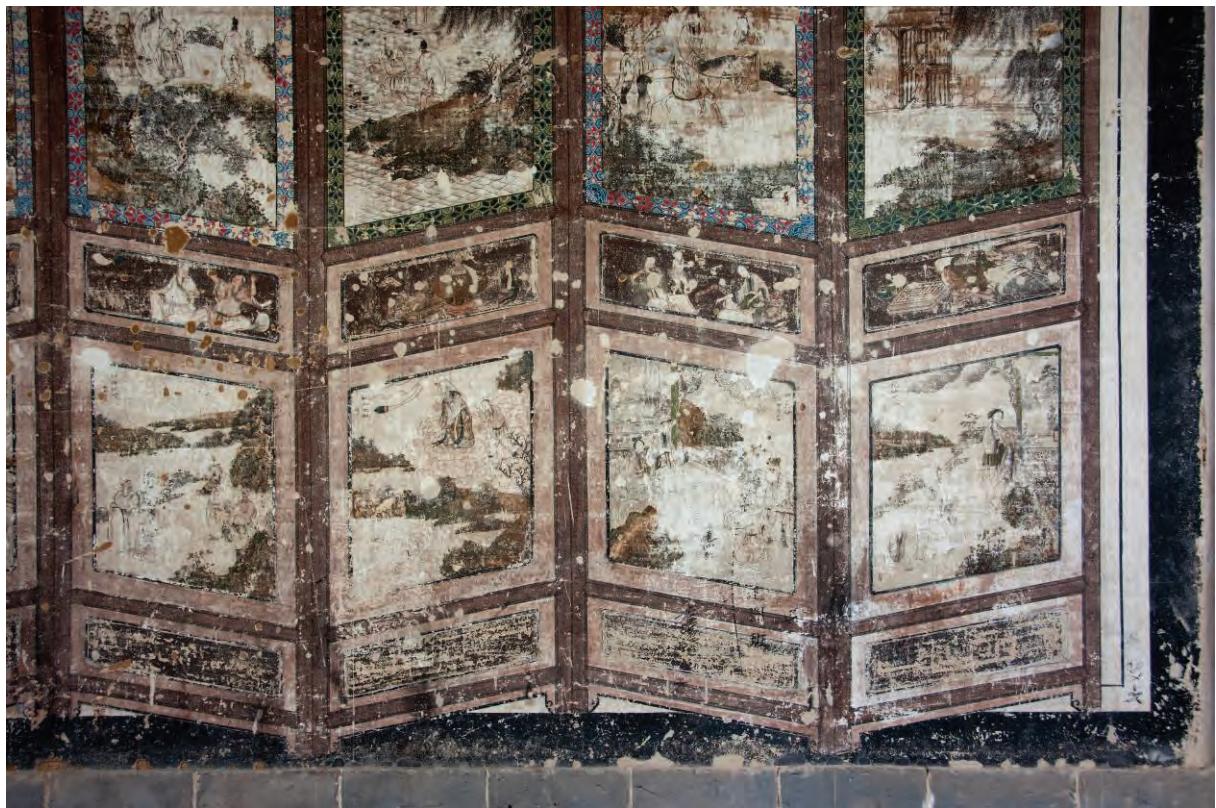
Fig. 107, 108 ▼

Pingfeng xi, panel 8c, during filling and after restoration. The retouching is always matching the surrounding colour of the loss. By this, the aged condition of the mural was not refreshed.

Reconstructible areas like the black framing, the folding screen's framework and geometric or distinctly shaped forms were reconstructed using tratteggio technique. The retouching was always carried out matching the surrounding colour of the loss. By this, the aged condition of the mural was not refreshed (fig. 107, 108).

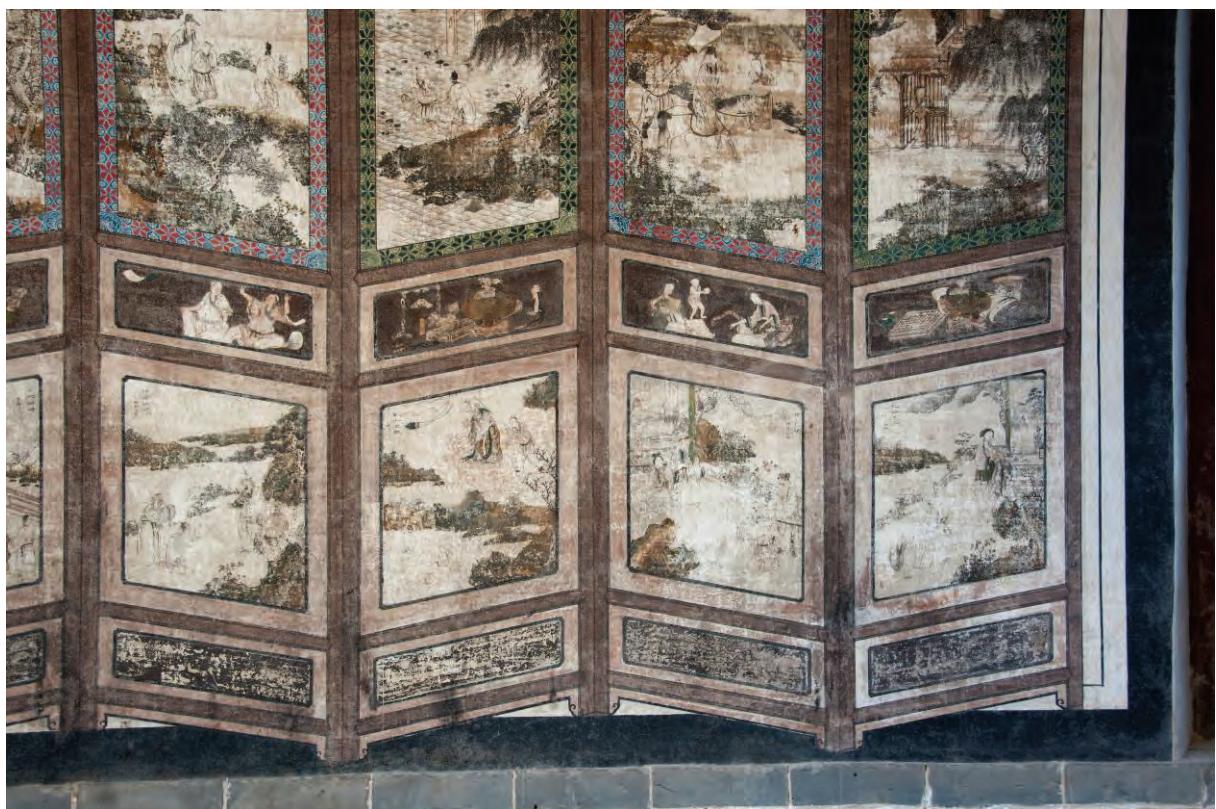
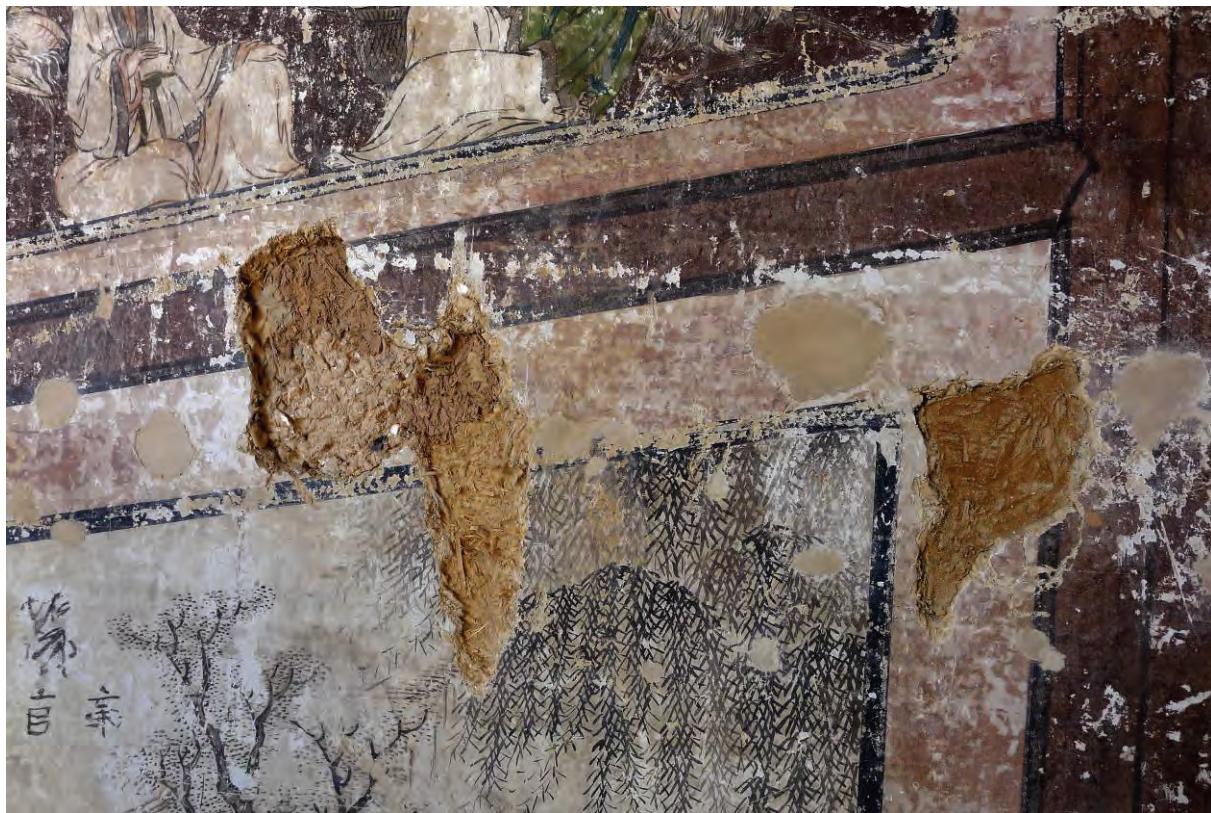
Fig. 109, 110▼

Pingfeng xi, bottom right quarter, after fillings carried out on the photo on the top, retouching done below.

The integrating by inpainting made the losses nearly invisible, depending on the distance of the viewer from it, and restored the mural's harmonic appearance (fig. 109, 110).

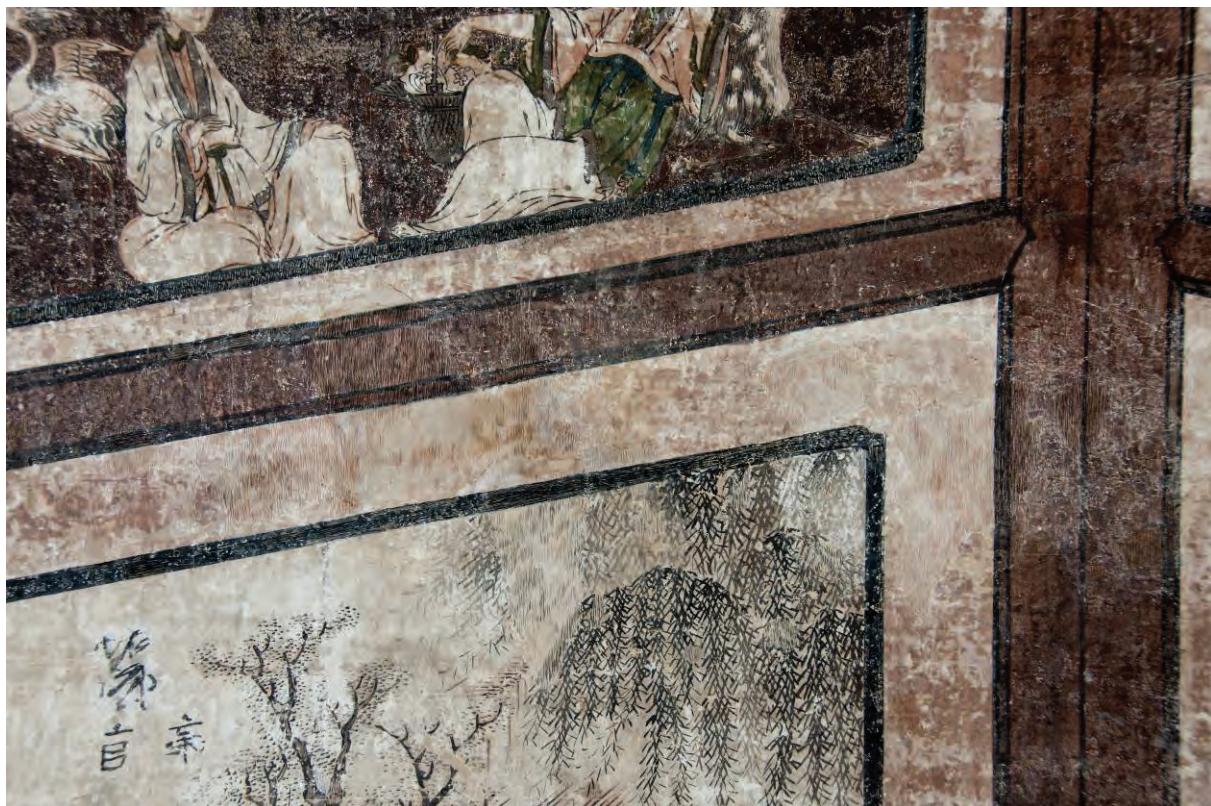
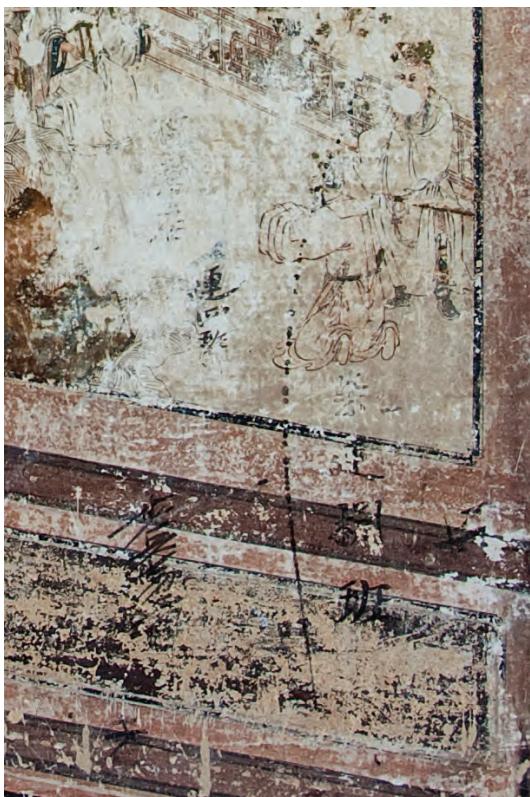
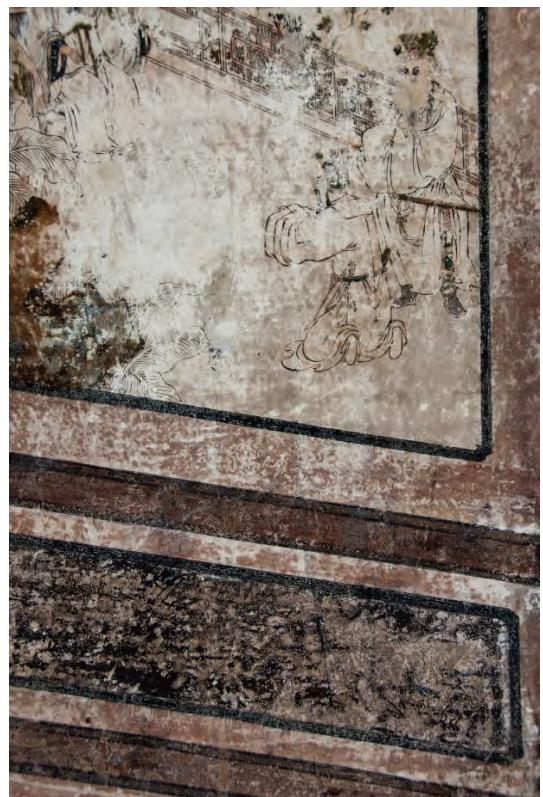
Fig. 111, 112 ▼

Pingfeng xi, panel 2d, during filling and after restoration. Losses, which had neither a geometric form, nor a repetitive pattern, were considered not reconstructible and integrated with a neutral hue. A neutral hue was applied to the loss using trattegio technique, so that the loss would disappear and not create a clear shape. For instance, the leaves of a tree were not reconstructed as they were neither a repetitive pattern nor a clear geometric shape.

Losses, which had neither a geometric form nor a repetitive pattern, were considered not reconstructible and integrated with a neutral hue (e.g. hands, faces, etc.). A neutral hue was applied to the loss using tratteggio technique, so that the loss would disappear and not create a clear shape. For instance, the leaves of a tree were not reconstructed as they were neither a repetitive pattern nor a clear geometric shape (fig. 111, 112).

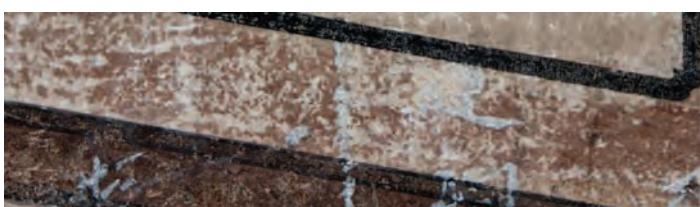
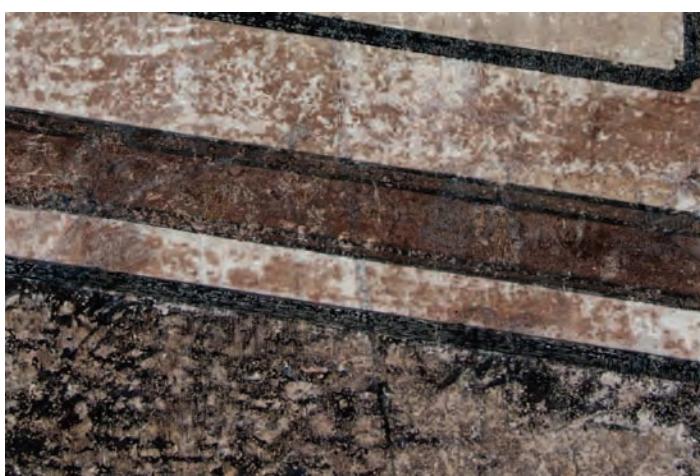
Fig. 113, 114 (right)
Pingfeng xi, panel 7d, before and after covering and retouching the graffiti.

Graffiti done with ink, which could not be taken off without damage to the painting were covered with priming material made of kaolin and rabbit skin glue. They were furthermore reintegrated by retouching using a colour similar to the surroundings (fig. 113, 114, 115, 116). In one place someone had tried to take off the graffiti mechanically. By this the original surface below the ink and he surrounding was damaged. The damaged area with remains of graffiti was then treated like the others, by covering it with kaolin priming and retouching it with tratteggio (fig. 117, 118)
