The Murals of the beiwusheng huiguan in Ziyang

Final report

Part 2: Condition, Conservation and Restoration

Research Project 01UG1001
„German-Chinese co-operation in the preservation of Cultural Heritage: Researches for the
conservation of selected monuments in the PR China“

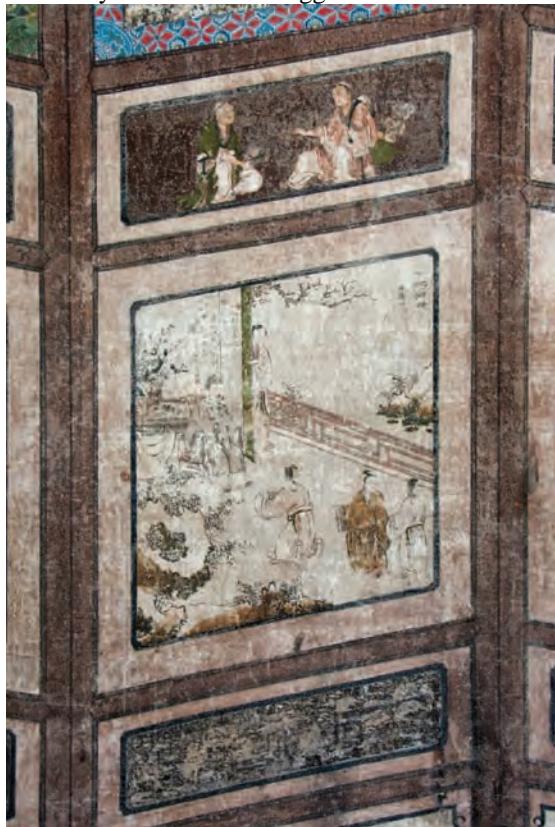
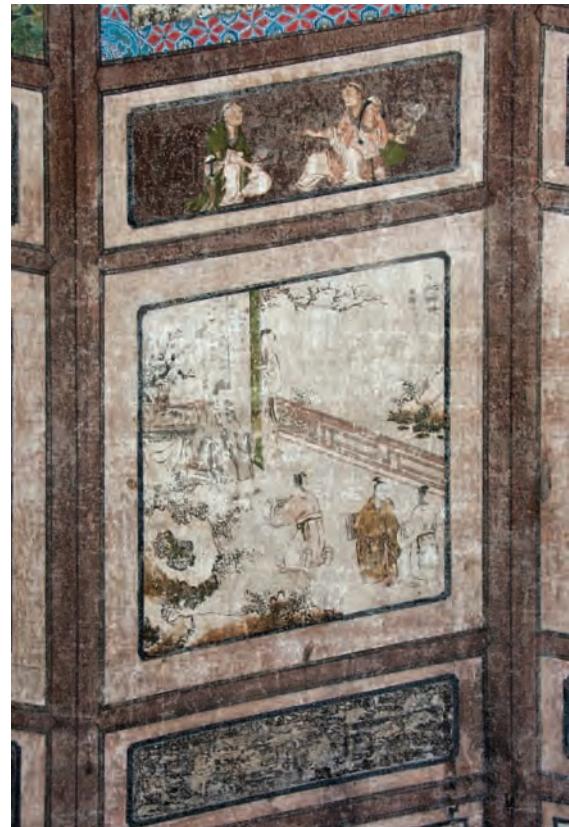
▼Fig. 119, 120

pingfeng xi, panel 4d, before and after application of “aqua sporca”, this calms the bright uneasy look caused by small with trattetaggio unretouchable losses.

Small-sized losses and scratches within an area of dark paint were treated differently since they are distracting and disturb the overall appearance. „Acqua Sporca“, a wash that is made of pigments and water was applied to this type of losses and makes it look less bright and hereby less obvious but still recognisable as a loss. Losses within bright areas of paint layer were not shaded, as here it would not be recognisable anymore as an addition (fig. 119, 120).

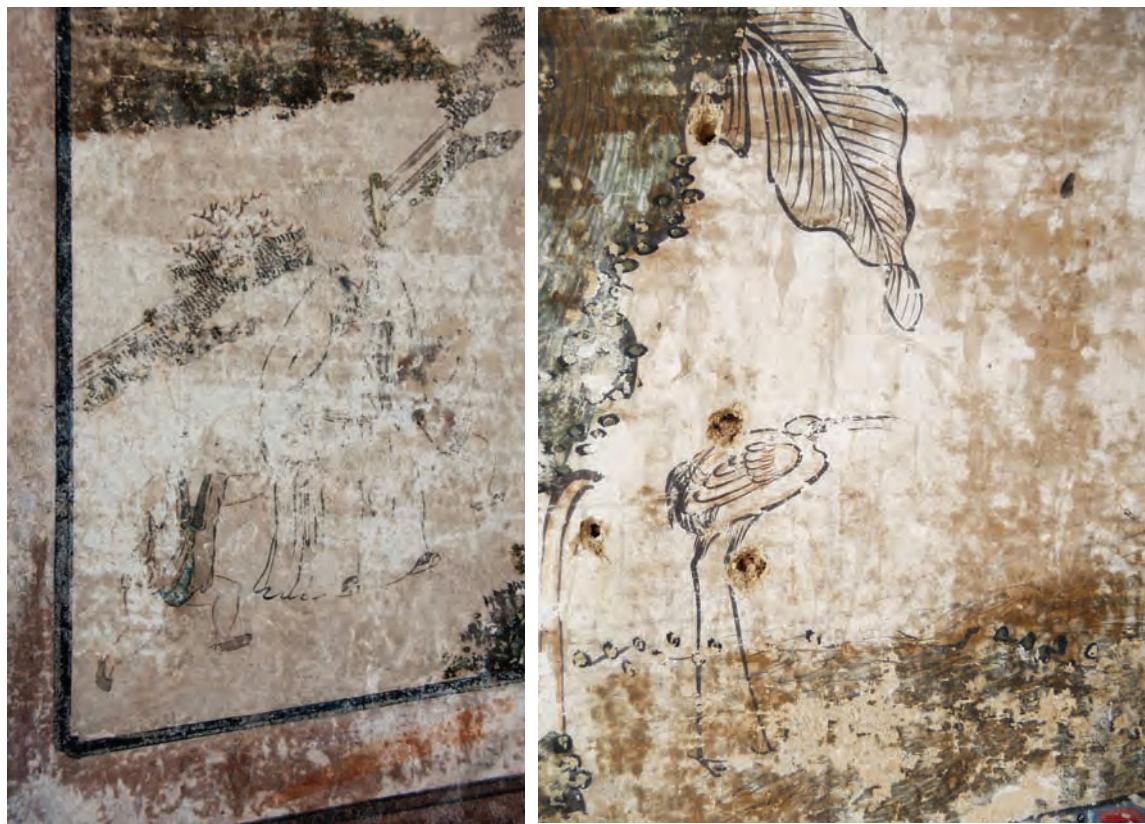
Fig. 121 , 122

Limits of the retouching technique: The miniature-like drawing lines here in panel 8d (left) could not be connected or reconstructed with tratteggio techniques and therefore stayed fragmentary. This also applies to the damaged contour drawing of the bird in panel 2b (right). The tratteggio lines would not be distinguishable from the original drawing and therefore not meet international standards in conservation of cultural heritage.

There are also limits to this retouching technique and concept. Areas, which are too small to be retouched with 3 – 5 mm lines, such as losses in the black drawings of the narrative panels, cannot be retouched (fig. 121, 122, 123). It is possible to connect some of the lines but due to the small size tratteggio retouching would not be distinguishable from the original painting anymore. Connecting the lines would mean not to meet international standards in conservation of cultural heritage, therefore, no action was undertaken to retouch these losses.

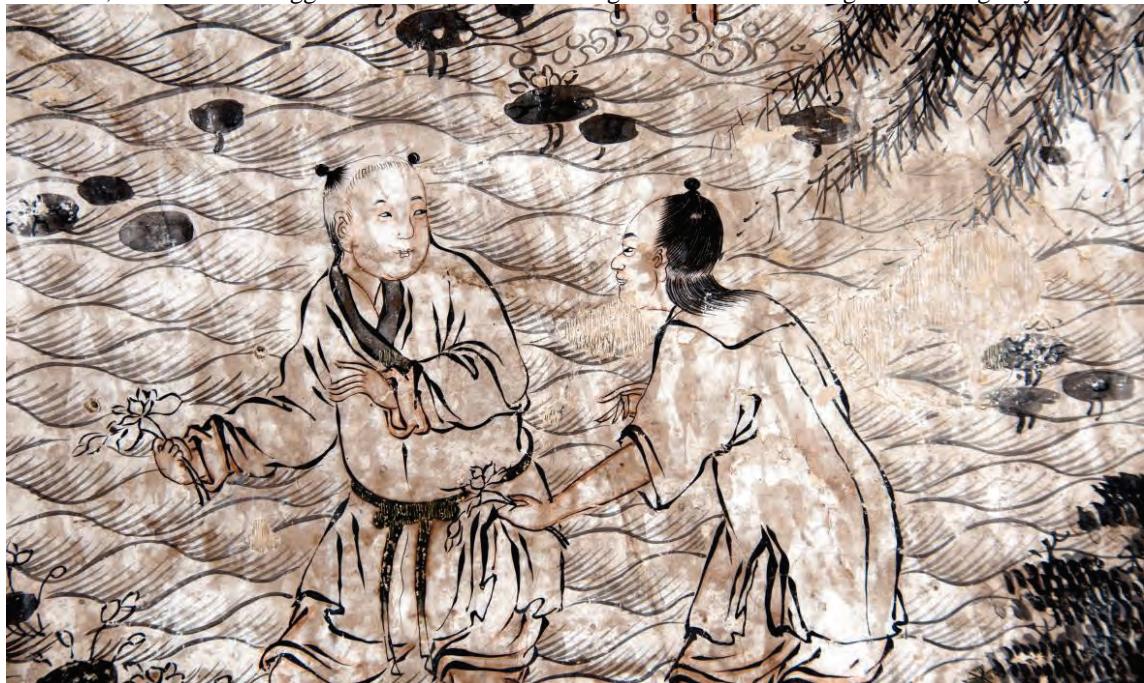
▼Fig. 123

Pingfeng xi, panel 6b, the lines forming the waves were not retouched in a reconstructing way. The size is too small, so that the tratteggio lines would not be distinguishable from the original drawing anymore.

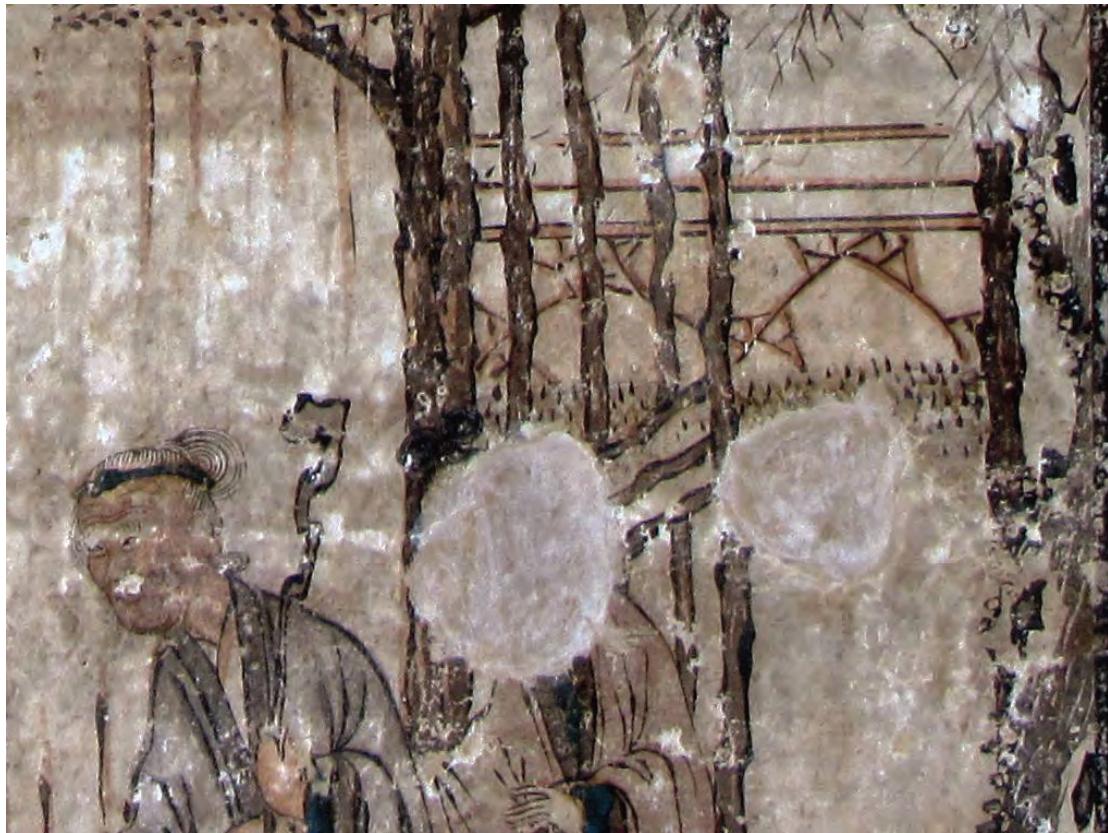
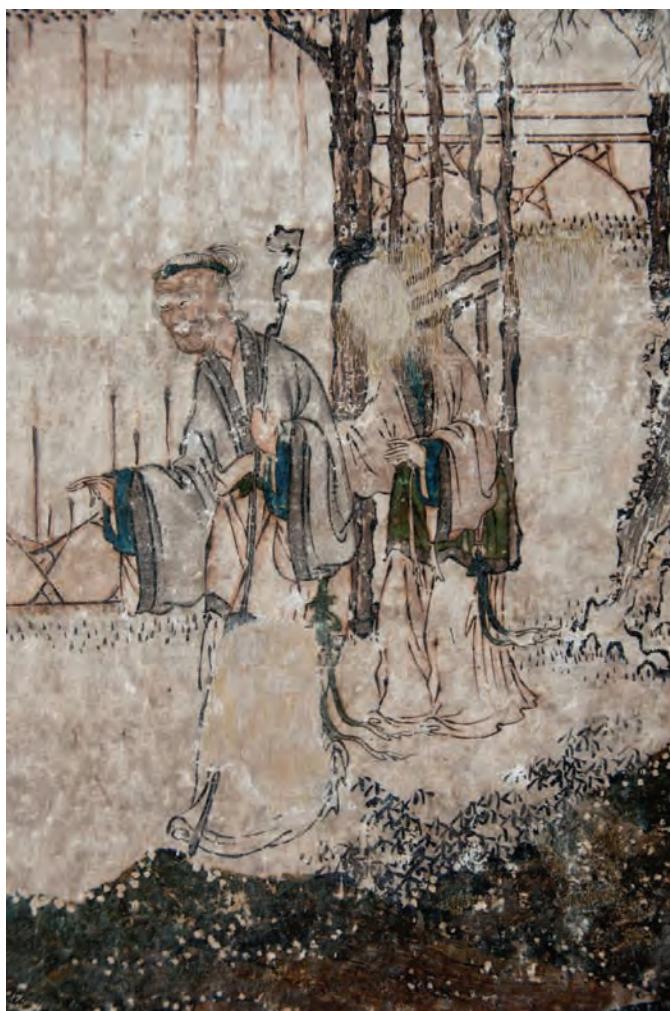
▲Fig. 124, 125 (left)

Pingfeng xi, panel 2d, limits to retouching, the head of the young lady cannot be reconstructed with retouching, as it would mean to invent the shape, but without retouching the loss distracts much. An integration with retouching needed to be done, without too much invention.

painting. So the attempt was made to retouch the loss in a way that the shape of the woman's head can be conjectured, without reconstructing it in detail (fig. 124, 125 136, 137).

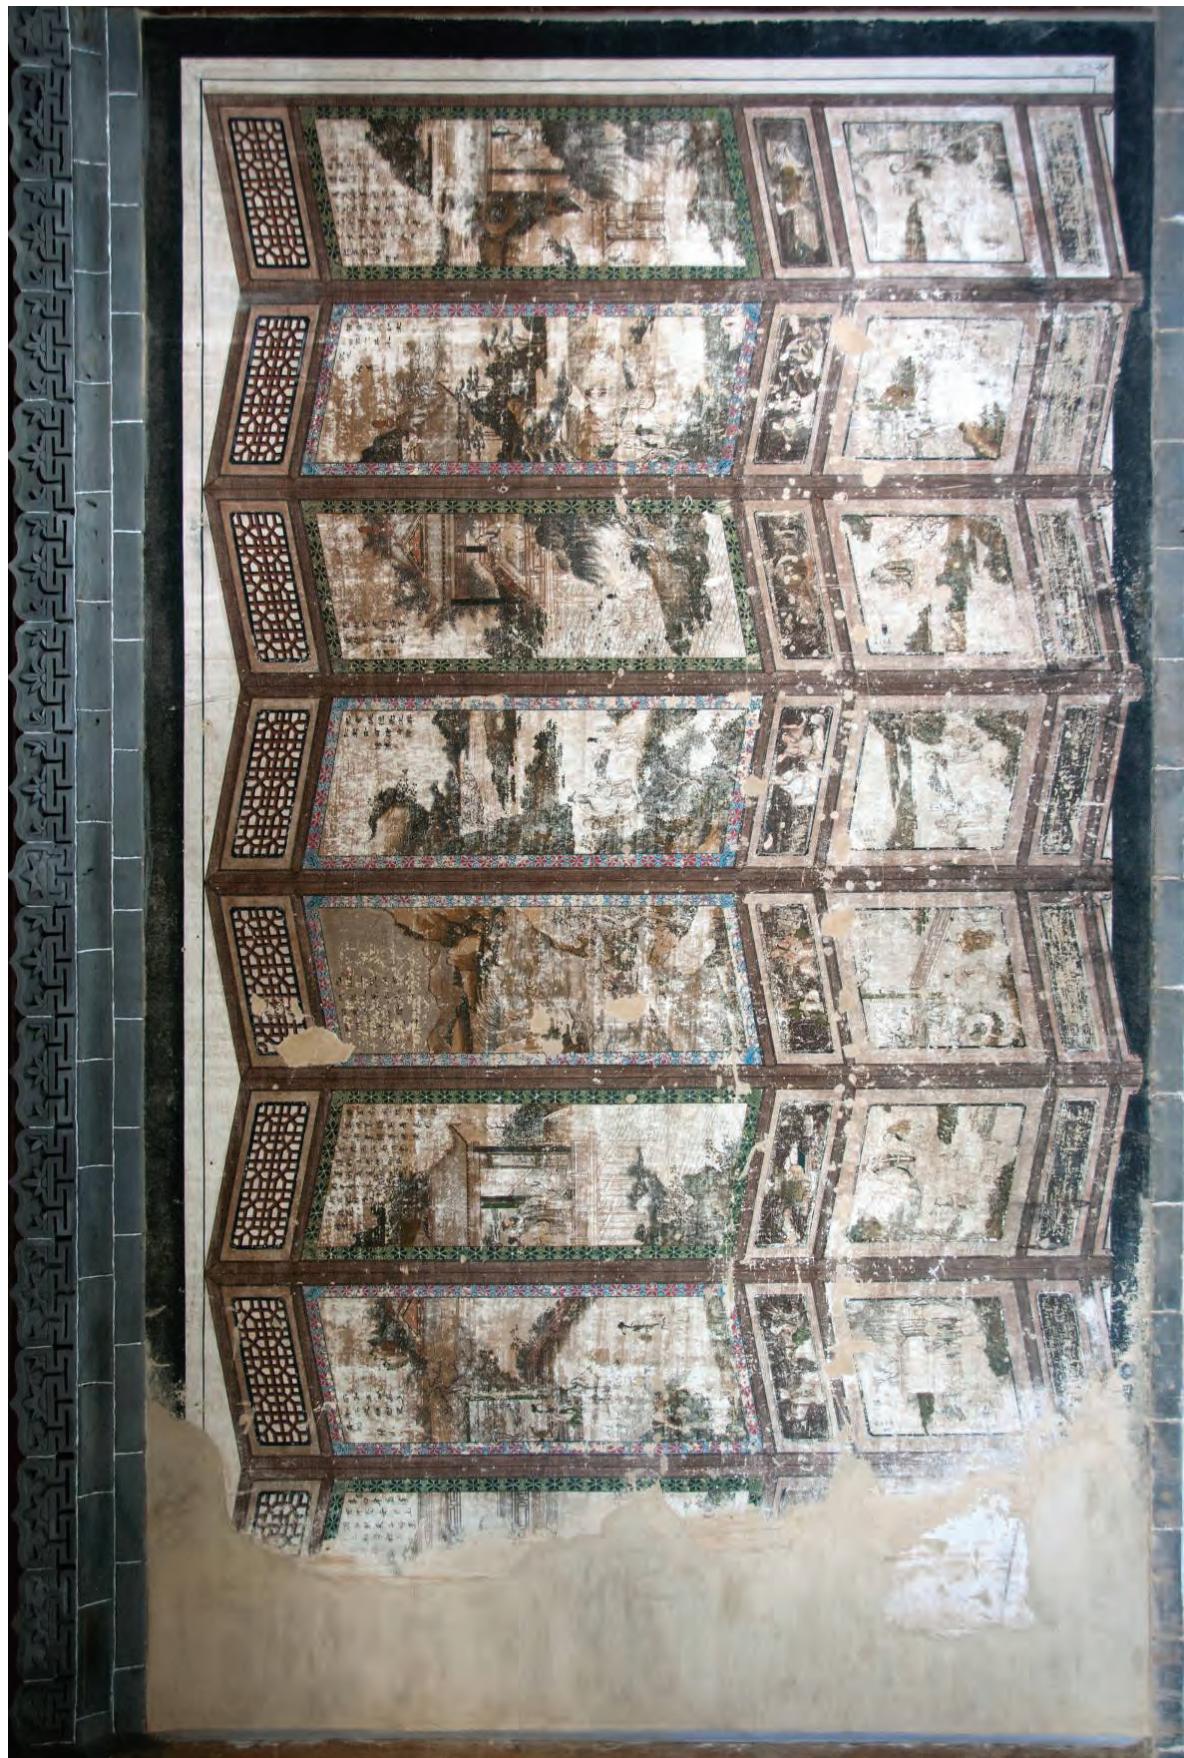
Fig. 126

State of *Pingfeng xi* at the end of the work stay in May 2013, with all conservation works, fillings and plaster addition on the left hand side of the mural carried out-

The big loss on the left hand side of the mural disturbed the painting very much, as the repetitive pattern of the framework of the eight-winged folding screen was interrupted by it (fig. 126). A reconstruction of the missing part would give back structure and balance to the motif, but would have to be carried out in an unobtrusive way, for example, by keeping it in a lighter colour than the original painting. For this already the priming layer to apply as the “white background” layer applied to the new plaster should be lighter than the old painting's white background. Before applying the priming a sizing was applied onto the new fine coat. The sizing was made from a 4 % rabbit skin glue solution, to which slaked lime was added. It was the same amount of slaked lime as used when making the retouching paints: 5 % of the dry weight of rabbit skin glue. The priming layer is made up of a 7 % rabbit hide glue solution (+ 5% slaked lime) as a binder and of kaolin and yellow loam (9,6 : 0,4 VP) as fillers and also as colouring components. 10 Parts of the 6 % animal glue solution were mixed with 8 parts of filler. The mixture was left to soak and then some water was added to achieve the watery diluted condition which was needed for a multi-layered application. In total 3 layers were applied. After the first layer and after the last one, the priming was smoothed with sanding paper. On top of the priming layer a sizing of a 3 % rabbit skin glue solution was applied (+5% slaked lime).

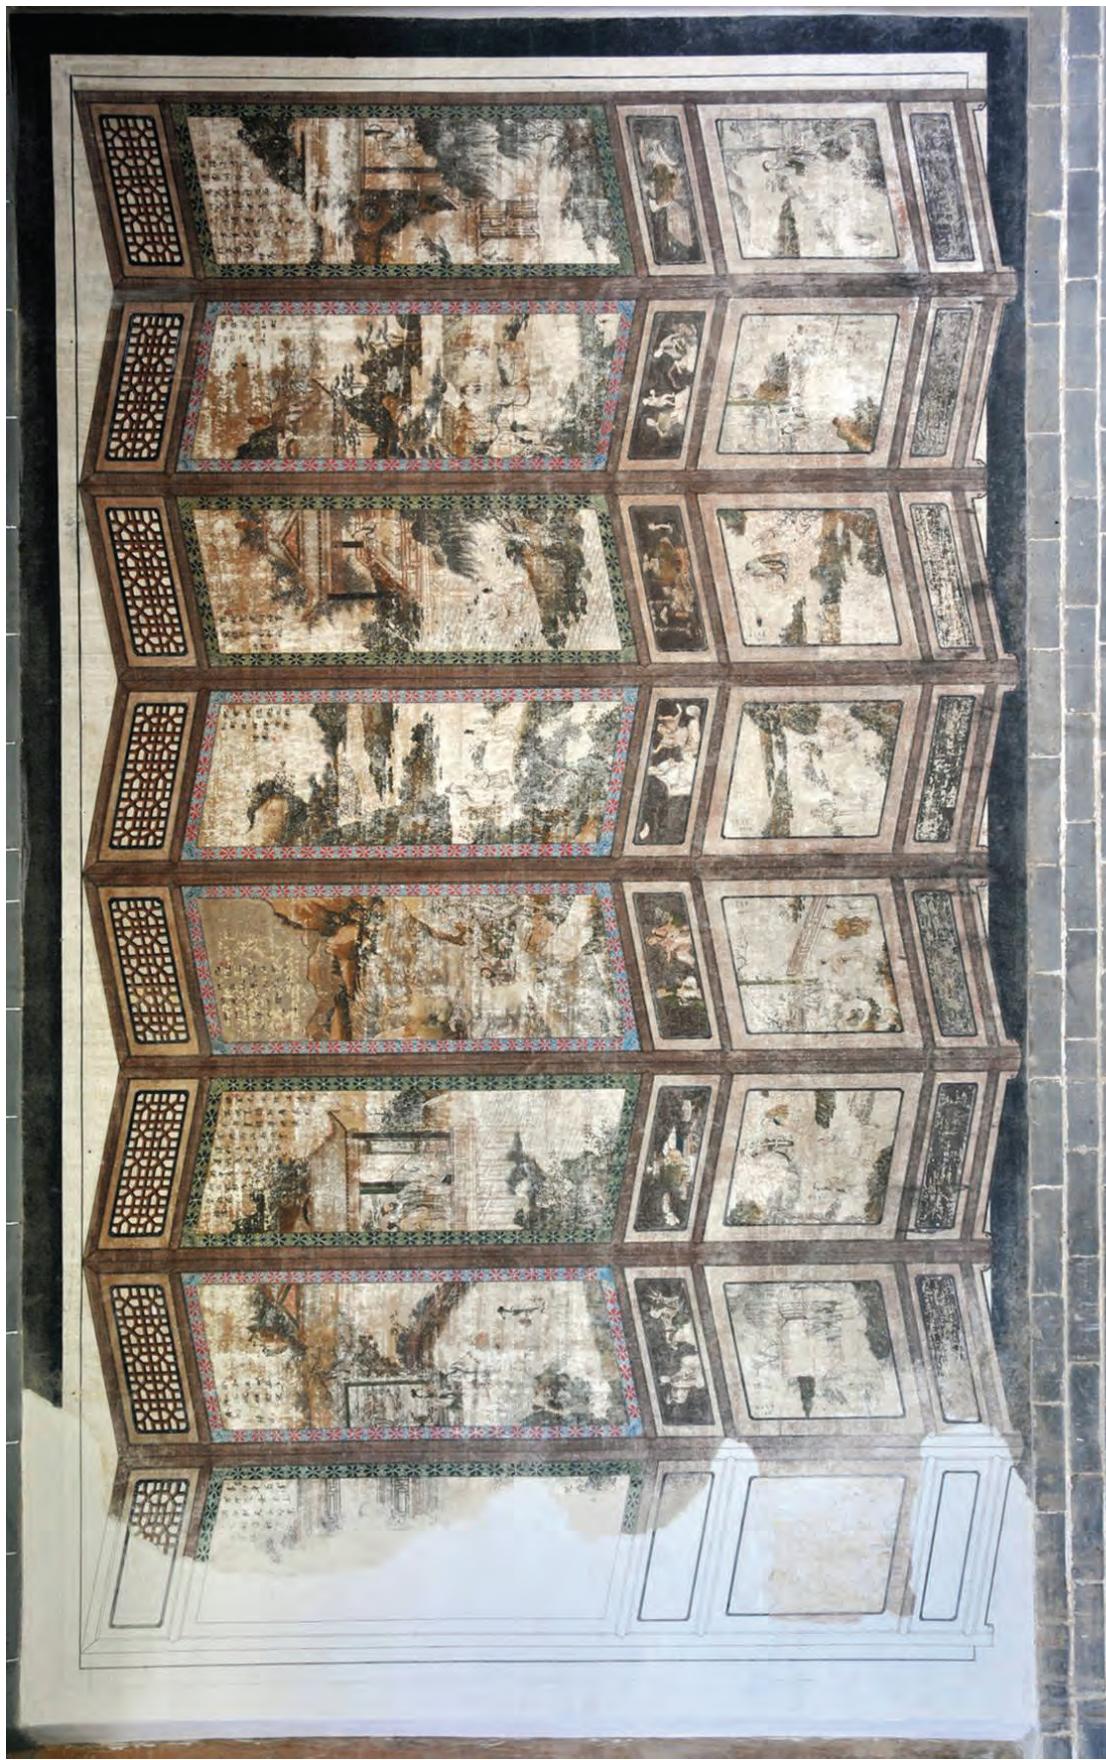
Fig. 127

Pingfeng xi during the reconstruction process in. Retouching on the original plaster is finished. The new plaster has been coated with priming layer and outlines are drawn.

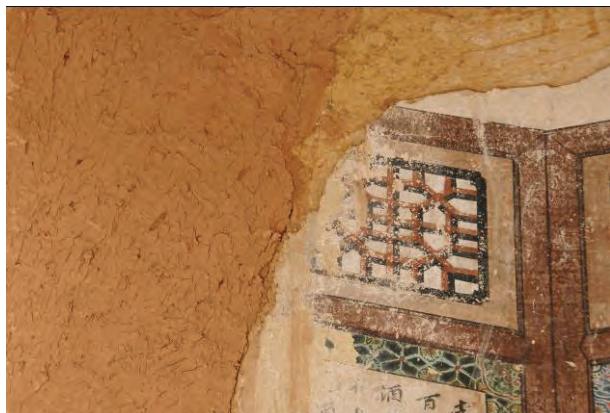
Fig. 128
Pingfeng xi, a-panel before restoration.

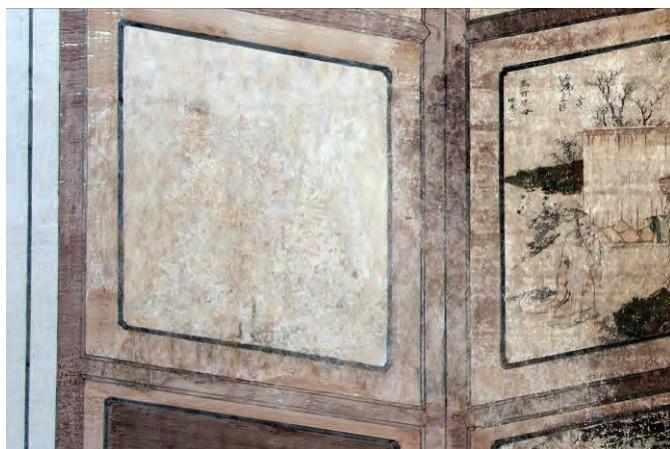
Fig. 133
Pingfeng xi, panel 1d, after restoration.

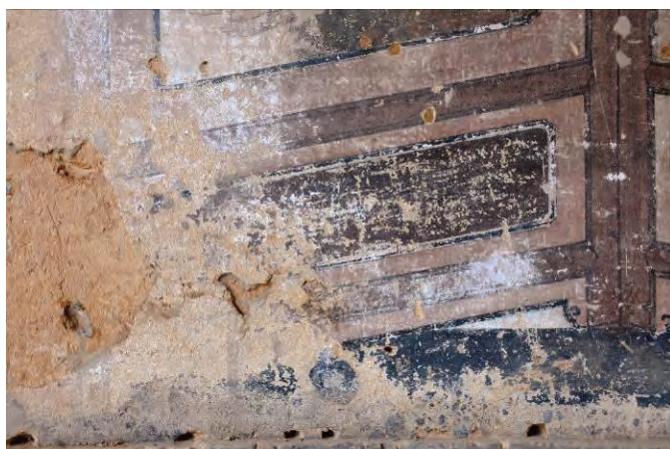
Fig. 134
Pingfeng xi, panel 2e, before restoration.

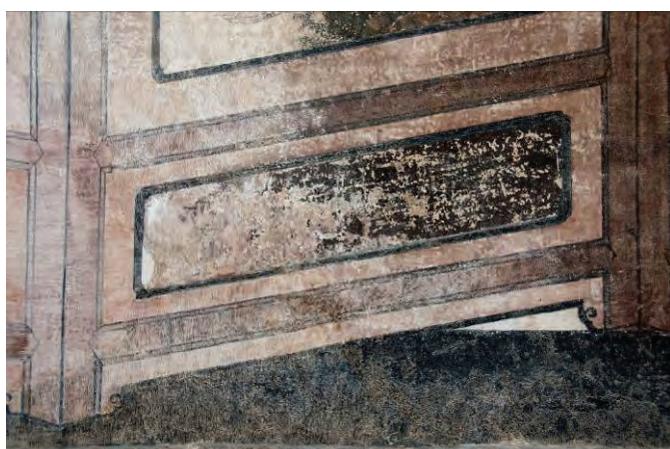
Fig. 135
Pingfeng xi, panel 2e, after restoration.

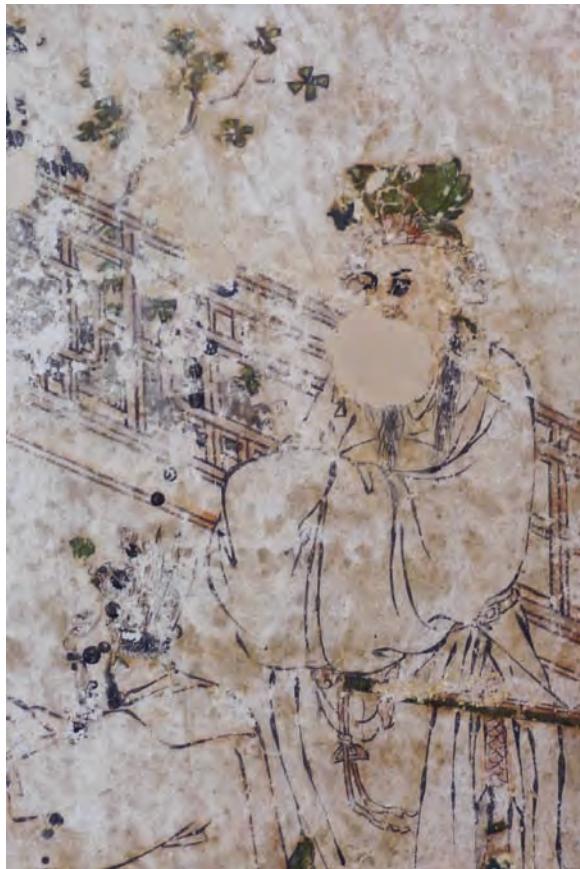
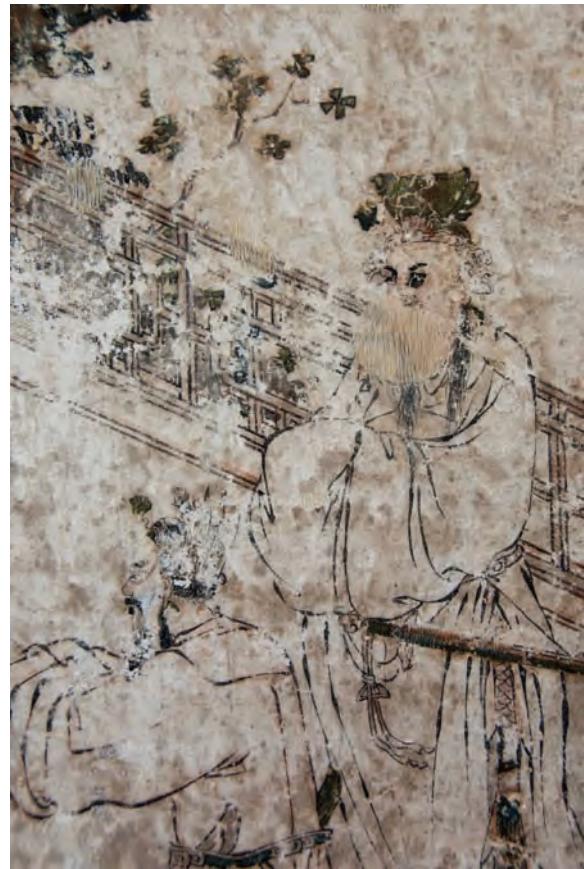
Fig. 136, 137

Pingfeng xi, panel 7d, the head of the man cannot be reconstructed by retouching, as it would invent something new, but without retouching the loss distracts much. An integration by retouching was attempted without too much invention.

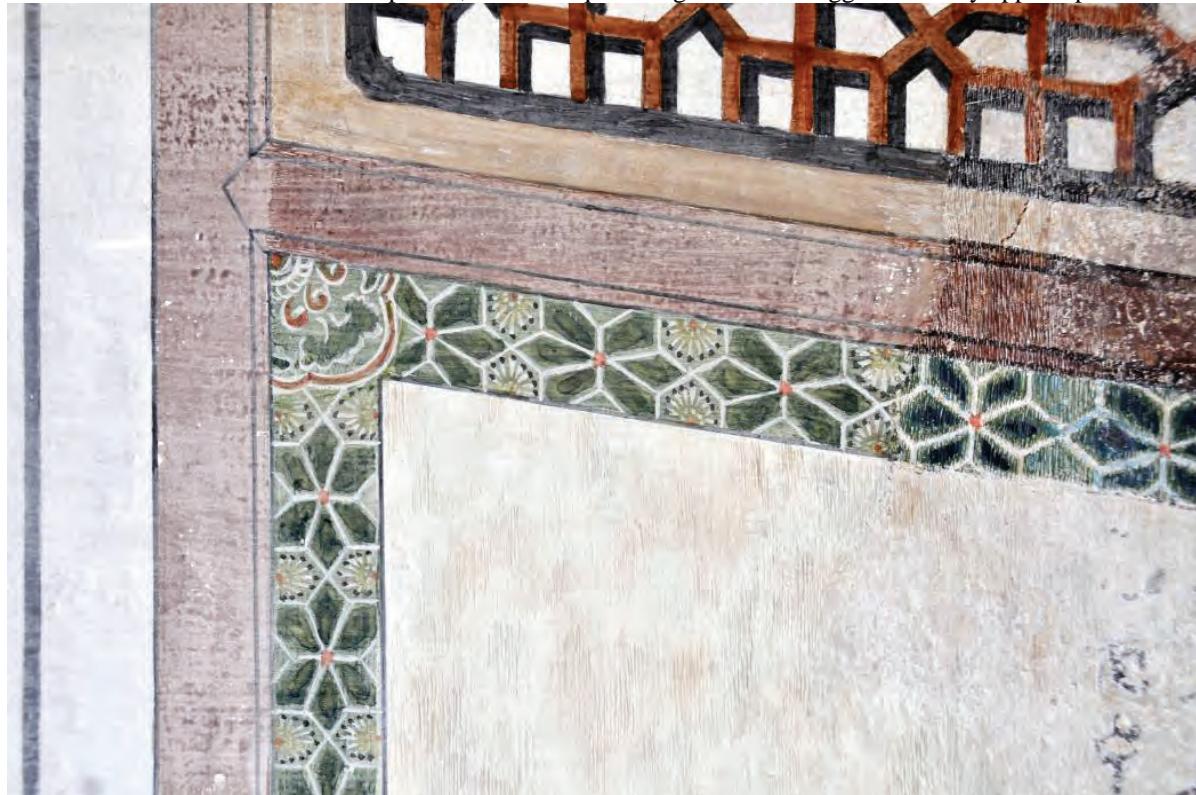
Fig. 138

At the border between old and new plaster, the technique changes from *tratteggio* to watery applied paint..

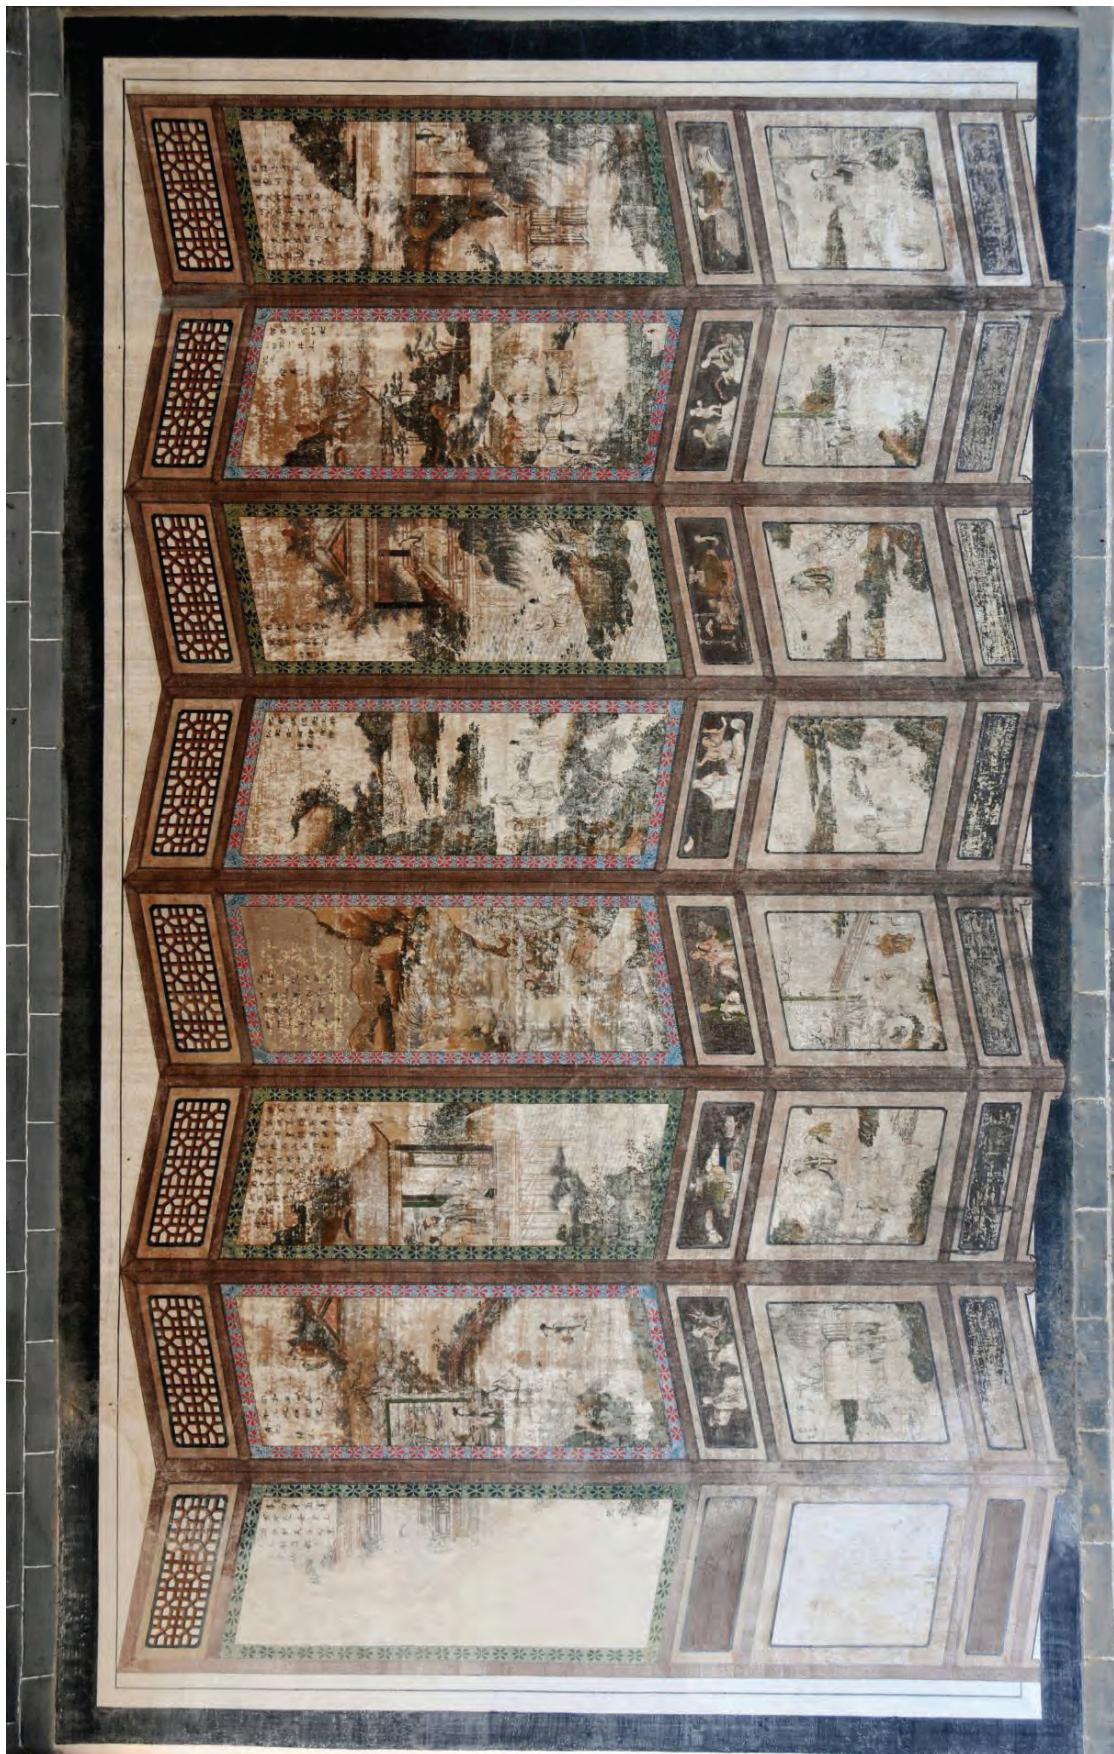
Fig. 139

Pingfeng xi in the final state, after all conservation and reconstruction works had been finished at the end of august 2013.

The paints for the reconstruction of the missing part were made from a mixture of rabbit hide glue, egg yolk and pigment. The pigments were ground with 5 % rabbit skin glue by weight relation of the pigment. When the mixing was finished 50% of the weight of the pigment eggyolk was added. For example 10 g of pigment were ground and mixed on the stoneplate with 10 g of a 5 % glue solution and 5 g eggyolk was added. From these pastes of paint the highly diluted washes needed to paint the new part were produced by adding water. After having finished the mixing more binder was added. To 80ml of a wash 20 ml of a 20 % glue solution was added and another 10 g of eggyolk. By this the pigment to binder relation can not be tracked exactly. It was a practical approach to attain the goal of getting the right dilution, to a paint or wash with the right properties to get the desirable thin character. The ability to bind was controlled by applying the paint to test boards and also to a test wall in an unused storage room in a building which is destined to be demolished. In a similar way, as in the original creating process, the missing part was outlined: with using chalk lines. After having completed the sketch, the contour lines were started to be drawn. A much thinner black paint was used than the painters had originally used to get a tone that is a like the worn black paint layer and even a bit less intense (fig. 127). Then the paints for the framework and the panel frames were applied in a translucent, wash-like way. The irregular structure of it, which is typical for the painting, occurred automatically when painting the missing part of the framework onto the new support (fig. 131). The adjoining areas to the old plaster, where paint layer and priming layer had been lost were prepared with priming layer as well, and integrated using *tratteggio* technique. Only on the new plaster, the lost form was reconstructed by painting it (fig. 128–135). Finally, the patterns in the top region and the flower borders were reconstructed with thin paint, with wash-like appearance. The middle and bottom panels, named c and e-panels, were filled with a brown middle tone, because figurative scenes were not considered reconstructible. Finally the mural had a well-balanced, harmonious appearance while preserving the signs of its aged condition (fig. 139).

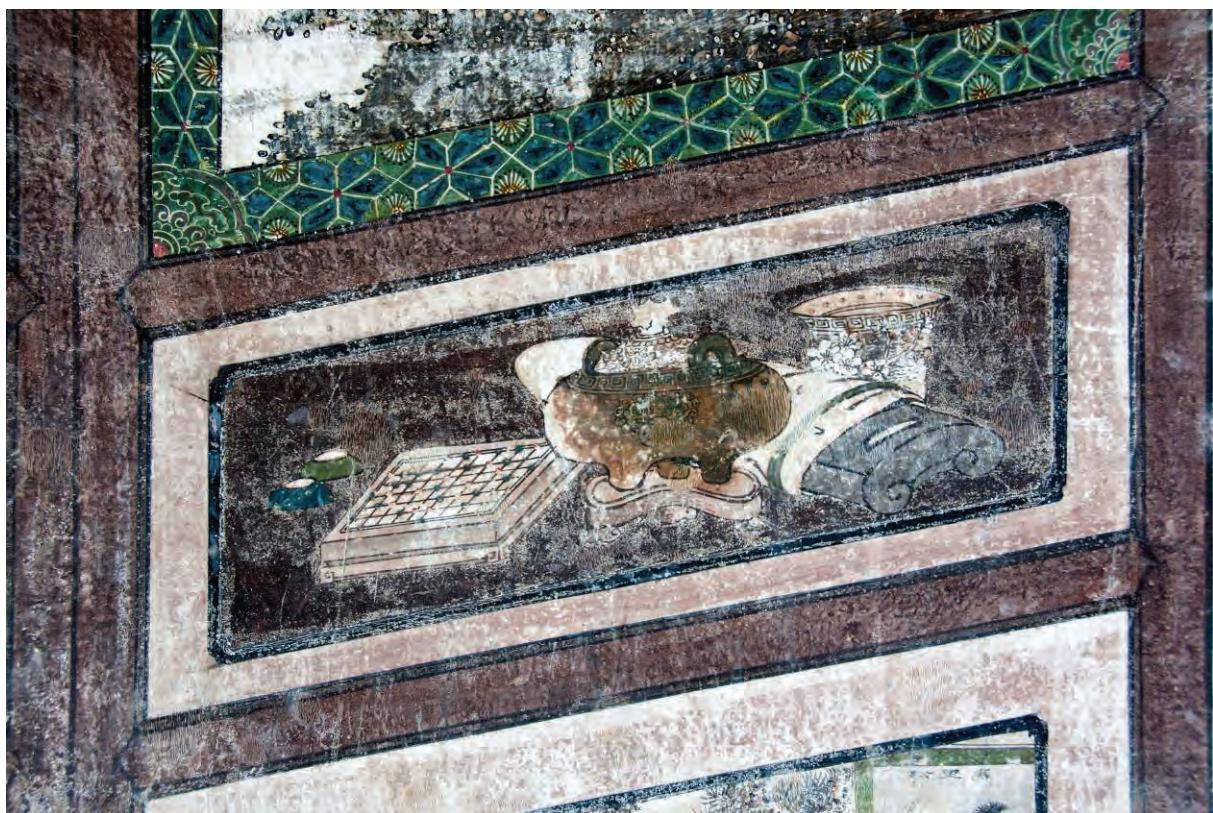
Panel 8c

Pingfeng xi, panel 8c, during filling and after restoration. The retouching is always matching the surrounding colour of the loss. By this, the aged condition of the mural was not refreshed.

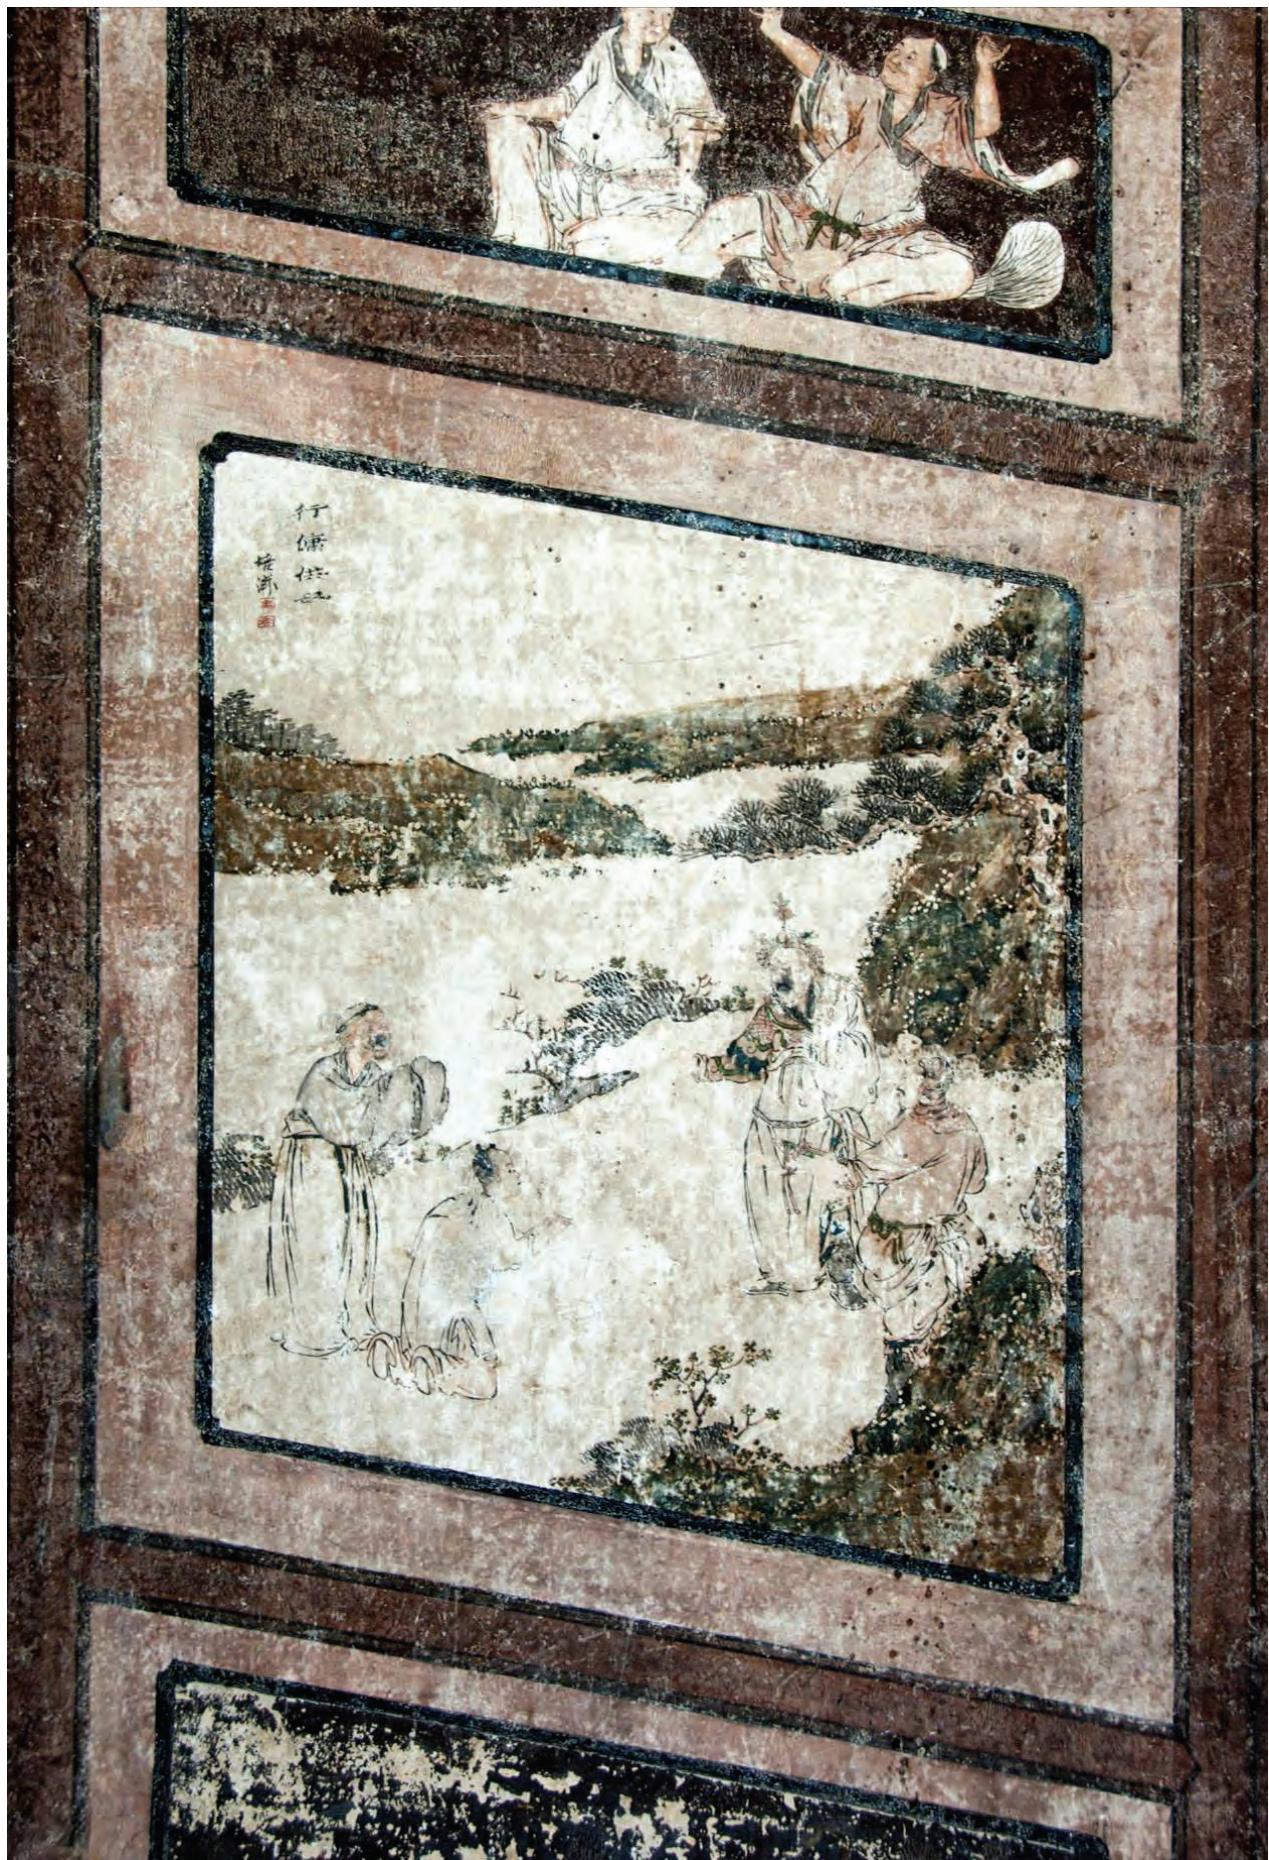
Panel 5d

pingfeng xi, detail of panel 5d. Inadequate try by somebody to remove graffiti (left). The remains were covered with priming material and made to match the damaged surrounding by retouching.
