Shuilu'an

Jahresbericht / Annual Report 2007-2009

**BMBF Forschungsprojekt / Research project
01GWS079**

Forschungsprojekt 01GWS079
„Deutsch-chinesische Zusammenarbeit im Kulturgüterschutz: Forschungen zum Erhalt
ausgewählter Denkmäler in der VR China“

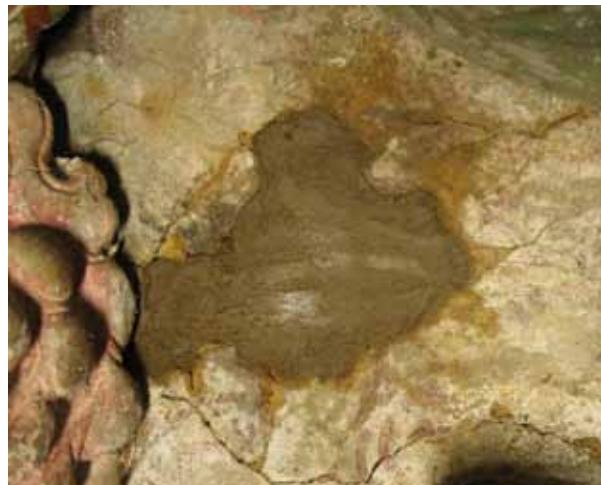
3

Test for filling in the level of the finish coat, lacunae with very fragile margins, diameter ca. 4-5 cm.

Left: Freshly applied clay-sand mixture, slightly bulging with visible traces of spatula.

Right: Filling after drying.

Deep holes were filled with mud-straw using spatulas. Lacunae were in most cases only filled to the level of the undercoat surface. Shallow holes in the finish coat were mostly not filled. If necessary a mixture of “black earth” and sand can be used. The addition of sand results in a grainy surface similar to the original.

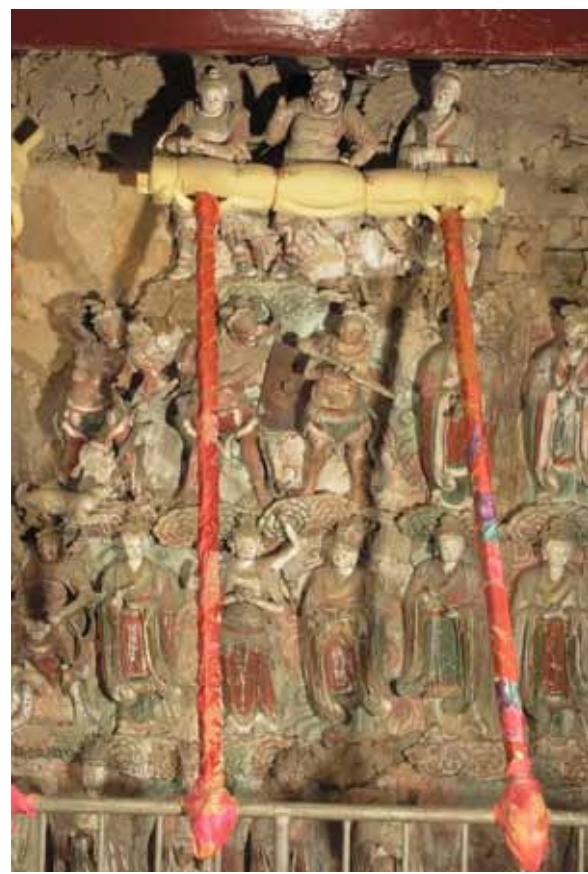
3

central part of section 2, W1.36, W1.37 and W1.38
 propped up by wooden support [Center for Conservation 2005]

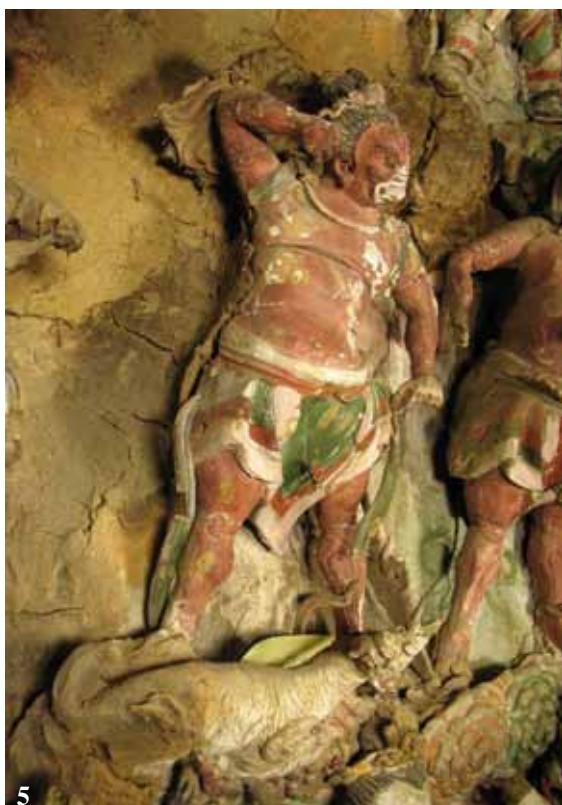
5

W 2.38 before treatment (September 2007):
the repair plaster from 1980-85 overlaps the sculpture

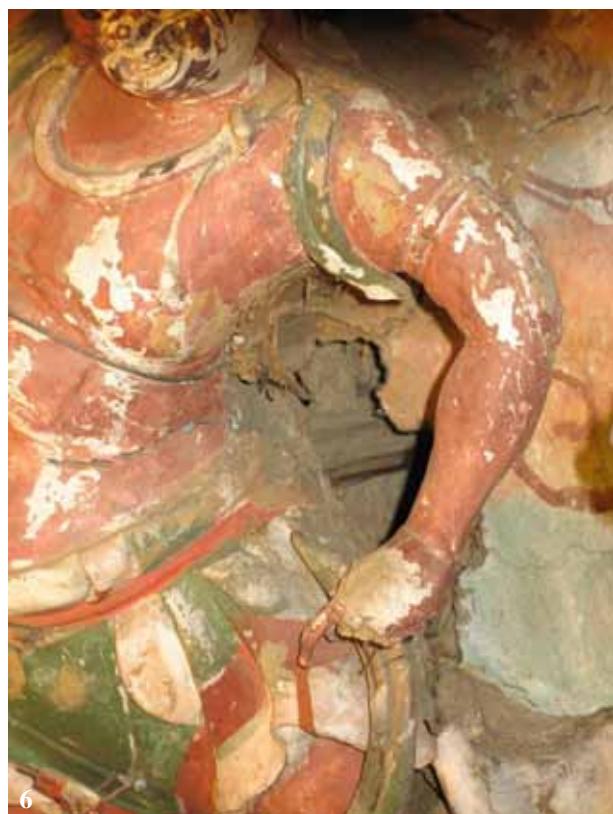
6

W2.38 after removal of repair plaster (September 2009):
hole around the peg

The sculpture W2.39 had been stabilised in 1980-85 with a wire around the waist and a large amount of clay-fibre-mixture on the back of the sculpture (fig. 7a). In this lump of clay a wire was imbedded which was laid around the waist of the sculpture. Wire and clay were removed (fig. 7b). This exposed a hole around the peg which had no connection to the wall anymore as it ended inside the void. The pegs were extended with a threaded bar, but the wall around was so eroded that the bar could not be stabilised. Finally a wooden crossbar was made which could be inserted inside the void with the help of tweezers (fig. 7c). Through a drill-hole in the wood the threaded bar could be inserted and affixed with a nut (fig. 7d and 4). The crossbar could be jammed behind the first row of stable bricks in the front part of the wall. Afterwards the threaded bar was puttied with clay. The

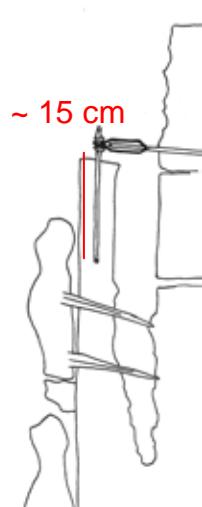
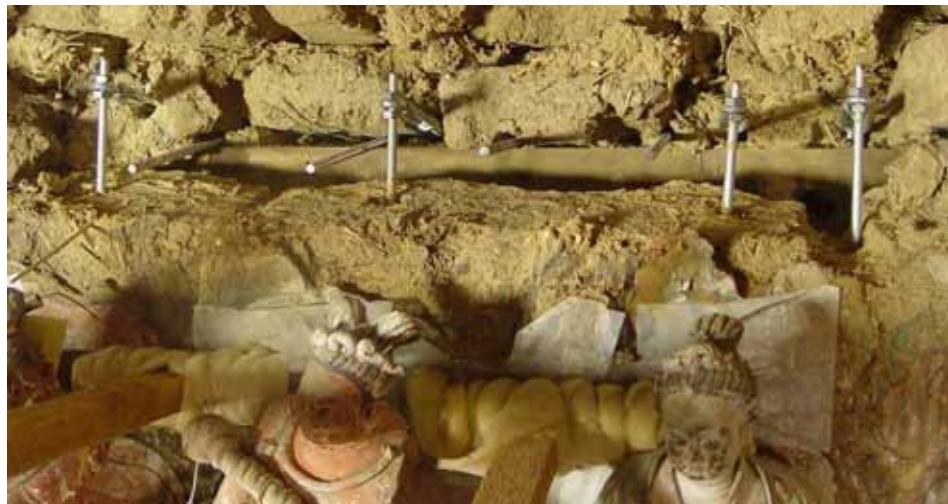
The top of the wall below the removed bricks consisted of a 12 cm thick part in front of the wooden lintel (fig. 8). This part was fragile and bent forward. It had to be stabilised against breaking off before the removed part of the wall behind tier no. 1 could be rebuilt on top of the part.

Stabilisation of wall in front of lintel with connected threaded bars

The stabilisation was done by inserting four threaded bars vertically into the 12 cm thick wall part. Because of the fragility of this part and the vibrations caused by drilling, the threaded bars were only inserted 15 cm deep. The vertical bars were connected to horizontal threaded bars which run across the complete wall and are affixed with a nut on the outside of the wall.

The threaded bars were placed behind the heads of W2.39, W2.40 and W2.41 as the wall was more stable behind the sculptures than between them. The fourth bar is positioned behind the right shoulder of W2.41 in the more stable adjacent and longer part of the wall. The threaded steel bars have a diameter of 8 mm. The anchors in an ideal case should be positioned vertically. This was not possible because they had to start above the lintel on the inside. On the outside in this level there is a repair layer of fired bricks which has been inserted in 2007 underneath the new purlin. It was not possible to drill through the fired bricks with the available drill bits. The anchors therefore were sloping from the inside to the outside, but there was no possibility to insert them straight.

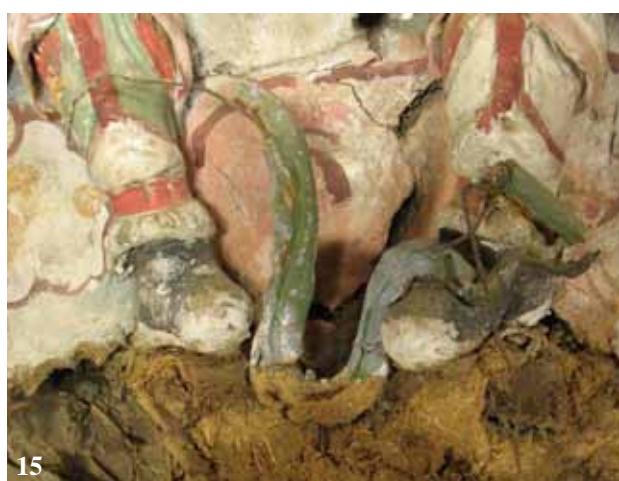
15

12-15 Situation before treatment, August 2009

Green band between the feet of W1.37 and W1.38

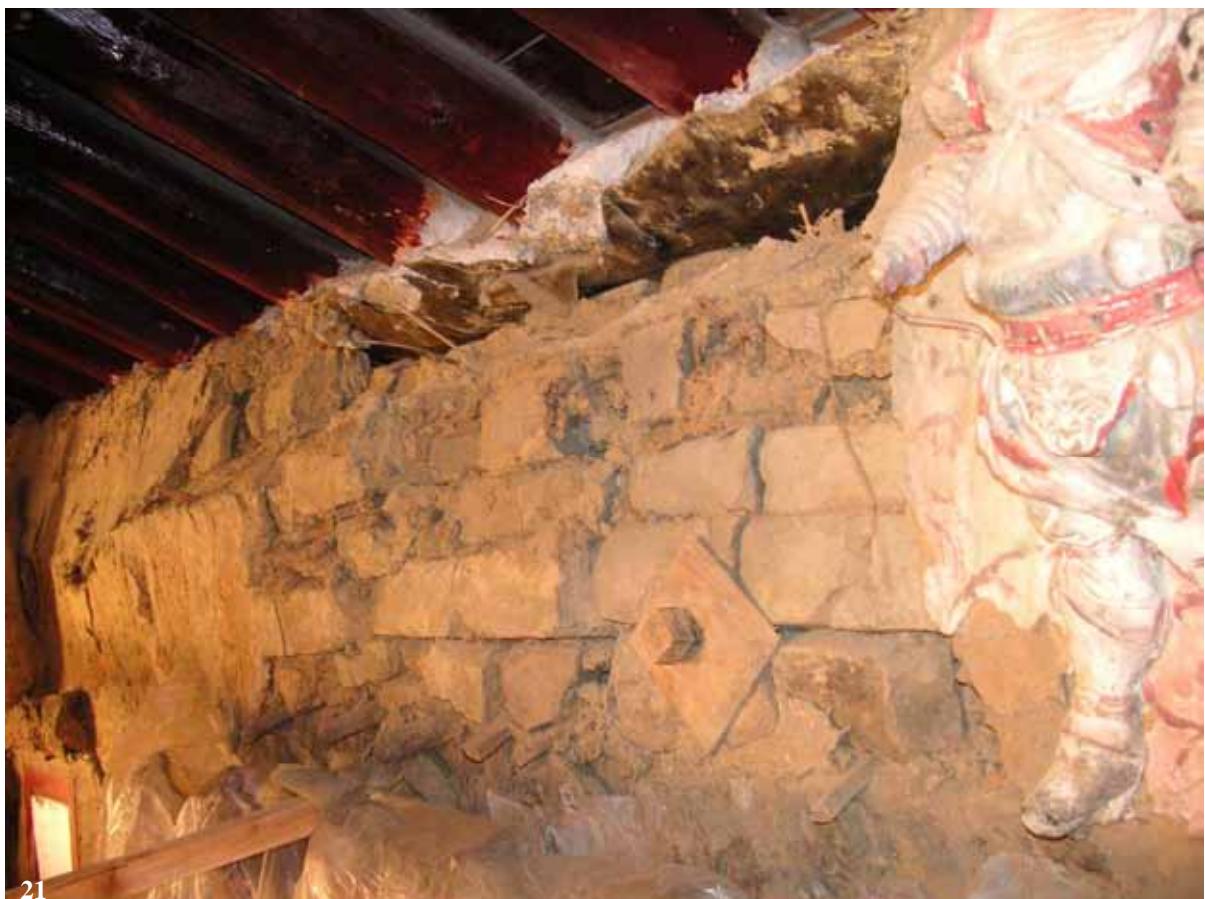
21

Wall after detaching the sculptures of the first tier; pegs for the feet still in place below the fourth row of adobe bricks

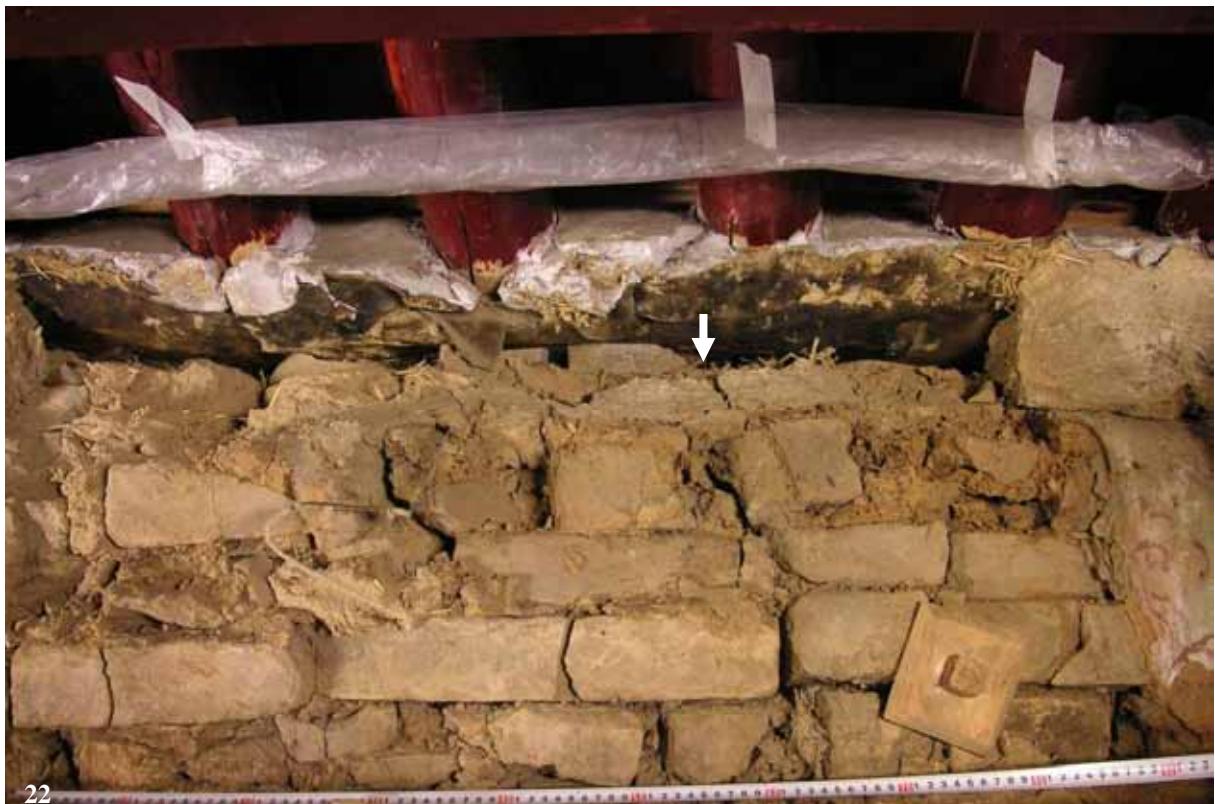
22

Wall after detaching the sculptures and removal of the pegs; arrow: original wall crest with traces of polychromy

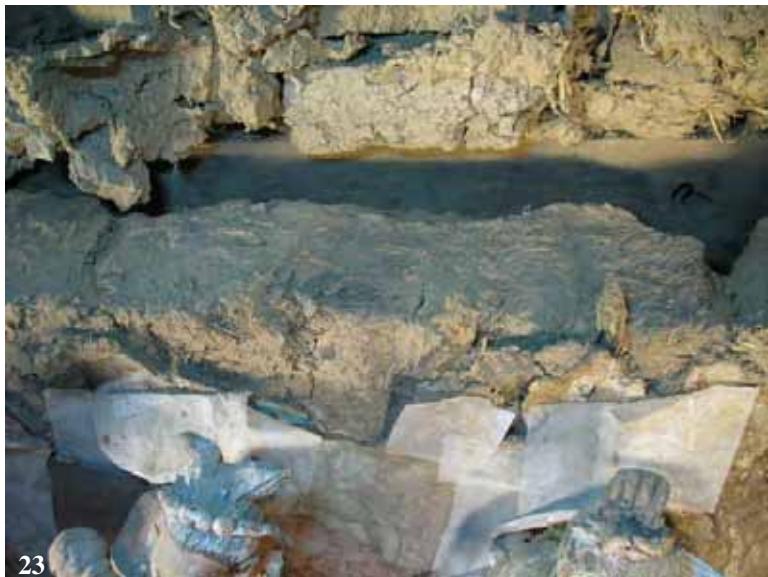
23
Gap between 12 cm thick wall part and wooden lintel

23-27 Void behind tier no. 2

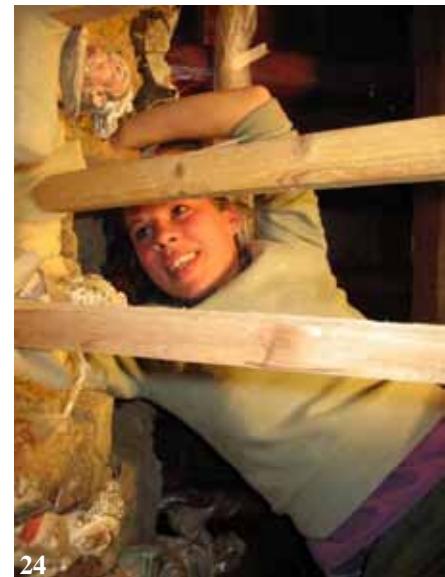
24
A lank arm could be put down into the 6 cm wide gap

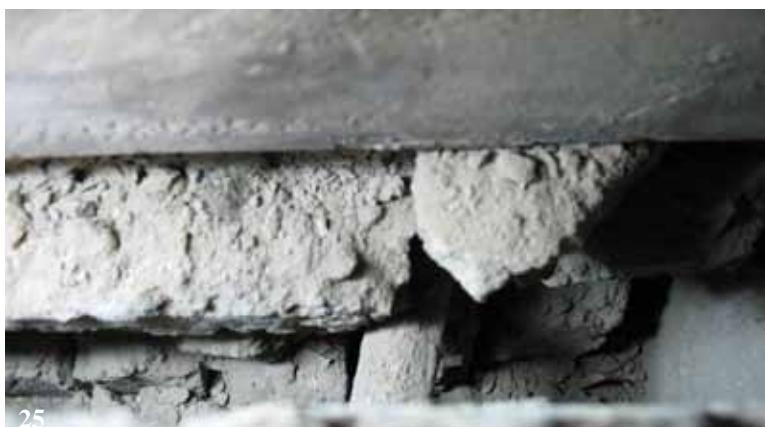
25
View into the gap on stable peg in the back of W2.41

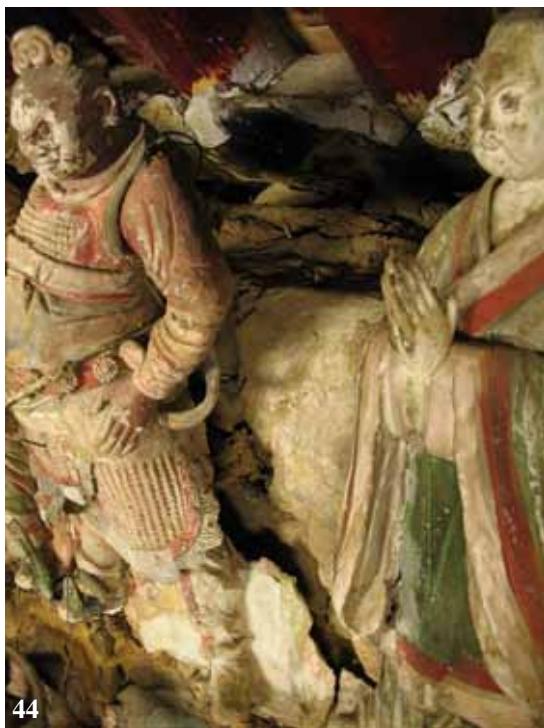
44

Wall before treatment: the wall is painted up to the crest

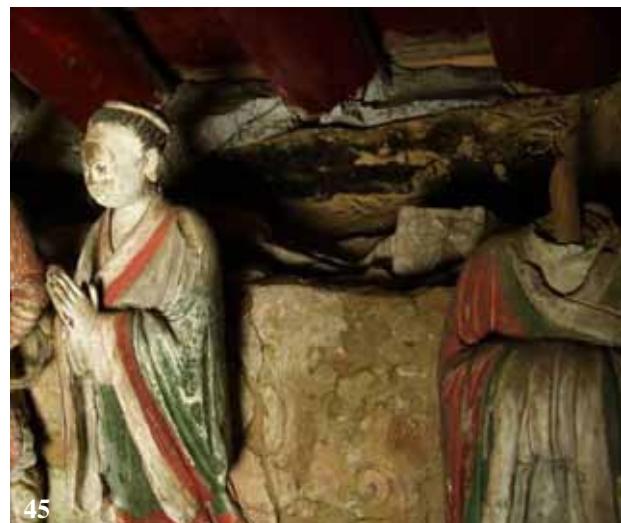
45

After conservation in June 2009: original crest still missing

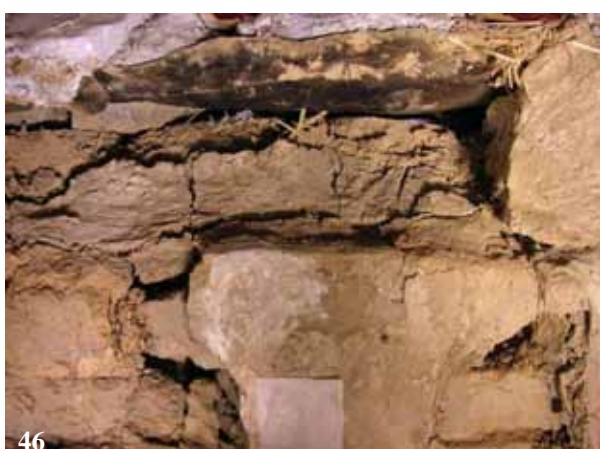
46

Between W1.38 and W1.38a: Original wall crest before detachment

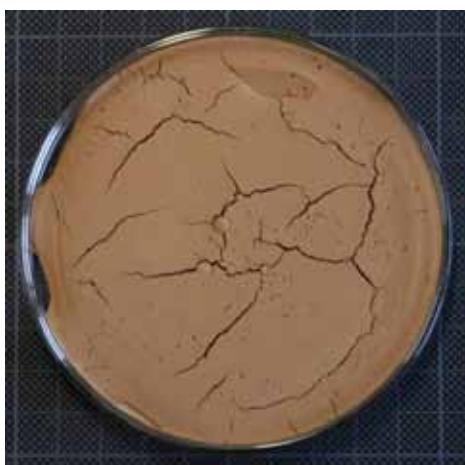
11

1G 2.5H + Tyl 3% After drying
cracks are visible in the mass with yellow clay

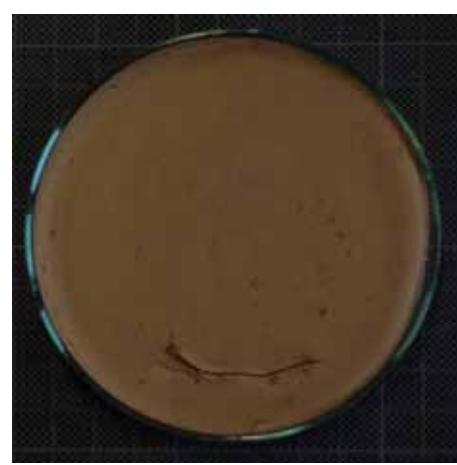
12

1B 2.5H + Tyl 3%
After drying no cracks are visible in the mass with black clay

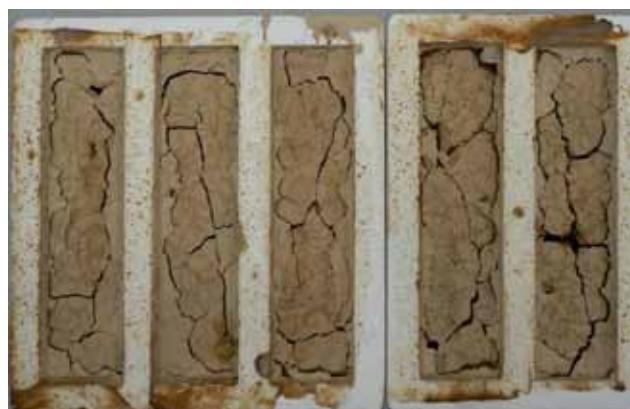
14

The adhesion strength was not realizable as the prisms broke in the Styrofoam forms when drying (Fig. 14). This problem was solved in the proceeding tests by adding cotton cloths in the forms.

Broken prisms

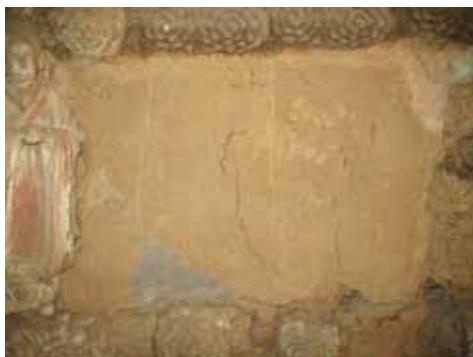
In Shuilu'an the west wall (section 1, register 3-4, fig. 17) was chosen due to a large void as an injection test field.

The area was largely overrendered between 1980 and 1985 and covers also parts of the original plastering. While taking it off mechanically, between section three and four, a reconstructed cloud became loose and was taken down.

Chosen area for backfill mortar tests, pre-state

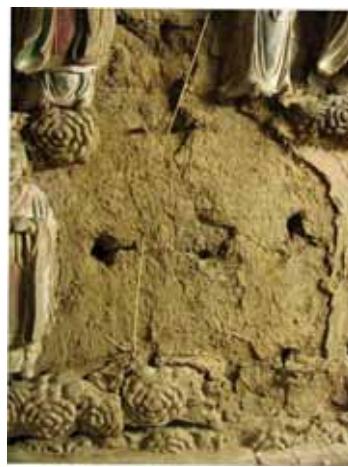
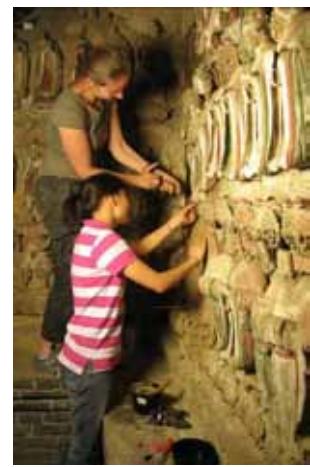
17
Testing of the backfill mortar

area after exposing

On the original surface, there was loosening between fine and raw mortar as well as small voids between adobe brick and raw mortar.

Injection tests

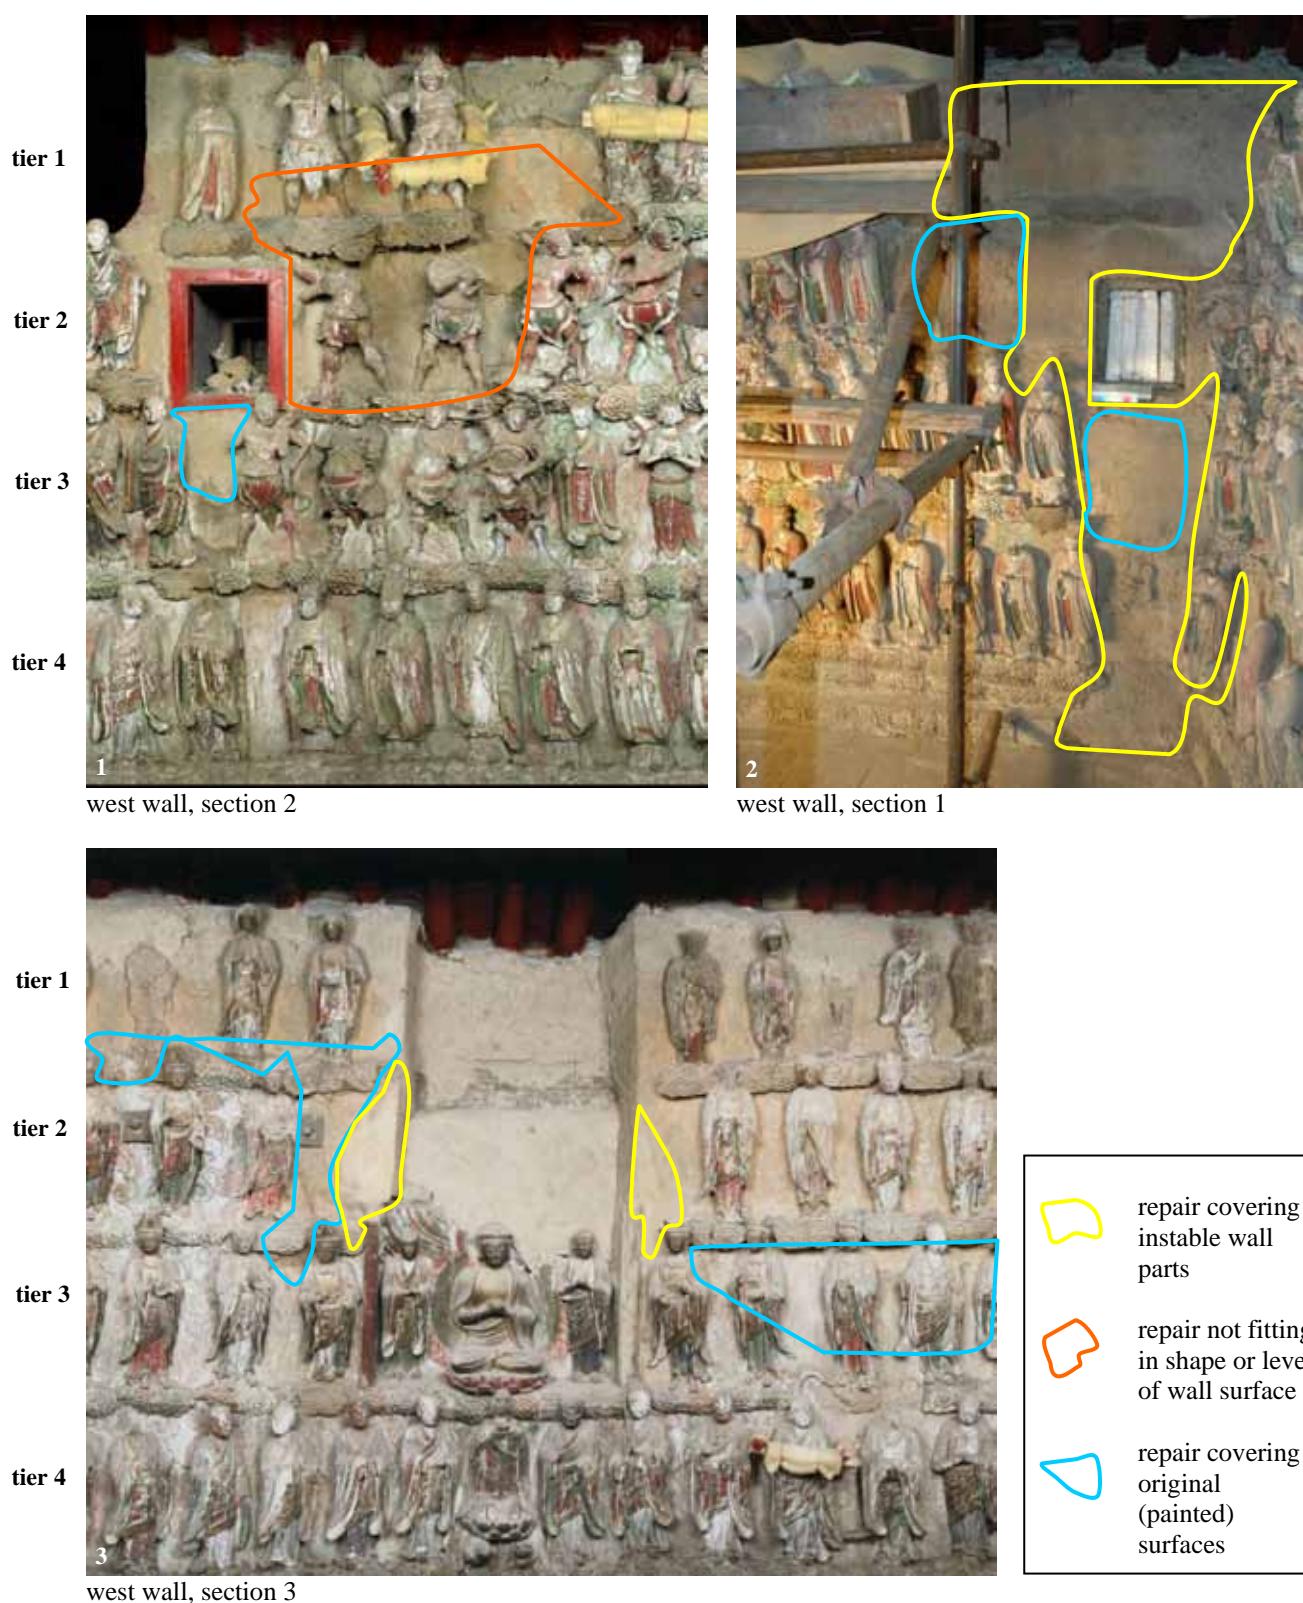
1-3

Areas with older repairs which have been reworked in April and September 2007

- Removal of plaster layers covering original surfaces and damaged parts of the wall: In April 2007 the repair plasters around window 1 of the west wall were removed superficially, revealing parts of the original surfaces or undercoat plasters and allowing the conservation and repair of the wall around the window (fig. 2).
- Removal of thin plaster layers which superficially covered painted areas of the background, especially in section 3 (fig. 1), in smaller scale also in the section 1 and 2.
- Removal of plaster layers to get access to the wall structure and to consolidate damaged or unstable repaired parts in section 1 and 3.
- Application of new plaster on top of the repair plaster to level a concave area of the wall in section 2 (fig. 3).

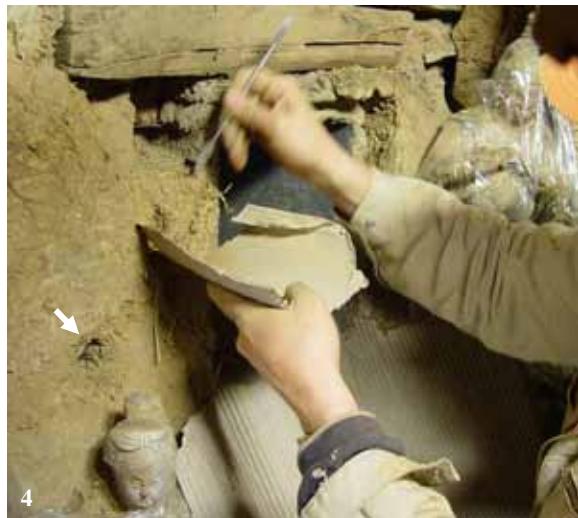
The repair plaster did not show a good adhesion to the wall. It could be easily removed and separated without problems from the original layers below using a spatula (fig. 4).

Removing repair plaster with a spatula

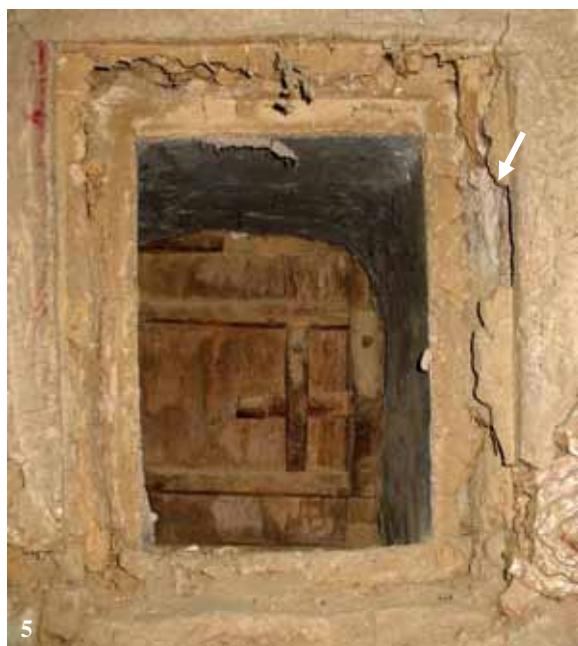
5
Window no. 3 with original painted background on the edge of the embrasure underneath the repair plaster and original wooden shutter in April 2007 (shutter lost meanwhile).

Around the window the repair plaster was not stable anymore. The window frame is a later addition, probably from the repair of 1980 to 1985. Originally the windows did not have frames, but the painted background continued into the embrasure of the window. This is still partly preserved underneath the repair plaster on window no. 3 (fig. 5).

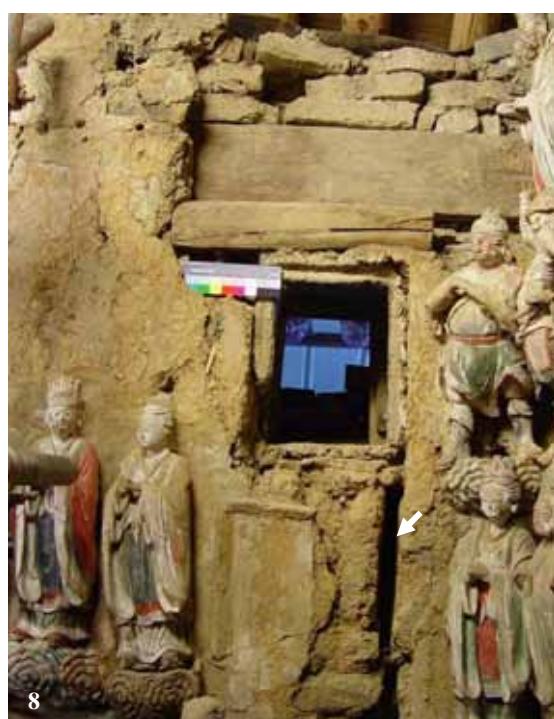
Removal of adobe bricks reveals original lintel and wooden plank
 arrow: crack between two standing adobe bricks

The wooden plank and the repair with adobe bricks were removed. The wall was cleaned. Under the supervision of the Chinese architects the wall was closed between April and September 2007, using mostly adobe bricks, but unfortunately also two fired bricks (fig. 11). In September 2007, the adobe bricks were covered by a plaster made of “black earth” and straw, except for the three layers above the lintel (fig. 12). The plaster was applied by Mr. Xu Liujin.

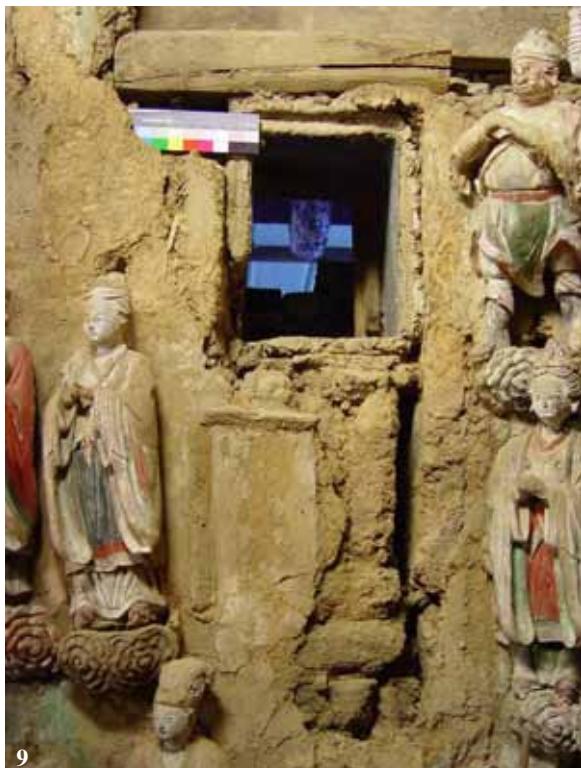
9

The removal of the repair plaster around window no. 1 showed that the wall was badly damaged above the window, but partly well preserved below the window.

Area around window after removal of repair plaster;
decorative frame revealed completely

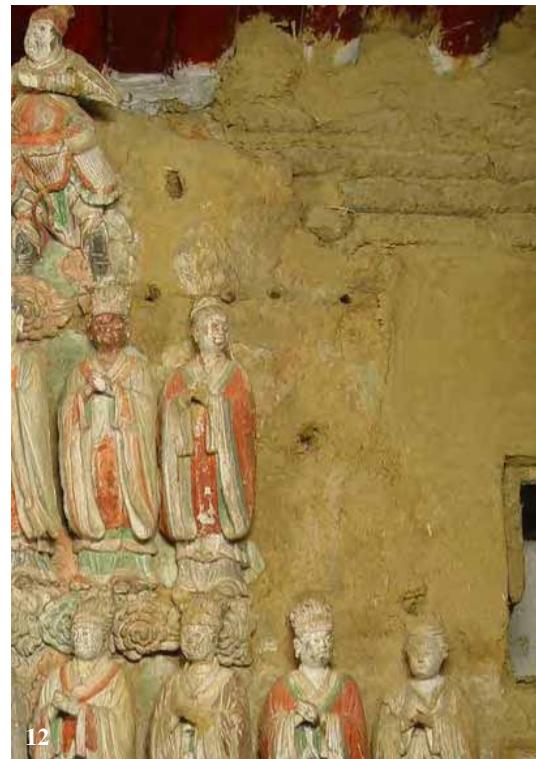
12

The removal of the repair plaster revealed the positions of the lost pegs (fig. 4, arrow). This helps to reconstruct the number of the original arrangement of sculptures and clouds. All holes for pegs and even parts of the painted cloud background could be rediscovered (fig. 12).

Situation in November 2007:
The bricks are covered with mud-straw plaster.
The position of the pegs and preserved pegs and
parts of the painted cloud background can be seen.

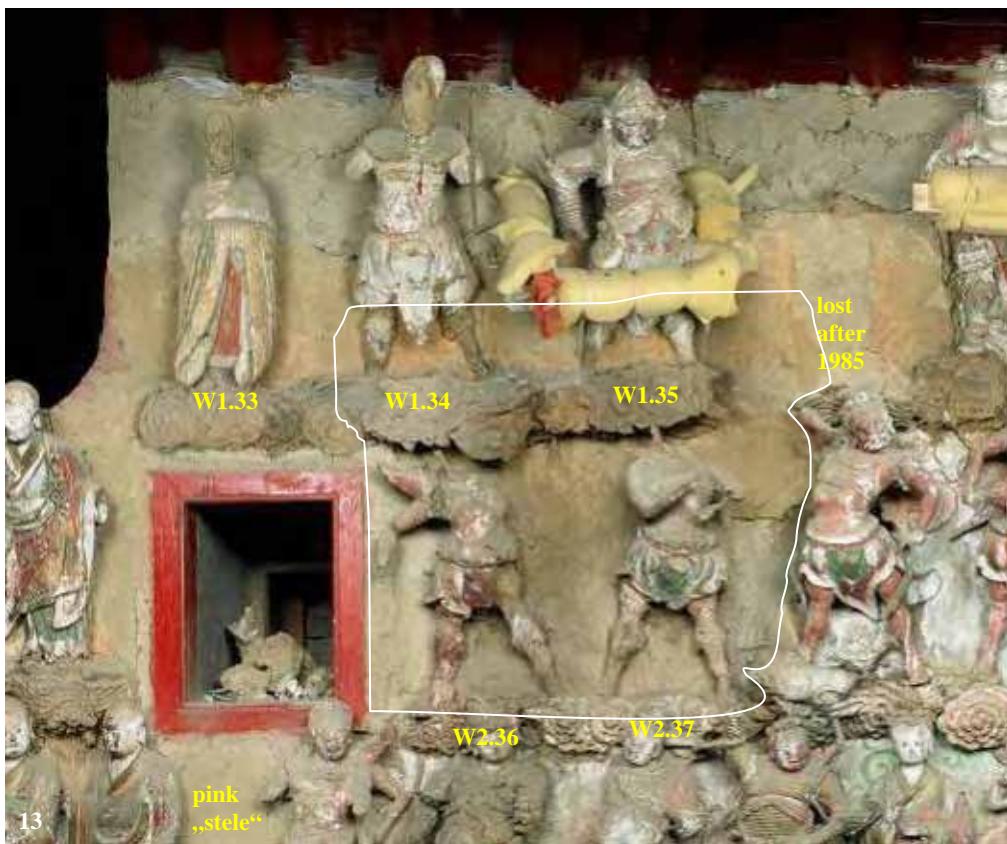
Situation in 2005 [Harlan Wallach, Northwestern University, USA]

The recessing part of the wall is marked with a white line.

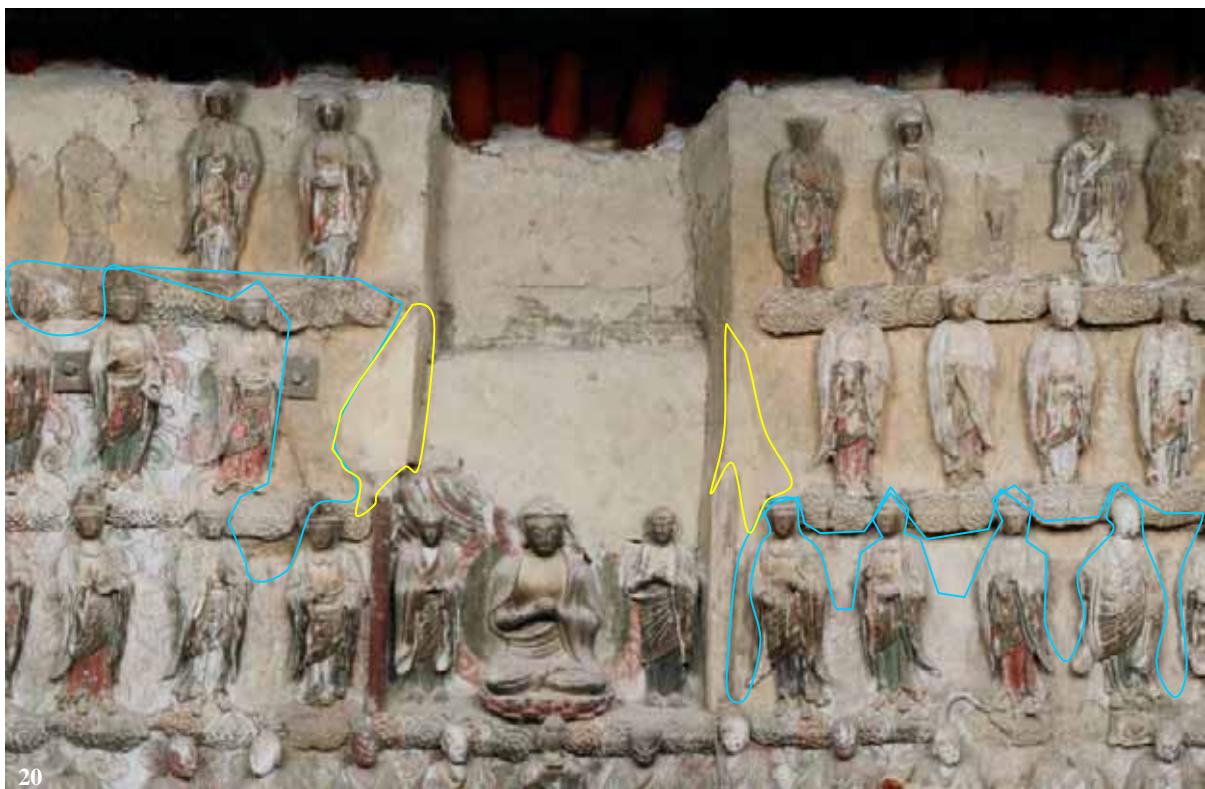
20

Central part of section 3, situation in 2005 [Harlan Wallach, Northwestern University]

Blue: repair plaster overlapping the painted cloud background

Yellow: broken-away parts repaired in 2005, probably originally: the connection of the pavilion roof to the wall

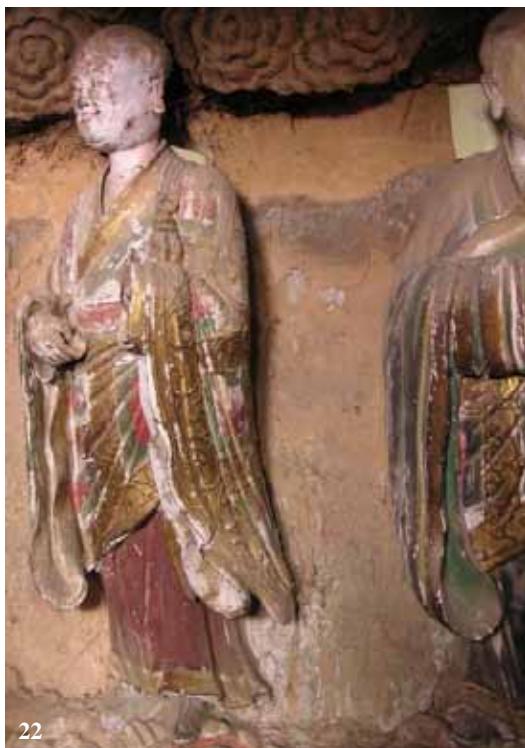
22

Background between W3.43 and W3.44 before treatment

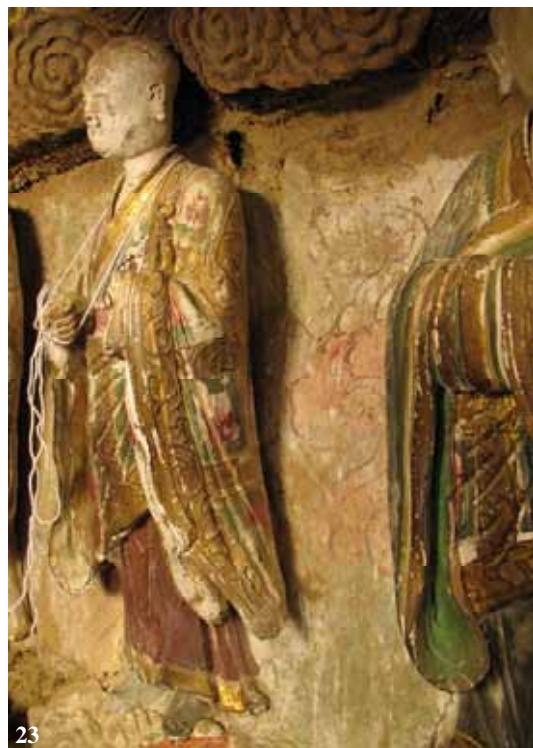
23

Background between W3.43 and W3.44 after removal of repair plaster layer

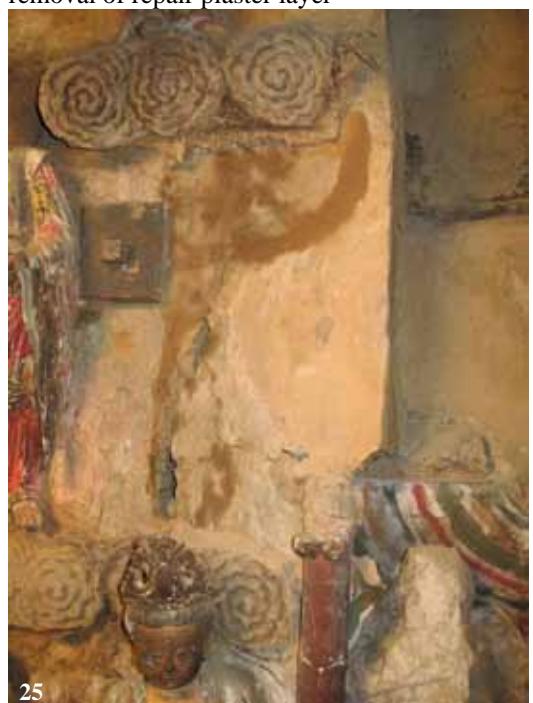
25

The removal of the repair plaster from the painted surface also revealed that on the southern (left) side of the niche as larger part had broken away above the pillar. Big cracks and large gaps between the parts were revealed (fig. 25). The broken-off part was secured by a wire which was revealed underneath a thick layer of repair plaster. The wire was removed as it was not improving the stability and was protruding out of the wall surface level. The cracks and gaps were filled or bridged by injecting clay mixtures (“black earth” with sand or with sand and poraver®, depending on the width of the crack). Cracks and damaged areas were filled superficially with a mixture of “black earth” and sand. After the stabilisation, background areas with repair plasters were covered with a thin suspension of “black earth” to homogenise the visual appearance (except for the interior of the niche). The connection areas of the two lost sculptures were omitted.

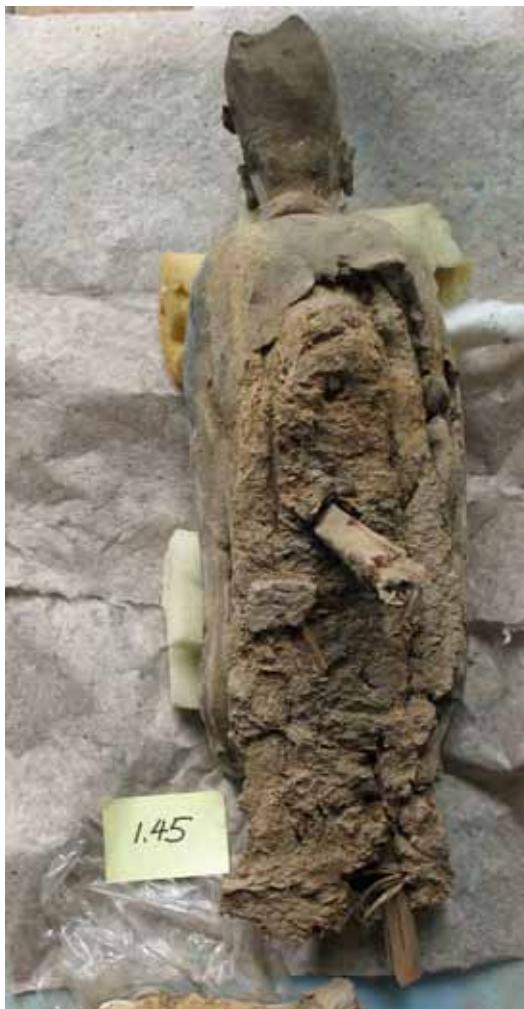
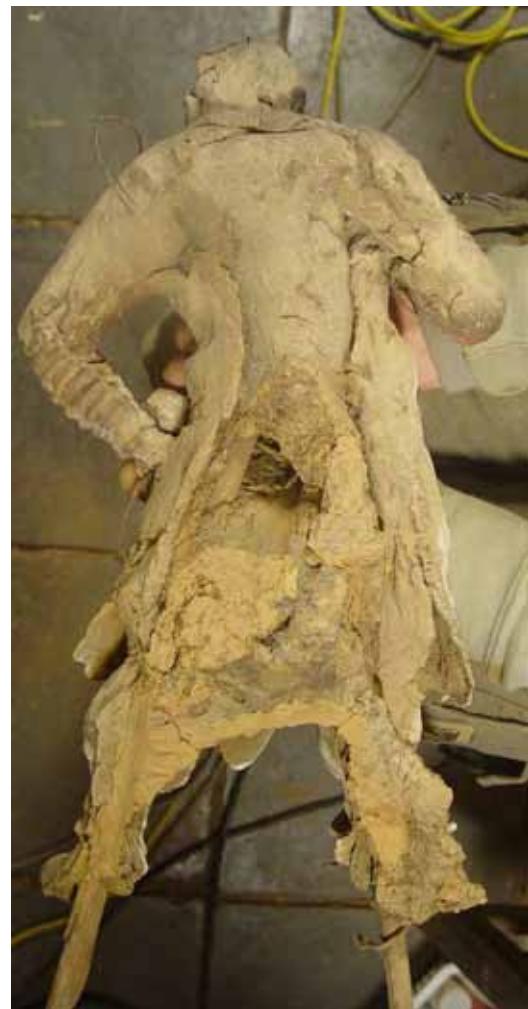
3

Two detached sculptures from the west wall, seen from the back side: The modelling in several layers is discernible. Around the feet the hemp strings from the connection to the pegs are visible. On the large peg in the sculpture on the left the tip is broken off.

As the pegs in the back are inserted deep into the sculpture and fastened with hemp strings, normally this peg remains inside the sculpture. Sometimes the tip deforms or breaks when the sculpture falls from the wall (fig. 3, left side). The pegs at the feet often remain inside the wall, being inserted deeper into the wall than into the structure of the sculpture. Additional damages caused by this process are breaks in feet or legs of the sculptures with visible feet and the falling-off of the clouds which are detached when the sculptures start to tilt seriously.

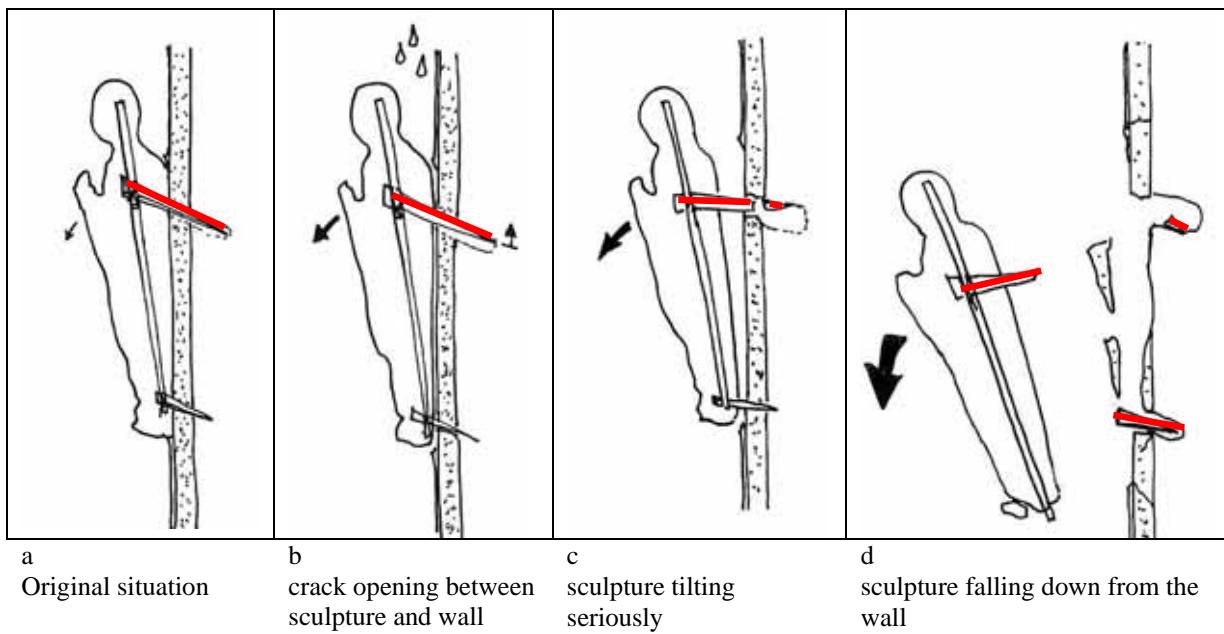
6

A typical damage process can be described in the following way: Due to the shrinkage during drying of the clay layers and to climate changes over a long time, the connection between peg and wall or peg and sculpture loosens slightly. As the sculptures are top-heavy, the tension and stress are much higher on the peg in the back than on the ones at the feet (fig. 6, b). A crack opens between sculpture and wall, allowing the sculptures to tilt forward (fig. 6, c). When the sculptures tilts, the pegs are pressed down from the oblique position come into a more vertical position. If the pegs are loose and completely vertical orientated, the sculpture can fall from the wall (fig. 6, d).

Process of detaching of sculptures from the wall

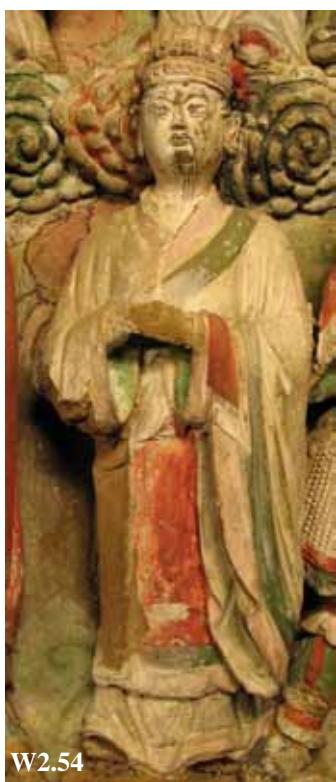
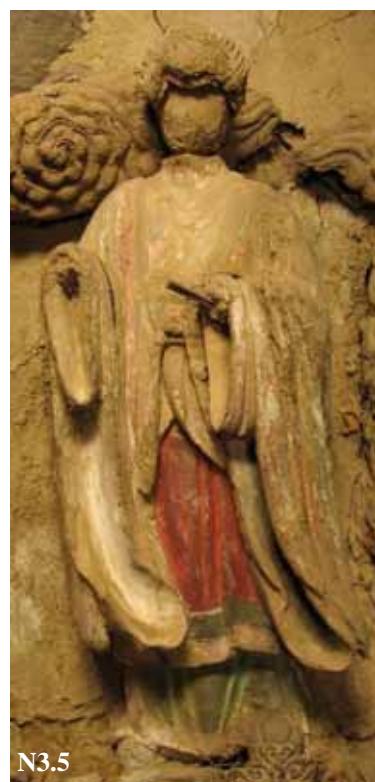
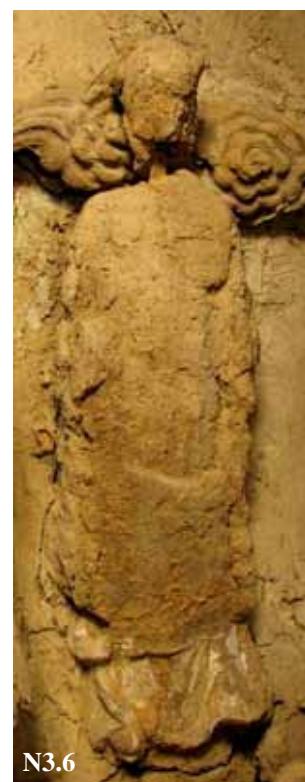
Left: sculpture from the west wall with mould-made hanging sleeve broken off.

Centre and right: two severely damaged sculptures from the north wall. On N3.5 face and collar are missing, the hands are broken off. N3.6 is reduced to the inner core and can only be recognised as female deity by one preserved shoe.

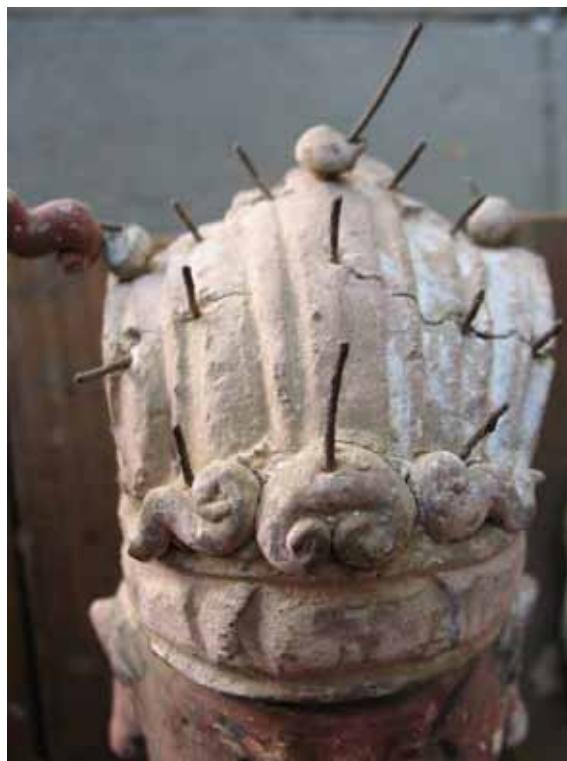
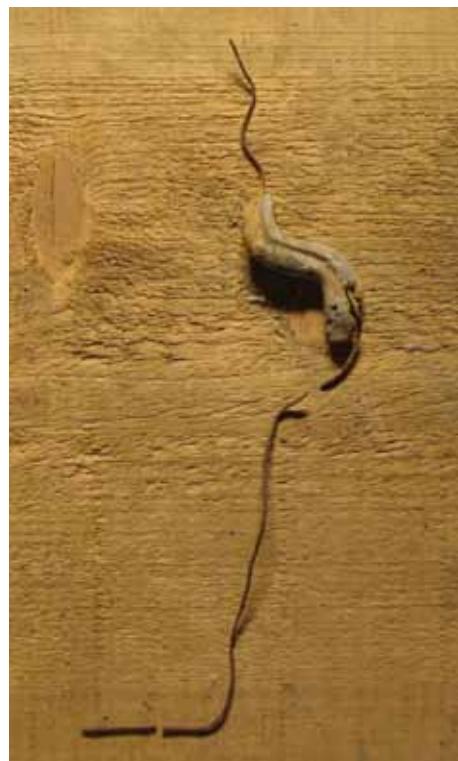
8

Corroded wire cores:

Left: on the headgear beads and spiral-shaped elements were applied on pieces of wire, nowadays mostly missing.
Right: remnant of a flying band. The wire is broken off from the sculpture and broken twice. Only a small portion of the modelling is preserved.

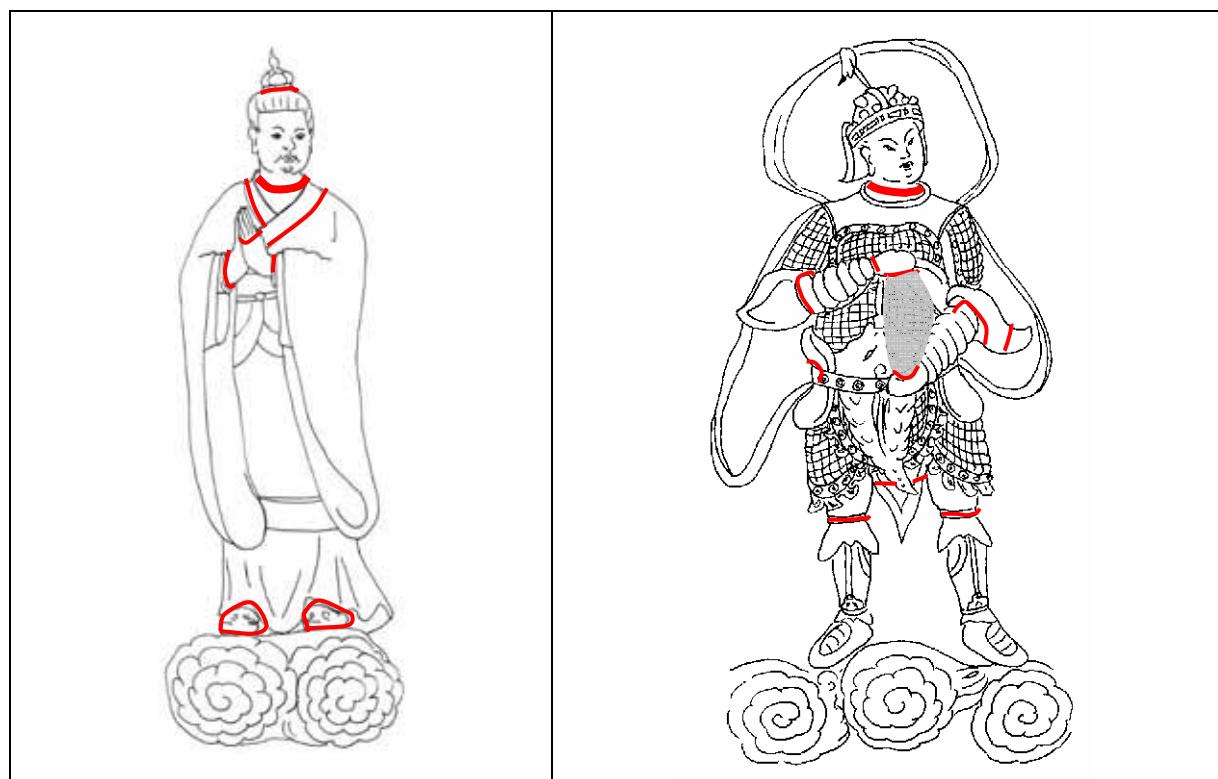
1

Position of fractures and opened junctions

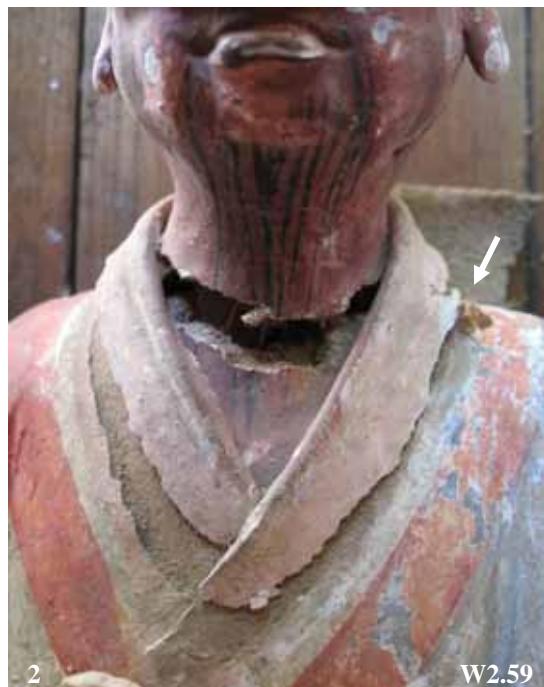
The most frequent damage caused by detaching along work joints is the loosening of collars which were applied as thin clay strips and originally stabilised only by thin strips of paper applied below or imbedded into the ground layer (fig. 2, arrow). Various small decorative elements on headgears, belts, armours as well as bracelets and necklaces tend to detach at the joints (fig. 6). Elements with wire core slip from the often corroded wire (fig. 5a, b) or break lengthwise parallel to the wire.

2 Head and collar broken off;
arrow: paper strip along joint of collar
