Shuilu'an

Jahresbericht / Annual Report 2007-2009

**BMBF Forschungsprojekt / Research project
01GWS079**

Forschungsprojekt 01GWS079
„Deutsch-chinesische Zusammenarbeit im Kulturgüterschutz: Forschungen zum Erhalt
ausgewählter Denkmäler in der VR China“

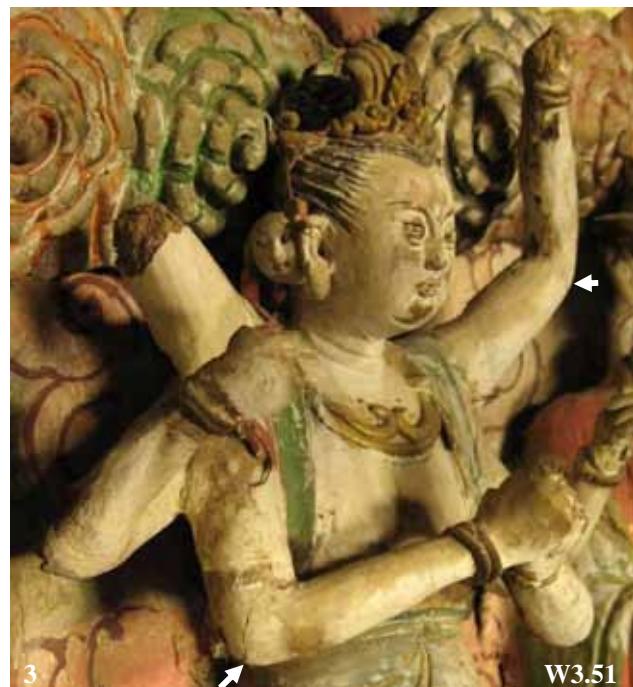
3 Break at elbow (arrows); raised arm broken off

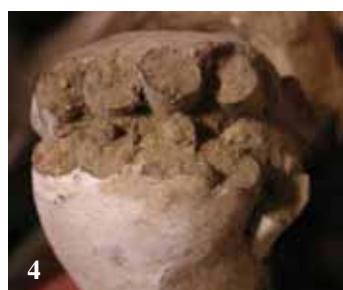
4 Fingers broken off

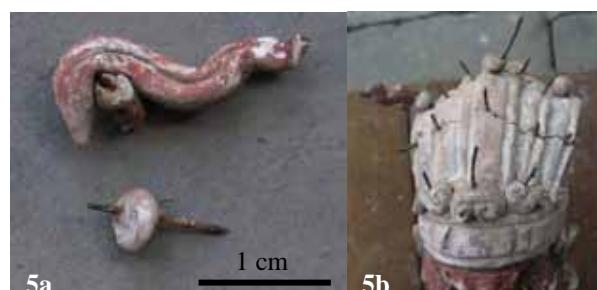
5a 1 cm 5b
Small decoration from the headgear of W2.58, made of several pieces, attached with a piece of wire

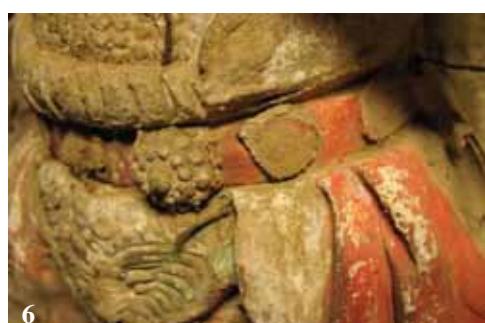
6 Mould-made belt decorations often detach and fall-off

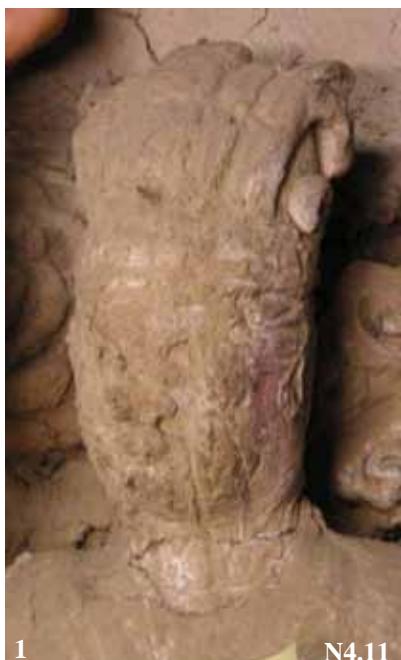
1
Eroded head

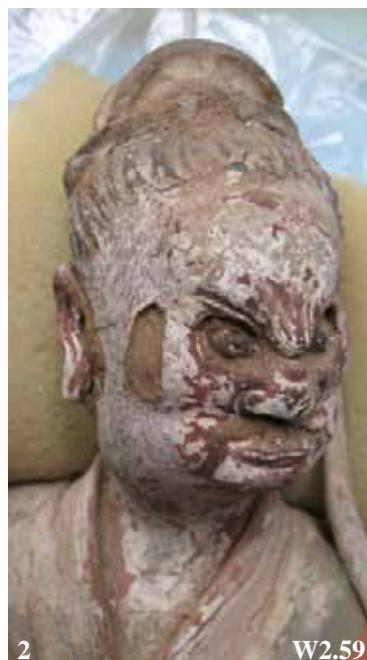
2
Rounded lacuna on the cheek.
Damage by water (?)

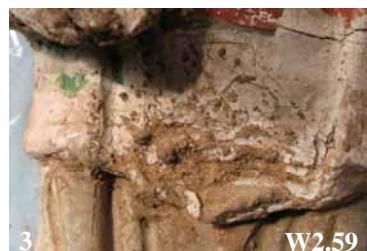
3
W2.59
Lower hem of skirt deformed
by water

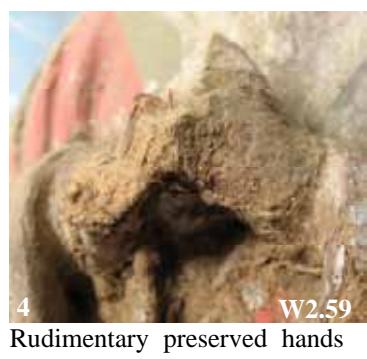
4
W2.59
Rudimentary preserved hands
with grainy surface

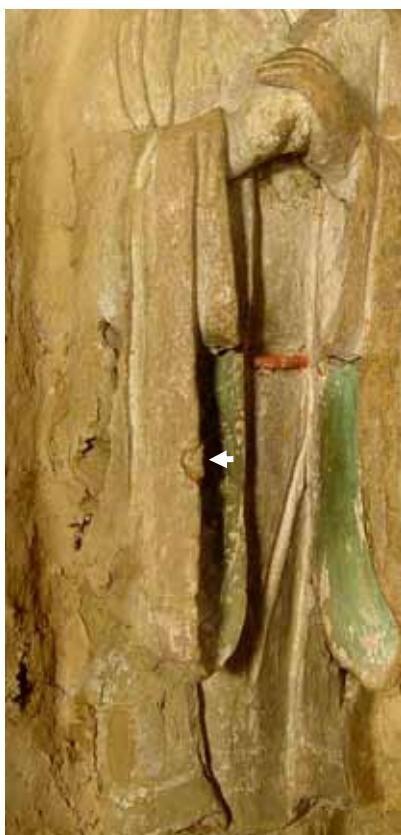
5
N5.1
Edge of the sleeve cuff broken-out
because of punctiform impact
(arrow)

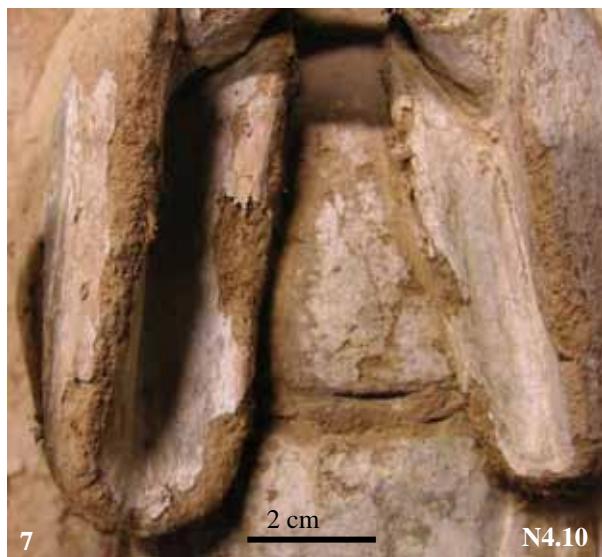
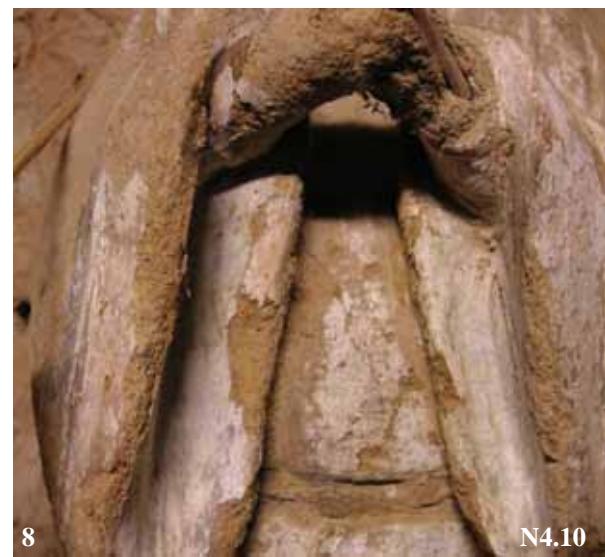
Damaged edges of sleeve cuff before (fig. 7) and after treatment in September 2007 (fig. 8).

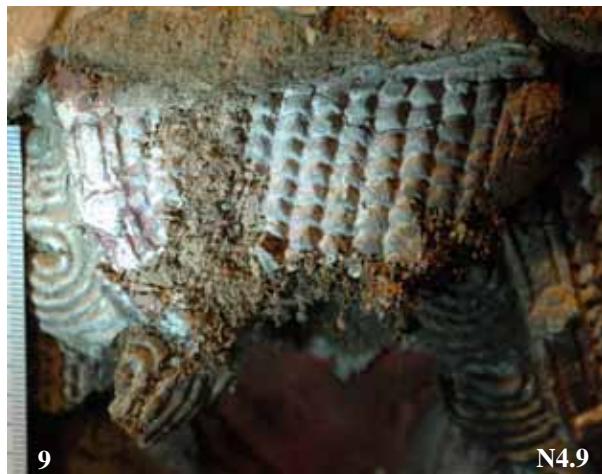
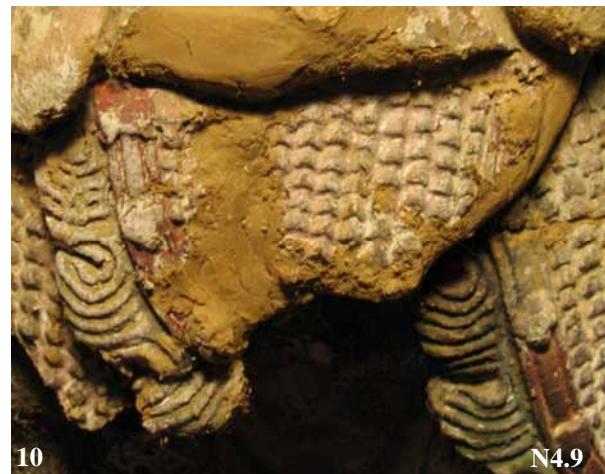
Damaged part of armour before (fig. 9) and after treatment in April 2007 (fig. 10).

sticking-out sand grains and fibres (fig. 10 centre, hanging part of armour). The type of earth is chosen depending on the colour of the surrounding which varies between yellow and brown. Margins of lacunae or sensitive fracture edges are treated in the same way. If necessary, fillings along the edges are made to stabilise them.

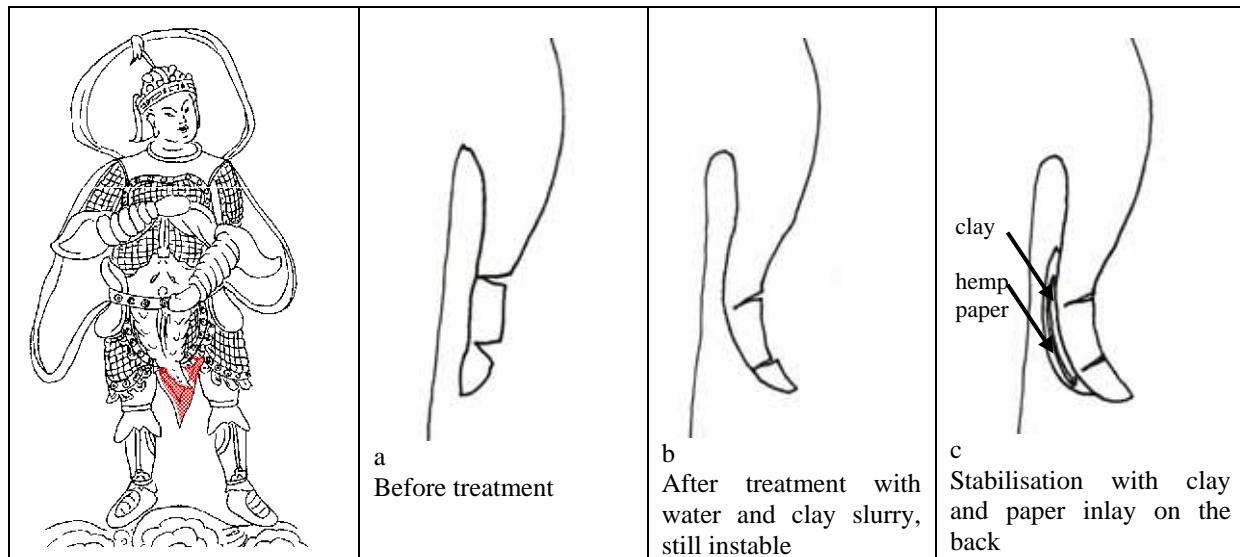
11

Stabilisation with applied clay layer and hemp paper inlay on the example of a hanging tip of a tunic

Bent parts are stabilised by injecting clay suspension (mixture of HFM 1) into cracks and holding the parts in the correct position until they are dry. In the case of the hanging tip of robes and armour of the *tianwang*, this sometimes is not sufficient. To avoid visible stabilisation like thicker fillings, stabilising layers are applied in three cases on the back of the element: the back is moistened with water. A thin layer of clay slurry (clay suspension or HFM 1) is applied. A piece of hemp paper is imbedded into the clay slurry. After drying the paper is covered with a thin layer of clay (“yellow earth”) with hemp fibres (fig. 11).

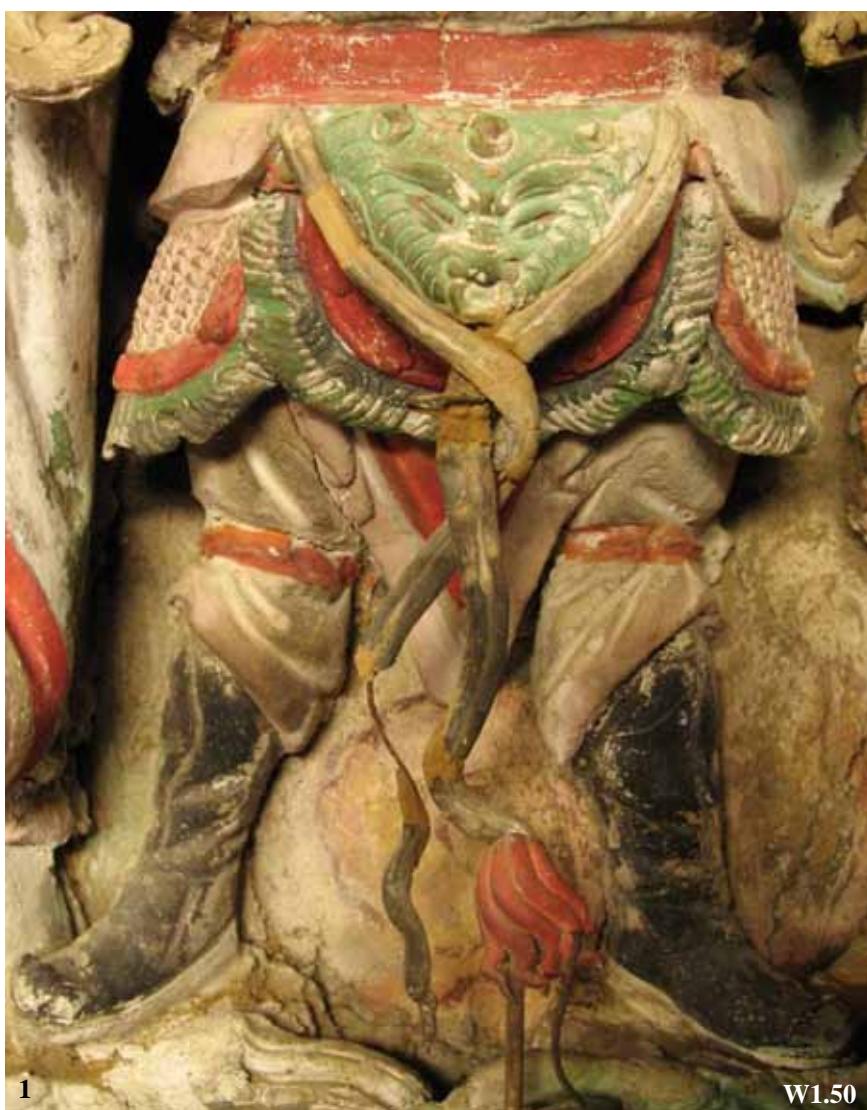
Stabilisation of fragmented hanging band on the sculptures with stabilising fillings

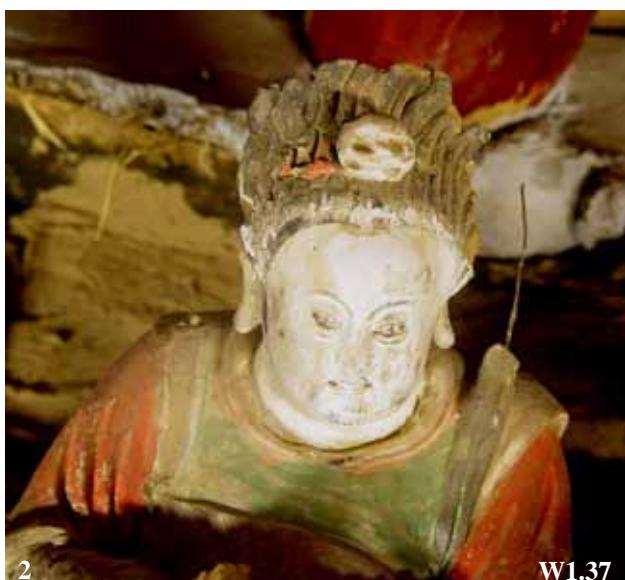
Stabilisation of a part a flying band including a loose part found on the sculptures back:
Situation before treatment

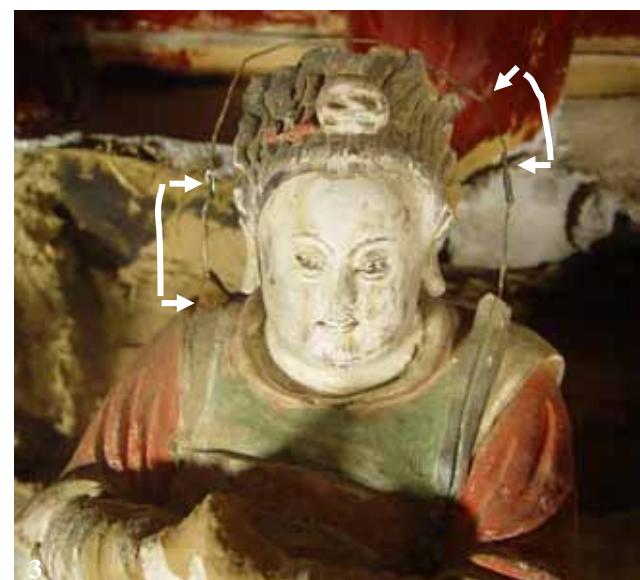
Situation after treatment (November 2007); arrows: connection points of old and new wire; white line: inserted pieces of new wire

Like most of the sculptures of this type, W1.37 had a band flying over his head. The band originally was attached on both shoulders. Only the band on the left shoulder was preserved, ending in a wire sticking up vertically (fig. 2). During cleaning of the sculpture in September 2007, another part of the wire was found lying on the shoulders of the sculpture. The preserved parts were reconnected with a new wire. This was attached with a small clay ball on the right shoulder. In this way, the preserved part of the wire could be re-attached and the original shape of the flying band can be recognised again (fig. 3). The “flying band” over the head of W3.47 was repaired in a similar way.

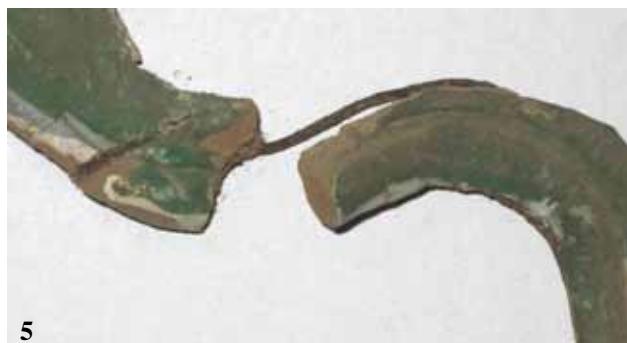
5

In parts, broken along the wire, often one half of the clay modelling is missing, exposing the wire to one side (fig. 5). In this case, clay has to be applied to coat the wire and reconnect the clay modelling to the wire. On thin bands, this results in the reconstruction of the missing half as the bands are so thin, that the clay necessary for stabilisation have the same thickness as the original part.

The band was broken in two parts and pieces of the clay modelling were missing (fig. 4, 5). The broken wire parts were reconnected with thin wires (fig. 6). The band had been deformed due to the fall and had to be bent cautiously into a position fitting to the sculpture. During the application of the stabilising fillings, the band had to be supported to dry in the required shape (fig. 7, 8). In the end, the band could be reattached to the sculpture W1.51 (fig. 9).

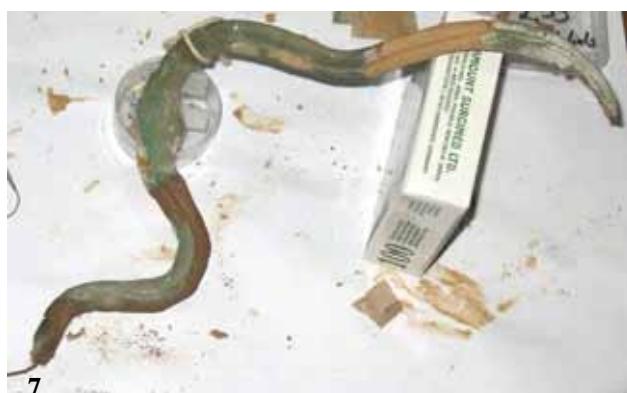
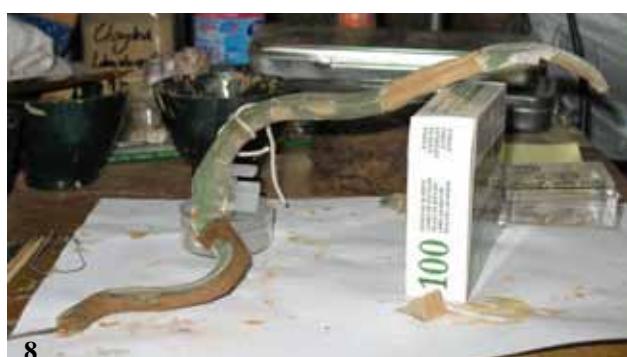
Consolidation of a hanging band from W1.51

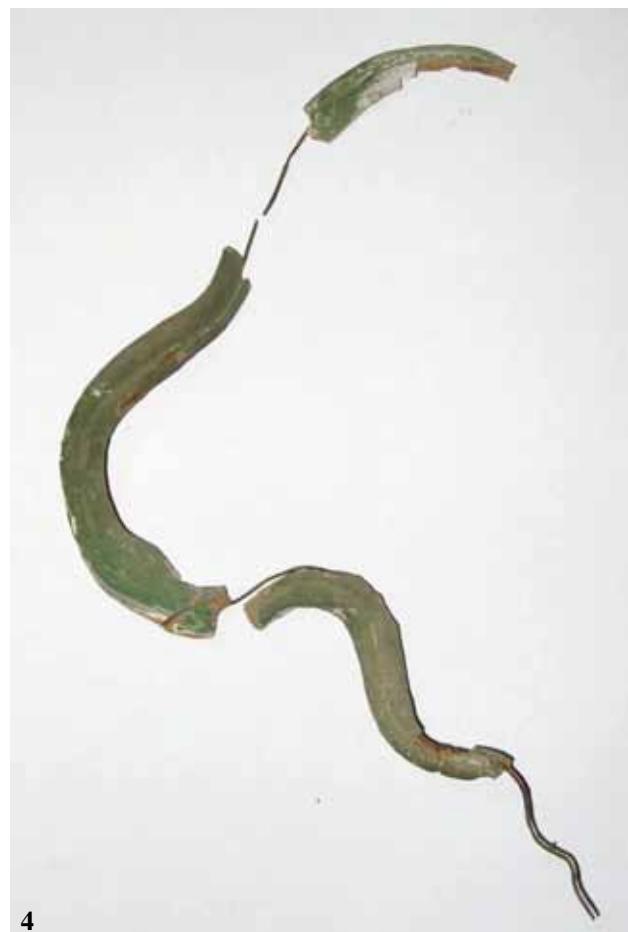
4

Especially the long “flying bands” are often broken into several pieces (fig. 4). They are mostly attached only on one end and maybe another point in the middle, so most of them are hanging down unsupported. If the wire is broken at one point, the band falls off. For reattaching these broken bands, the wire has to be reconnected.

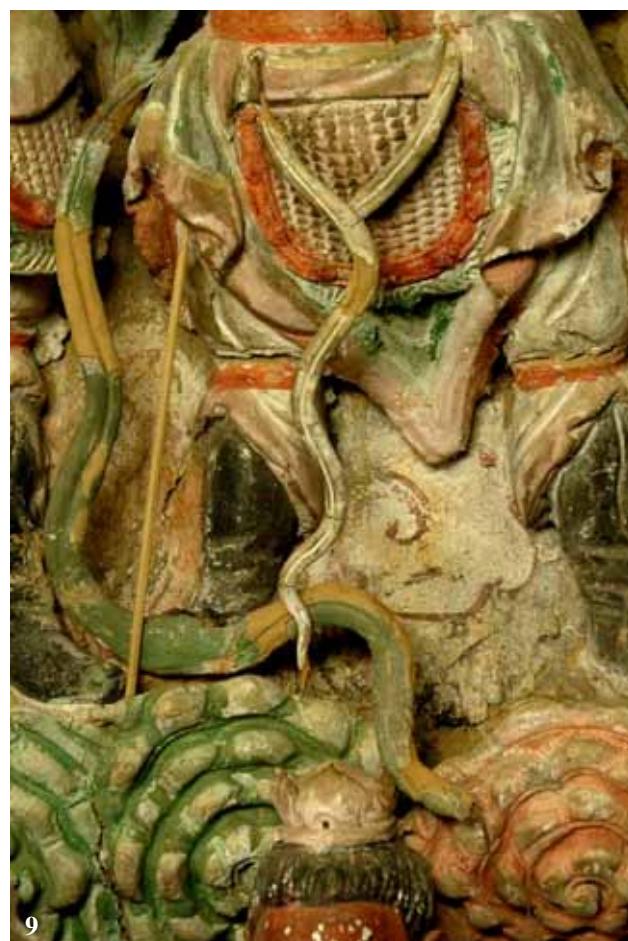
9

After re-attaching to the wall (with temporary support)

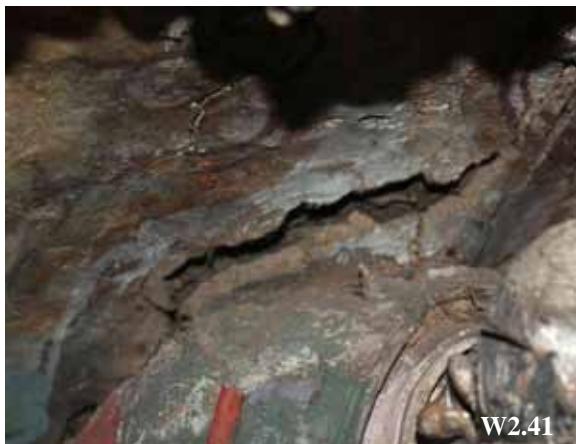
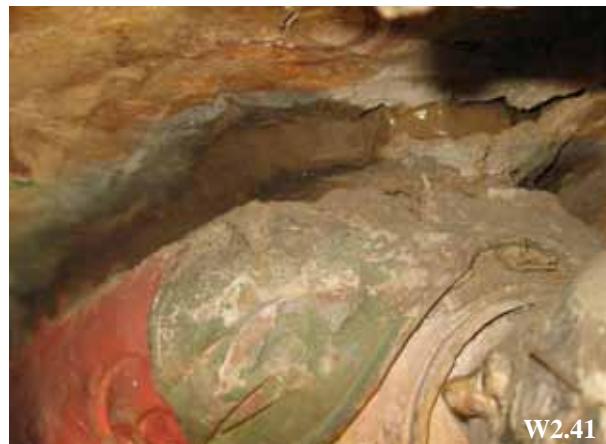
1

Stabilising sculpture W2.41, June 2009: Cracks around the gap closed with clay mixture

All cracks and holes connected to the gap behind the sculpture have to be closed, using half-dry clay (fig. 1), tissue papers or cotton (fig. 2), to prevent clay suspension flowing out. The use of cotton has to be restricted to smooth areas as cotton fibres are hard to remove from rough surfaces. Where the system of cracks or voids inside the wall can not be estimated, the surrounding background is protected by facings with Japanese paper (adhesive: Klucel E, 2.5 % in ethanol). If the cracks are not closed tightly, water will flow out during moistening of the gap, revealing the leaking spots.

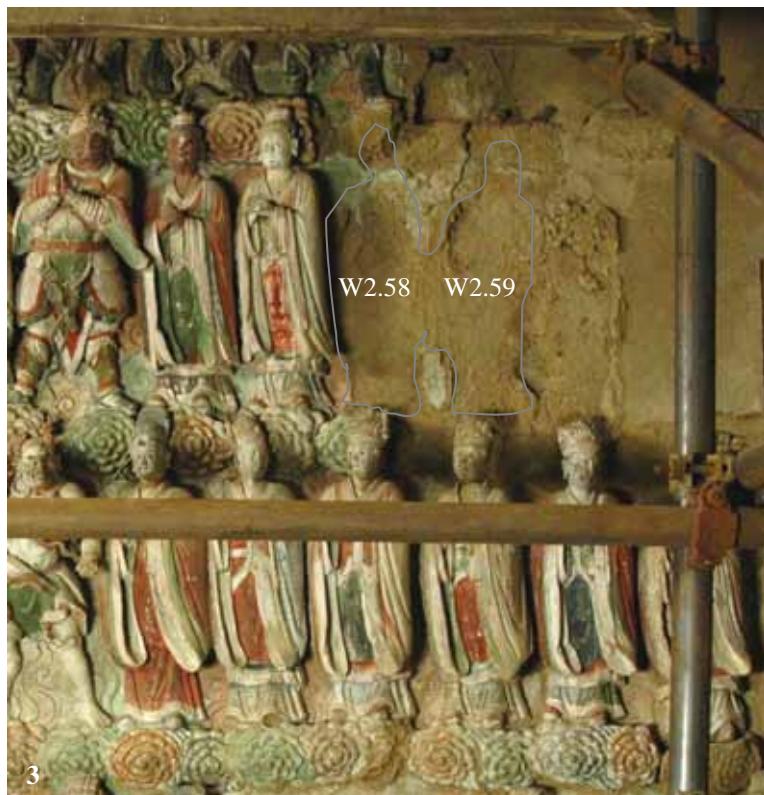
Detail of west wall, section 1 in April 2007 before treatment. The sculptures W2.58 and W2.59 have been detached in 2005.

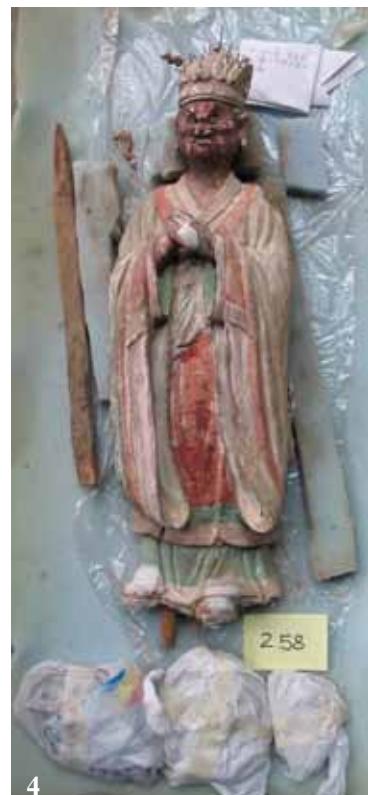
W2.58: the peg in the back has fallen out, the one at the feet is missing. The plastic bags contain the clouds.

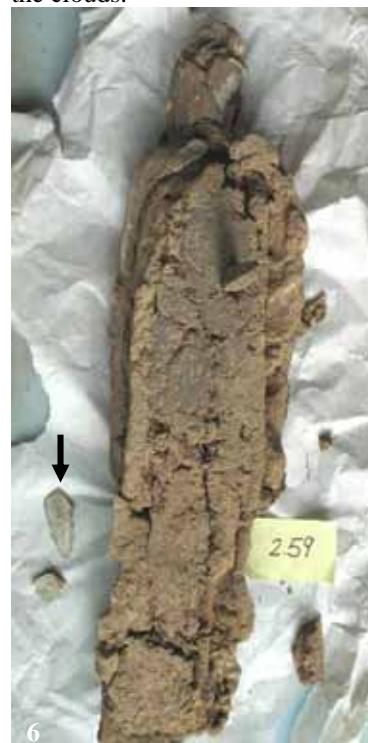
W2.59: the back has opened drying cracks. Arrow: small parts of the painted cloud background detached together with the sculpture.

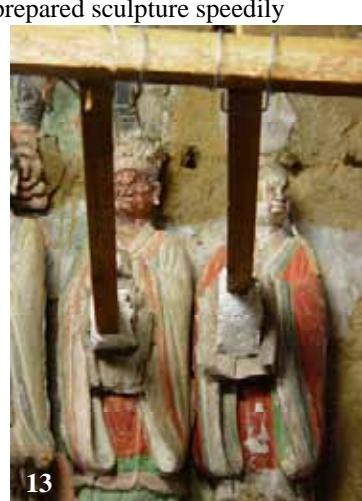
13

W2.58 and W2.59 after
re-attaching, stabilised
by wooden props

5. The sculpture is attached to the wall (fig. 12) and adjusted correctly.
6. The support system is set up, giving a light pressure to the sculpture (fig. 13).

During the work periods in April and September 2007, this ideal case was not given. The props were made of wood (fig. 13, 14). For the uppermost tier, also slats of polystyrene were used which could be jammed behind the lintel of the purlin (fig. 15). Except for the top of the wall, the only place to attach the props was the scaffold. The scaffold consisted of iron bars, connected by metal clamps. This meant that the system was rather flexible as additional bars could be added at different levels. The main disadvantage however was that the scaffold was not vibration-free and was shaking as soon as a person was moving on top of it. Climbing on the scaffold resulted in props falling down. Adding horizontal bars at all required levels,

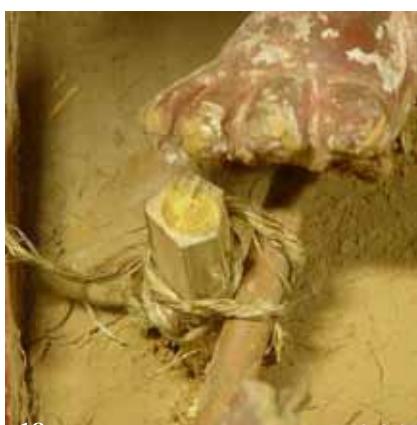
18

Replaced missing peg made of Smoke tree and replaced hemp string; the yellow heartwood of the smoke tree wood is discernible.

In section 2, a larger number of pegs at the feet were missing (W1.34, W1.35, W2.36, W2.37 and W1.38a). Some pegs had splintered tips and could not be reused because they would have been too short if the tip was carved to a pointed shape again (W1.37). The missing and unsuited pegs were replaced by new ones. These were cut from branches of Smoke tree or Young Fustic, a wood species that has been identified on original pegs. Typical for Smoke tree or Young Fustic is the yellow core of the very hard wood (fig. 18). The yellow heartwood is still well-visible on many original pegs. Smoke trees are shrubs with thin boles and branches. They are still growing wildly in the mountains behind the Shuiliu'an. The branches used for the pegs were thinner than the original ones: For the original pegs the wood was split into thirds or quarters. The new branches were so thin, that only the bark was cut off to get the fitting diameter (fig. 18).

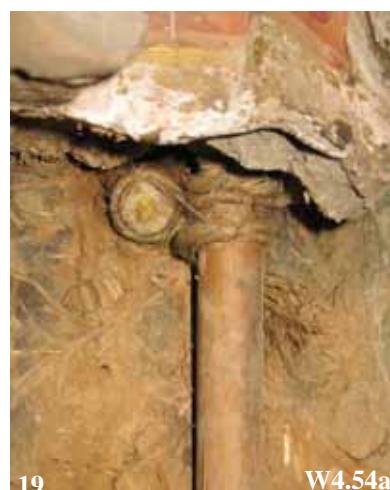
Replaced peg and the original hemp string, which still was connected to the bamboo pole. The connection was covered with clay for protection.

Missing hemp strings were replaced by hemp strings made by Mr. Xu Liujin for this purpose (fig. 16 and 17). The replaced pegs and strings are partly still visible if they are not hidden behind a cloud. If the original hemp string was preserved, but too short to tie it in a knot, the connection was covered with a layer of clay for protection and stabilisation of the string (fig. 19 and 20).

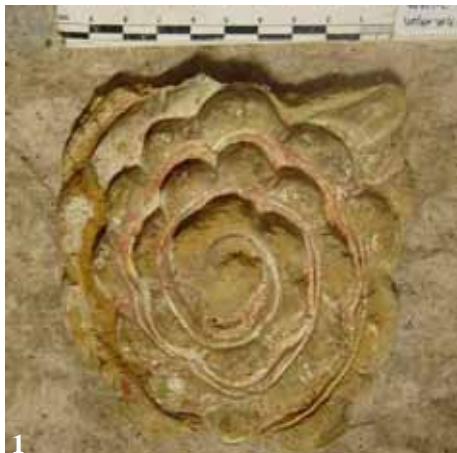
1
Cloud below W4.55 detached

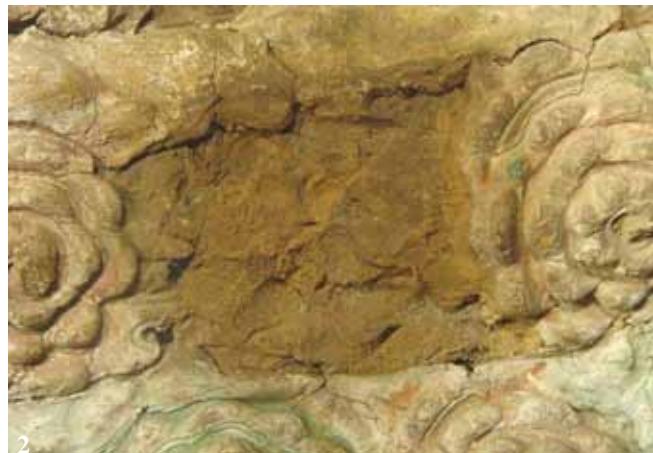
2
Substructure behind cloud below W4.55

If the substructure was instable or missing, it had to be prepared first. As the clay mixtures used for conservation in April and September 2007 are not suited to be applied in thick layers and do not possess enough creeping strength to hold the cloud in the right position during drying. Therefore, the substructure was prepared by forming a layer of mud-straw which could dry for at least 24 hours before the clay bed for re-attaching the cloud was applied.

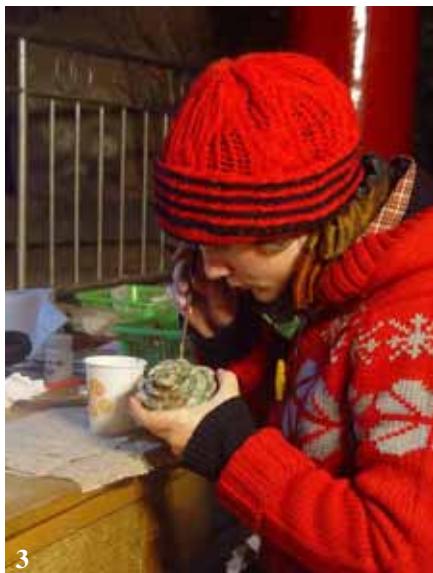
3
Consolidation of a cloud before re-attaching

Loose clouds were stabilised in the same way as loose sculptures. Detached clouds were consolidated with the same methods as the sculptures (fig. 3) and prepared for re-attaching. If the substructure was still intact, the cloud was mounted with a layer of clay with sand (HFM 2) and supported with a prop during drying (fig. 1, 2, 4).

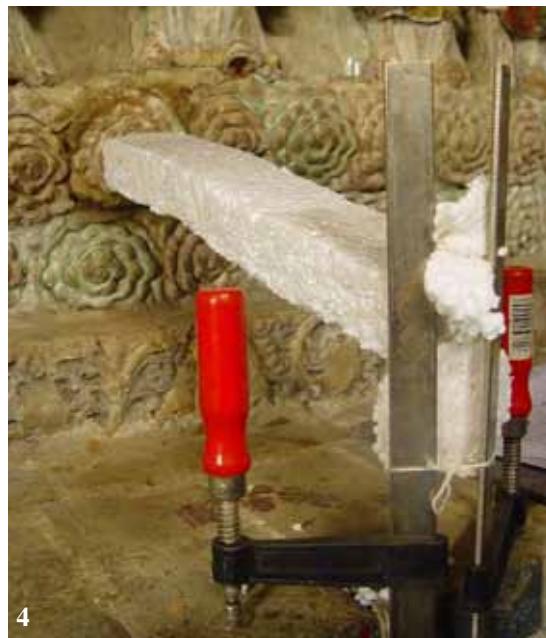
4
Re-attached cloud below W4.55 during drying

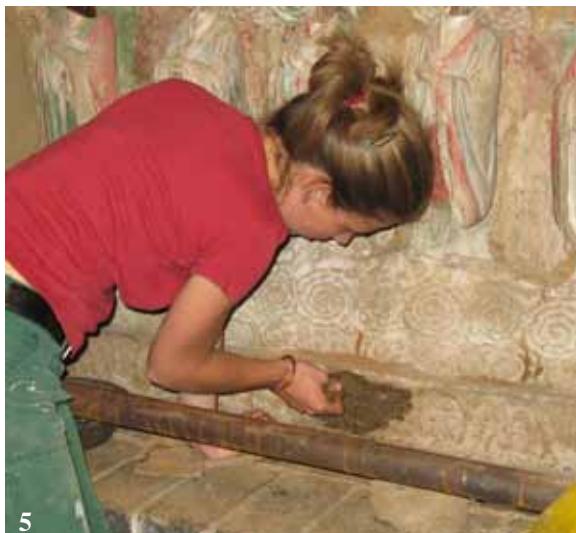
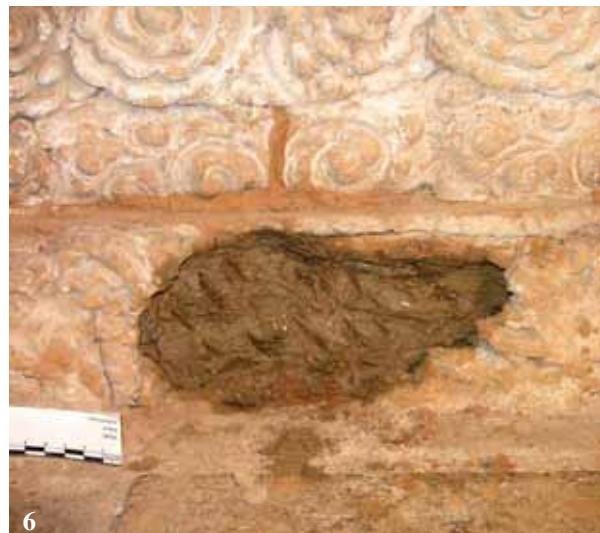
Deep hole in the twine frieze of the north wall: closing of hole with mud-straw mixture in several applications.

Holes in the pedestal caused by losses of twine relief of clouds were closed with a mud-straw mixture to protect the margins (fig. 5, 6). As the holes are often deep and connected to larger voids inside the wall, also the transport of dust into and out of the hole should be stopped. The surface of the filling is kept in the level as the substructure of the surrounding.

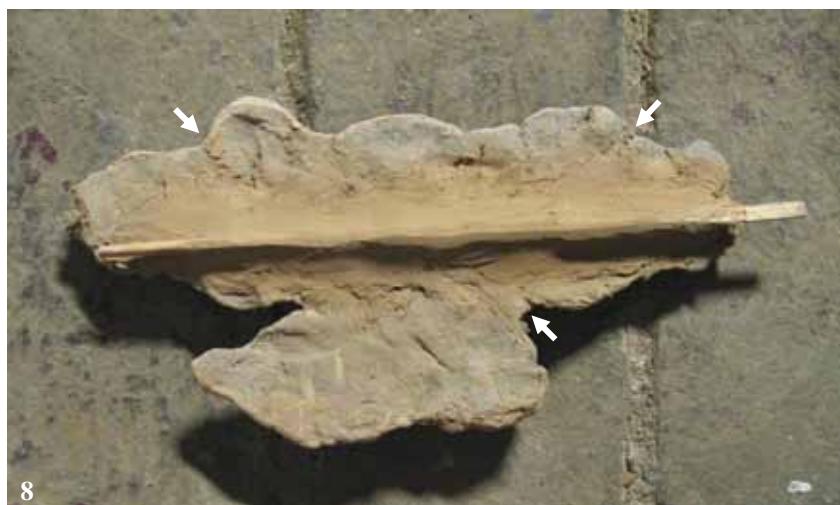
Stabilised cloud from the back
arrows: ends of hairline cracks that destabilised the cloud

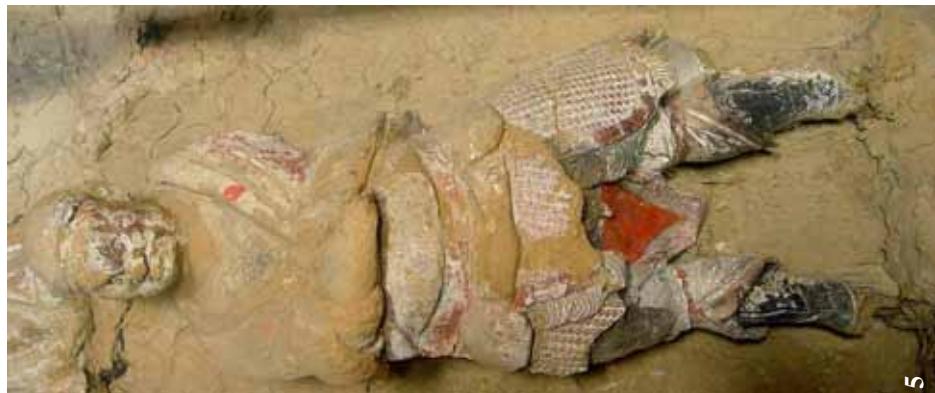
5

N4.9 after re-attaching the head
and consolidation of clay surfaces
and polychromy

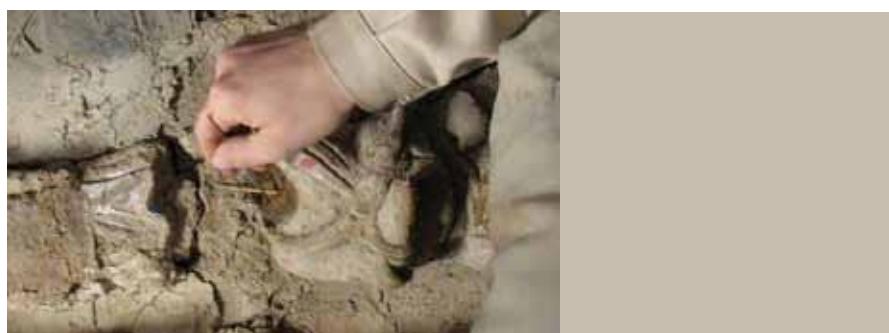
4

Filling the hole inside the
neck

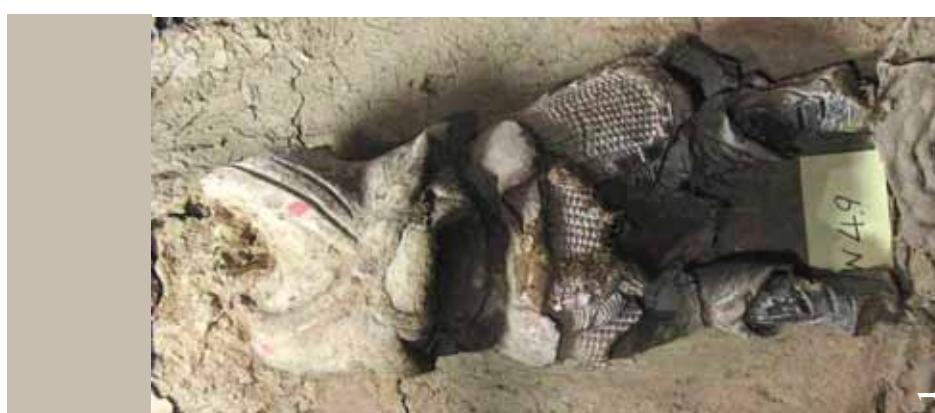
2

Insertion of bamboo chop
stick into the bamboo pole

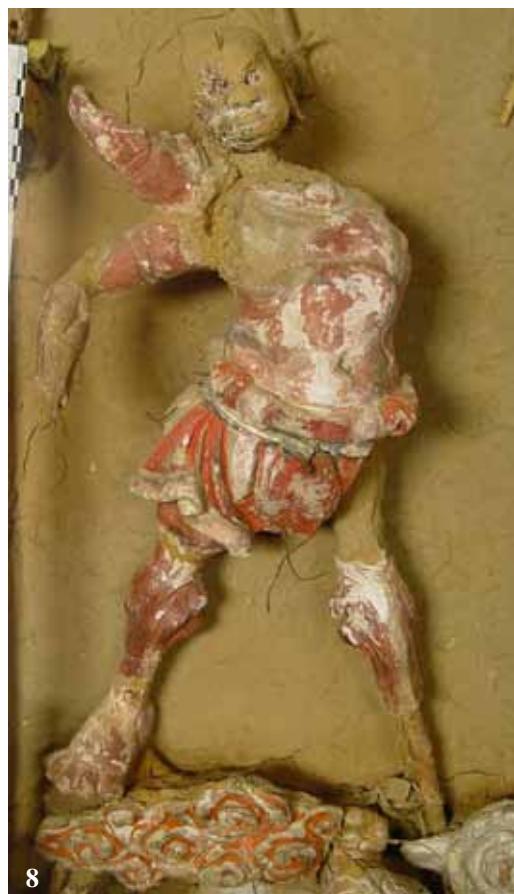
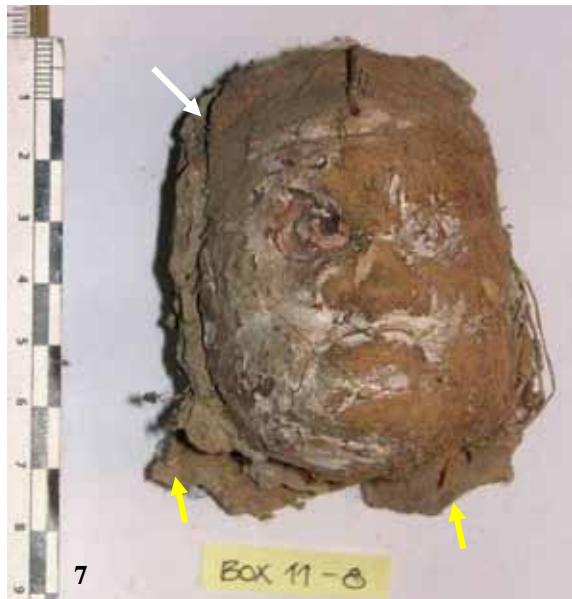
Head of W2.36 catalogued as find “box 11-8”
 The face was separating from the back of the head (arrow); the clay surface was powdery and the polychromy showed tenting flakes.
 On the back of the head there was a layer of repair plaster from 1980-85 (yellow arrows).

W2.36 was detached during the work of the wall to be built up the wall behind to a fitting level. As the sculpture was pushed too far back towards the wall when mounted in 19890-85, the head could not have been re-attached in that position (fig. 6). After the identification, head and body were consolidated. The clay layer of 1980-85 was removed from the back. The head showed severe damages. The face part was separating from the back of the head (fig. 7, arrow). The head required careful consolidation before it could be re-attached to the body. As the bamboo pole was still intact, there was a stable core for the head, but as the throat was missing, the clay parts of head and body had only a small contact zone at the right shoulder. The head was attached to the bamboo pole using clay suspension (HFM 1). In the back the joint was filled and the head stabilised. At the throat the bamboo pole was only coated with a thin layer of clay, without remodelling the missing neck (fig. 8).

Re-attaching the head to W2.36. The head was found in one of the window niches in April 2007 and stored in a cardboard box under the number “box 11-8”.

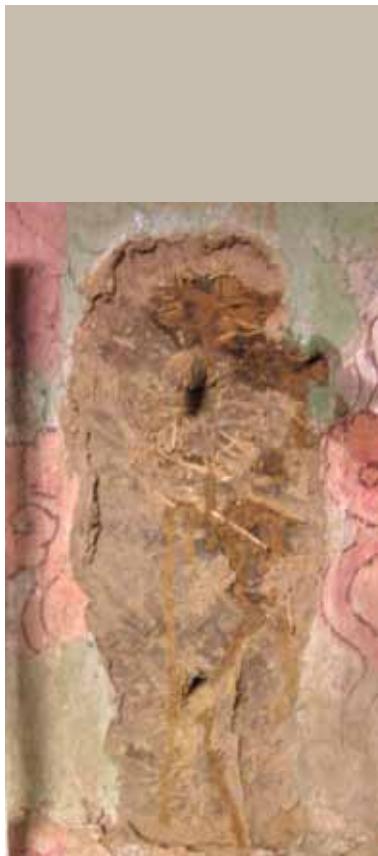
The peg from the back was preserved inside the wall (fig. 9). The one for the feet was missing. It is positioned at the height of the knees in this case. This position might have caused the sculpture to break at that level. The lower part with shins and feet is lost today.

9
Missing sculpture: situation before treatment

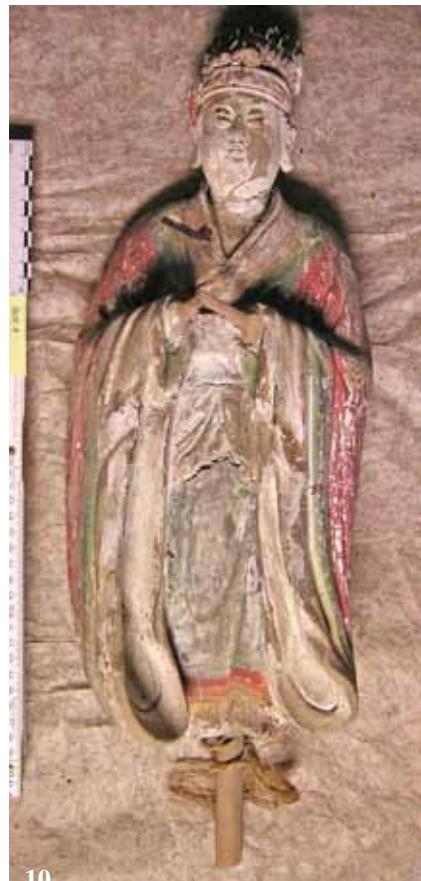
W4.54a was detached from the wall and its position was not known anymore in 2001 when it was used for conservation tests. Cracks in the back were filled up and two holes, in the left cheek and at the loop at the bottom of the hanging sleeves were filled suing a mixture of “black earth”, hemp fibres and sand. In April 2007, the sculpture was lying on the “bench” below the south wall. It was stored and catalogued under “box 7” (fig. 10).

10
Sculpture catalogued as "Man in box 7", Sept. 17, 2007

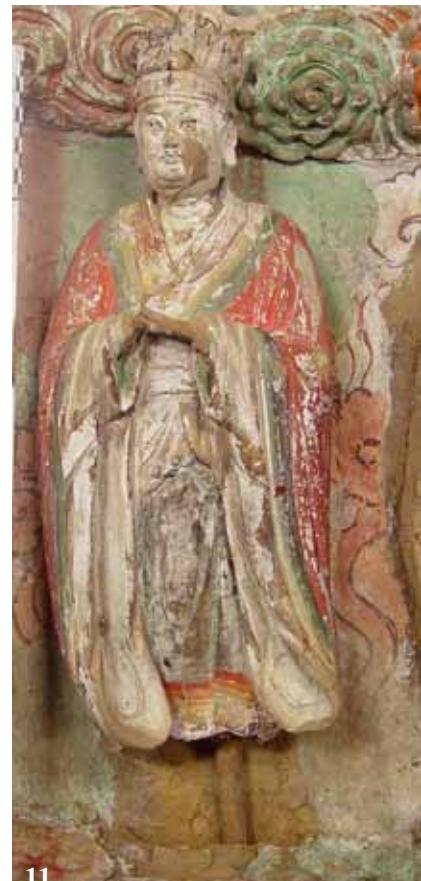
11
W4.54a after re-attachment to the wall

The sculpture was cleaned and reattached to the wall (fig. 11). The missing peg was replaced by a new one made of a smoke tree branch.

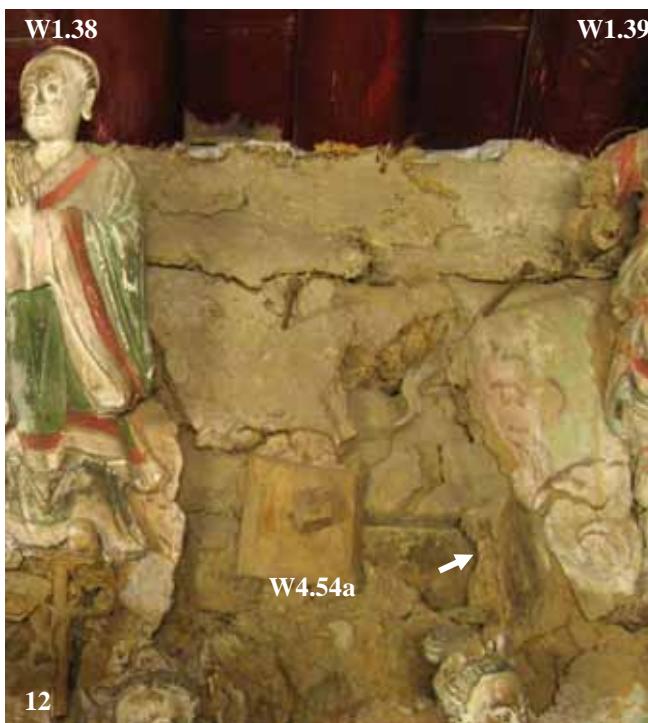
The sculpture was found without head. The identification of its position was made possible by the “negative” of adobe brick surfaces still visible on the back of the sculpture. When the sculpture detached, the wall plaster remained on the back of the sculpture. Additionally one part of the inner modelling with an imprint of the bamboo pole was still preserved on the wall (fig. 12, arrow).

12
Situation before treatment
Nails from an attempt to hold the sculpture on the wall (after 1985). Part of the inner core of the sculpture is preserved (arrow). The clouds below W1.38 and W1.38a were detached in 2005.

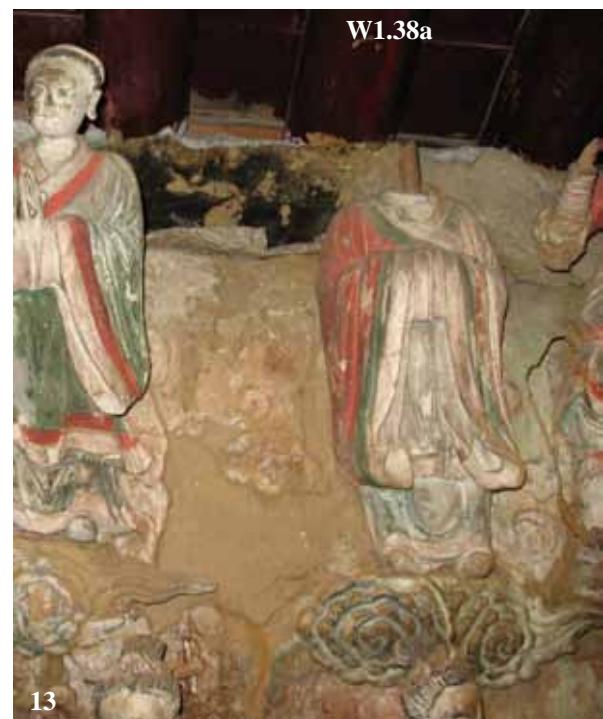
13
Situation after treatment
W1.38a and the two clouds are re-attached.

After the surface of the new wall plaster had dried for 10 days (slow drying during continuous rain fall) the detached sculptures were mounted again. Next to W1.38, there was the position of a lost sculpture. The peg for the feet was preserved as well as an imprint of the bamboo pole in a remnant of rough clay modelling. Two big nails had remained from an attempt to hold the loose sculpture on its place (fig. 14). Based on these traces a headless sculpture, found in the rear part of the hall, could be identified to belong there (numbered as W1.38a).

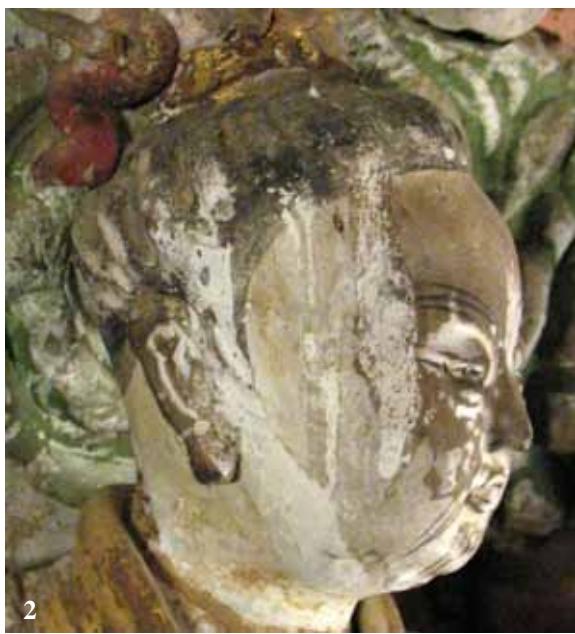
Separation of layers and loss of cohesion can be traced back to water penetrating into the hall. In some cases even stains from water running down over the surfaces can be observed (fig. 2). Climate changes and natural ageing of the binders might have supported the process, but water-damaged areas prove that the penetration of water through leakages of the roof is the main source of damage.

2
Stains from water running down over the surfaces

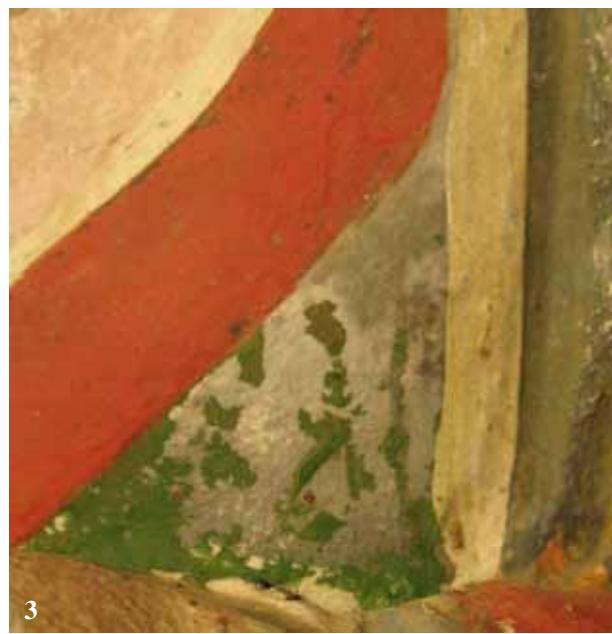
The water caused leaching and degradation of the binding media resulting in chalking layers. The coarse-grained atacamite (green) is extremely powdery and cannot be touched without losses. Especially in thicker applications often larger losses occur (fig. 3).

3
Detail of green robe: thick application of atacamite almost lost

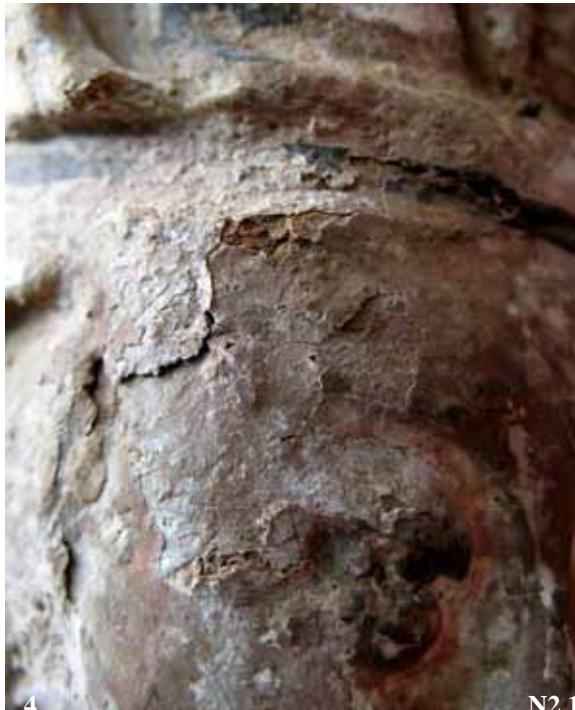
The swelling and shrinking of the surface clay layers caused by contact to liquid water also resulted in separation of layers. Often the thin, but more compact and harder paint layer detaches from the thicker, soft priming layer, but separation also occurs between polychromy and clay surface or even within the surface of the clay modelling (fig. 4). Often detached layers are tenting due the temporary swelling caused by the water penetrating the clay (fig. 4). Loose layers flake off, leaving lacunae with distinct borders and often rounded shapes (fig. 5).

4
N2.1
Delaminating paint and surface layers in the face of a water-damaged sculpture from the north wall

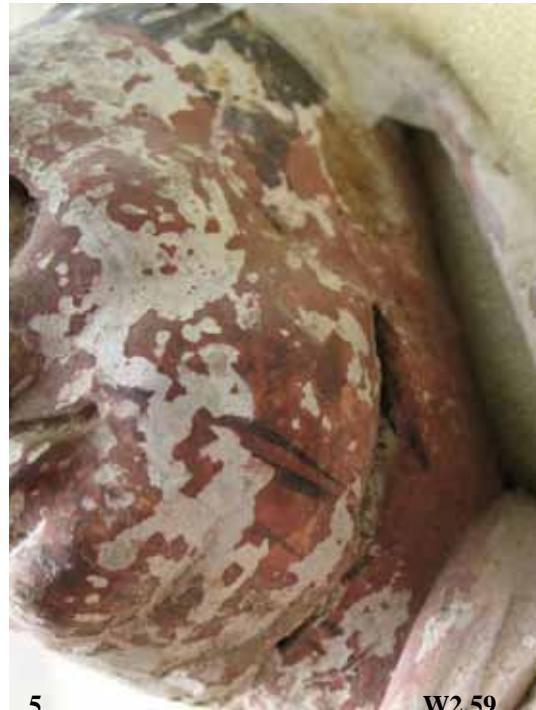
5
W2.59
Losses caused by detached layers in a face: Lacunae with rounded distinct shapes

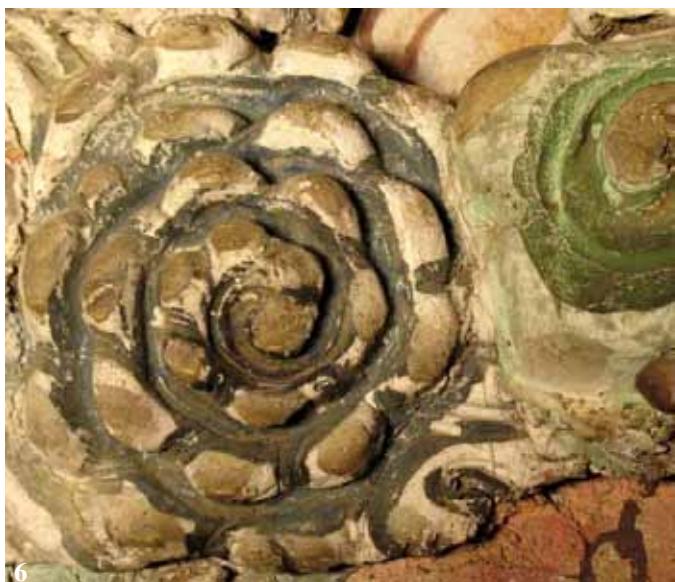
Most changes in colour seem to result from contamination of the surface with different kinds of material, but one type can be attributed to the material itself: The thickly applied white serving as highlights of the clouds (fig. 6) and separation between hem and robe became grey or greenish as a result of changes of the pigment. Many white areas, especially faces, show a certain darkening or greying and mostly this is not connected to pigment changes, but to some kind of contamination (fig. 7).

6
Cloud with discoloured white highlights

The discoloration in the thick white layers can be explained by the formation of black lead sulphide from lead carbonate (lead white) which was not sufficiently protected by binder and therefore undergoes changes caused by the contact to sulphur. The exact damage reasons and the origin of sulphur have not been investigated yet. In the surrounding there is no industrial production which could be the source of nitrogen oxides. It is important to respect that these discolorations cannot be removed by any acceptable kind of cleaning.

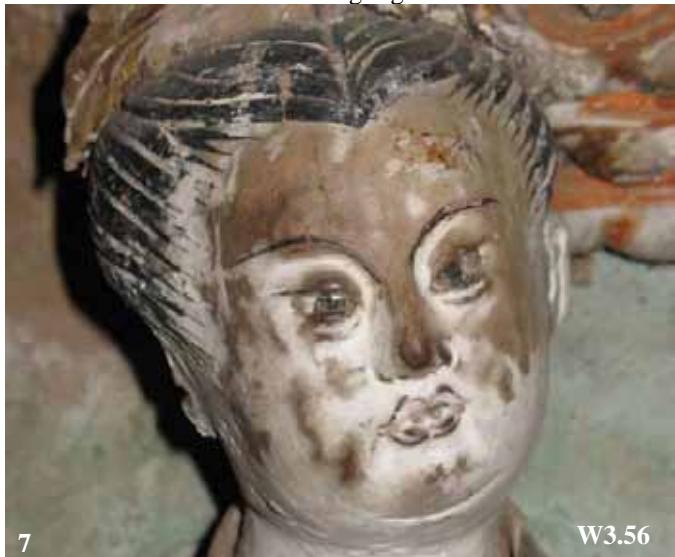
7
White face discoloured by unknown substances or influences
