Shuilu'an

Jahresbericht / Annual Report 2007-2009

**BMBF Forschungsprojekt / Research project
01GWS079**

Forschungsprojekt 01GWS079
„Deutsch-chinesische Zusammenarbeit im Kulturgüterschutz: Forschungen zum Erhalt
ausgewählter Denkmäler in der VR China“

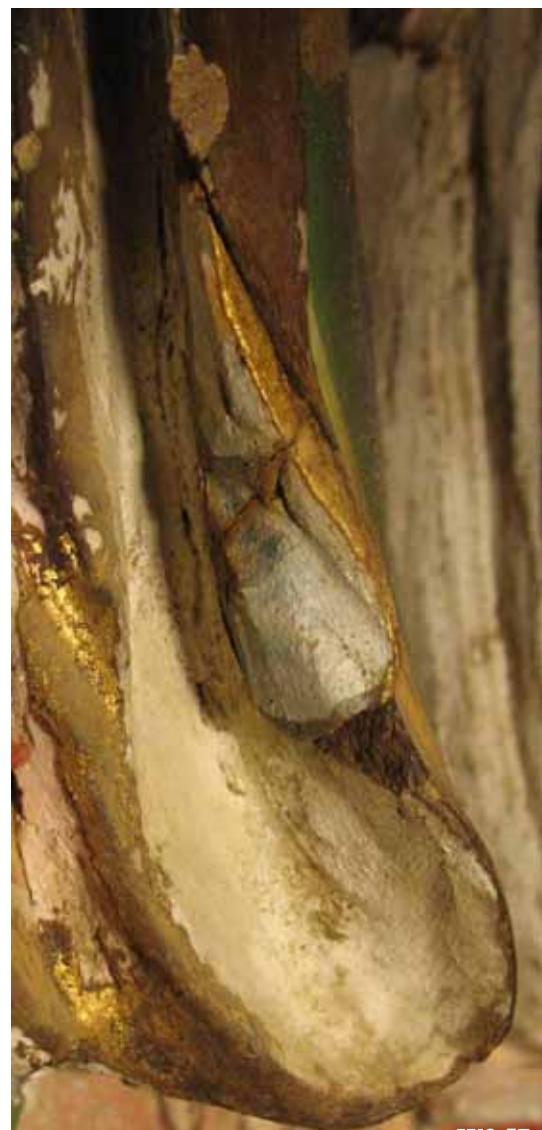
8
Light blue of the lining and bright gilding preserved on a broken-off piece of a sleeve

colours are only preserved in recessions and well-hidden parts. A broken-off part of the left sleeve of W3.57 was discovered behind the sculpture. On the sculpture, the gilding of the borders is tarnished or covered by a darkened, brown coating and the lining of the sleeve is white. On the discovered fragment, however, the gold is bright and clean and the lining is light blue (fig. 8). As a natural dyestuff indigo is not completely light fast and can fade. As no organic dyes were discovered in the yellow or light green however, the loss of light colours might also be caused by too extensive cleaning. Traces of extensive cleaning can be found on several sculptures where the rubbing resulted in scratches and losses of polychromy.

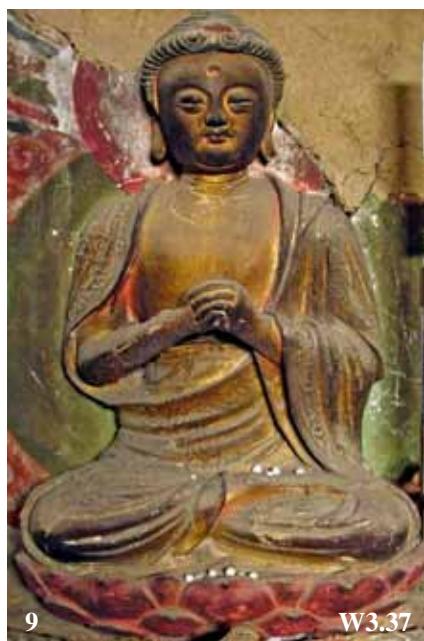
9

Today it is forbidden to bring burning incense sticks into the hall, but the sculptures still show traces of this former ritual use of the hall. Especially on the larger and on the more important sculptures the surfaces are darkened by soot. Often it is still recognisable that the incense sticks were placed below the sculptures, affecting the lower sides more than the upper ones (fig. 9). Only in deep recessions the original colouring still can be seen.

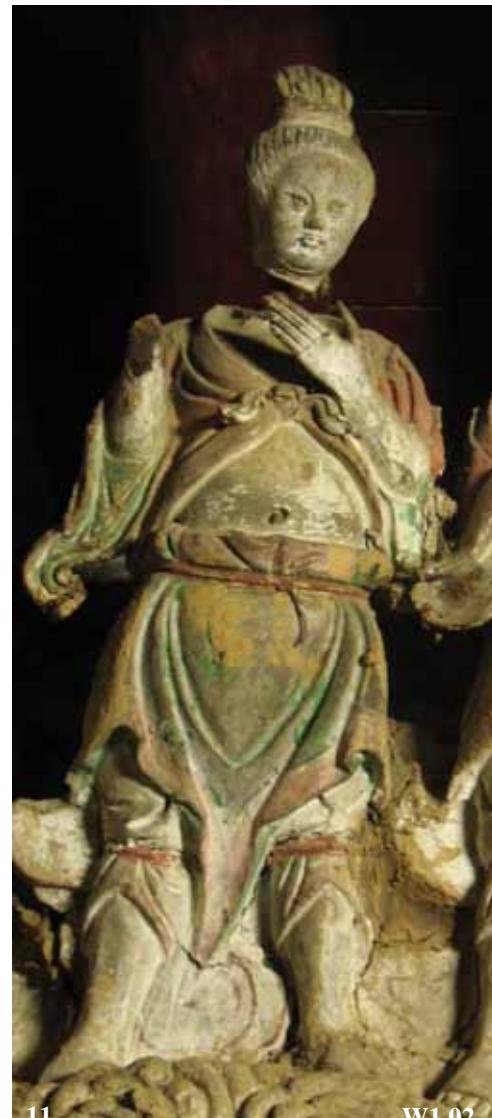
11

Clay marks from holding the sculpture with dirty hands on the green tunic
W1.02

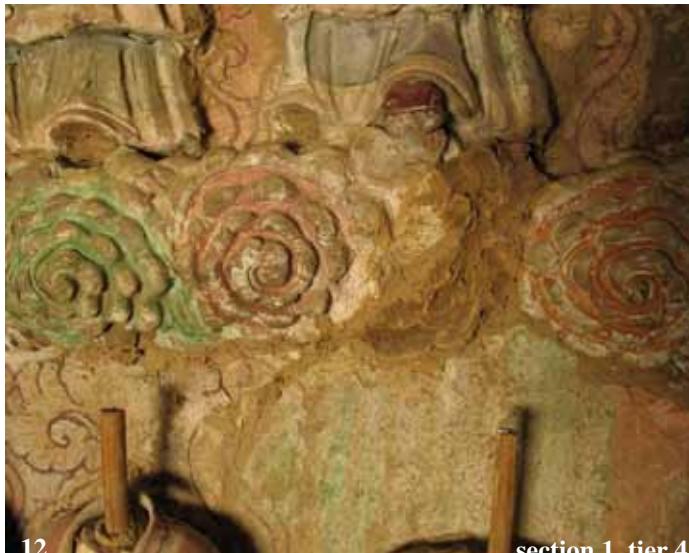
12

Fillings of gaps and reconstruction of cloud which overlapped and damaged the paint layer

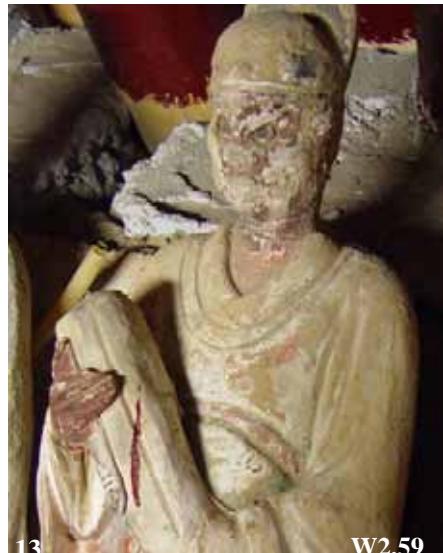
13

Numerous sculptures show tears and drips, sometimes also splashes of transparent material and red paint (fig. 13). These spots are caused by painting the beams and rafters of the hall without protecting the sculptured walls sufficiently. As the drips of red have different nuances and consistencies, the problem seems to have occurred repeatedly.

Tear of red paint which obviously dripped down during painting the rafters
W2.59

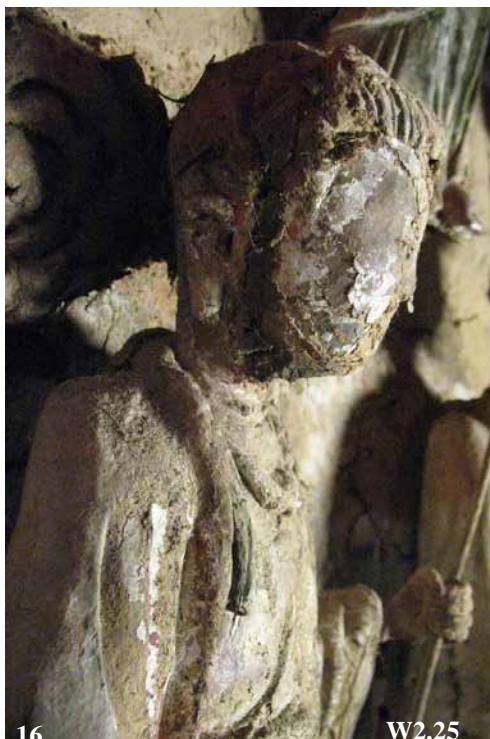
16

During the conservation work, the sequence of work steps normally meant that firstly the work was done which produced a lot of dust and dirt. Afterwards the area was cleaned. If more “dusty” work had to be done, the surrounding was protected by plastic foil or paper coverings. If possible consolidation of the paint layers was done *after* cleaning, to avoid consolidating the dirt as well, but often the polychromy was so fragile that consolidation of the most endangered parts had to be the first of all steps as cleaning with consolidation would have resulted in considerable losses (fig. 16).

Dust and loose polychromy; a flake of the polychromy hanging on the tip of the nose

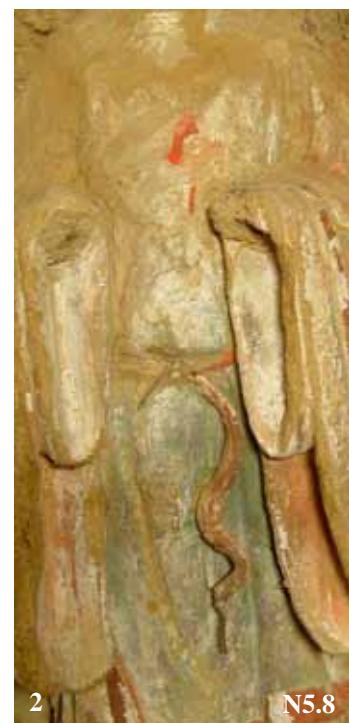
2
N5.8
Drip of red paint and traces of clay on a conserved sculpture

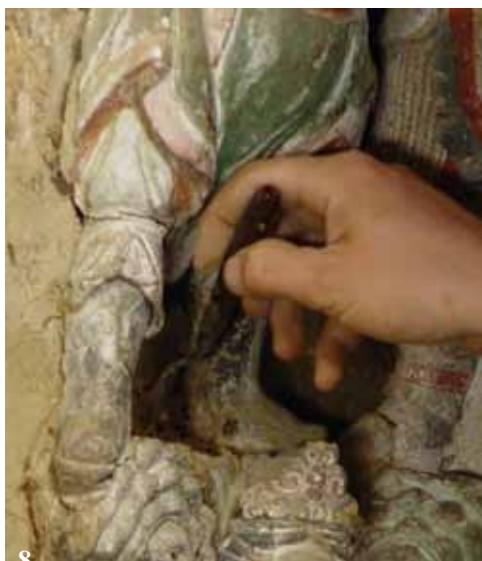
8

Larger spatula for clearing a cavity
(Siegfried Scheder)

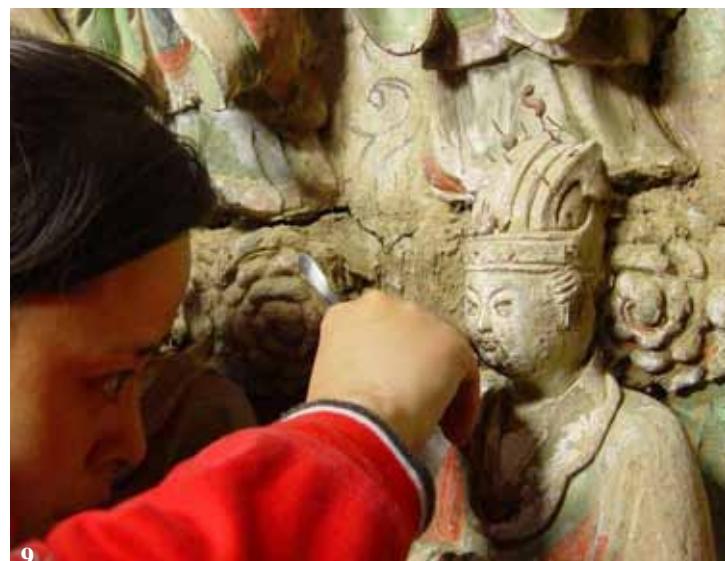
9

Removal of clay suspension from paint layer with small spatula
(Ma Linyan)

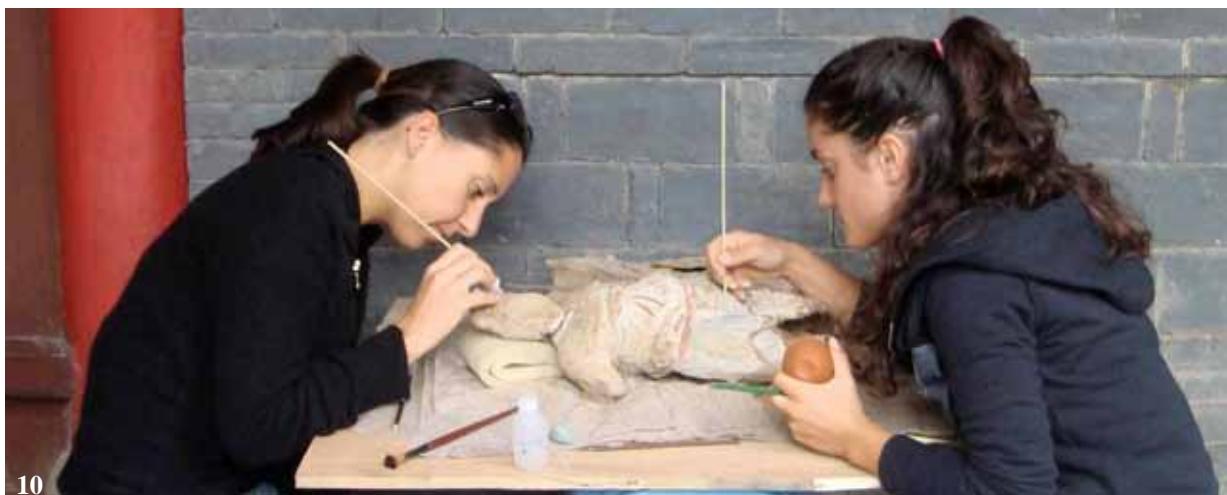
10

Removal of adhering clay with bamboo blades (Francesca Dominici and Valentina Furetto)

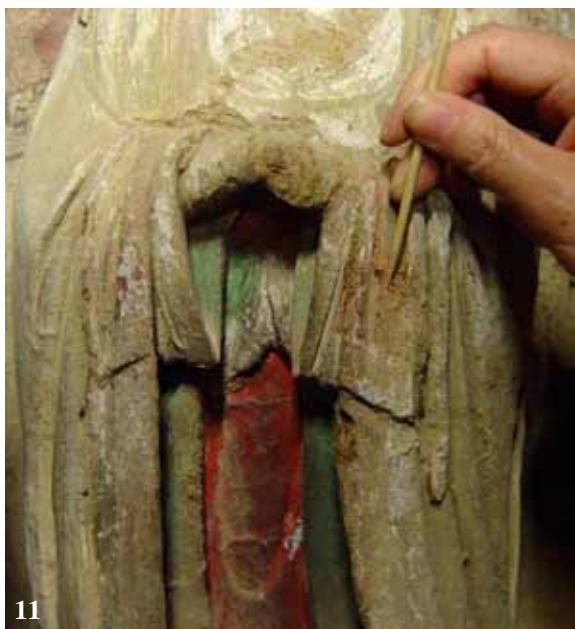
11

Removing clay residues with pointed bamboo stick
(Yang Qiuying)

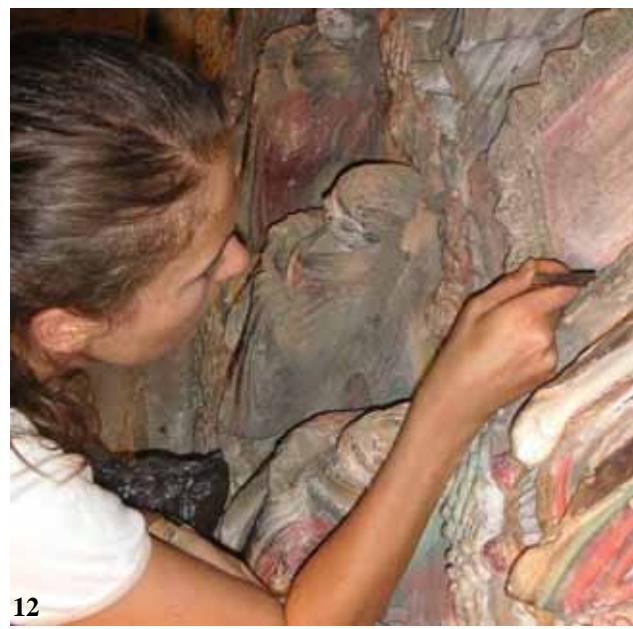
12

Thinning of persistent clay residues with scalpel
(Ina Meissner)

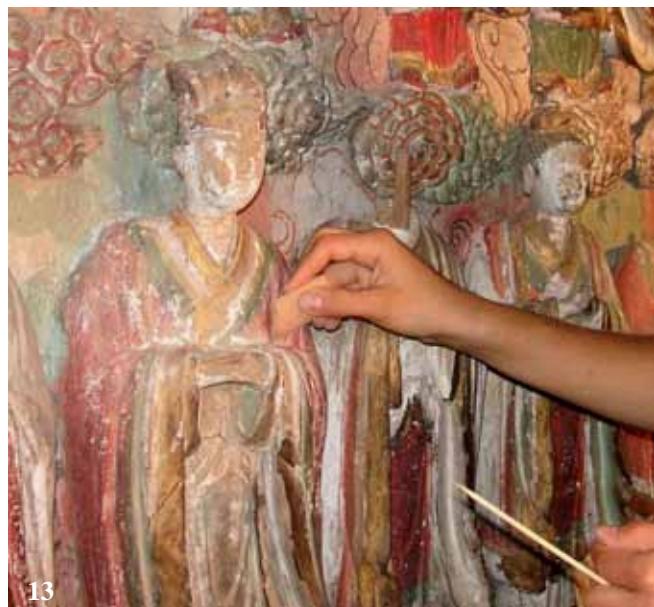
13

Cleaning with akapad® sponge and bamboo stick (Ina Meissner)

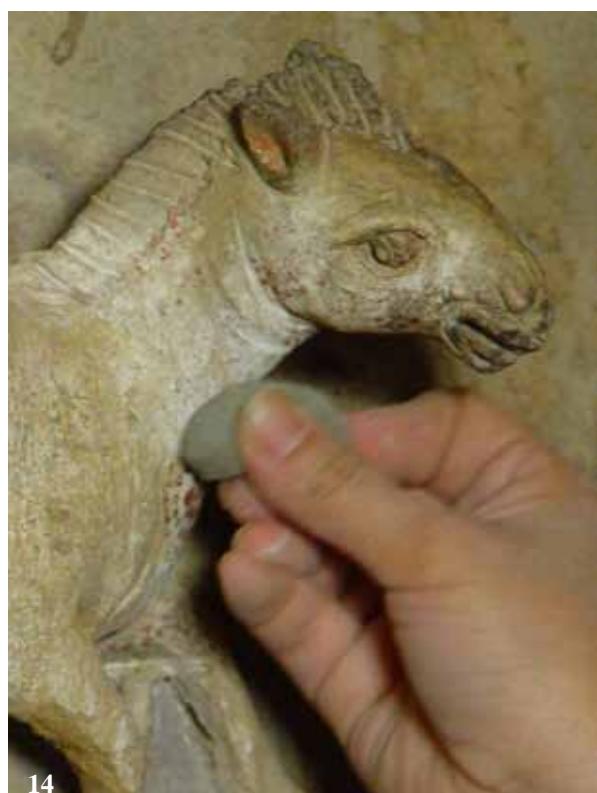
Gomma pane gave excellent results for removing fine dust from the surfaces (fig. 14 and 15), often giving the cleaned surfaces a fresh and bright look as also dust from small cavities in the surface can be removed. It can be used in different degrees of softness and stickiness. It is necessary to check that it does not stick to the surface. *Gomma pane* tends to leave small particles behind. Thus it is necessary to check and dust off again after using *gomma pane*. During the summer time it is advisable to store it in a refrigerator, because it dries out fast and gets too sticky when covered with plastic foil. As there is no refrigerator in the Shuili'an, the *gomma pane* was prepared freshly about every second day.

Cleaning a white horse by dabbing off with *gomma pane* (Liu Linxi)

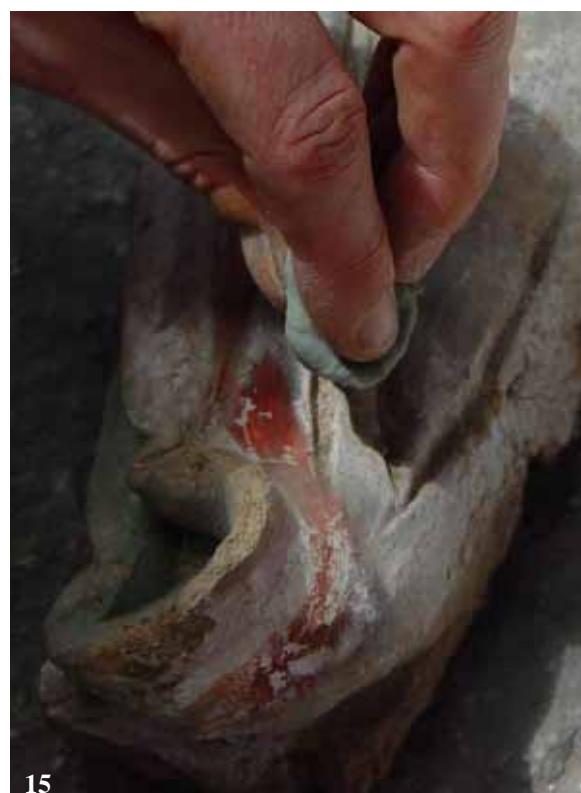
15

Test with *gomma pane* on the red polychromy of a fragment of a sculpture

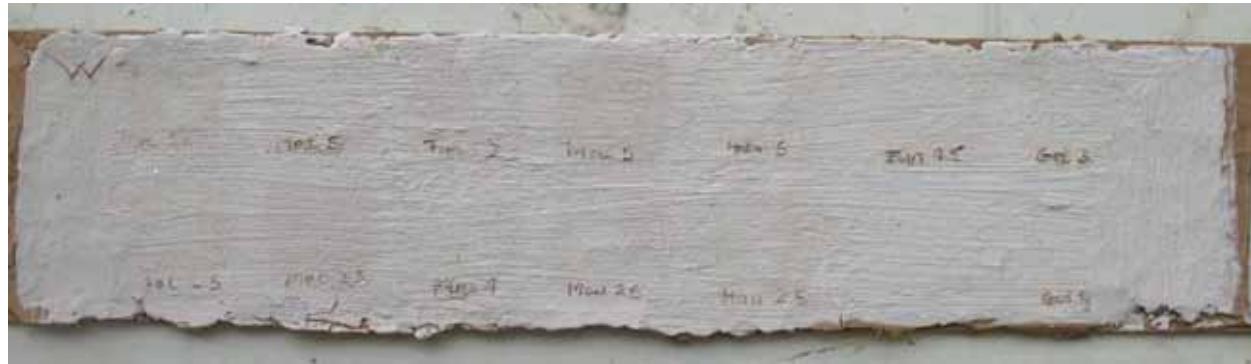
1

Overview of the test area with different consolidates. Priming with kaolin mixed with water.

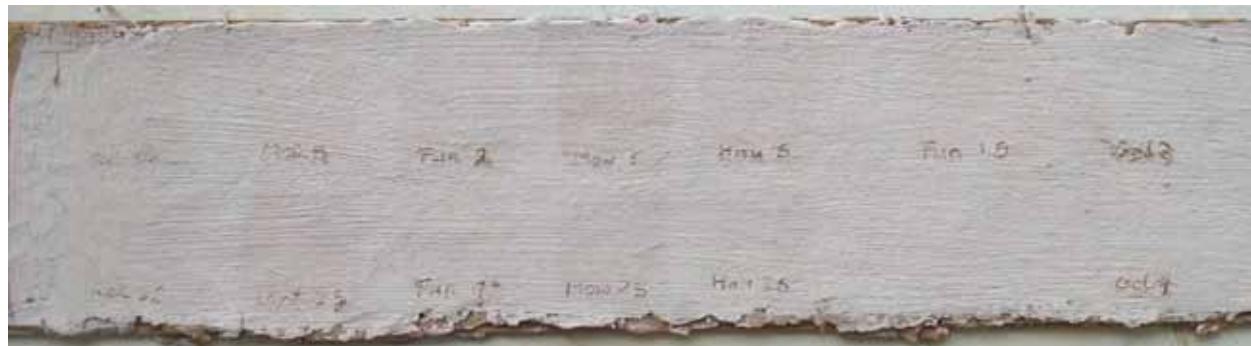
2

Overview of the test area with different consolidates. Kaolin-priming bound with 1% Tylose MH 300 (dissolved in water)

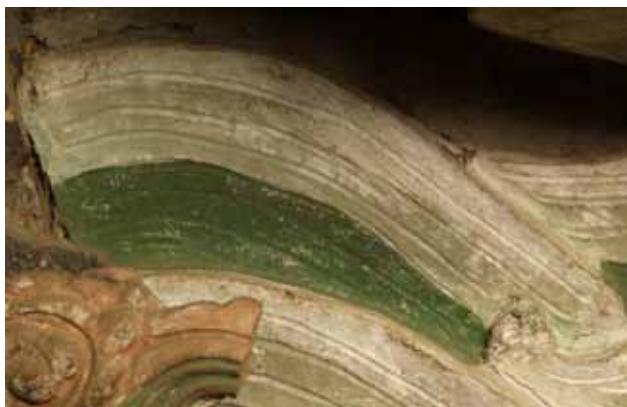
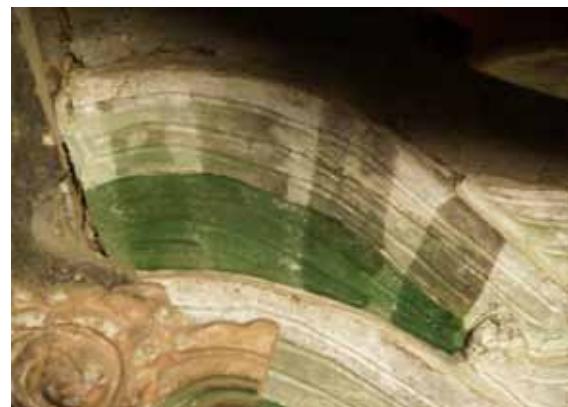
4

A test area was selected below the 1000-armed *guanyin* in the part representing the pond from which the lotus flower raises serving as seat for the *guanyin* (fig. 4). The surface was cleaned with *gomma pane*. It was treated from left to right with sturgeon glue 3%, gelatine 3 %, funori 1.5%, and for comparison with Mowiol 4-88 2.5 % (fig 4).

Cleaned test area

Application of consolidants (from left to right:
sturgeon glue 3%, gelatine 3%, funori 1,5%, Mowiol
4.88, 3%)

Test area in the lotus pond of the 1000-armed *guanyin*

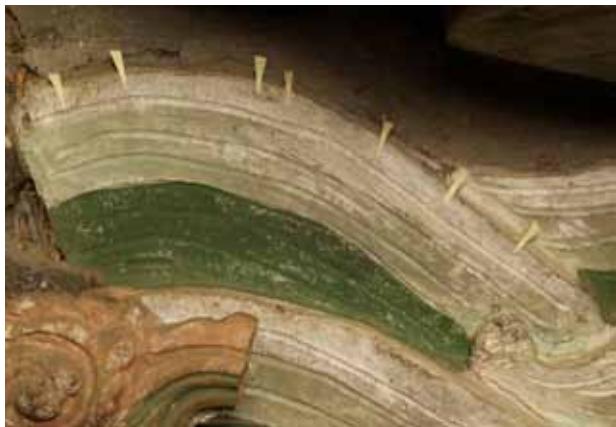
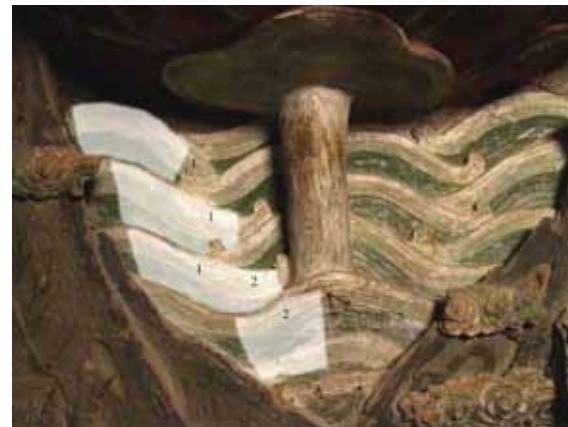
5

test area after consolidation

whole test area after consolidation tests

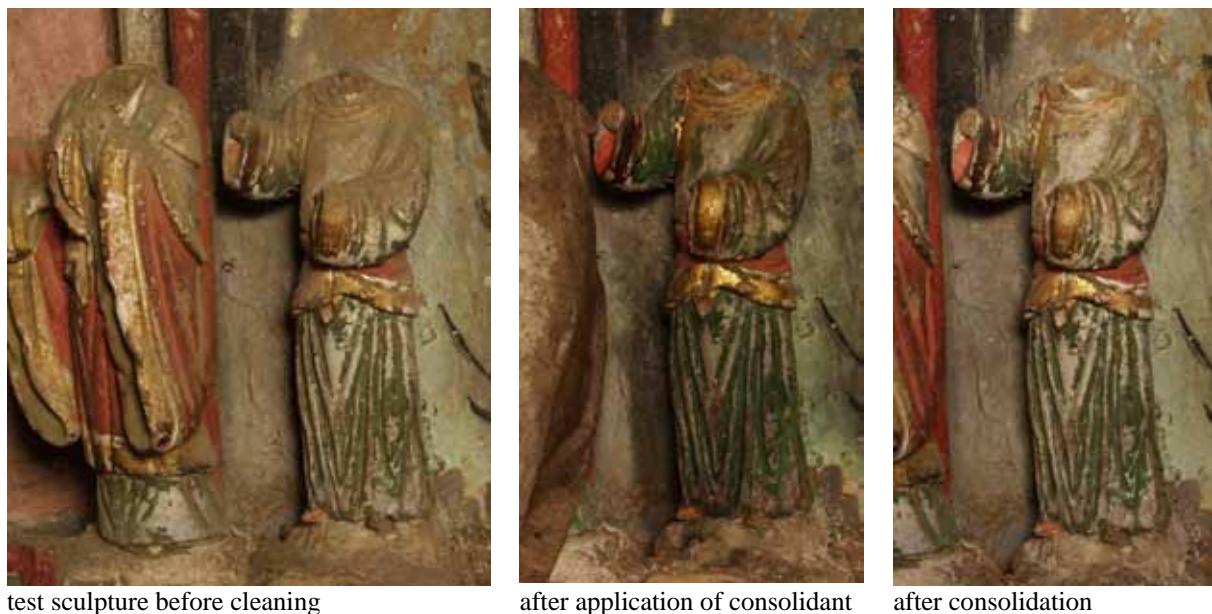
test sculpture before cleaning

after application of consolidant

after consolidation

6
Consolidation tests on the right sculpture

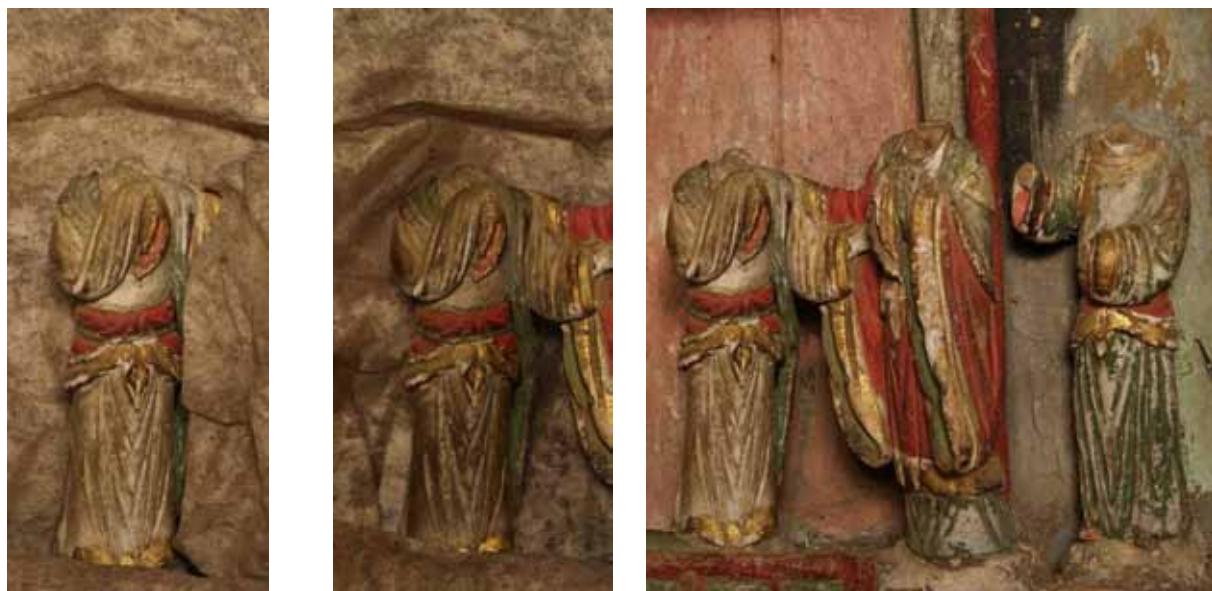
test sculpture before
application of consolidantafter application of
consolidant

after consolidation

7
Consolidation tests on the left sculpture

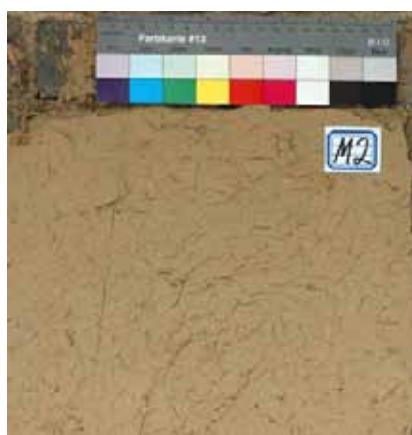
4
Mixture
M2, crack
system
comparable
to original
wall

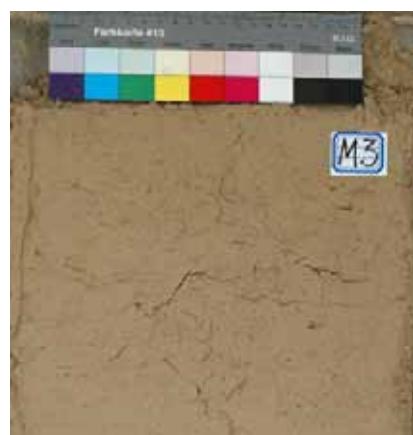
5
mixture M3
with fewer,
but larger
shrinkage
cracks

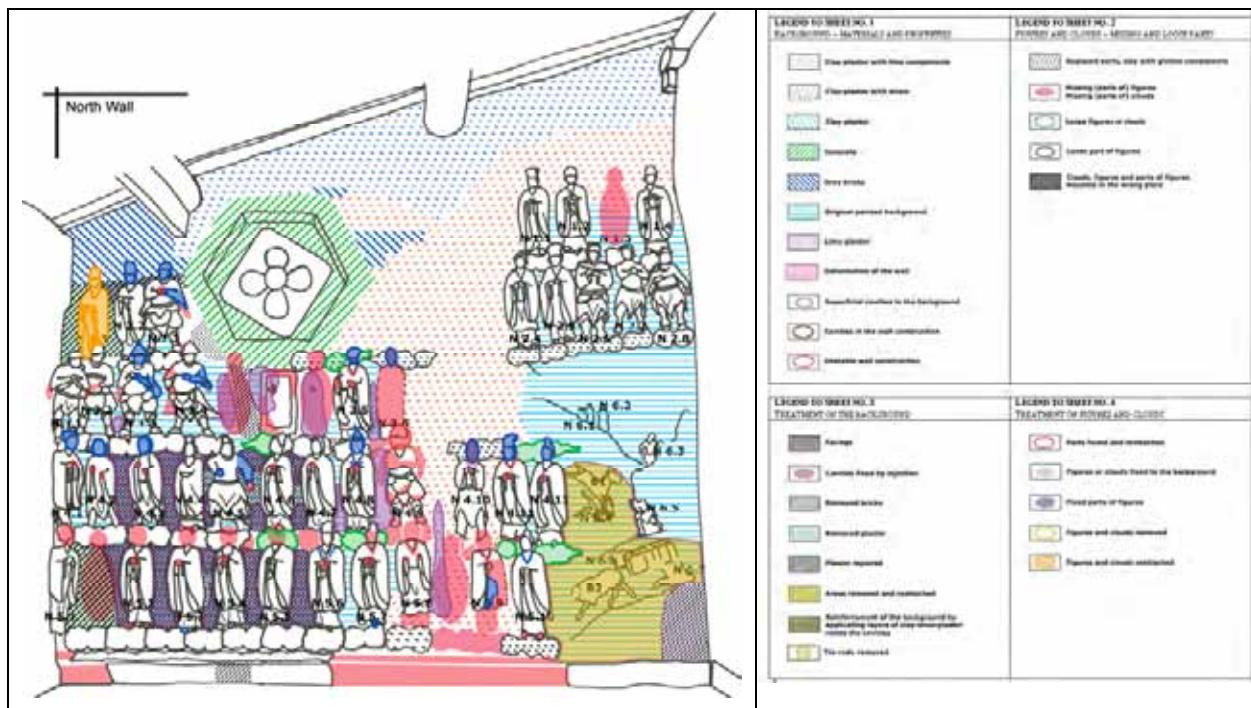
7

Mapping of condition and treatment (executed by Laura Thiemann); north wall with all information overlying and legend

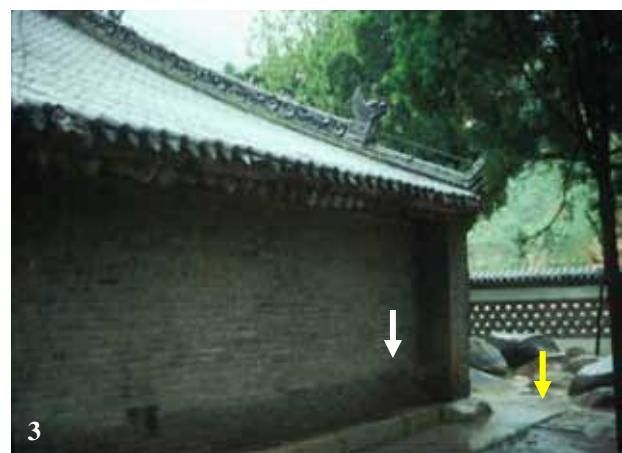
West wall on a rainy day in May 1998: wet lower part of wall (white arrow); concrete area around the wall (yellow arrow)

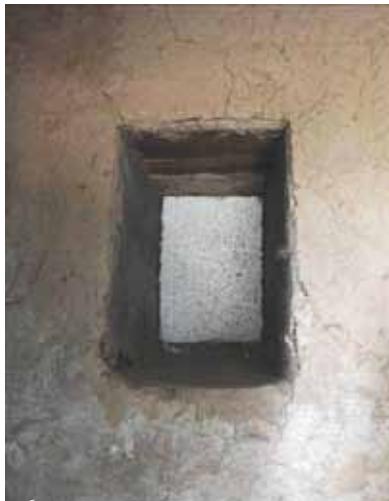
6

In April 2007 the windows were closed with polystyrene blocks to keep out dirt of the construction work (fig. 6). The polystyrene was inserted from the inside and thus was fully visible. Besides poor aesthetical properties, it tended to crumble spreading the surrounding with white pellets. In November 2008, wooden frames were attached on the outside of the windows (fig. 7). A dust- and water-proof polyethylene fleece (Tyvek[©] 1622E, DuPont company) was mounted on the frames (fig. 8). The fleece blocks the air stream, but allows the penetration of air and humidity.

Temporary closing with polystyrene block

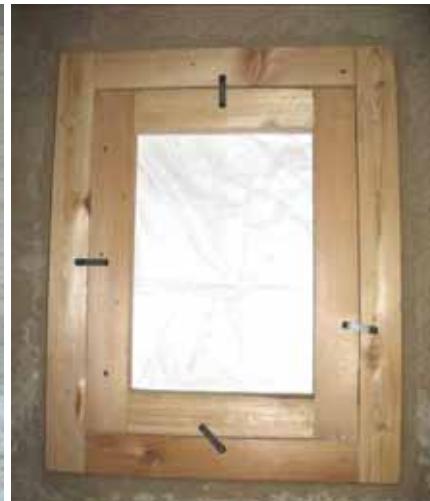
8

window after installation of fleece

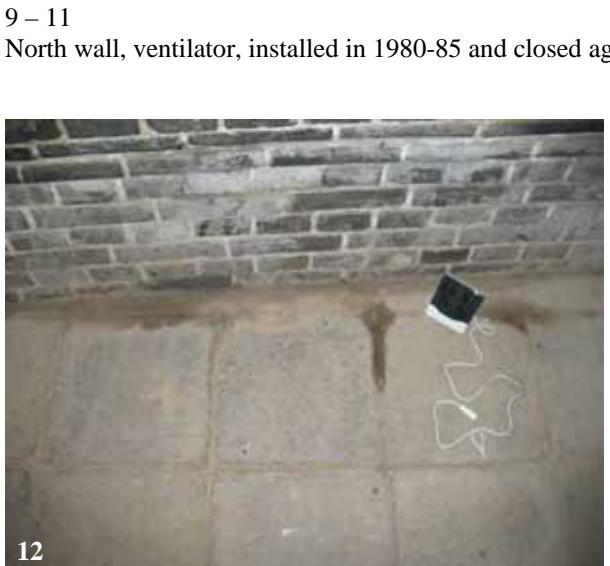
12

Since March 2008 a mysterious water spot has been observed in front the ‘accident scene’ on the north wall (fig. 1, * and fig. 12). The humidity seems to come out of the gap between two tiles. It never dries, but also did not change since then.

20 cm long water spot in front of the 'accident scene' of the north wall, western part.

During the three hours of rain the humidity increased about 3 %, reaching 82 % rh on the floor. The strange ‘water mark’ did not expand during rainy periods, but does not disappear in dry months either. If there is an underground water supply, this seems to be independent from outside precipitation.

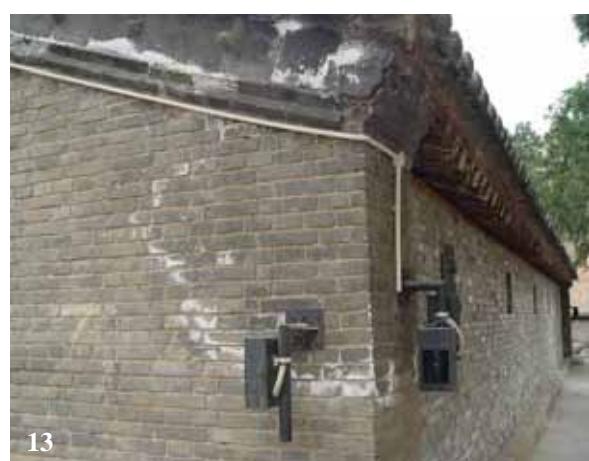
13

grids to keep animals and larger insects out, but as the spacing between the rafters are open, birds come in. The windows are staggered compared to the original ones (fig. 1, red and green squares), so daylight does not reach the original windows anymore. After the new wall was erected, salt efflorescences formed on the wall (fig. 13). They are probably caused by bricks or mortar with high salt content.

New protective wall in front of the west wall in June 2009; newly developed salt efflorescence on the revetment walls of the north side, probably caused by the salt inside the bricks of the new protective wall

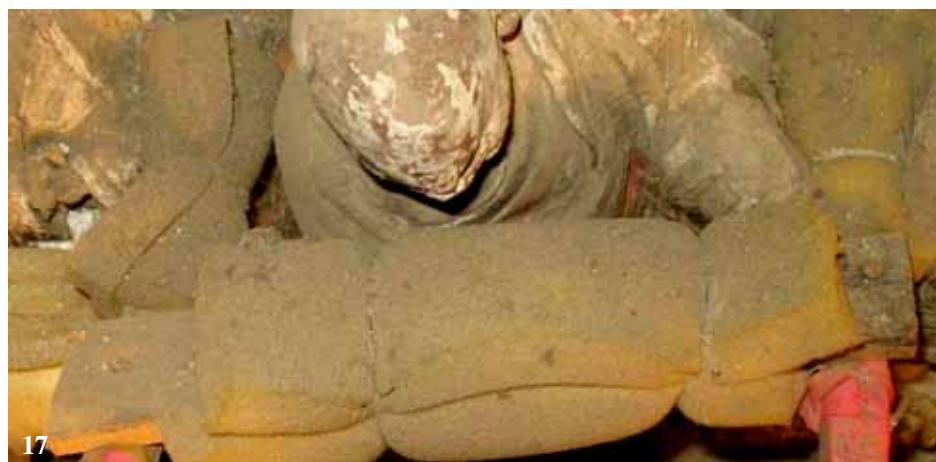
W4.30 (west wall, section 3), Oct. 17, 2007: The foam rubber upholstery around the wooden prop shows how much dust has accumulated since 2005.

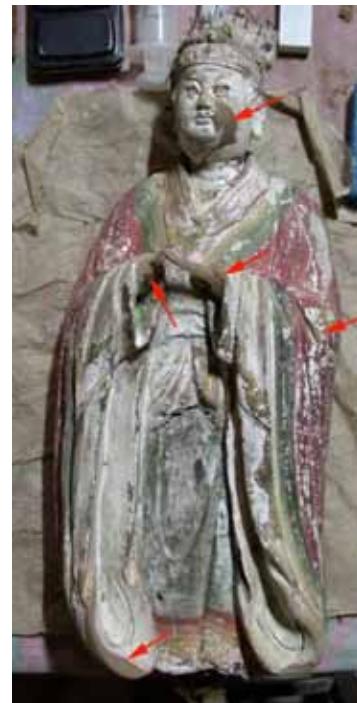
An der abgefallenen Figur W4.54a wurden Lehmbergänzungen getestet und so Fehlstellen an einer Ärmelkehre, im Gesicht und an den abgebrochenen Händen geschlossen. Auch dazu wurde der Feinlehm verwendet. Hierfür wurde der Untergrund gut angefeuchtet die Ergänzung schichtweise aufgebaut und an den Kontaktändern zum Original penibel angearbeitet. Nach einem Tag Trocknung zeigte sich eine partielle Haarrissbildung im Kontaktbereich. Deshalb wurde während der Austrocknung ein feuchtes Papier aufgelegt und die Fläche anschließend noch einmal geglättet. Kittungen aus ästhetischen Gründen wurden an den Wandabschnitten im Shuilu'an jedoch nicht ausgeführt.

1
W4.54a mit Teilergänzungen
(rote Pfeile)

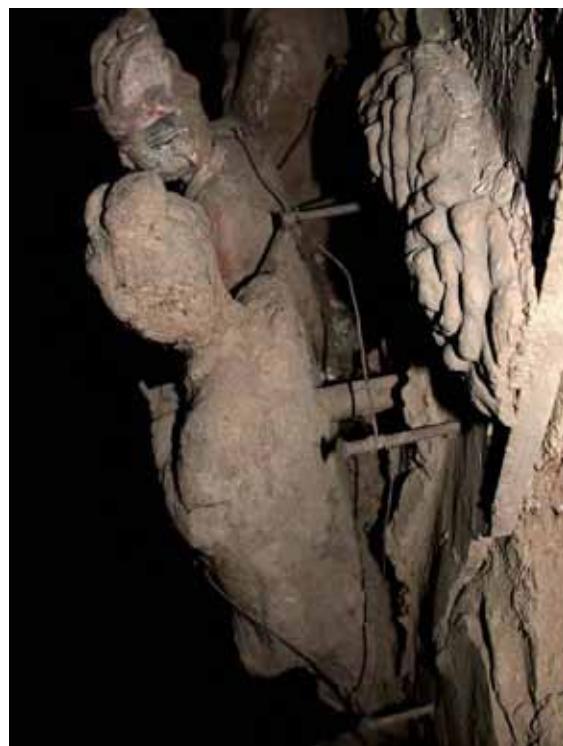
4

Notgesicherte Figuren von der Seite

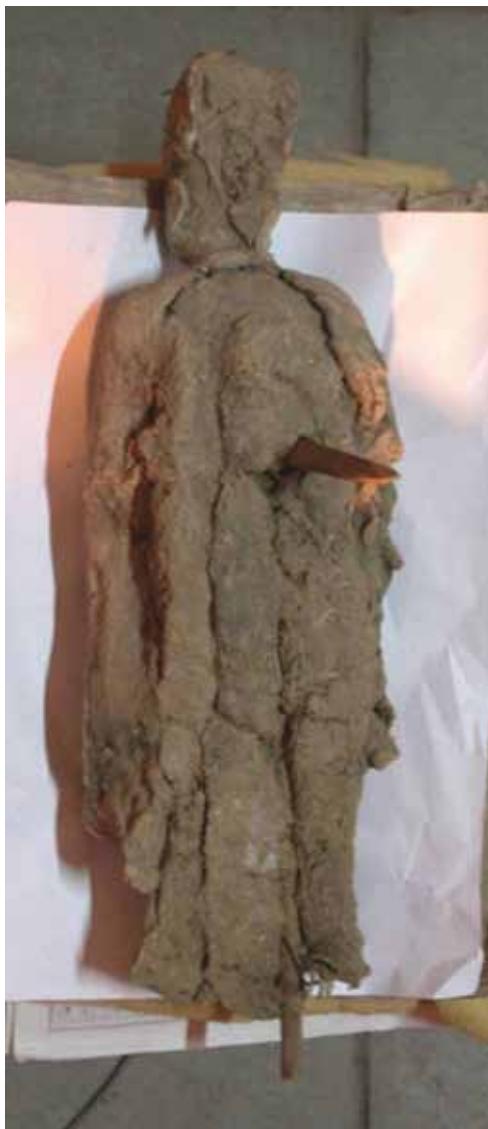
5

Figur W3.70: schadhafte Rückseite

Zur kraftschlüssigen Wiederbefestigung des Dübelsystems in der Figur wurde dieselbe Lehmmischung als dickflüssigerer Injektionsmörtel verwendet. Die gelockerten Dübel erhielten durch wieder einen festen Halt. Ebenso wurden Risse im Lehm mit Injektionsmörteln mit zunehmender Viskosität ausgespritzt. An der Figur 3.71 wurde dafür zunächst der alte Versatzmörtel (von einer vorangehenden Restaurierung, vermutlich 1981-85) abgenommen.

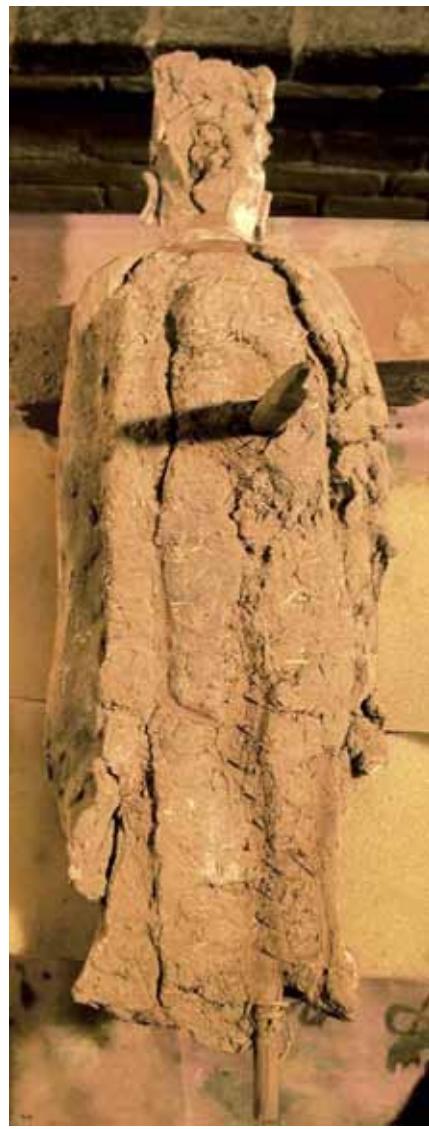
6

Figur W.370: Verpresste Hohlräume mit gekittetem Rissbild unter Oberflächenniveau

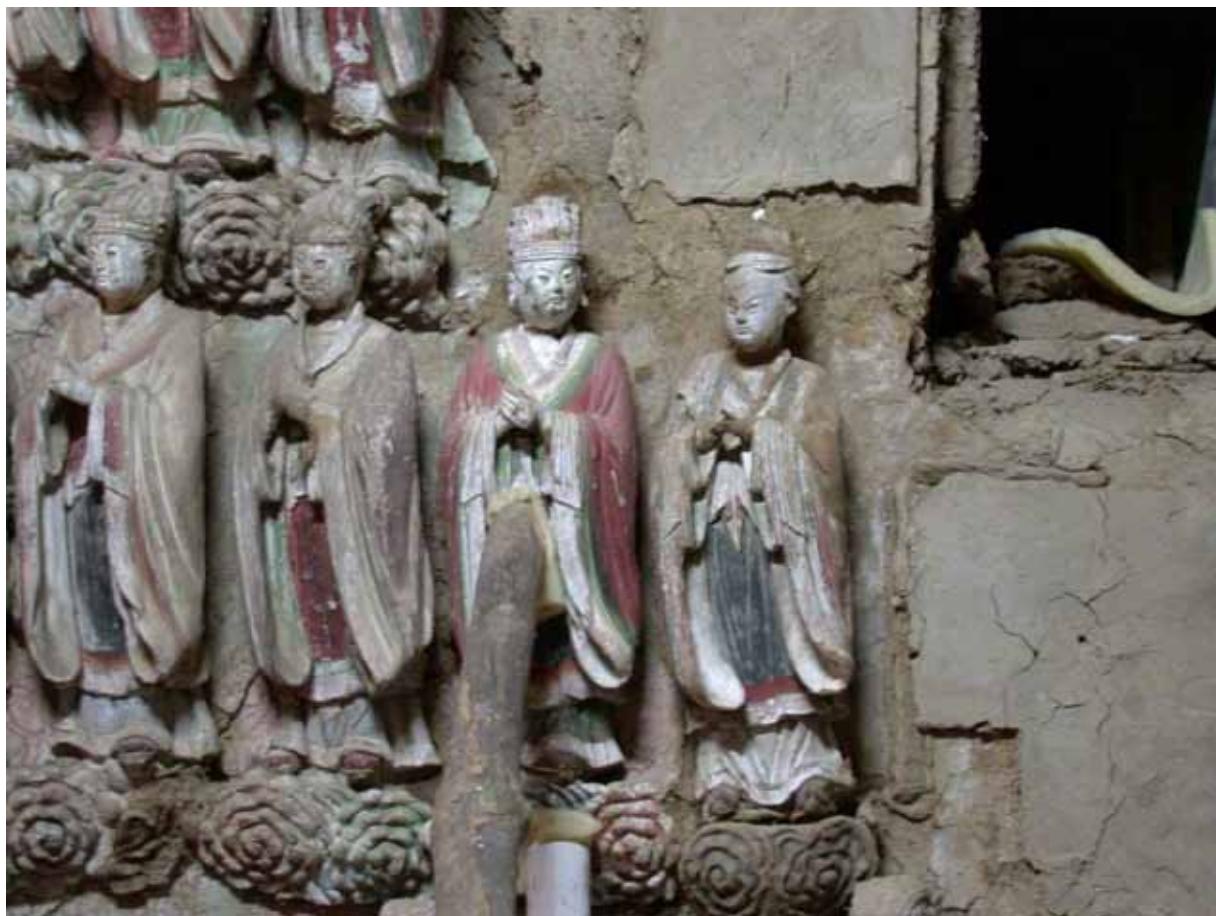
7

Neuversatz der konservierten Figuren in der Testfläche. Der unmittelbare Hintergrund der Figuren ist freigelegt. Rechts neben W3.71 ist der Rand des noch überputzten Rahmens eines beschädigten Schriftfeldes zu erkennen.

Die Figur W3.71 war während einer früheren Restaurierung an eine andere Position versetzt worden. Da gewünscht wurde, die Figur wieder anzubringen, wurde entschieden, sie nicht kraftschlüssig mit der Wand zu verbinden, so dass sie wieder abgenommen werden kann. Der Dübel wurde deshalb mit Korkstückchen verkeilt. Im Fußbereich wurde eine Sicherung mit einem aufschraubbaren Metallband angebracht, das verdeckt hinter der (ergänzten) Wolkenkonsole sitzt. Auf diese Weise ist auch eine temporäre Wiederbefestigung falsch positionierter Figuren möglich. Bei einer Gesamtmaßnahme können diese schnell wieder abgenommen werden, um sie an ihrer ursprünglichen Stelle wieder zu befestigen.

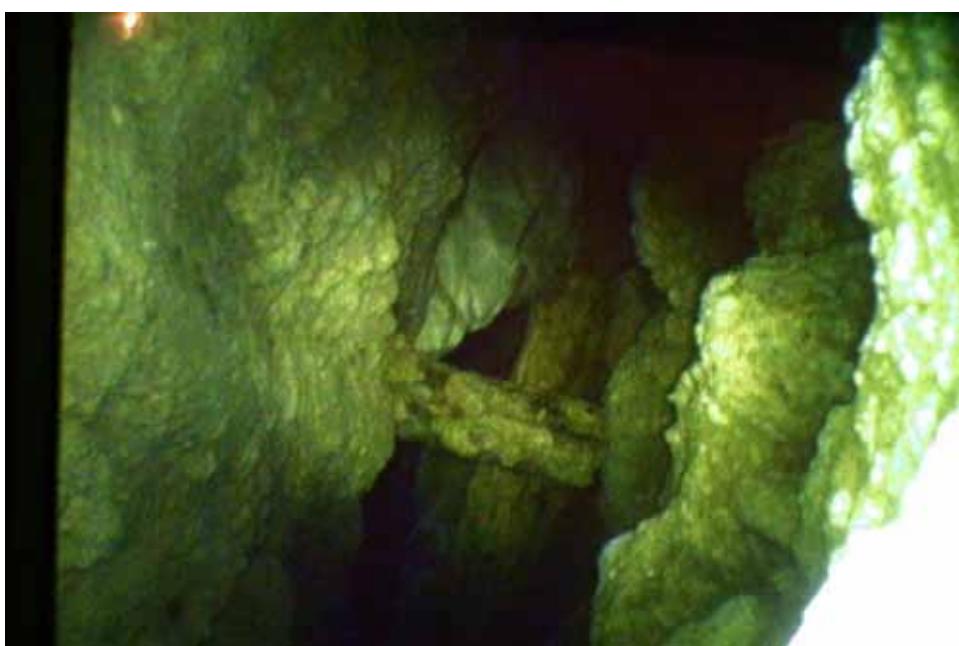
2

Endoskop-Aufnahme: Links die Rückseite des Wandputzes, in der Mitte ein Holzdübel

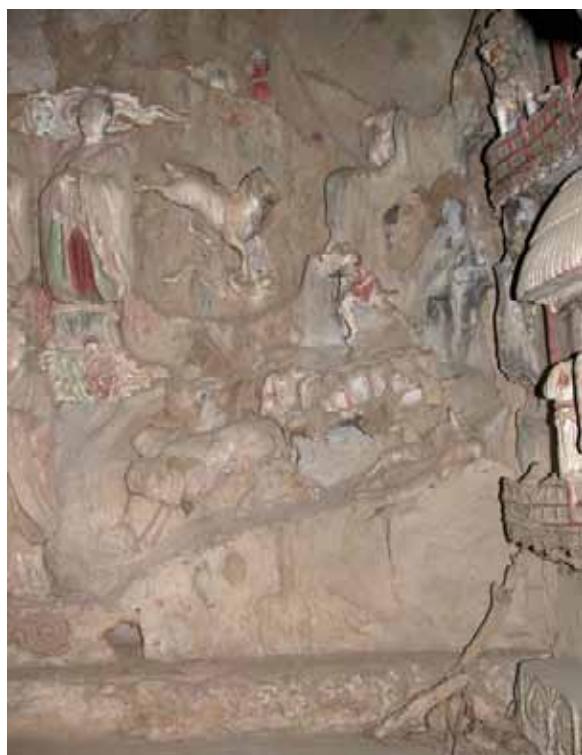
8

Unfallszene vor Beginn der Maßnahmen
Der gesamte sichtbare Bereich liegt hohl.
Die untere rechte Ecke ist eine überputzte
Vermauerung.

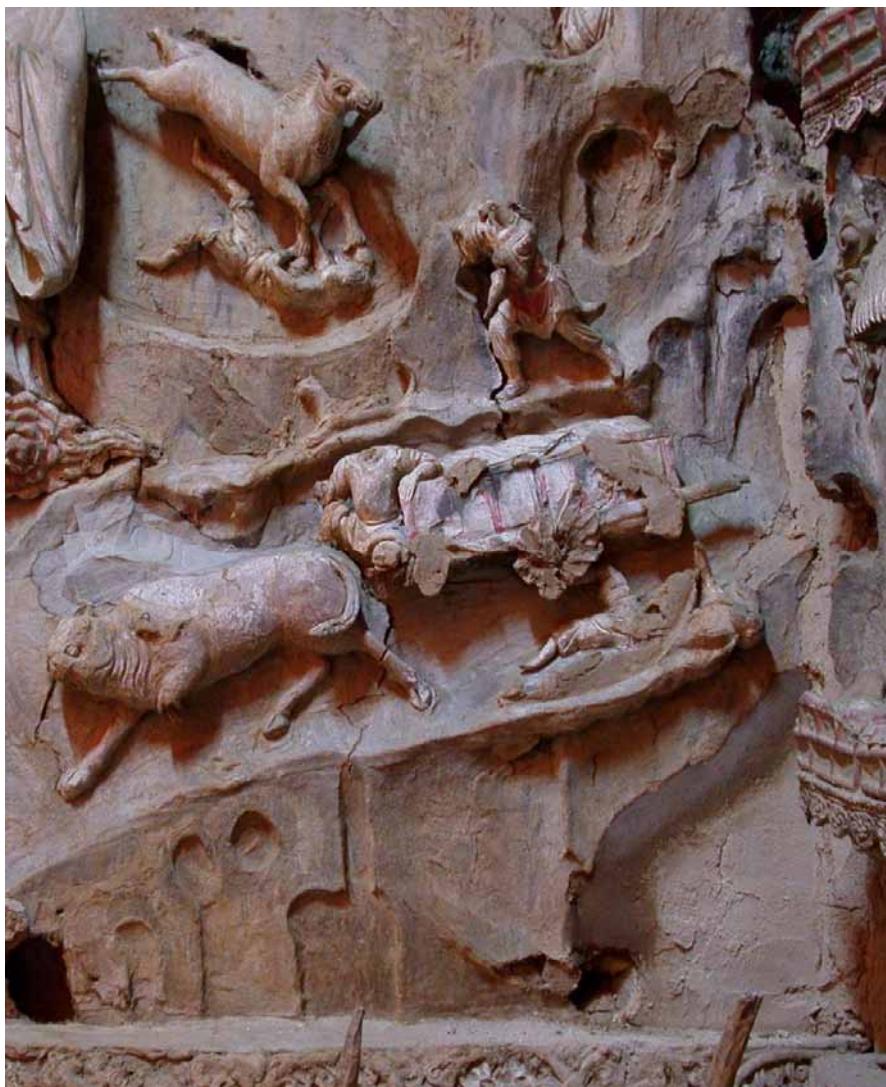
9

Testfläche 2 im gereinigten Zustand vor den Maßnahmen 2002. Überputzungen sind abgenommen worden, die Neuputzung angeböschkt und ein freigelegtes Loch mit Japanpapier kaschiert.

Nach der Freilegung wurde die über Niveau liegende Neuputzfläche der Ausmauerung angeböschkt. Die dabei entstanden körnige Oberfläche der Böschung wurde mit Lehmputz an den Randbereich des originalen Bestandes angearbeitet.

Um den freigelegten Bereich des Loches oberhalb der Wangenszene optisch zurückzudrängen, wurde diese temporär geschlossen. Hierfür wurden mehrschichtig Japanpapierstücke überlappend mit @Glutolinleim verklebt. Abschließend wurde die Papierfläche farblich in die umgebende Szenerie integriert.

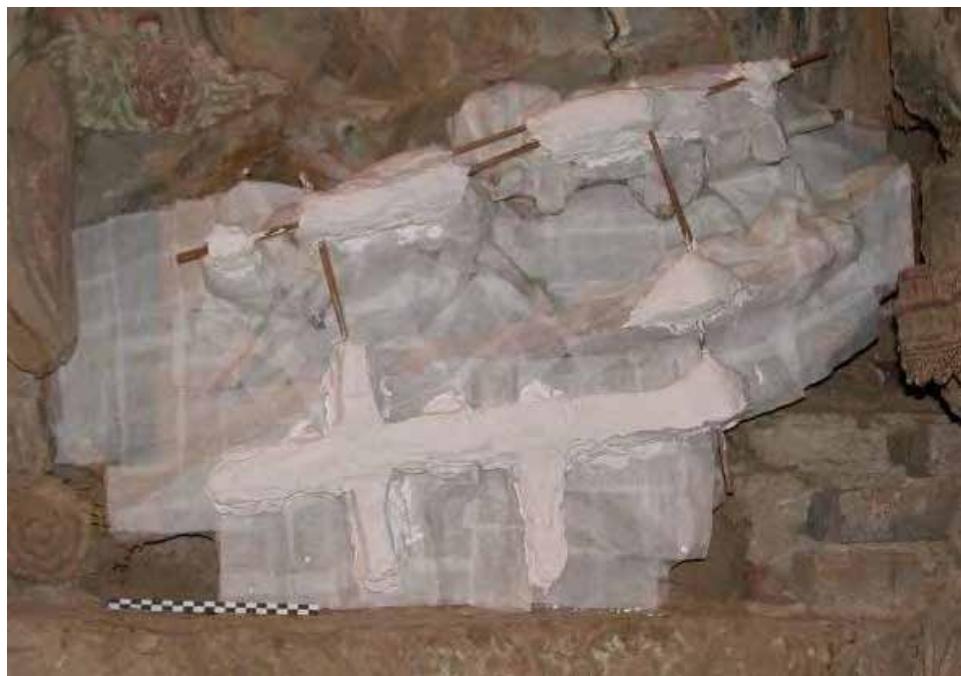
10
Abnahme des Reliefs:
Aufbringung eines
Stützgerüsts

Nach dem Test für ein Stützgerüst an einem Lehmziegel wurde die Reliefplatte zur Abnahme vorbereitet. Die Oberfläche wurde mit Japanpapier abgeklebt und darauf mit Gips ein Stützgerüst aufgebaut. Als Armierungssystem wurden Essstäbchen aus Bambus verwendet (Abb.). Anschließend wurde das Relief mit einem feinen Sägeblatt mit zwei kurzen Schnitten oben und einem längeren über dem Sockel von der Wand getrennt und abgenommen.

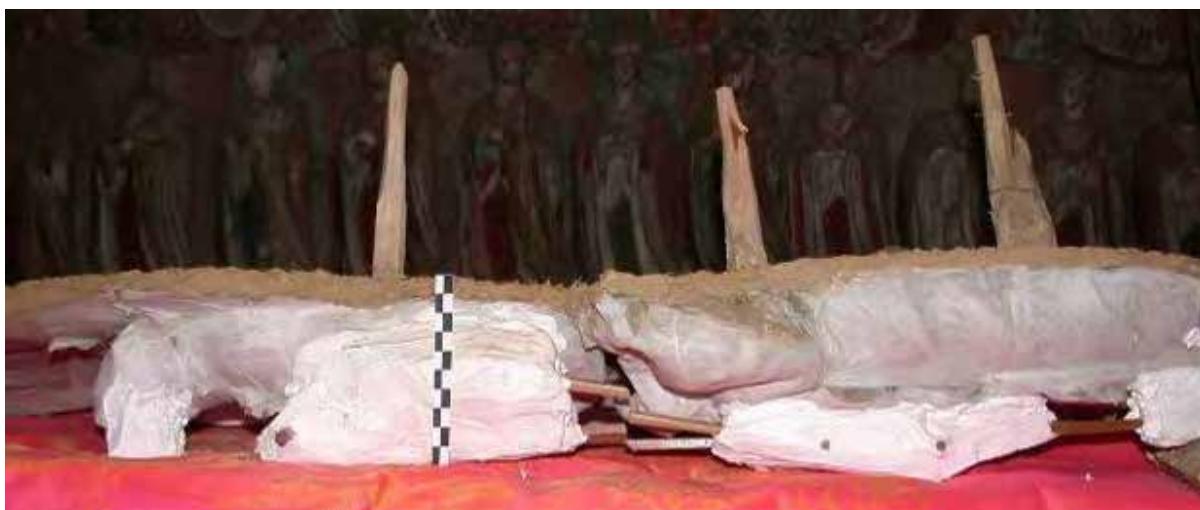
11

Begradigung des Reliefs

Das Relief wurde auf der Vorderseite liegend, von der Rückseite her bearbeitet. Als erstes wurde die Rückseite vorsichtig befeuchtet. Die Zunahme des Gewichts und die Erweichung des Lehms führten zu einer Rückformung der Reliefplatte durch ihr Eigengewicht. Während der Maßnahme wurden die Essstäbchen des Stützgerüsts durchgesägt, um eine Rückverformung zuzulassen. Es ergab sich eine Begradigung von mehr als 1 cm (Abb.). Das Relief konnte, auf der Vorderseite liegend und von der Rückseite, durch sein Eigengewicht zurückgeformt werden. Danach wurde der lose Lehm von der Rückseite entfernt und mit Lehmputz ergänzt. Die gebrochenen Dübel wurden durch neue, längere Holzdübel ersetzt, die mit Lehmsuspension eingesetzt wurden.

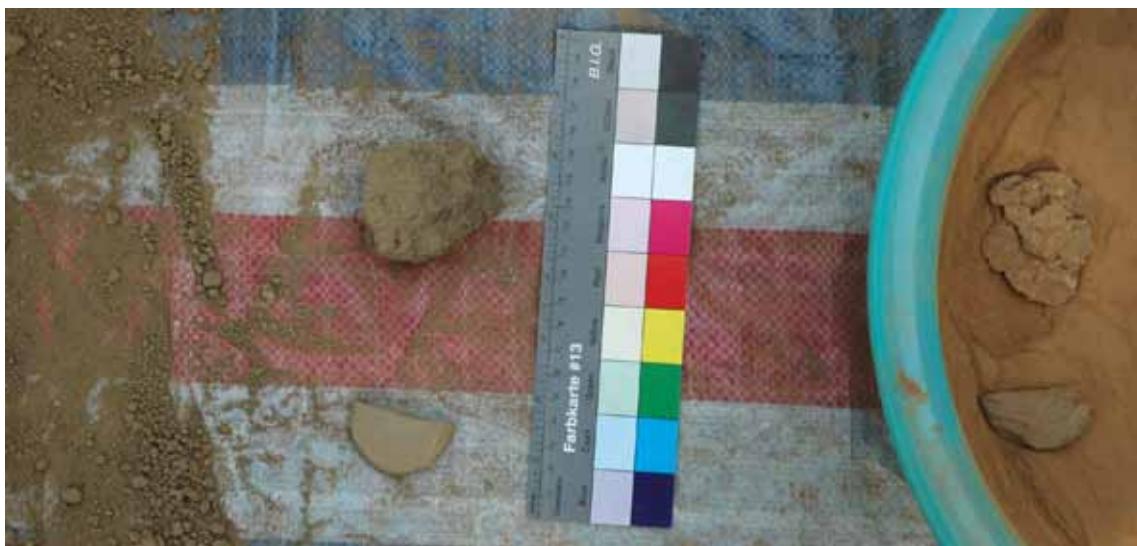
1

Optisch-haptische Prüfung der Lösserde. Die Mörtelscheiben wurden in der Mitte auseinander gebrochen. Links im Bild die „schwarze Erde“ für Wandputze, ein Prüfkörper für Mauermörtel mit Granulatzugabe und Bruchstücke eines ursprünglichen Lehmziegels. Rechts in der Schüssel die gesiebte „gelbe Erde“ für Injektions- und Klebemörtel mit gebrochenem Prüfkörper (unten) und Fragment des ursprünglichen Grundputzes (oben).

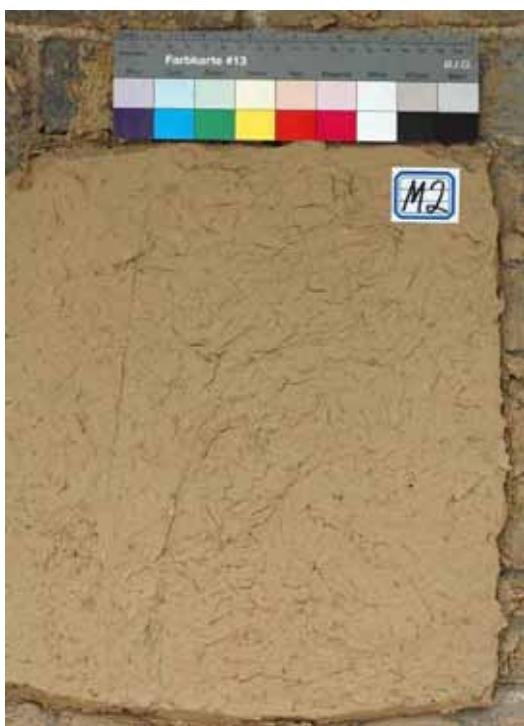
2

Lehmstrohputz mit gleichmäßigen Rissystem (1cm stark), dem ursprünglichen Wandputz vergleichbar.

Testflächen mit den Wandputzen M2 und M3 zeigten, dass M2 in seinem Rissbild dem des ursprünglichen Wandputzes entspricht und somit das traditionelle Rezept von Herrn Xu vielleicht dem der Ming-Zeit entspricht.
