Shuilu'an

Jahresbericht / Annual Report 2007-2009

**BMBF Forschungsprojekt / Research project
01GWS079**

Forschungsprojekt 01GWS079
„Deutsch-chinesische Zusammenarbeit im Kulturgüterschutz: Forschungen zum Erhalt
ausgewählter Denkmäler in der VR China“

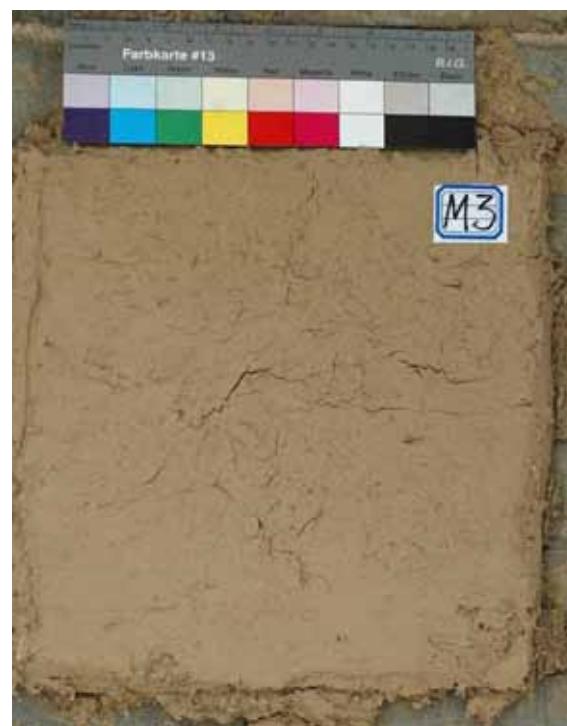
3

Lehmstrohsandputz mit mittigen Rissen größerem Spaltmaßes (1,5cm stark).

Testflächen mit den Wandputzen M2 und M3 zeigten, dass M2 in seinem Rissbild dem des ursprünglichen Wandputzes entspricht und somit das traditionelle Rezept von Herrn Xu vielleicht dem der Ming-Zeit entspricht.

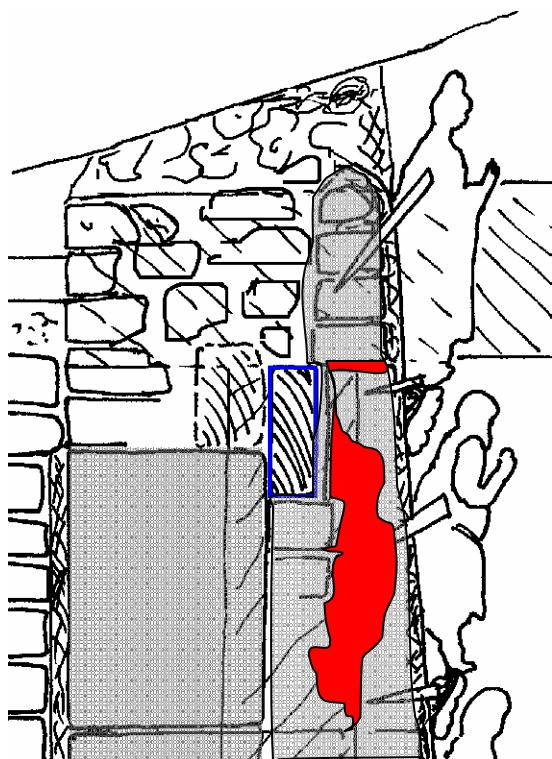
Die größeren Ziegel der oberen vier Ziegellagen waren fast alle gebrochen und zur Wand hin im Niveau stark verschoben. Sie wurden deshalb ausgebaut.

1
Westwand, oberstes Register, Situation 2007
Grau: Ursprüngliche Wandsubstanz
Blau: erhaltener Sturzriegel
Rot: Bruch und Hohlstelle in der Wand

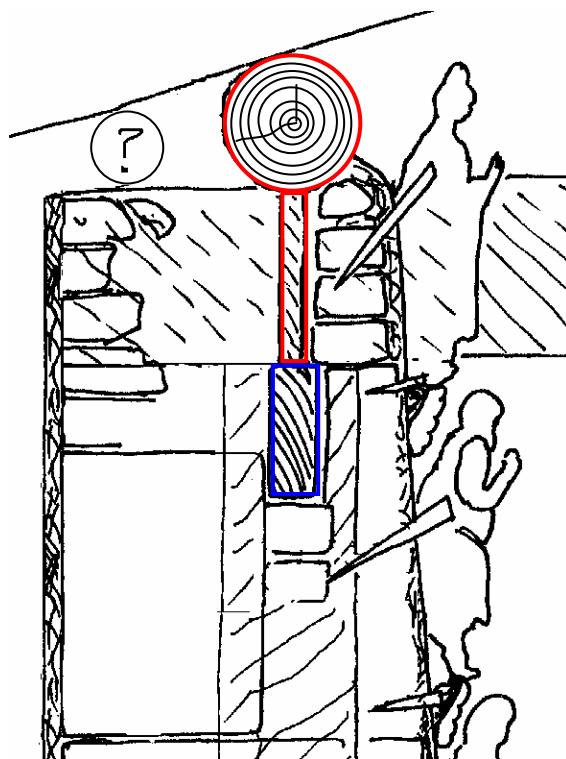
2
Rekonstruktion der ursprünglichen Mauerkrone und der Traufpfette mit doppelstöckigem Sturzriegel
Holz Lehmziegel

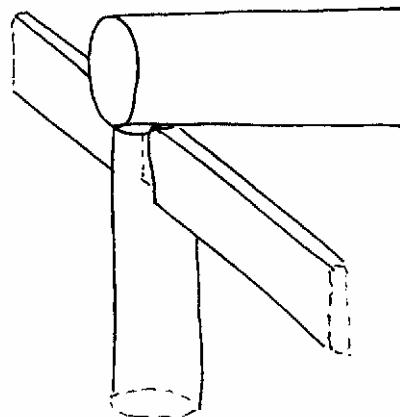
3
Westwand, erhaltene Holzkonstruktion

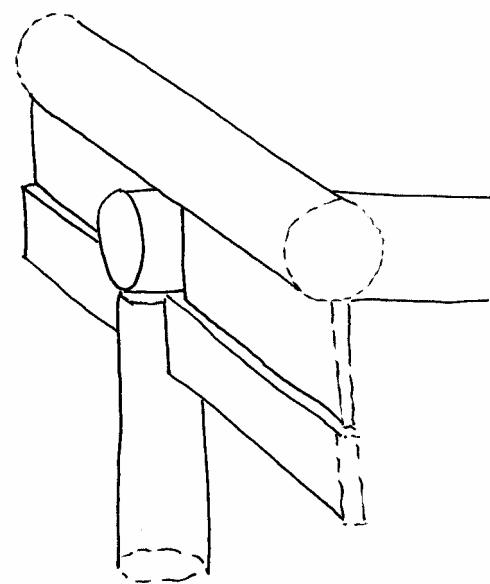
4
Rekonstruktion der ursprünglichen Traufpfette mit doppelstöckigem Sturzriegel

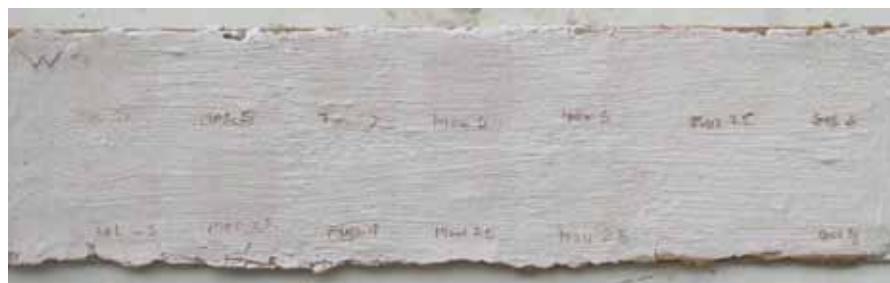
1

Probeplatte für Malschichtfestigung mit Aufstrichen und nachgestellte Figur für Tests zur Sprühfestigung

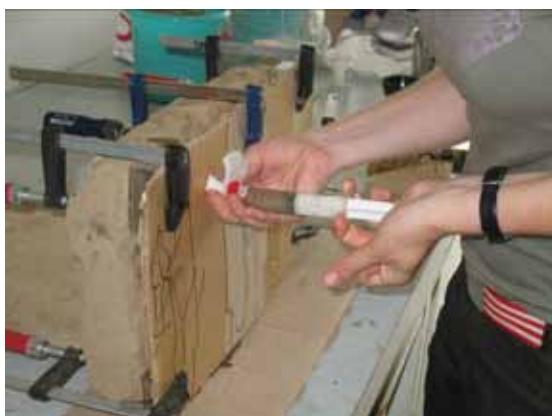
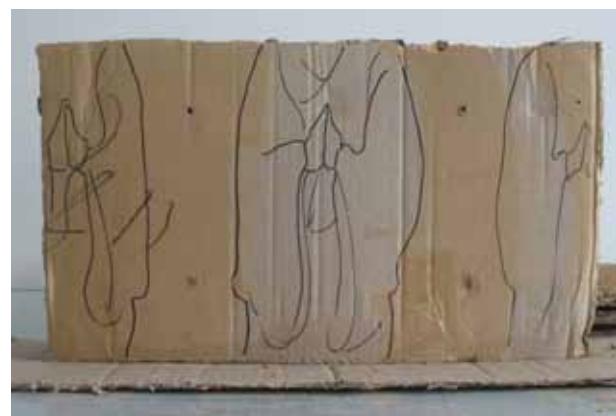
2

Tests zur Hohlraumüberbrückung in der Wand mit Hinterfüllmörtel, Wandmodell: Die Fläche wird an vier Punkte durch Mörtelstempel gesichert.

Vornetzen mit 0.5 % Tylose mit Spritze und verschiedenen umgebogenen Kanülen, je 20 ml. 4 bis 5 20ml-Spritzen mit Lehm (ca. 80 ml) eingespritzt, bis sich ein Stempel bildet und Lehm aus dem Einspritzloch quillt.

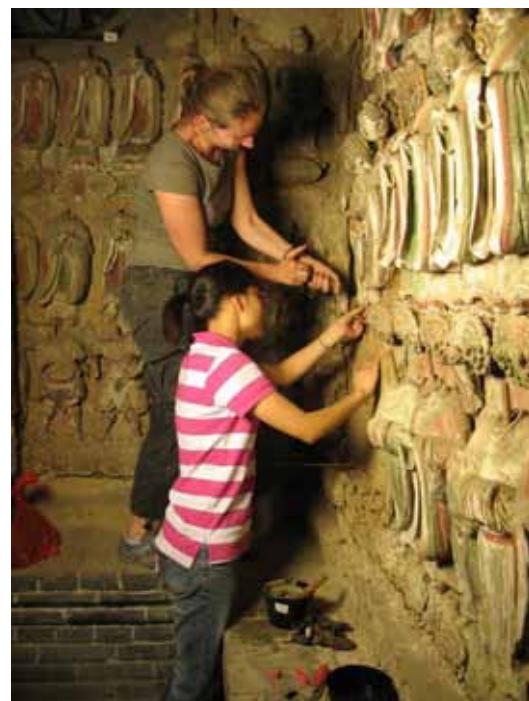
4

Hinterfüllen an der Testfläche

In der Südwestecke an der Westwand unterhalb des Fensters im 4. Register Überputzung entfernt, um Hinterfüllung zu testen. Die Ersatzwolken unter 3.3 und 3.4 dabei auch abgenommen und eingelagert (Unterbau viel zu dick mit *mazhi*-Lehm). An der Wandfläche 1985er Putz mit Stroh/Dreschrückständen und Kalk, daneben auch reiner Strohlehmputz und *mazhi*-Lehm verwendet. Darunter Reste von (bemaltem) Feinputz und Grundputz. Dübellöcher freigelegt und somit Position der drei fehlenden Figuren rekonstruierbar. 17:30-18:10: Erste Versuche zum Hinterfüllen in der Fläche.

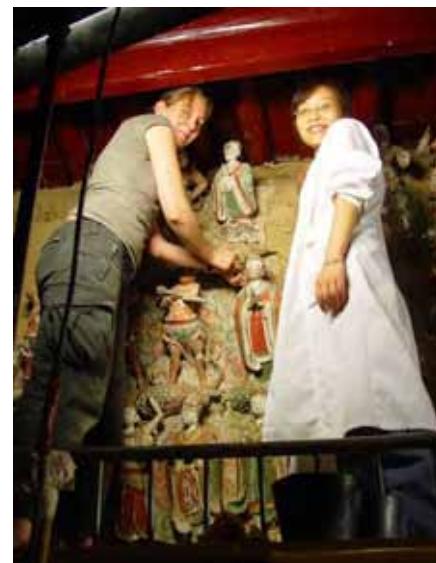
6

Hinterspritzen der Figur W2.41

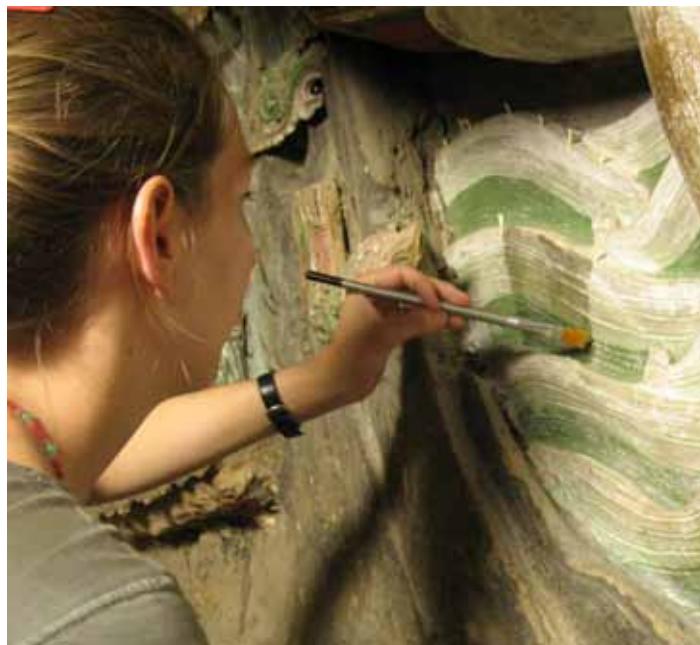
7

Test für Malschichtfestigung

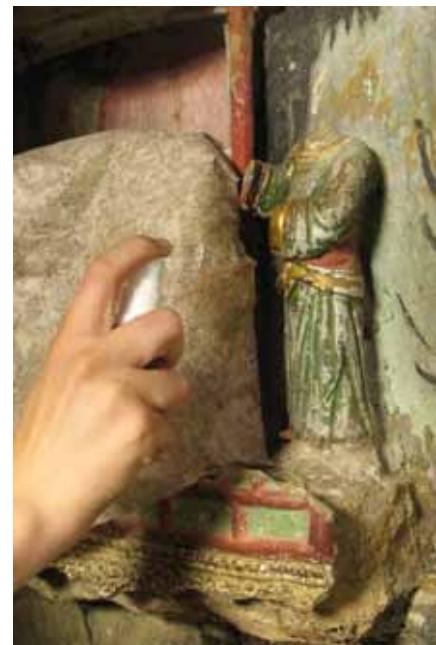
8

Festigung mit Sprühen
